# **Ground Gas Mitigation: Verification Inspection Report**

Pearsons Close  
(Prev. 128 Barrier Bank),  
Cowbit, Spalding, PE12 6AL

Issue 2

March 2026

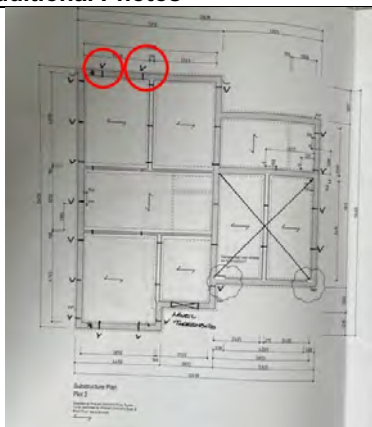
| (Section 1, Materials and Method of Seal) | |
|---|---|
| Plot 2: Advisory, 2x telescopic vents missing due to coordination issues on site. | |

Plot 2. Areas highlighted are where telescopic vents are missing due to door / threshold coordination issues.

MEC observed that telescopic vents and air bricks have been constructed per the venting layout plans, with the exception of Plot 2 (where 2 No. vents / air bricks had been omitted due to a coordination issue with door / threshold detailing) and Plot 4 (where 1 No. vent / air brick has been omitted, presumed by error). Revised ventilation calculations were completed by East Anglian Civils Limited for Plots 2 and 4 (see Appendix C). These confirm the as-built venting provision to exceed requirements by 32% at Plot 2 and 41 % at Plot 4. As such, retrospective installation of the missing vents is not considered to be required.

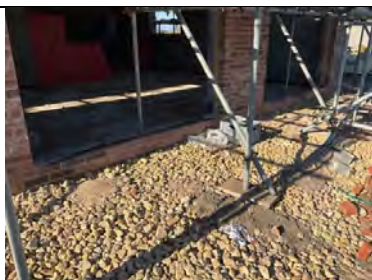
Plot 2. Area where the 2 telescopic vents are missing due to door / threshold coordination issues.

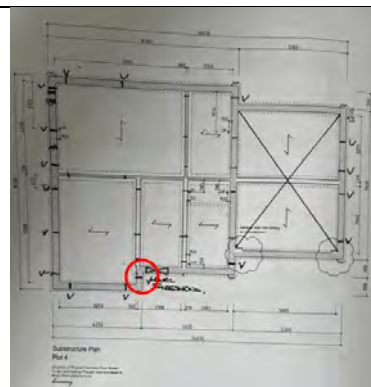
| (Section 1, Materials and Method of Seal) | |
|---|---|
| Plot 4: Advisory, 1x telescopic vent missing. | |

Plot 4. Area highlighted is where the telescopic vent is missing.

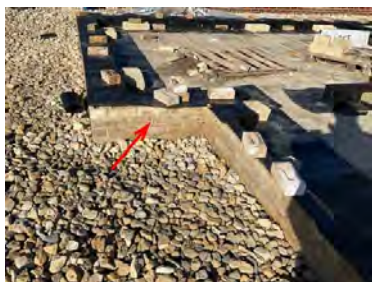
Plot 4. Area where the telescopic vent was missing.

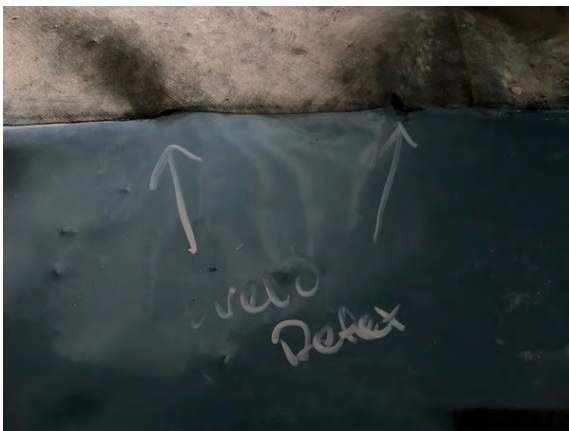
| Plot Number | (Section 3, Defects List) | Action Required |
|---|---|---|
| 2 | 2x weld defects recorded at the time of our inspection. These were patch repaired by MEC using Juta GP1 SAM, heat and pressure applied.<br><br>No further defect recorded at the time of our inspection. | N/A |

2x Weld defects identified.

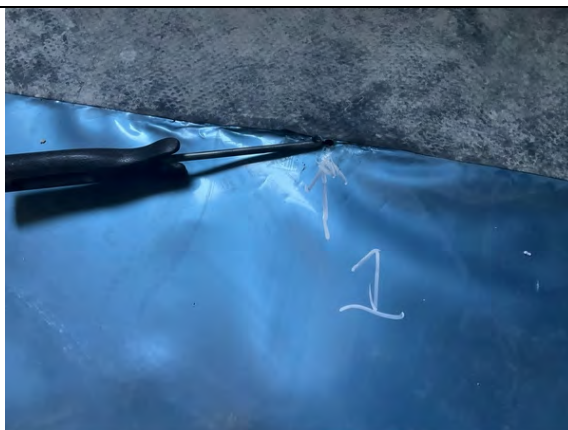
| Plot Number | (Section 3, Defects List) | Action Required |
|---|---|---|
| 1 & 3 | Plot 1 infill: 4x Defects were identified during inspection, these were patched repaired using Juta GP1 SAM and probe tested. No further Defects were recorded at the time of our inspection. | N/A |

Plot 1. Recorded defect.

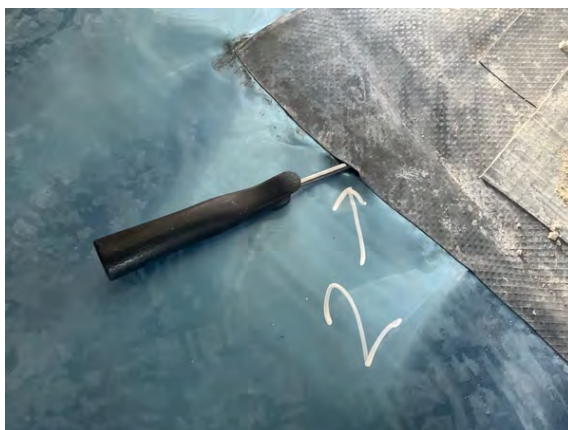
Plot 1. Recorded defect.

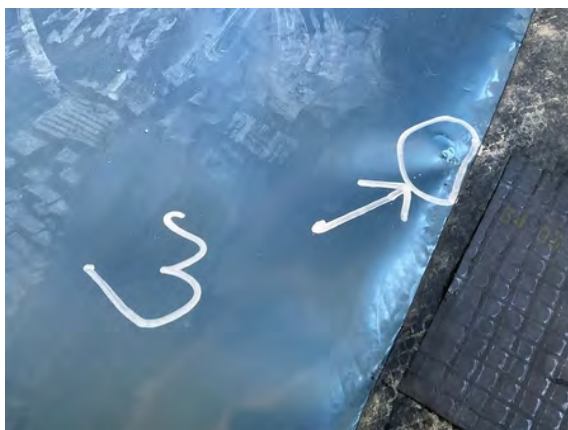
Plot 1. Recorded defect.

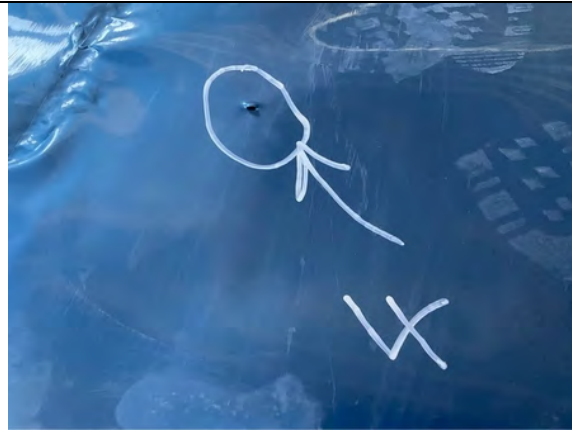
Plot 1. Recorded defect.

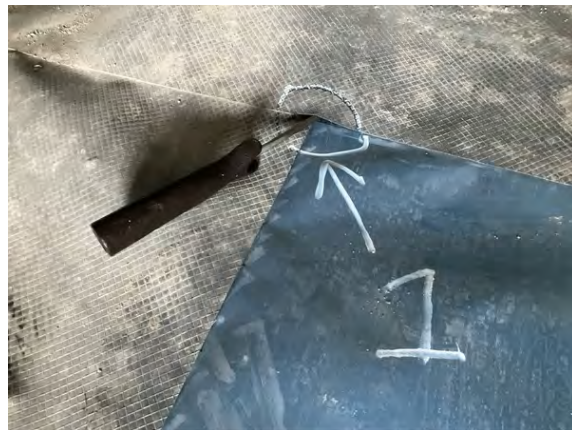
| Plot Number | (Section 3, Defects List) | Action Required |
|---|---|---|
| 4 & 5 | Plot 4: 3no of defects identified.<br>Plot 5: 2no of defects identified.<br>These were patch repaired by MEC with adequate heat and pressure applied.<br>No further Defects were recorded at the time of our inspection. | N/A |

Plot 4. Recorded Defect.

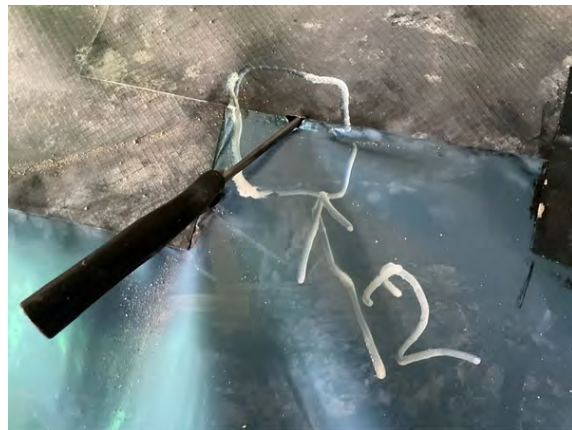
Plot 4. Recorded Defect.

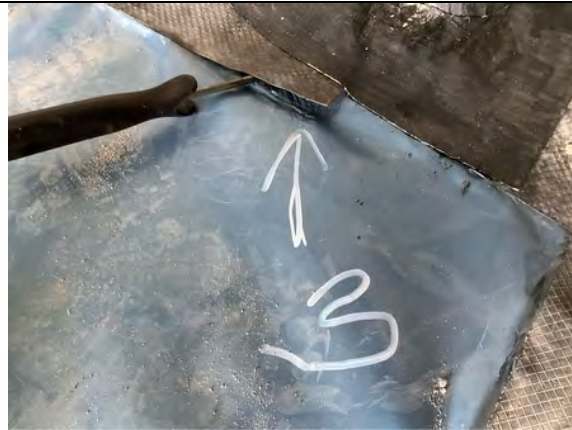
Plot 4. Recorded Defect.

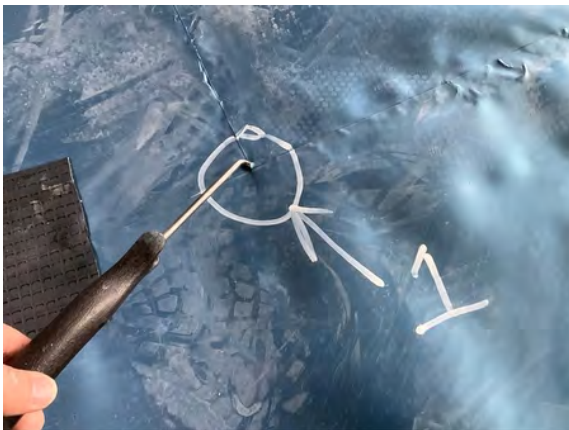
Plot 5. Recorded Defect.

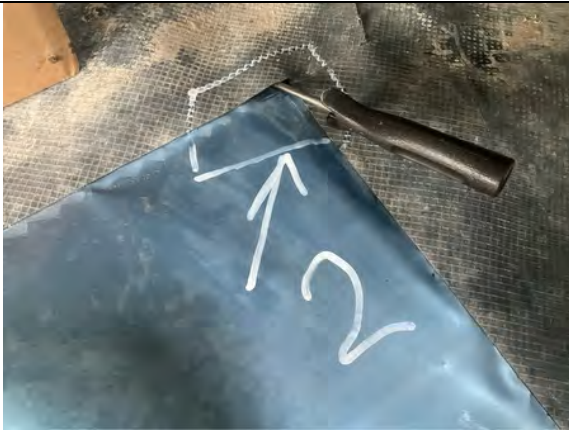
Plot 5. Recorded Defect.

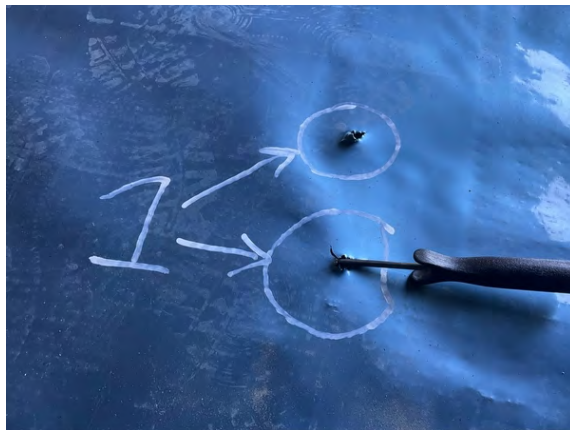
| Plot Number | (Section 3, Defects List) | Action Required |
|---|---|---|
| 3 | 3x defects were identified during inspection, these were patch repaired by MEC using Juta GP1 SAM and adequate heat applied.<br><br>No further Defects were recorded at the time of our inspection. | N/A |

Recorded Defect.

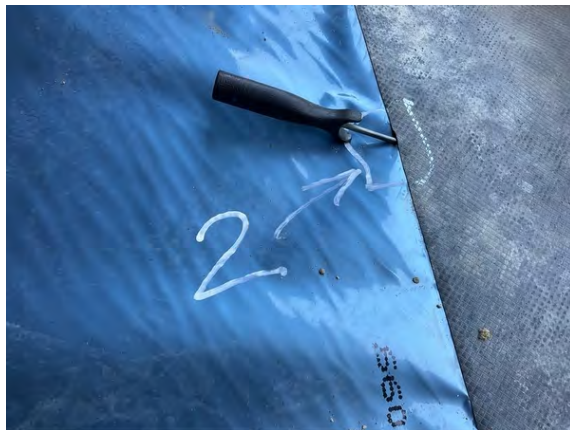
Recorded Defect.
