## Addendum Arboricultural Report

### Subsidence Damage Investigation at:

42 Stonegate  
Cowbit  
Spalding  
Lincolnshire  
PE12 6AH

| MWA REF: | SUB190206-3516Rev02 |

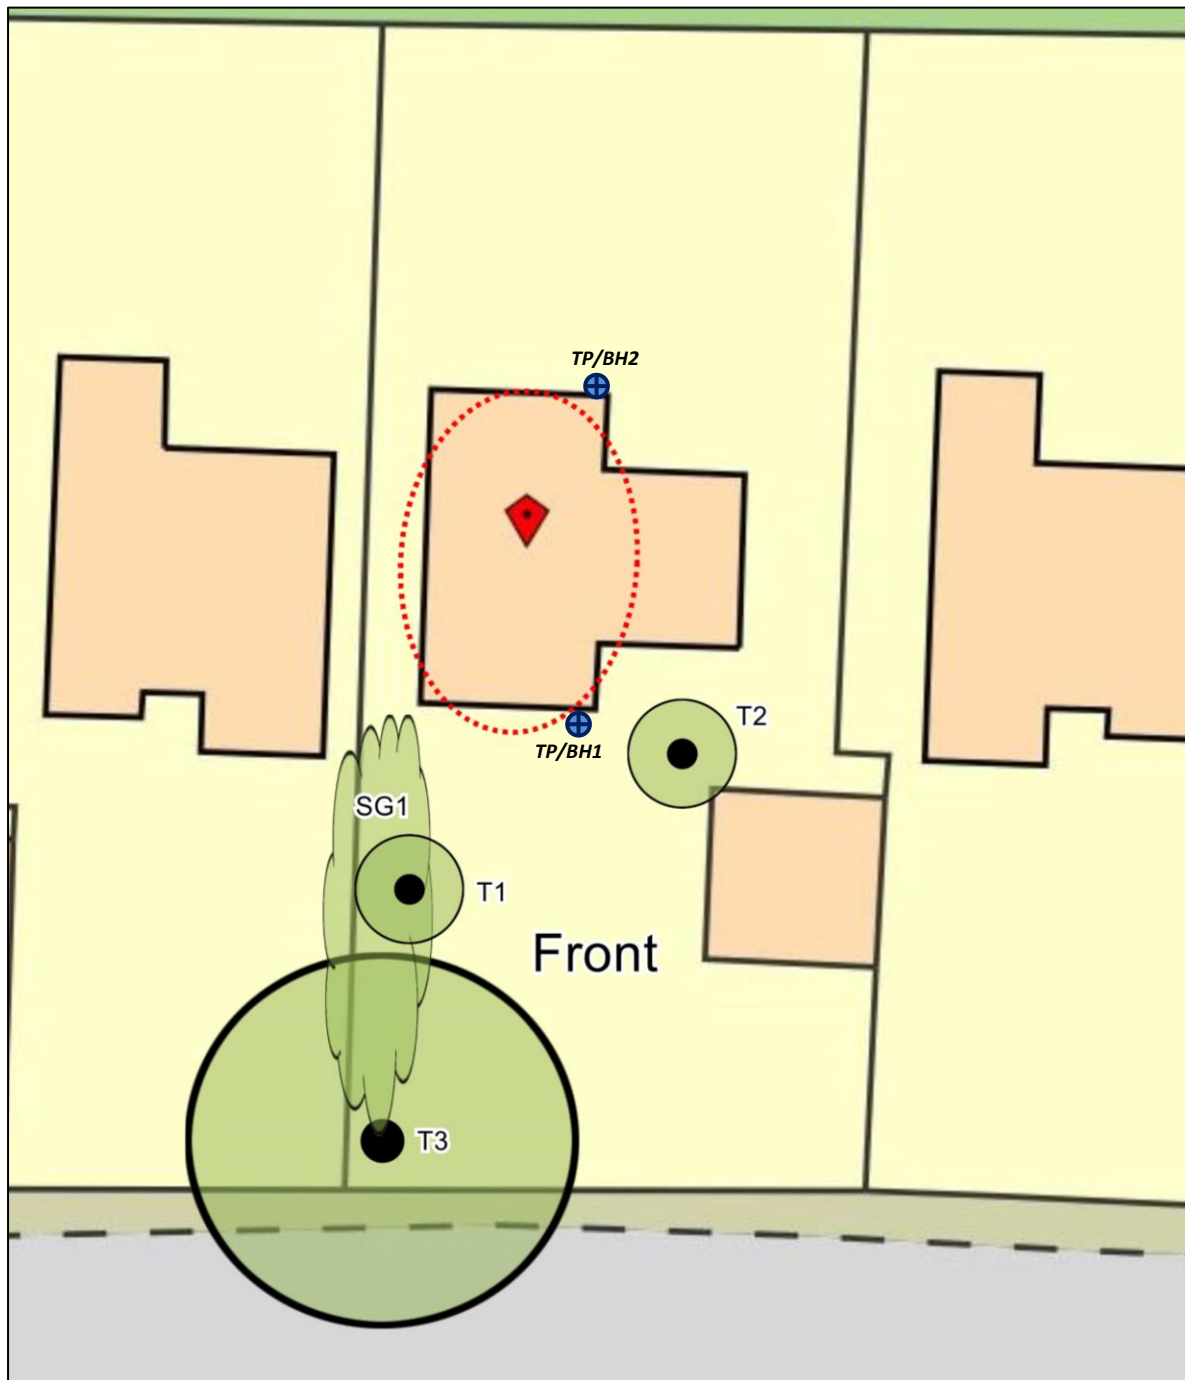
## Site Plan

Approximate areas of damage

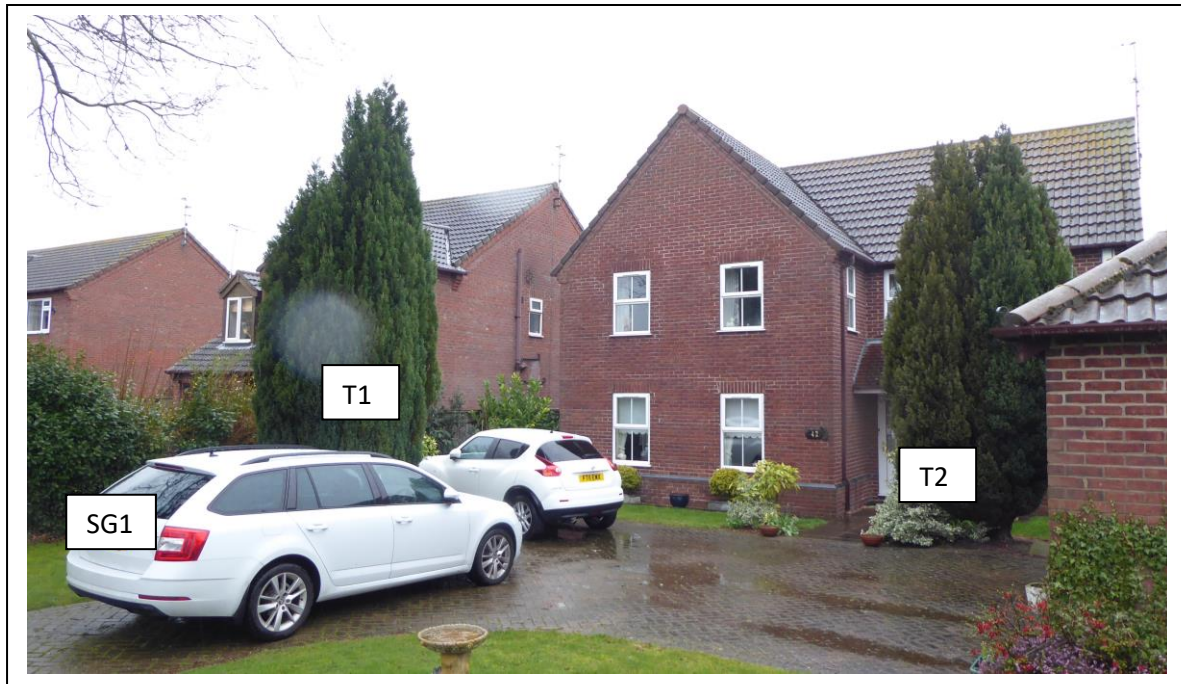
Having considered the information currently available, it is our opinion that T3 Oak is the principal cause of the current subsidence damage - the drying effects of which across the site will be significant. Nearby Cypresses T1 and T2 are a potential contributory influence, as well as a localised influence to a much lesser degree from the Laurel of SG1 group. Vegetation to the rear of the property [not recorded], comprising mostly Birch and shrub spp. vegetation, is of mostly low moisture demand and sufficiently distal from the property not to be significant.

View of T1 and T2 Cyresses with SG1 group visible to left of frame

If an arboricultural solution is to be implemented to mitigate the influence of the trees/shrubs considered to be responsible for the damage we recommend that T1, T2 and T3 are removed. The nearby Laurel from SG1 group should also be removed in order to negate any contributory influence.

| Tree No. | Species | Ht (m) | Dia (mm) | Crown Spread (m) | Dist. to building (m) | Age Classification | Ownership |
|---|---|---|---|---|---|---|---|
| Recommendation | | Remove (fell) to near ground level and treat stump to inhibit regrowth. | | | | | |
| Recommendation | | Remove (fell) Laurel adjacent to front left corner of building to near ground level and treat stump to inhibit regrowth. | | | | | |

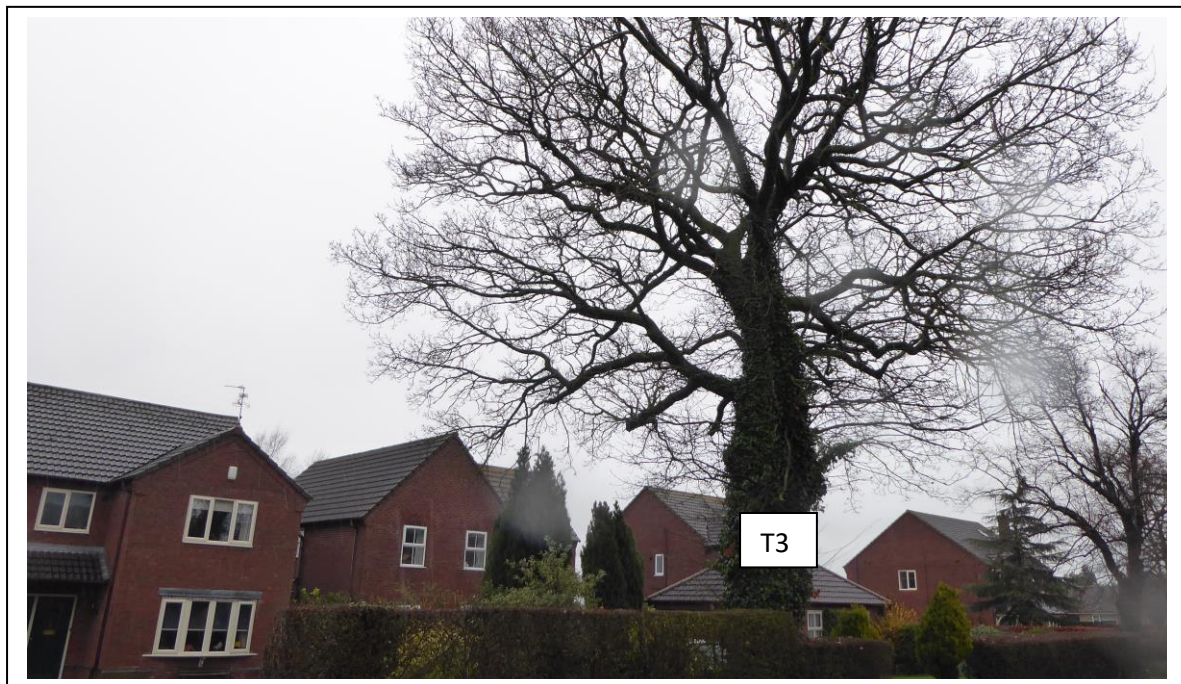
The origin of the *Prunus* spp. roots will be the Laurel within SG1 group. Given the absence of any nearby *Castanea* species, the *Quercus* spp. roots will emanate from T3 Oak.

View of T3 Oak

| Tree No. | Species | Ht (m) | Dia (mm) | Crown Spread (m) | Dist. to building (m) | Age Classification | Ownership |
|---|---|---|---|---|---|---|---|
| Recommendation | | Remove (fell) to near ground level and treat stump to inhibit regrowth. | | | | | |

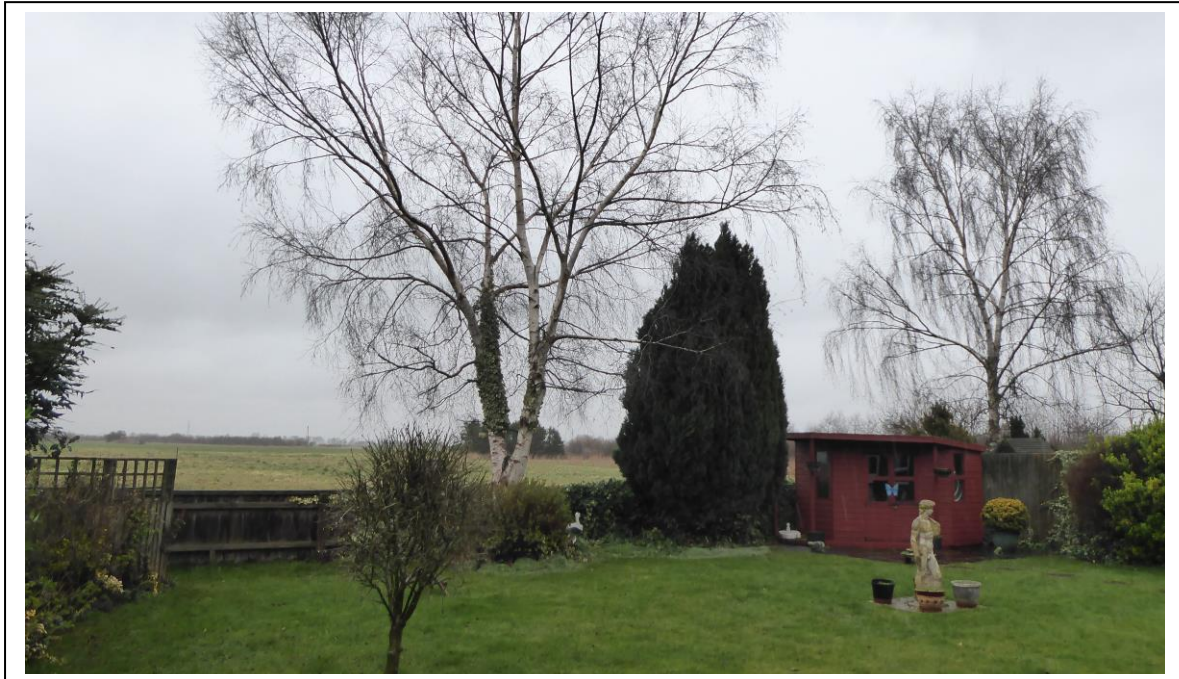
View of rear garden – mostly Birch and shrub spp. vegetation [not recorded] not considered relevant
