# **TECHNICAL REPORT ON A SUBSIDENCE CLAIM**

**Crawford Reference: SU1807857**

**42 Stonegate  
Cowbit  
Spalding  
Lincolnshire  
PE12 6AH**

**SUBSIDENCE CLAIM**

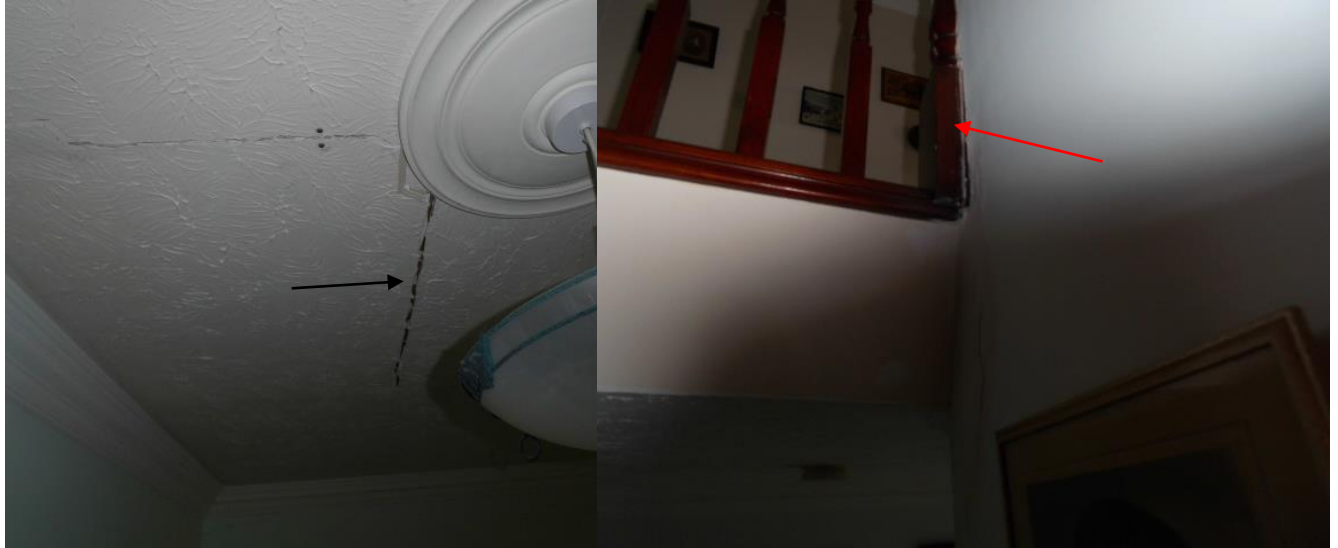
Landing – cracking to ceiling

Hall – cracking to stairs at junction with wall

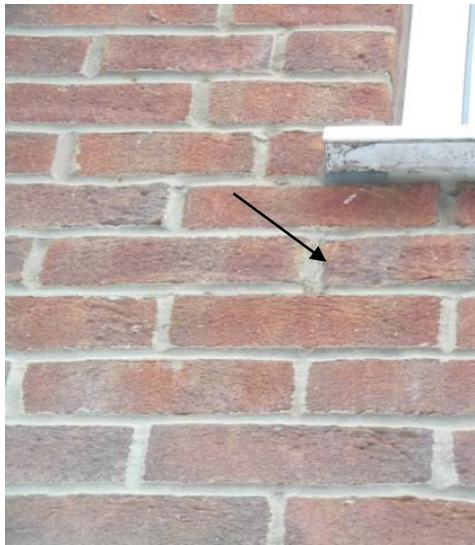
Minor cracking below left hand ensuite window

- Hairline crack to soldier course above lounge/diner window.
- Stepped crack under ensuite window up to 0.5mm wide.

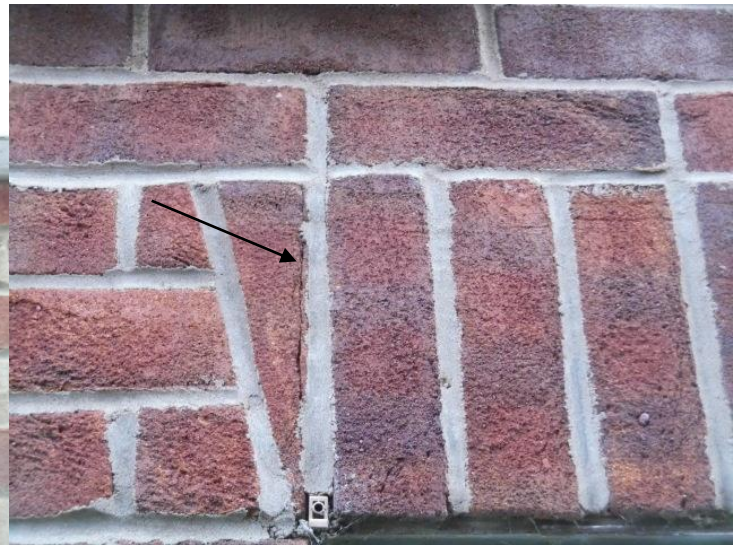
Minor cracking above left hand lounge/diner window

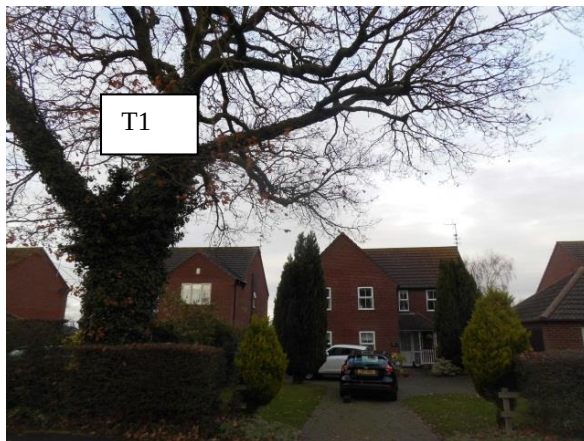
| Type | Height | Distance | Ownership |
|---|---|---|---|
| T1 Oak | 12 m | 16 m | Owners |

Oaks are, in my experience, worthy of considerable respect when dealing with subsidence claims. Their root system extends for surprising distances and can be associated with particularly high soil suctions.

View of Tree T1

Although the cause of the movement needs to be dealt with, we note the vegetation is likely to be the subject of a Preservation Order. Subject to this being confirmed, then unfortunately current legislation requires certain investigations to be carried out to support an application for the tree works.

It will also be necessary to obtain a specialist Arboricultural Report.

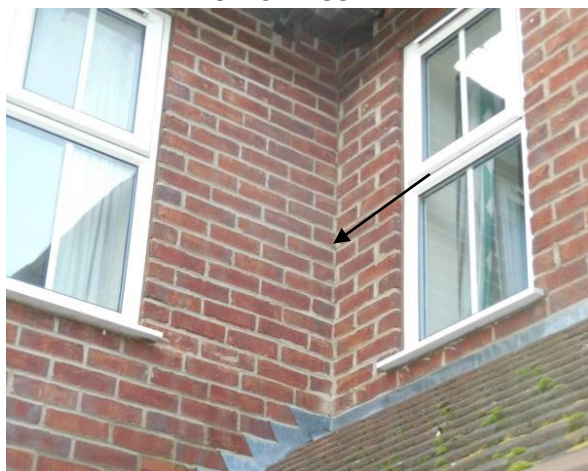
- Minor cracking to junction at return junction by landing window.

Minor cracking at front junction

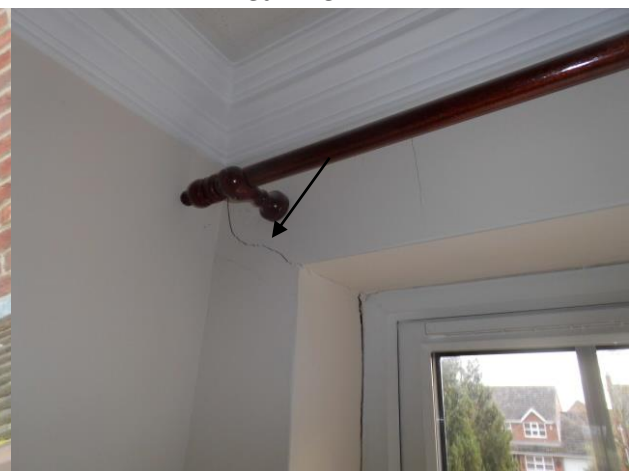
- Vertical tapering crack to right hand wall up to 0.5mm wide
- Cracking through ceiling/coving up to 3mm wide from front to back

Cracking to front right bedroom window

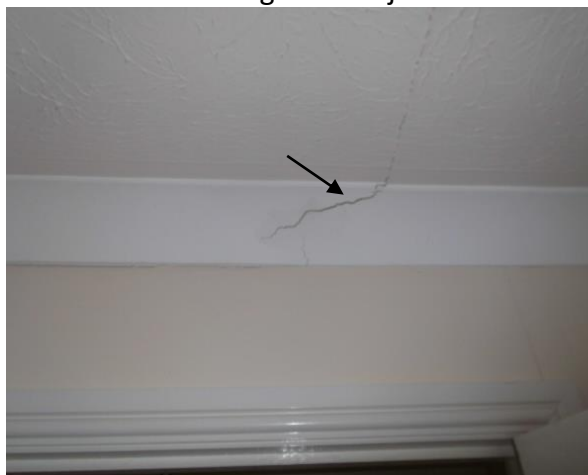
- Cracking through coving/ceiling from door onto landing to rear wall up to 5mm wide
- Vertical cracking to rear left hand corner up to 1mm wide
- Cracking under rear window up to 0.5mm wide

Cracking above rear left hand bedroom  
door way onto landing

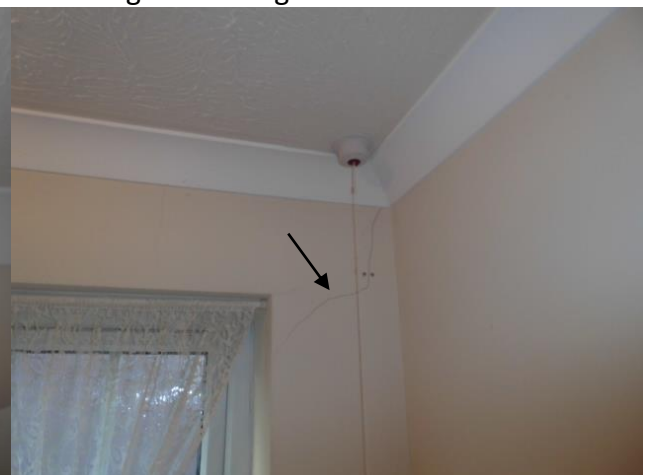
- Diagonal crack above left hand window up to 1mm wide
- Cracking through coving to ceiling from bedroom to rear wall with disturbance of artex finish

Cracking to ensuite (LHS)

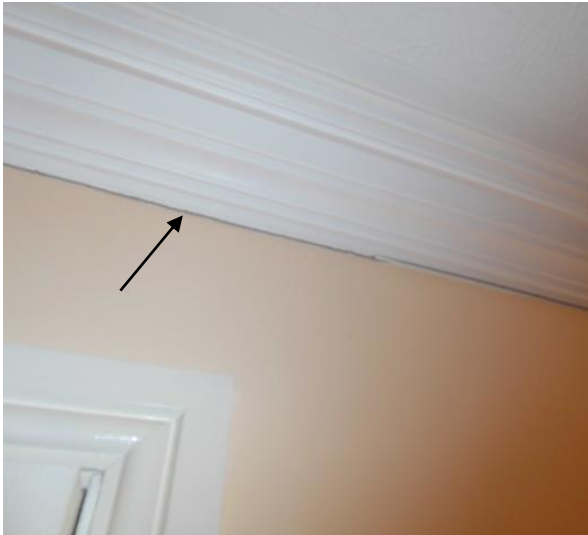
- Cracking between wall and coving to hall door wall up to 3mm wide
- Diagonal cracking above left hand window up to 1mm wide

Cracking between wall and coving to  
lounge/diner

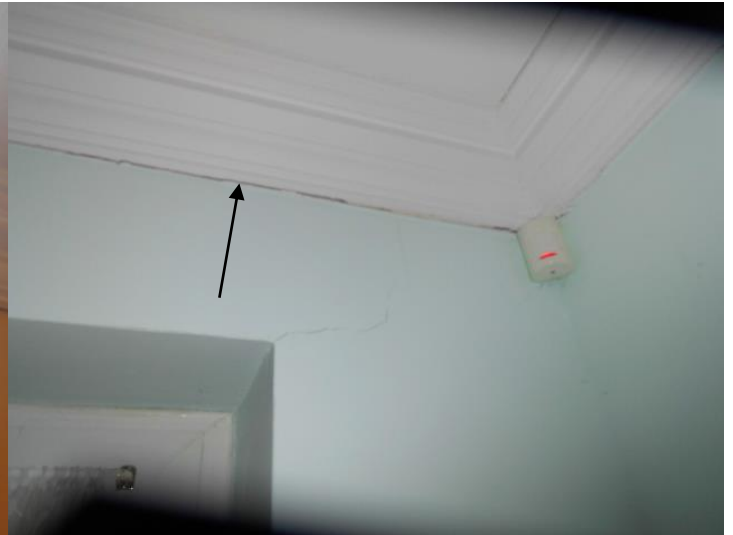
- Gap at floor/landing connection where stairway returns at top up to 10mm wide
- Cracking between wall and coving to lounge/diner door area up toward front up to 6mm wide
- Diagonal crack above front door of less than 0.5mm wide

Cracking above front door to hallway
