**Arboricultural Survey with reference to BS 5837:2012  
Trees in Relation to Construction**

**For Land to the rear of  
21 Peterborough Road  
Crowland  
Cambridgeshire  
PE6 0BB**

**Arboricultural Method Statement with reference to BS  
5837:2012 Trees in Relation to Construction**

**For: Land to the rear of 21 Peterborough Road  
Crowland  
Cambridgeshire  
PE6 0BB**

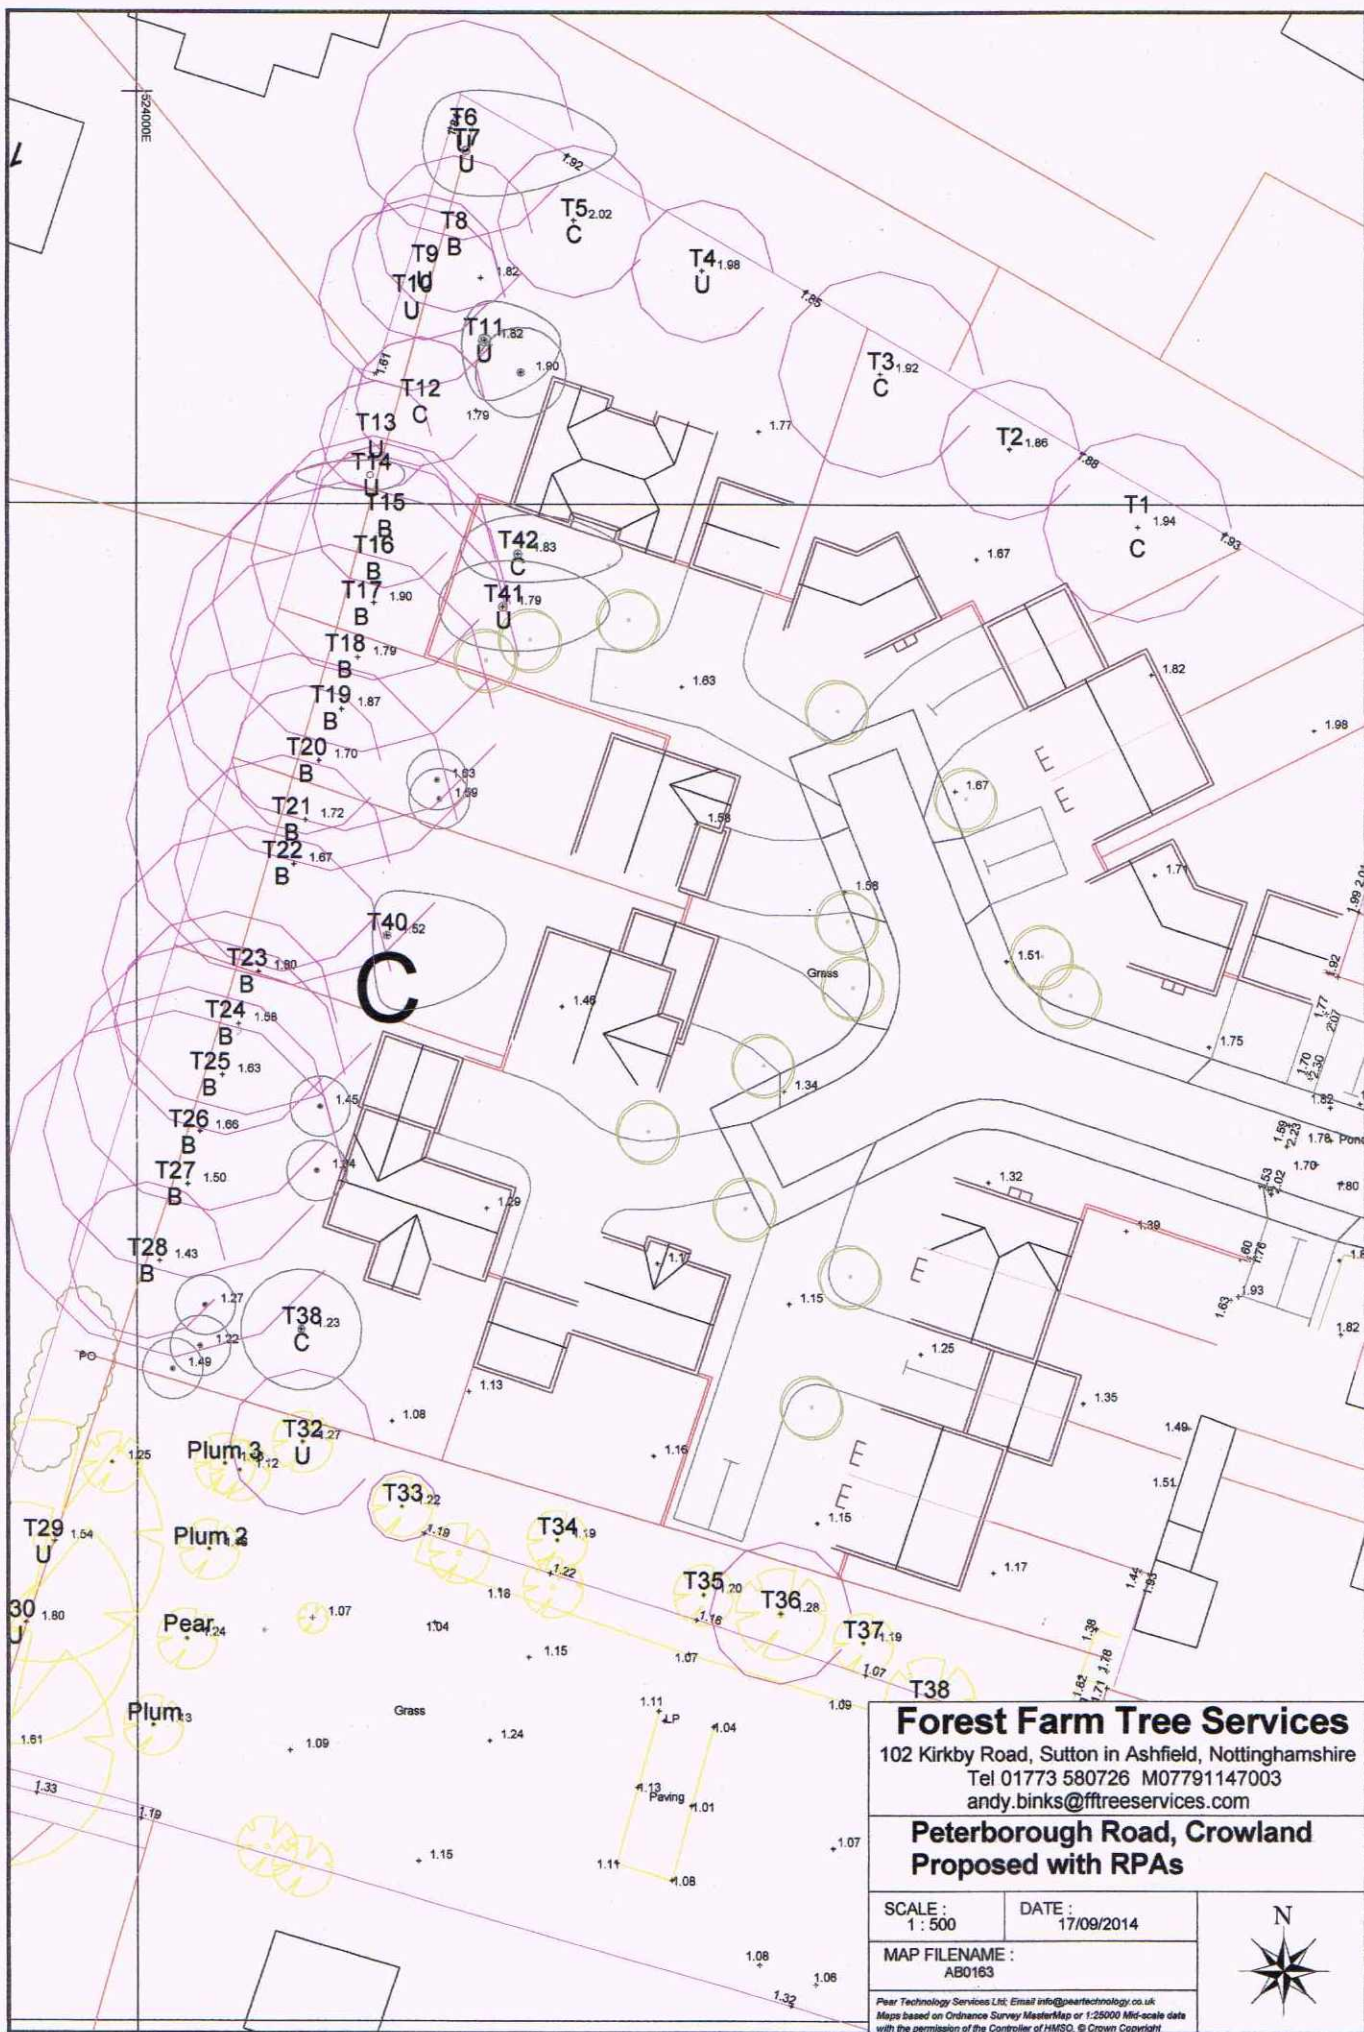
**Peterborough Road, Crowland  
 Proposed with RPAs**

- 4.5** There is to be minor infringement to the edge of the RPA of T1 & T27 for the construction outer walls for 1 dwelling alongside each tree. The amount of infringement, together with the resilient nature of the species involved it is deemed unnecessary to utilise specialist building techniques. It is however stressed that the remainder of the RPA be protected from damage from access to carry out the works. It will be necessary to install a temporary ground layer designed to prevent compaction in these areas.

- 5.2 Minor infringement into the RPA of T1 & T27 is not deemed excessive enough to warrant specialist building techniques, based on the species involved. Ground protection measures must be taken to prevent damage to the RPA through access to carryout works.

The **RPA** and its radius has been included within the tree survey table, this information has been plotted on the site plan
