PRELIMINARY ASSESSMENT OF EXTERIOR AT MANOR HOUSE, CROWLAND,  
LINCOLNSHIRE

JOB NO. 438-44

MR AND MRS SMEDLEY

14 NOVEMBER 2024 AND 28 JANUARY 2025

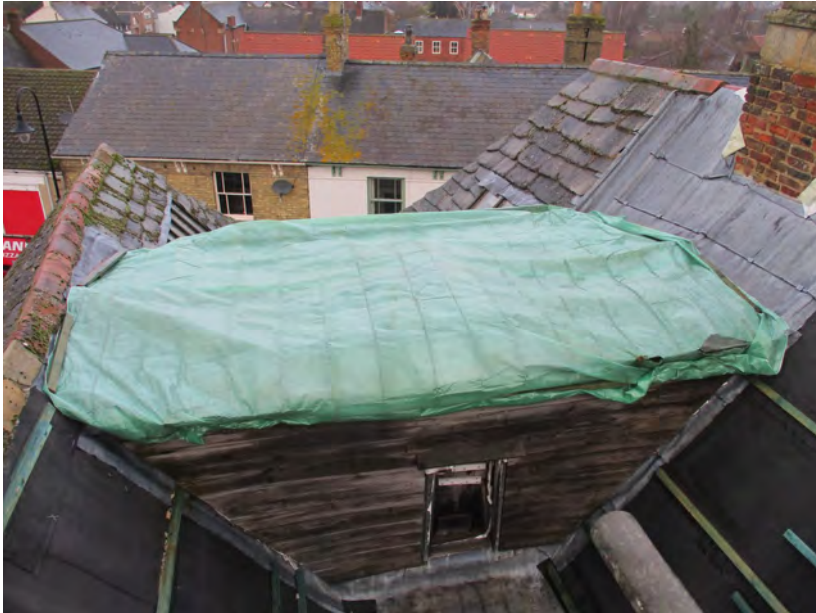
**Fig 5:**

Roof R1/R2 link ('rabbit hutch').

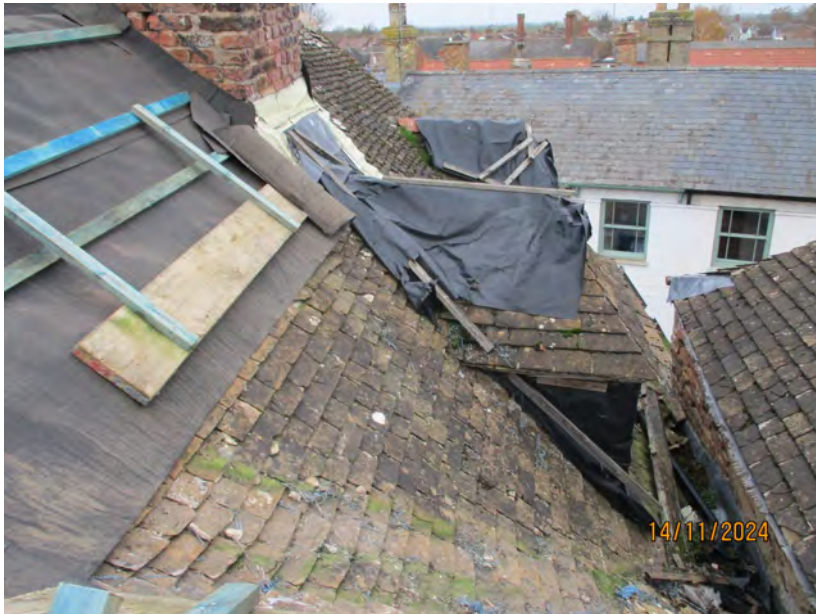
**Fig 7:**

| Roof: R2<br>Name: <b>East range</b> | | |
|---|---|---|
| Roof | <p>Pitched roof with north hip slope (R2a), south parapet abutment, 2 no. dormers windows to east slope, rudimentary rooflight to west slope, link ('rabbit hutch') to west attic and pitched roof intersecting east slope between R2/R4. Collyweston stone slate covering to north and east slopes shows damage to slates and holes through covering with risk of rainwater penetration. West slope without slates protected with temporary covering. Temporary coverings to upper part of east slope and dormer windows roofs. Link as Roof R1</p> | <p><b>Maintain temporary covering to east and west slopes including dormers</b><br/> <b>Maintain temporary protection to link as Roof R1</b><br/> Consider replacement of roof covering<br/> Consider replacement or removal of rooflight subject to LBC</p> |

Roof R2b..

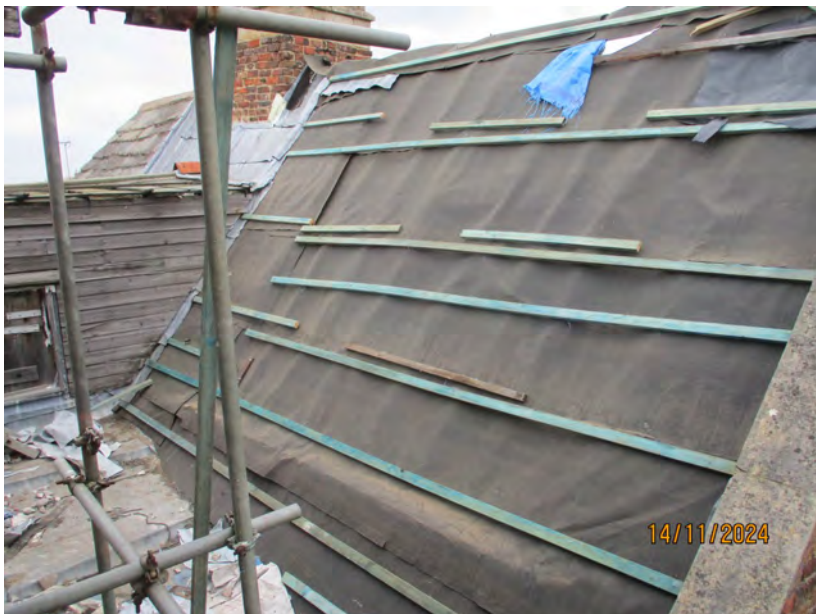
**Fig 8:**

Roof R2c..

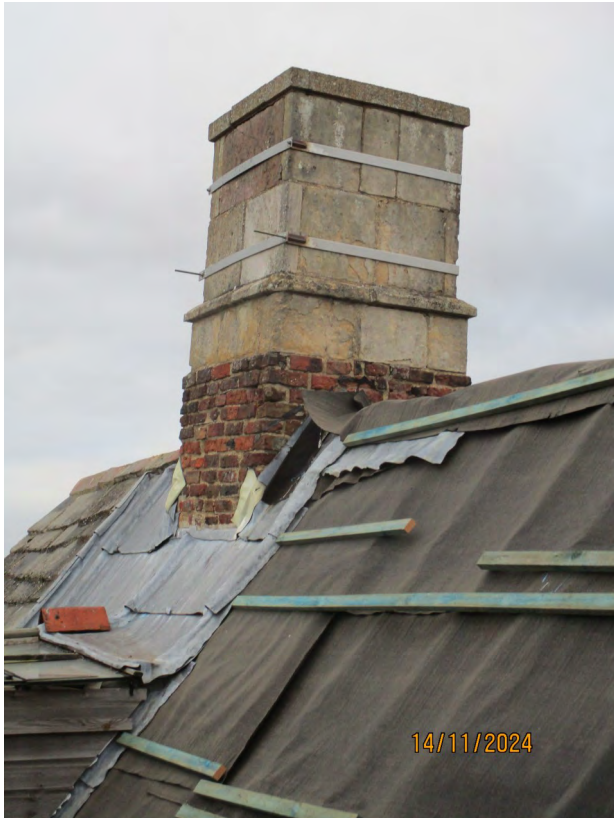
**Fig 9:**

Chimneystack Cs3 (Roof R2).

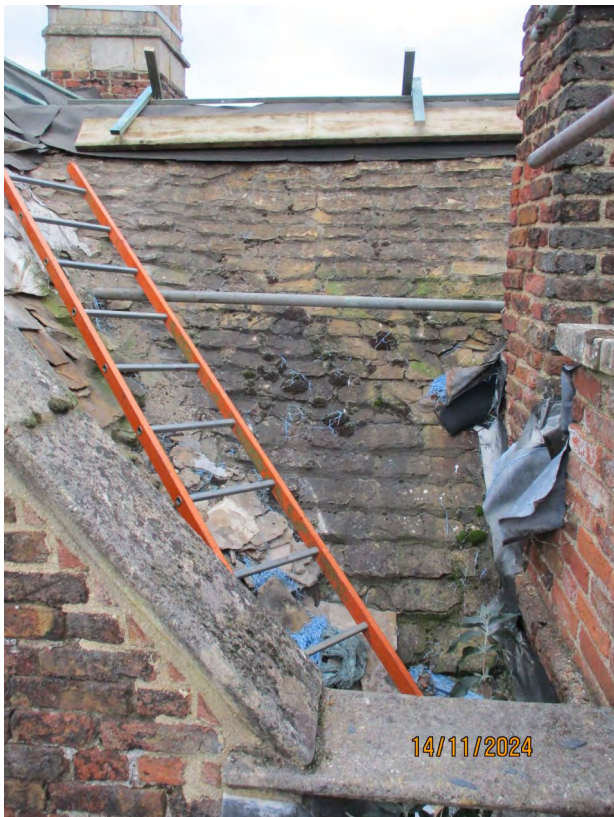
**Fig 10:**

| Roof: R3<br>Name: <b>Intersecting roof between R2/R4</b> | | |
|---|---|---|
| Rainwater disposal | North valley drains to assumed box gutter between R2b/R4e with debris and likely blockage and south valley drains to small flat roof between R3b/R4f (R3b) draining rainwater to hopper head and downpipe | Clear assumed box gutter at north valley<br>Repair/maintain existing rainwater goods<br>Consider modification to improve drainage from building |

Roof R3b..

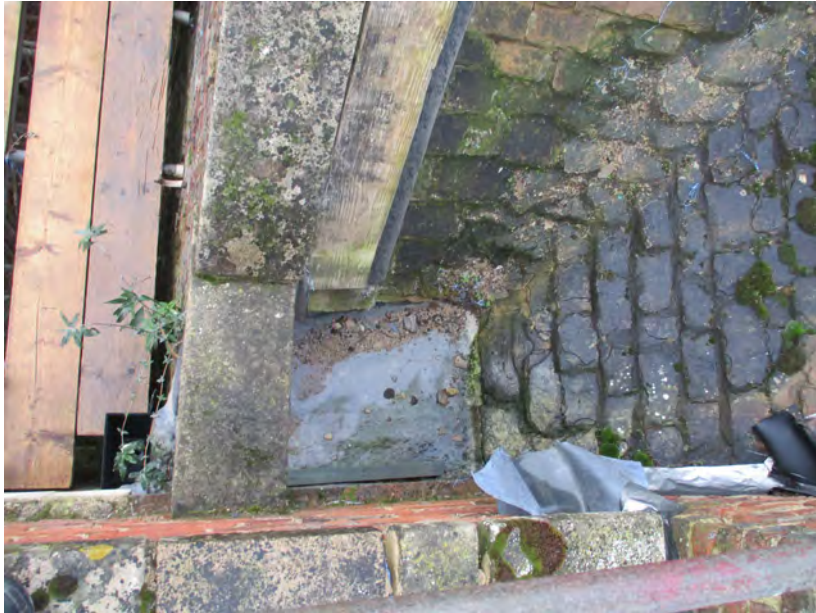
**Fig 11:**

Roofs R3b/R4f gutter.

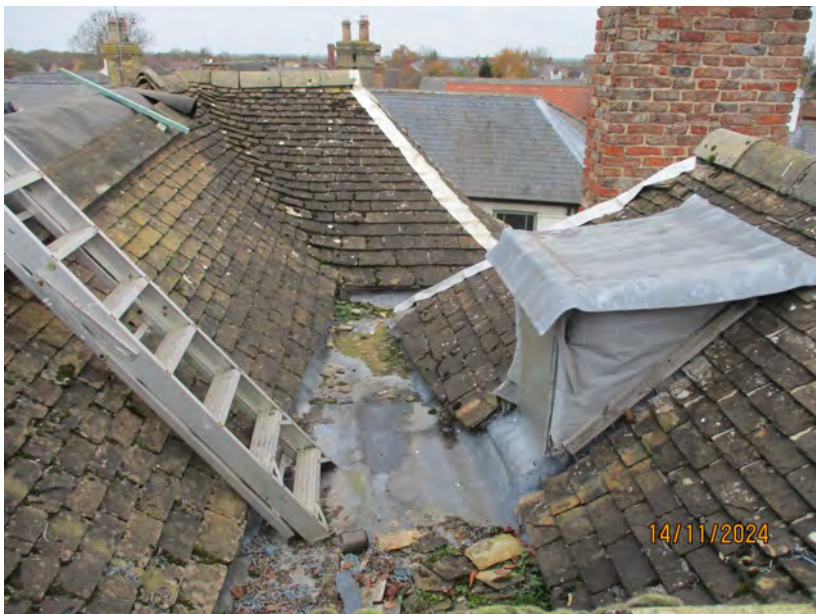
**Fig 12:**

Roofs R4c, R4d and R5c.

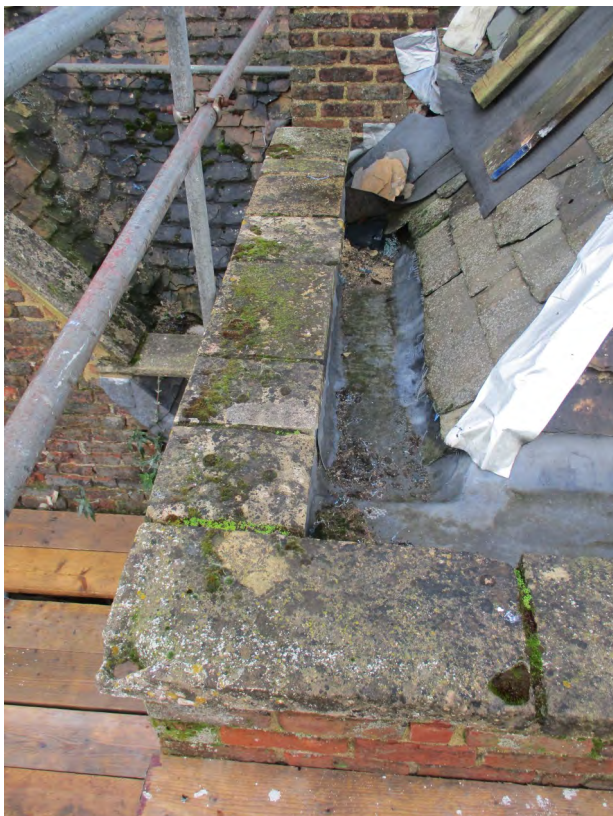
**Fig 14:**

Roofs R4f.

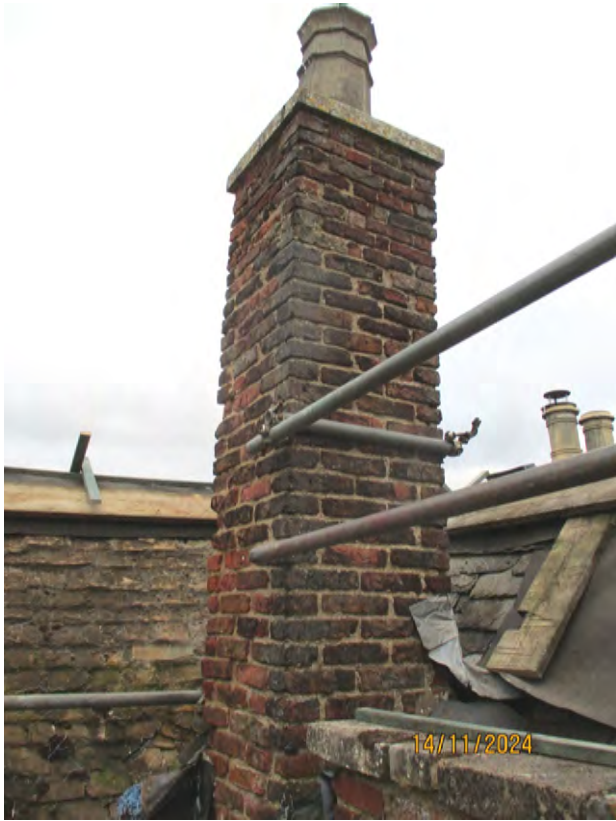
**Fig 15:**

| Roof: R4<br>Name: <b>L-shaped west roof to C18 addition</b> | | |
|---|---|---|
| Chimneystacks | CS4 intersected by Roof R3b/R4f valley gutter as tall brick stack with 1 no. buff pot and back gutter. Brickwork shows open and/or defective joints | |

Chimneystack Cs4 (Roof R4).

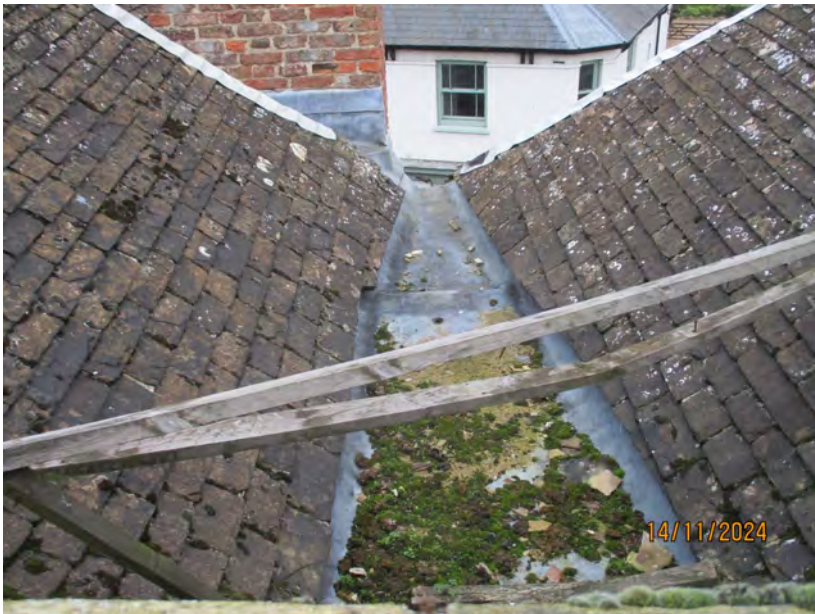
**Fig 16:**

Roofs R5b and R6c

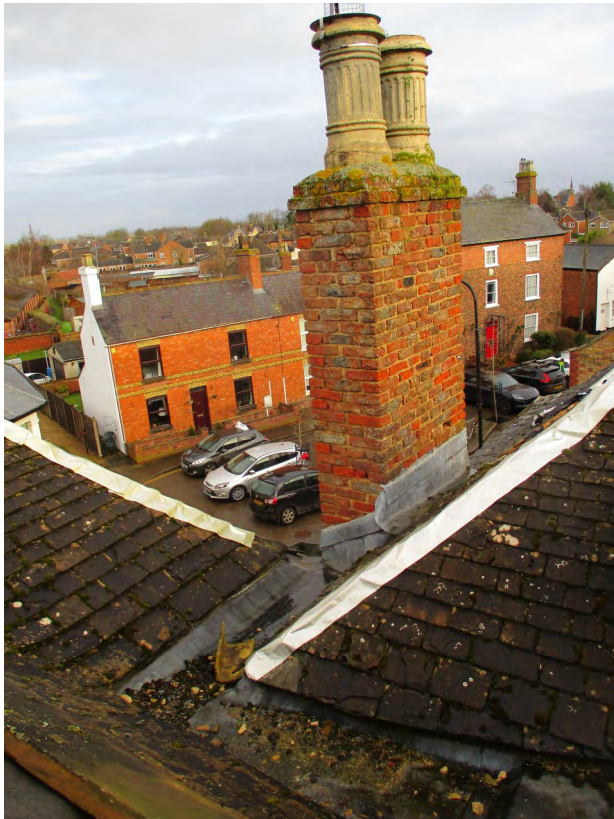
**Fig 17:**

Chimneystack Cs5 (Roof R5).

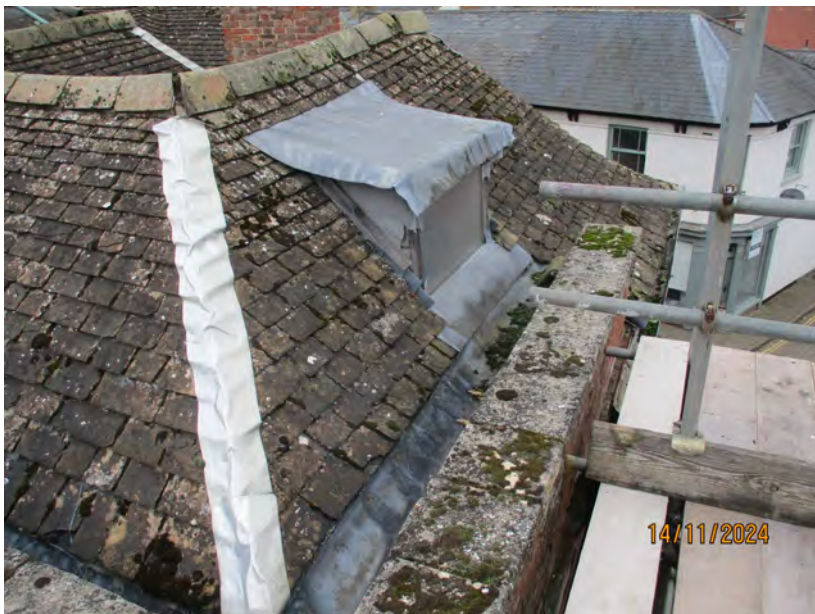
**Fig 18:**

Roof R6b.

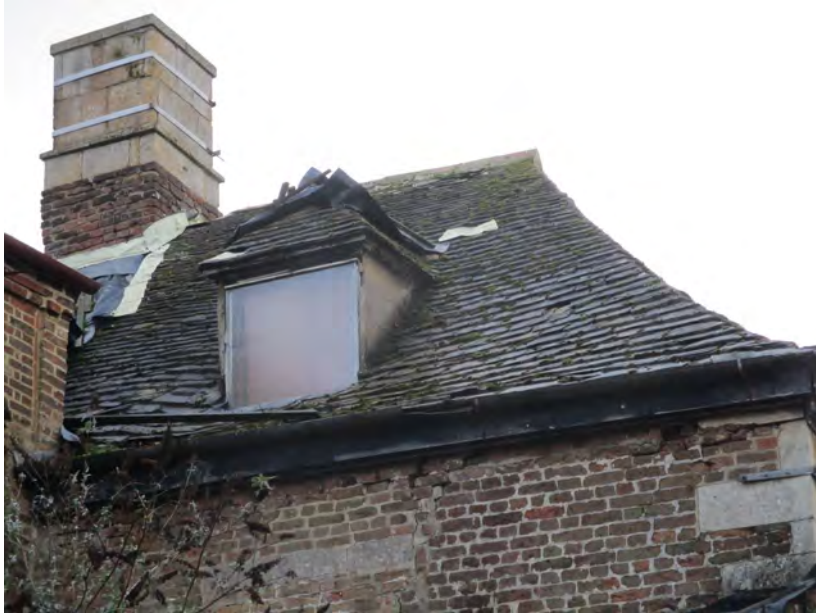
**Fig 19:**

Roof R6b.

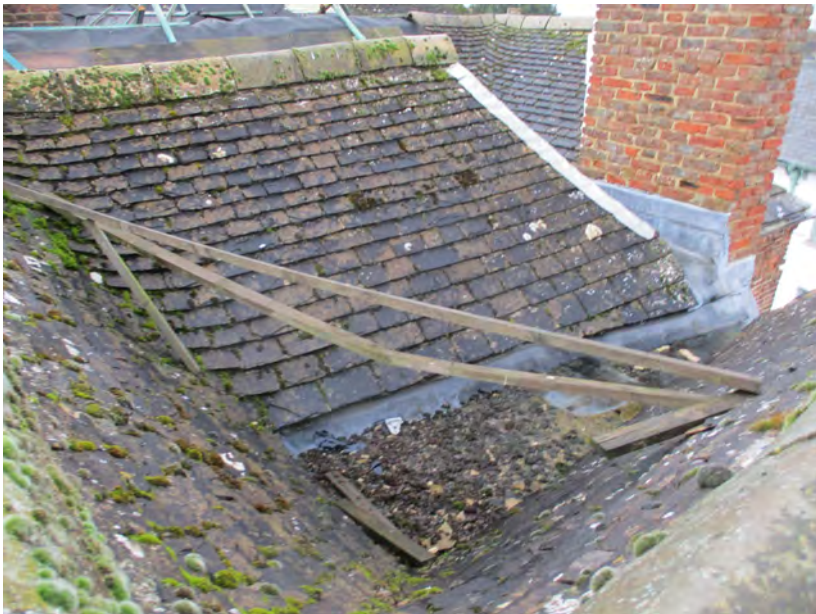
**Fig 20:**

Roofs R5b and R6c.

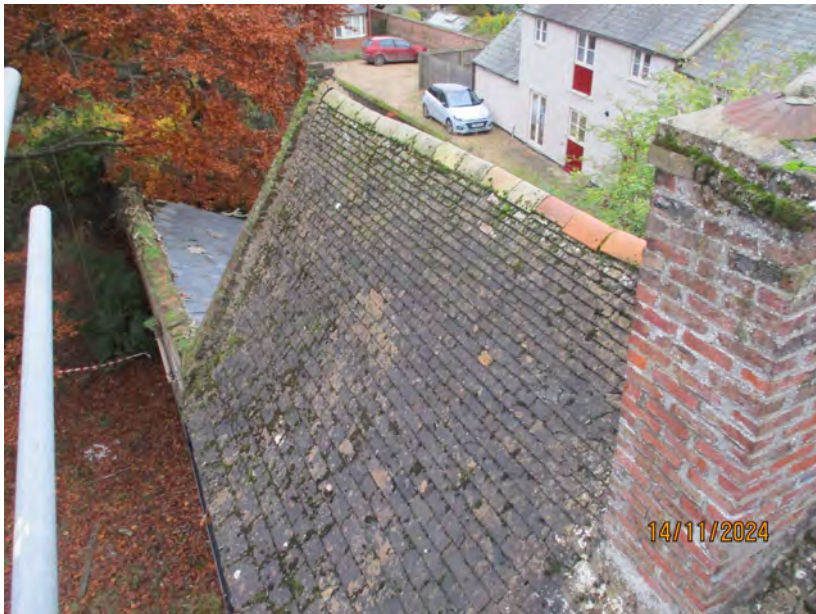
**Fig 24:**

| Roof: R9<br>Name: <b>Rear service range</b> | | |
|---|---|---|
| Roof | Pitched roof with mortar fillets to north at abutments to house and south at gable parapet; north abutment shows open joints suggesting previous flashing. Collyweston stone slate covering shows undulation, damaged slates and holes through west slope covering particularly to south with high risk of rainwater penetration. Distortion to south gable elevation causing failure of abutment with likely rainwater penetration | Consider replacement of roof covering |

Roof R9a.

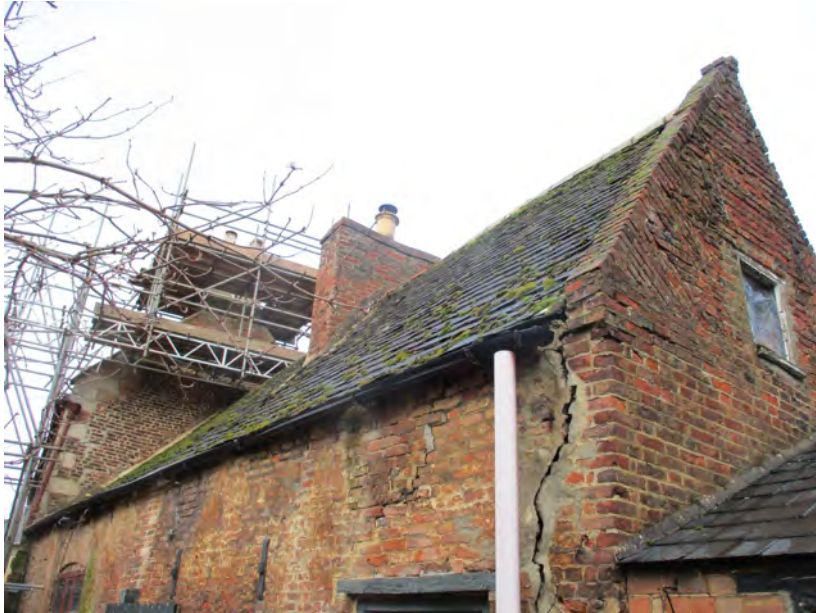
**Fig 25:**

Roof R9b.

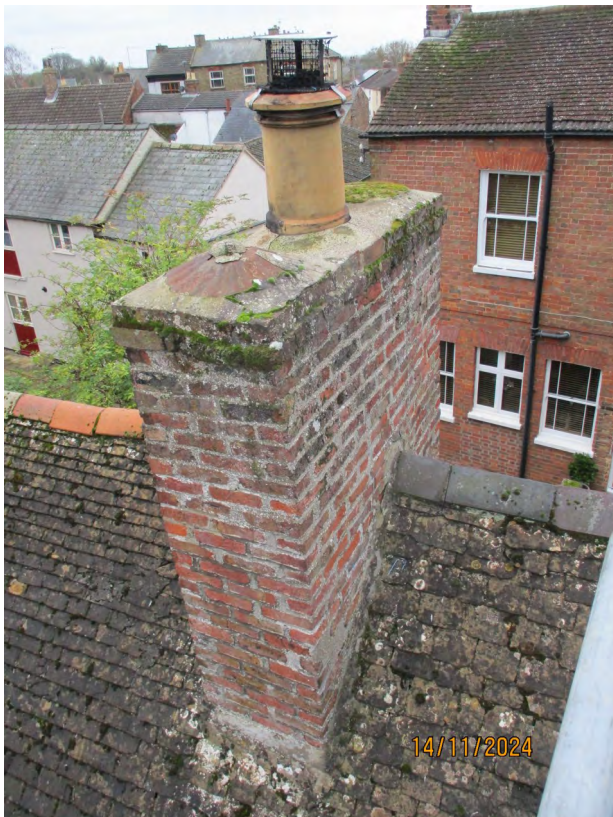
**Fig 26:**

| Roof: R9<br>Name: <b>Rear service range</b> | | |
|---|---|---|
| Chimneystacks | Cs6 to ridge as brick stack with 1 no. butt pot and covers over 2 no. flues (assumed dustbin lid) and mortar fillets. Flashing shows cracking with high risk of rainwater penetration. Staining and biological growth to upper brick courses indicative of saturation | |

Chimneystack Cs6 (Roof R9).

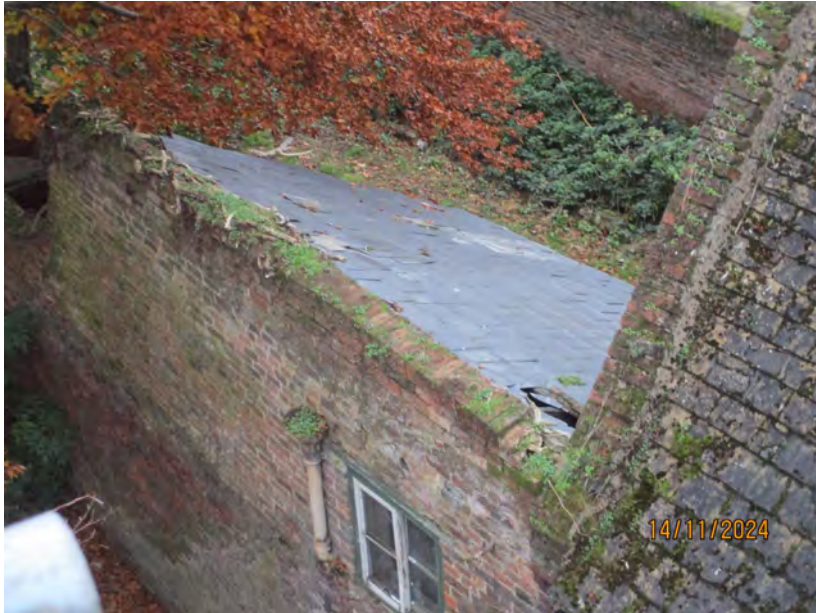
**Fig 27:**

| Roof: R10<br>Name: <b>Rear service addition</b> | | |
|---|---|---|
| Roof | Monopitch roof with gable abutment to north and verge to south. Slate covering with failing mortar fillets to head at defective garden wall head and north abutment shows undulation, damaged/missing slates and glass pane. Root growth through south verge. Damaged and missing slates with high risk of rainwater penetration<br><br>Garden wall with failing mortar fillet shows brick-on-edge capping, significant distortion, open joints and vegetation growth | <b>Remedial works possibly not relevant as building likely to be dismantled due to significant structural problems</b> |

Roof R10.

| Rainwater disposal | West slope intended to drain to (missing) eaves gutter with saturation of ground at dripping eaves | Fit temporary rainwater goods draining to suitable outfall (until building repaired/re-built) |

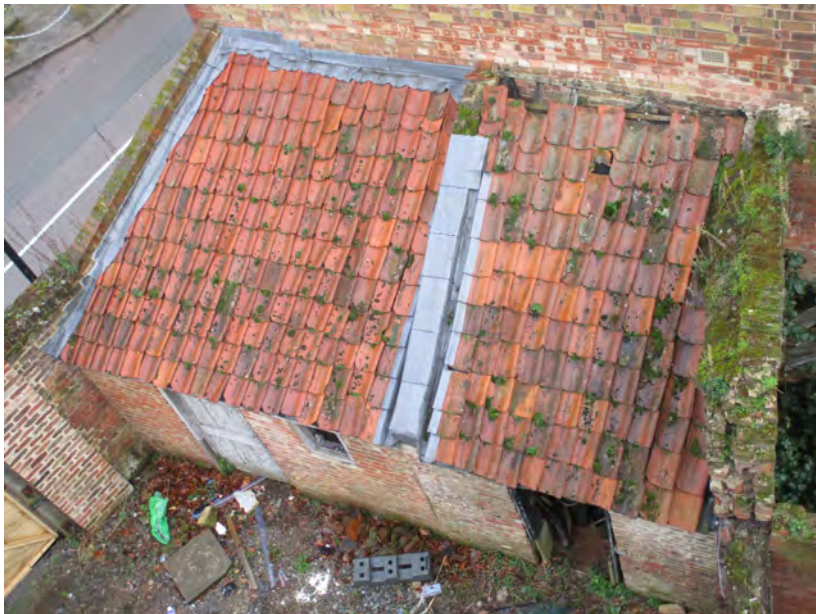
**Fig 28:**

| Roof: R11<br>Name: <b>Outbuilding</b> | | |
|---|---|---|
| Roof | Monopitch roofs against party wall to east with abutments with boundary wall to north and garden wall to south. Lead head flashing to north roof and missing flashing with vegetation and high risk of rainwater penetration to south roof. Pantile covering separated by central lead-covered parapet with basic secret gutters | Remove vegetation from south roof<br>Fit temporary protection to south roof at failed head and south side abutments |

Roofs R11a and R11b.

| Roof: R11<br>Name: <b>Outbuilding</b> | | |
|---|---|---|
| Rainwater disposal | Intended to drain to (missing) eaves gutters over west wall with saturation of ground at dripping eaves | Fit temporary rainwater goods draining to suitable outfall<br>Consider modification to improve drainage from building |

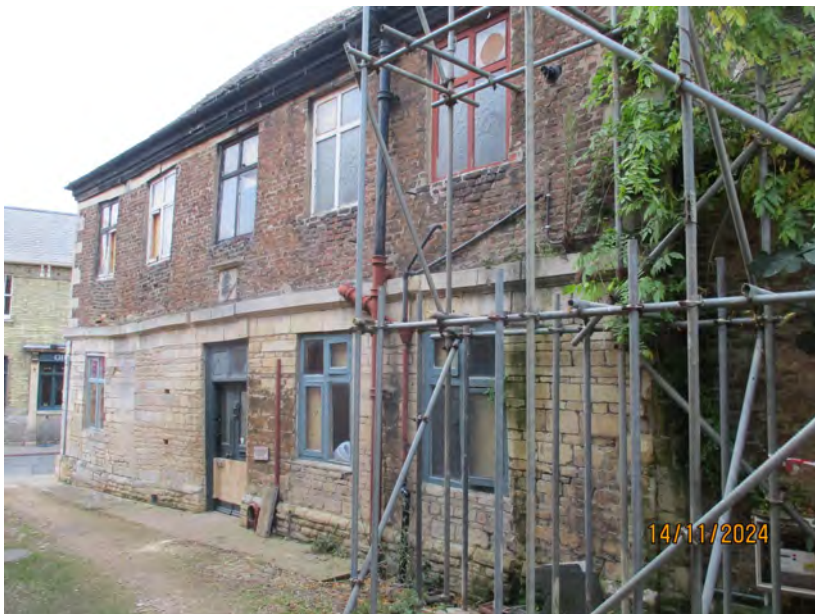
**Fig 30:**

Elevation 2 (west)

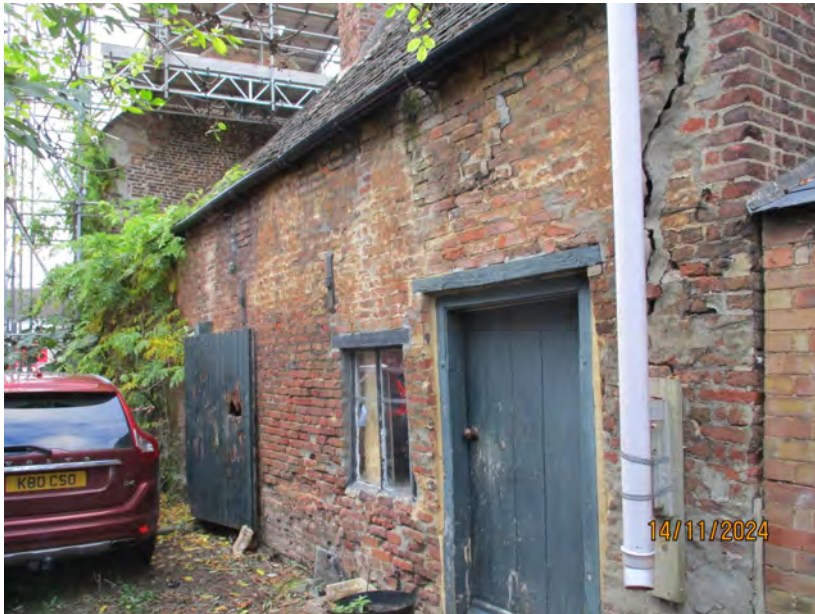
**Fig 31:**

Elevation 3 (west).

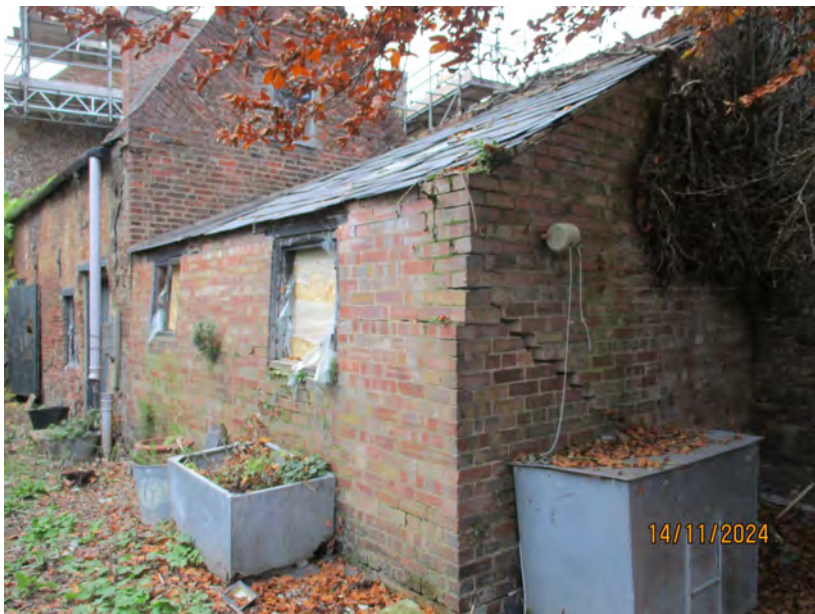
**Fig 32:**

Elevation 4 (south).

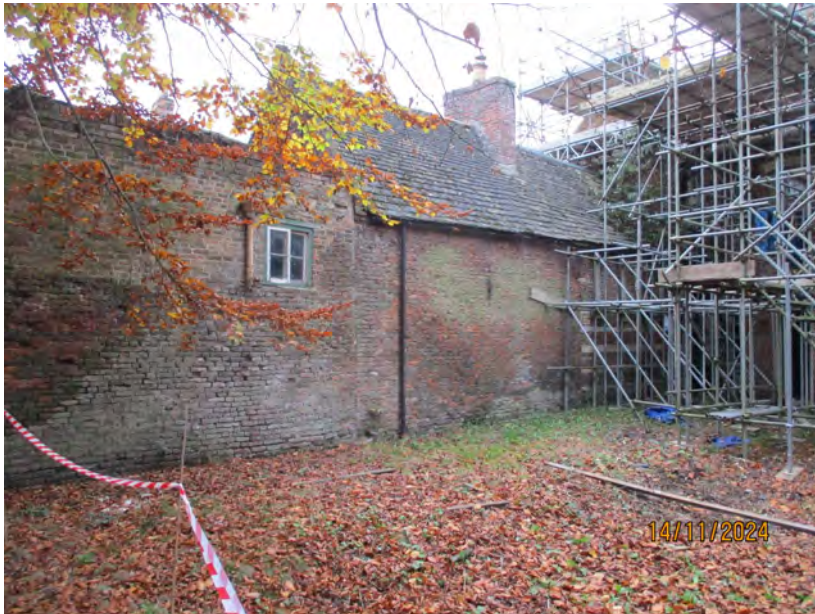
**Fig 33:**

Elevation 5 (east).

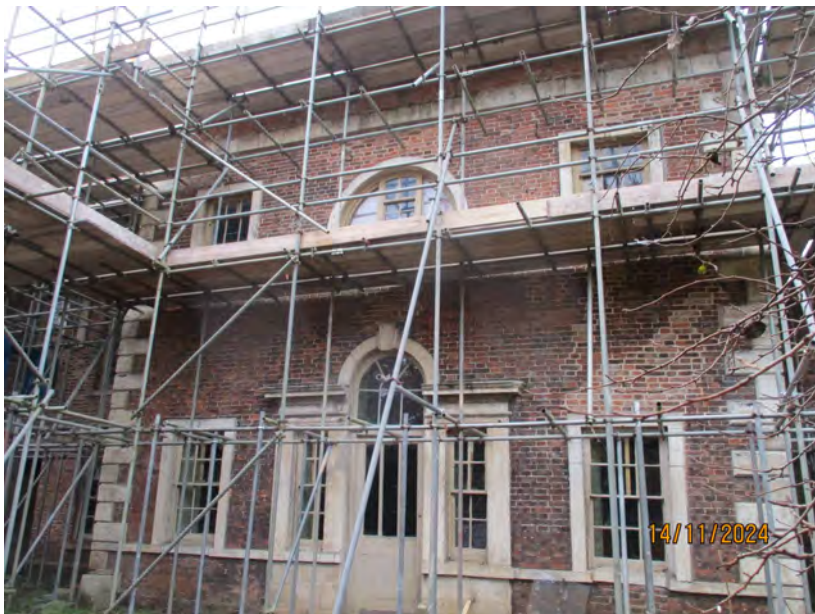
**Fig 34:**

Elevation 6 (south).

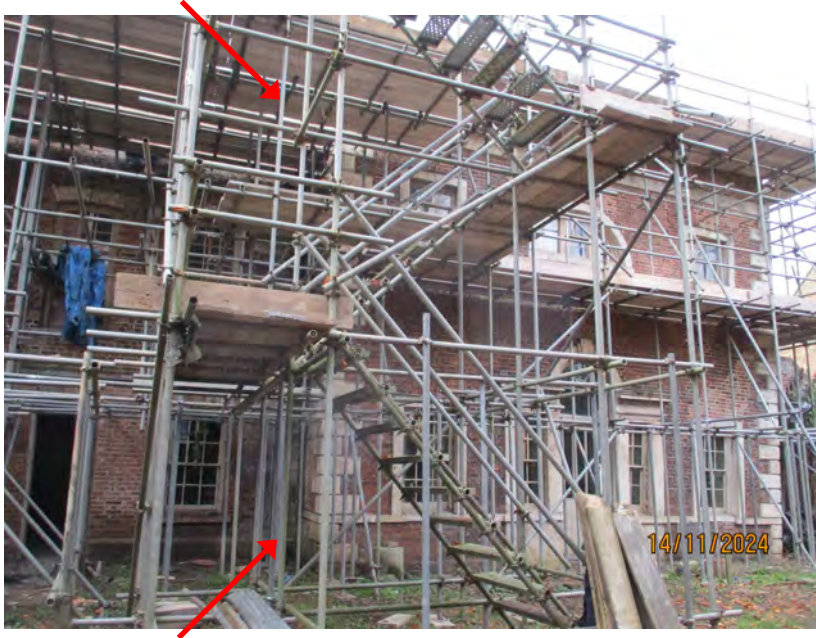
**Fig 35:**

Elevation 7 (west; arrows) obscured by scaffolding.

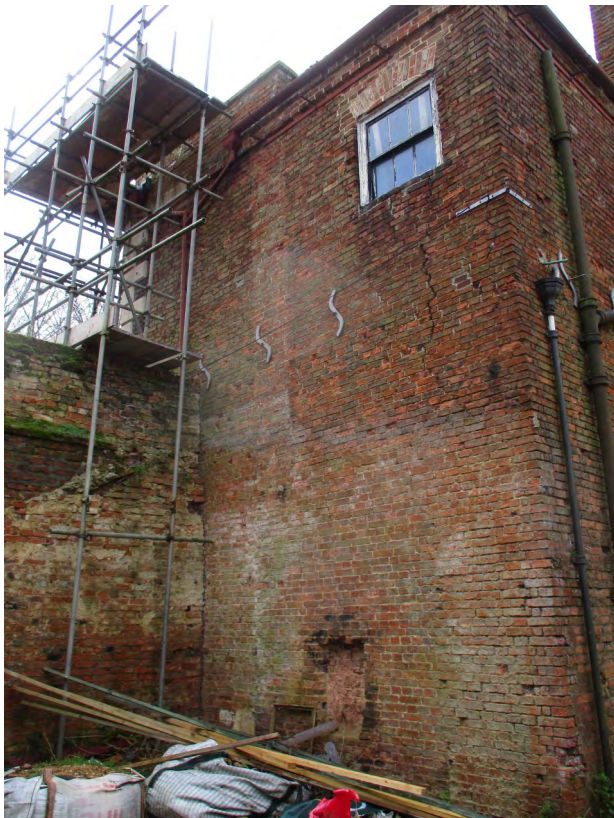
**Fig 36:**

Elevation 8 (east) with adjoining courtyard garden wall (see Figs. 40–41).

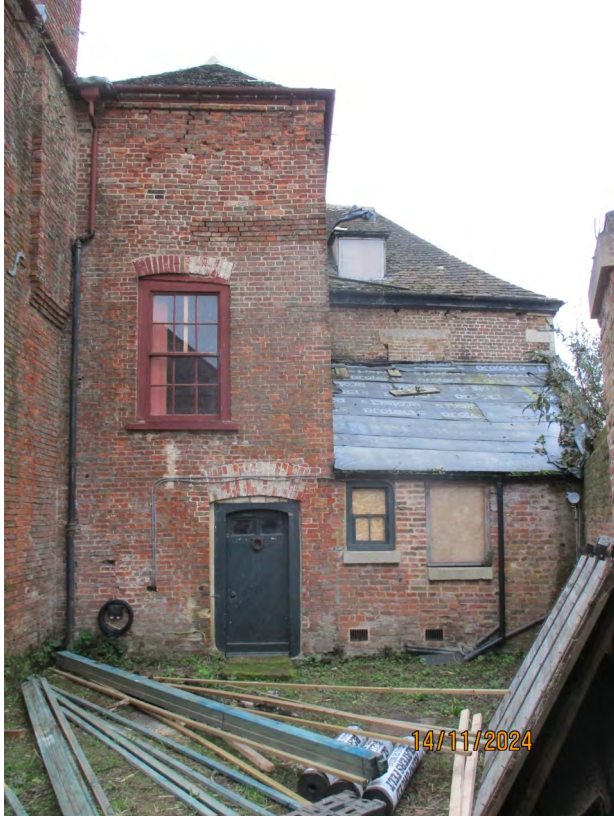
**Fig 37:**

Elevation 8 (east).

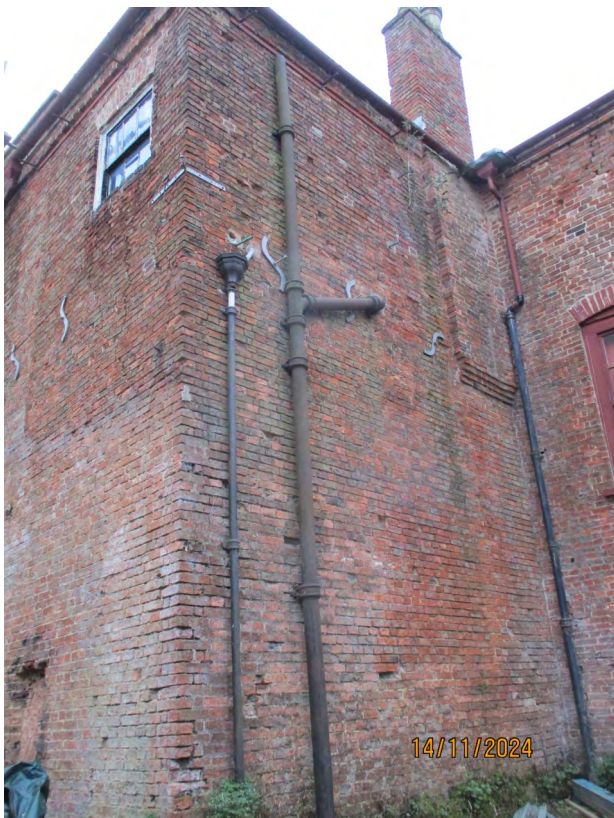
**Fig 38:**

Elevation 9 (north).

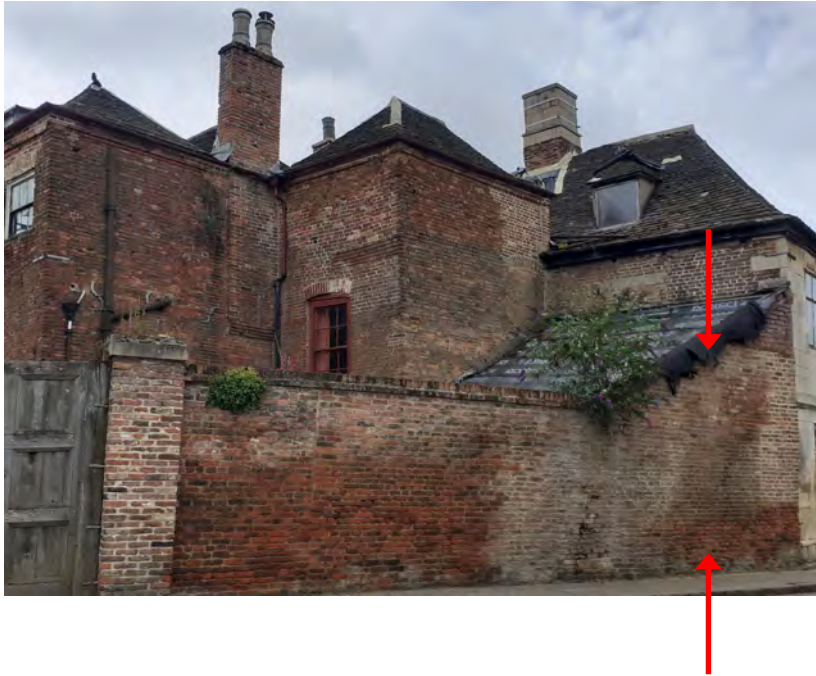
**Fig 39:**

Elevation 10 (north; arrows).
