**\*ADDENDUM \*TECHNICAL REPORT ON A SUBSIDENCE CLAIM**

**Crawford Reference: SU2205333**

**113 North Street  
Crowland  
Peterborough  
Cambridgeshire  
PE6 0EG**

**SUBSIDENCE CLAIM**

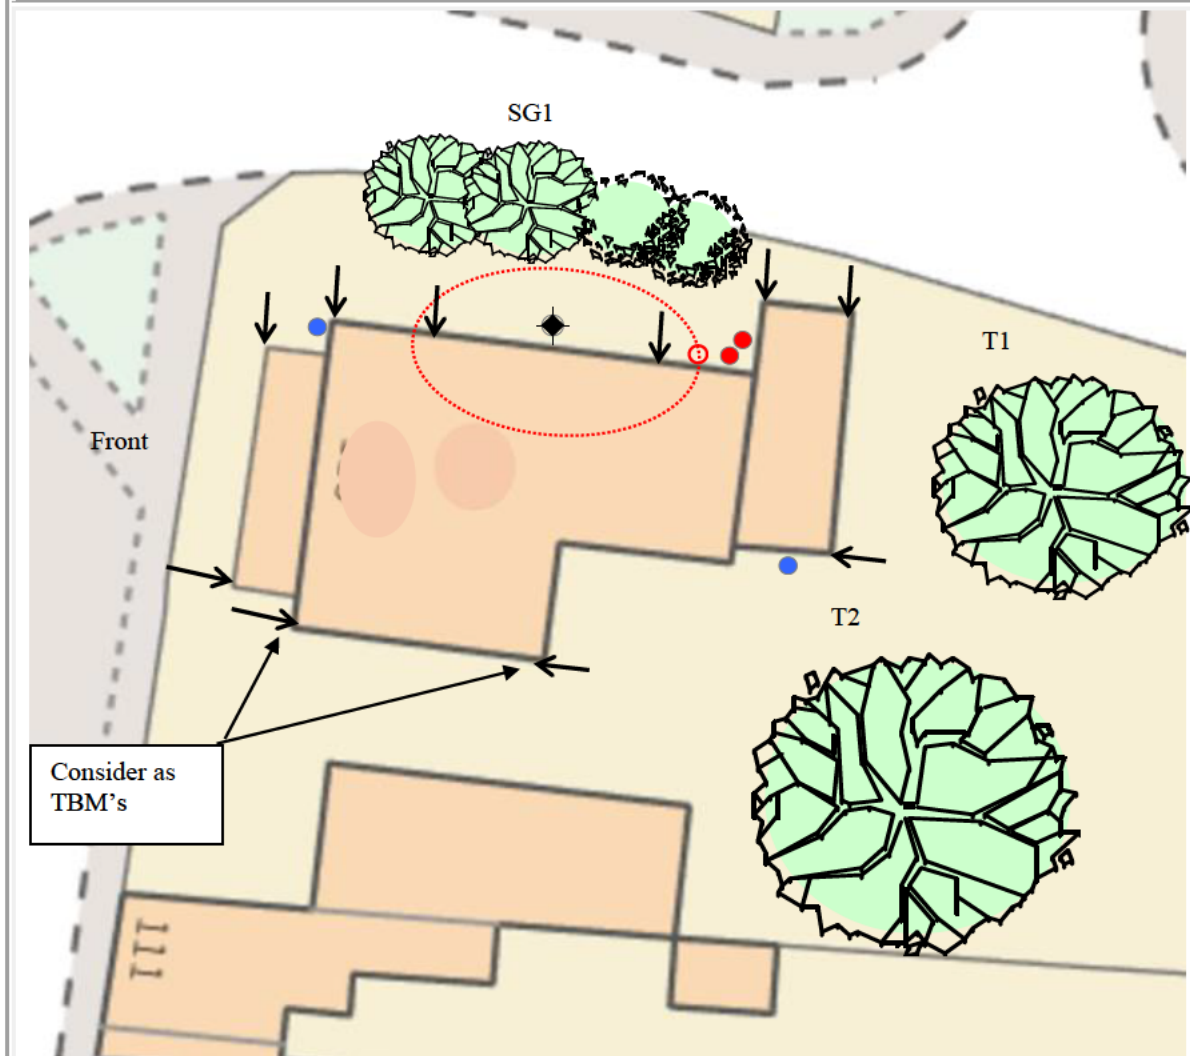
## Site Plan

The cause of the movement needs to be dealt with first. From the results of the site investigation, we are satisfied that your *Hedera spp.* (include ivy; *Fatsia spp.* are shrubs closely related to ivy) (T1, T2 & SG1 shown on the site plan) can be removed. Based on our analysis, we are satisfied there is no adverse heave risk to the property.

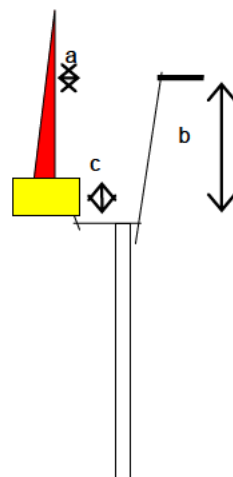
Foundation Details

| No. | Borehole Depth | Footing (a) | Underside (b) | Thickness (c) |
| TH1 | 3.00 m. | 40 mm. | 1,000 mm. | 450 mm. |

Mid brown silty sandy CLAY.
