# Geotechnical Survey Report

| FSI Ref: | 26156 |
| Risk Address: | 113 North Street<br>Crowland<br>Peterborough<br>Cambridgeshire<br>PE6 0EG |
| Claim Ref: | SU2205333 |

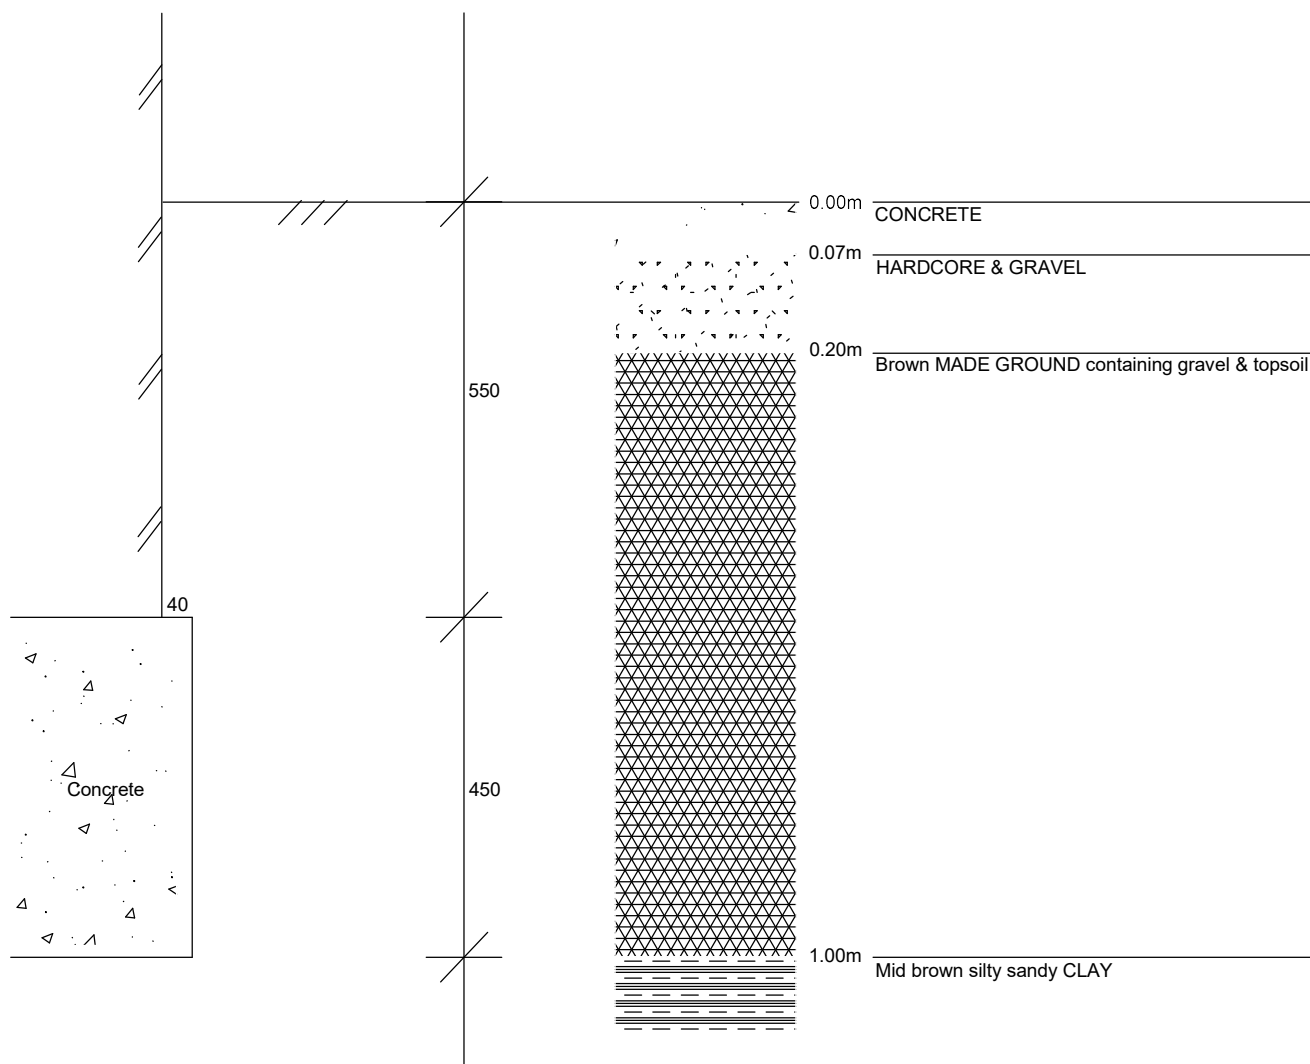
## TRIAL PIT 1

D1 @ F.L. (1.00m)

V = 69-74kPa

Founding strata: Mid brown silty sandy CLAY
