# Addendum Arboricultural Appraisal Report

## Subsidence Damage Investigation at:

113 North Street  
Crowland  
PE6 0EG

| MWA REF: | SUB230428-12997REV01 |

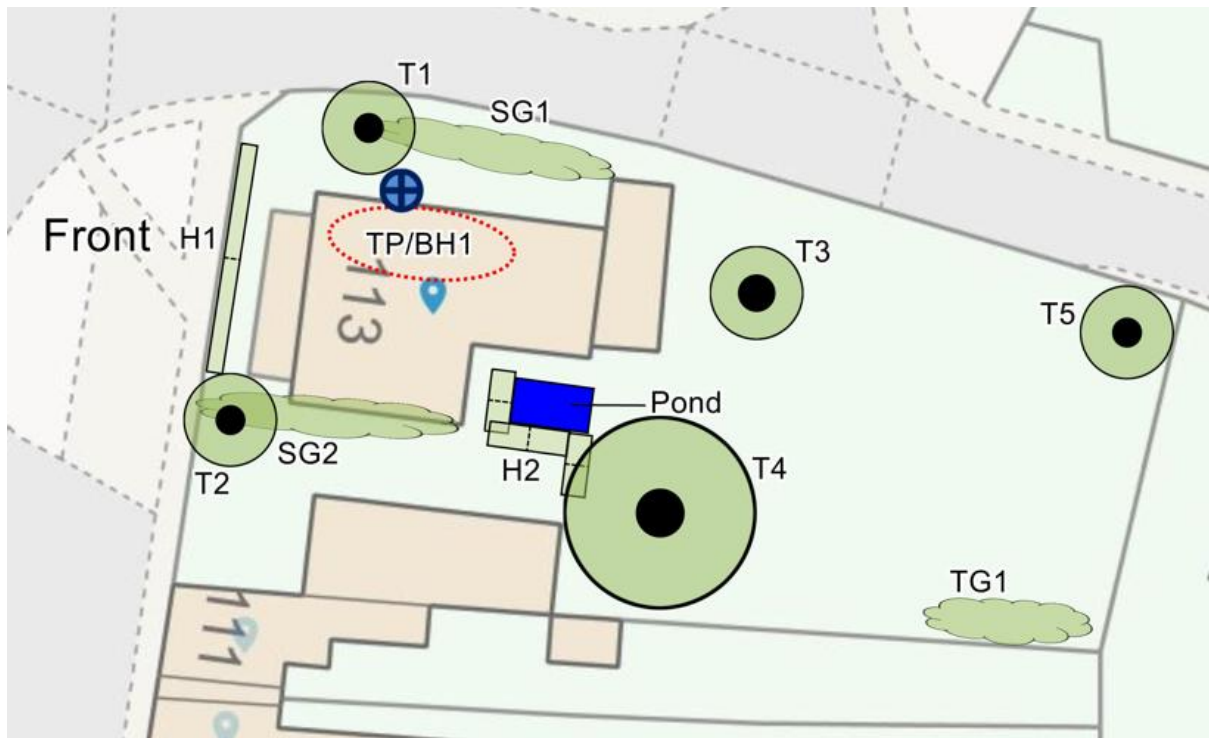
Approximate areas of damage

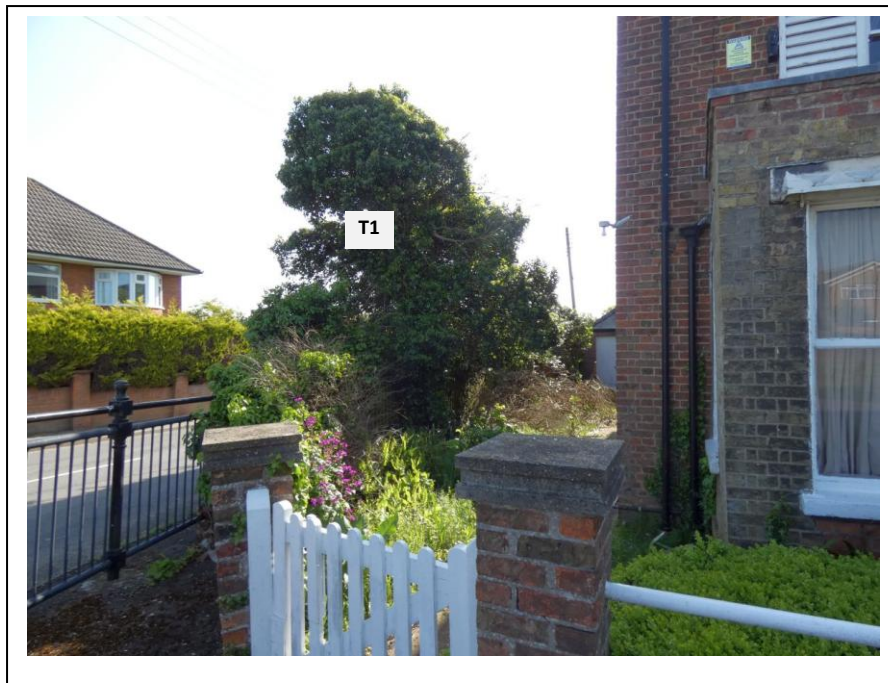
View of front left.

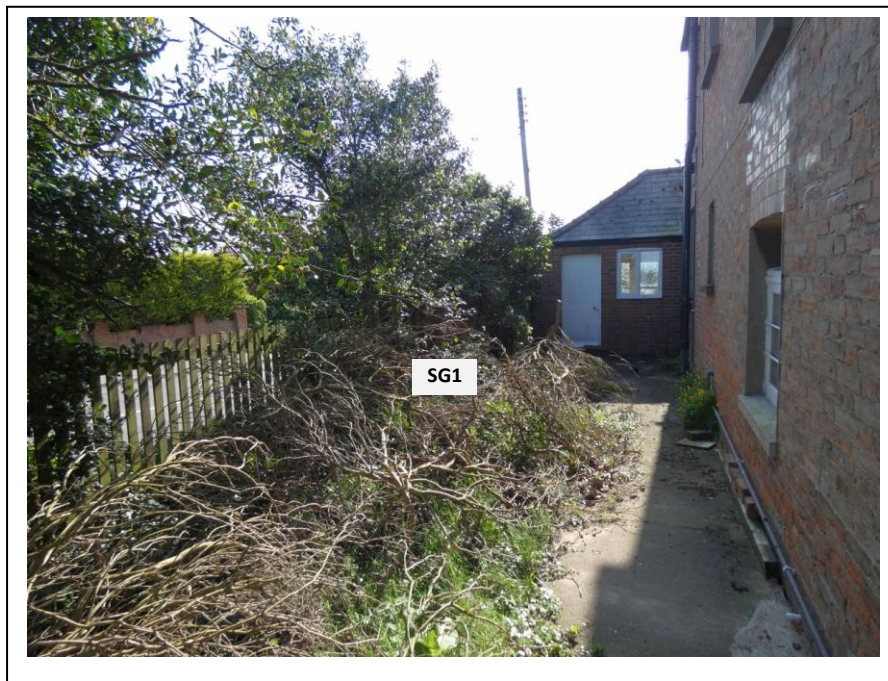
View of left.

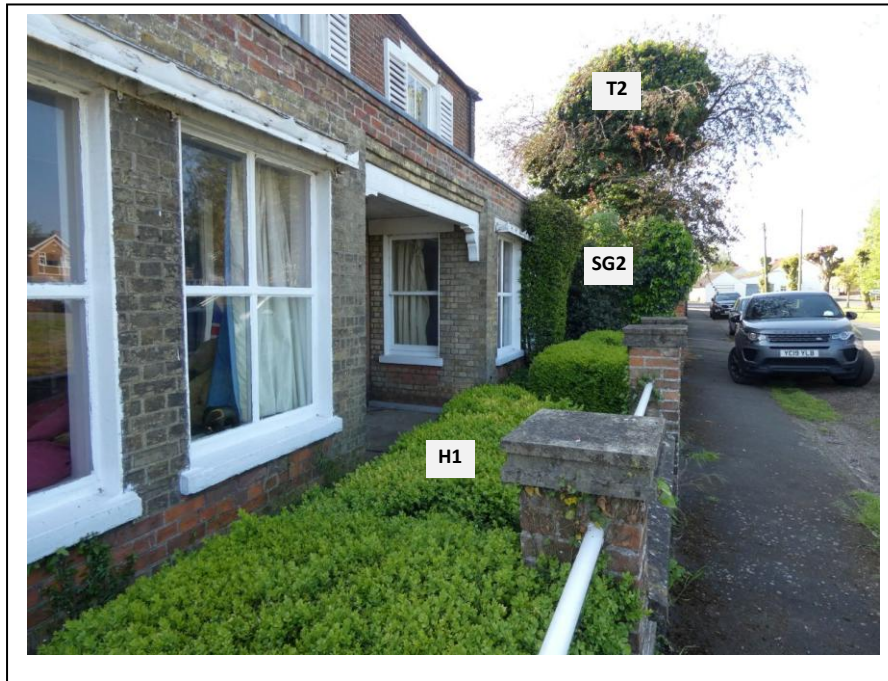
View of front.

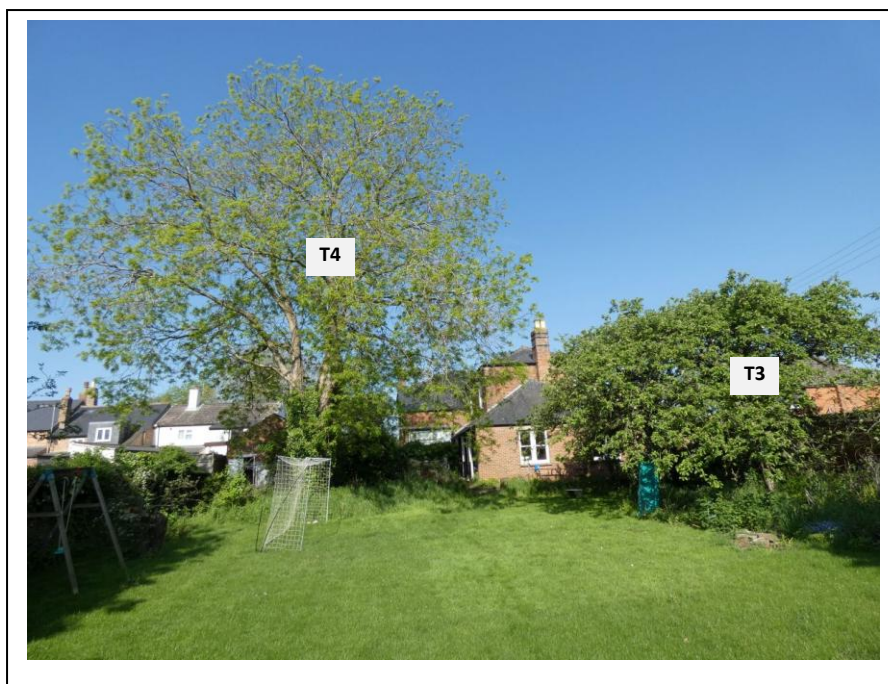
View of rear.
