## **Structural Appraisal**

**Wykes Manor  
Wykes Lane  
Donington  
Spalding  
PE11 4SD**

**Ref: 9267**

**Date: November 2021**

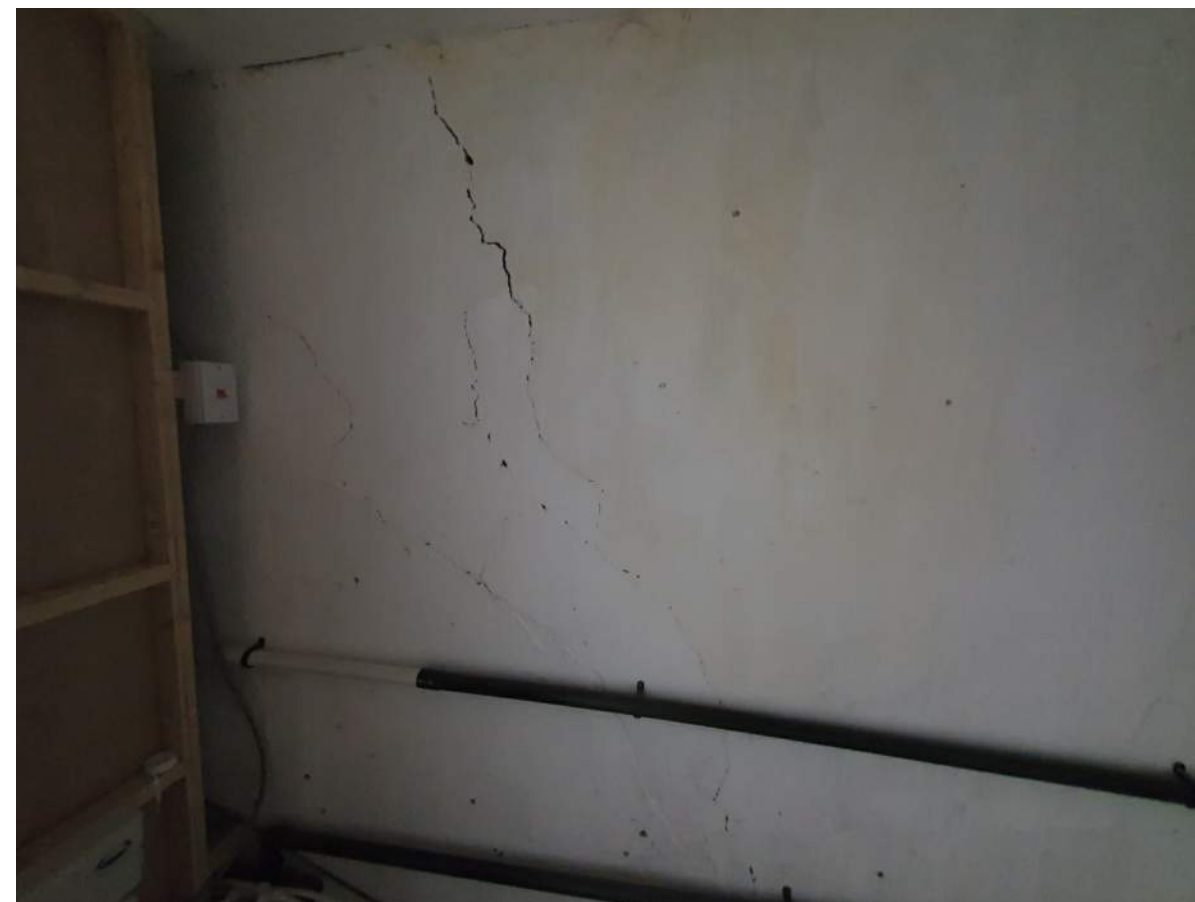
Photo (1)

Minor localised cracking.  
Photo 1. Monitor

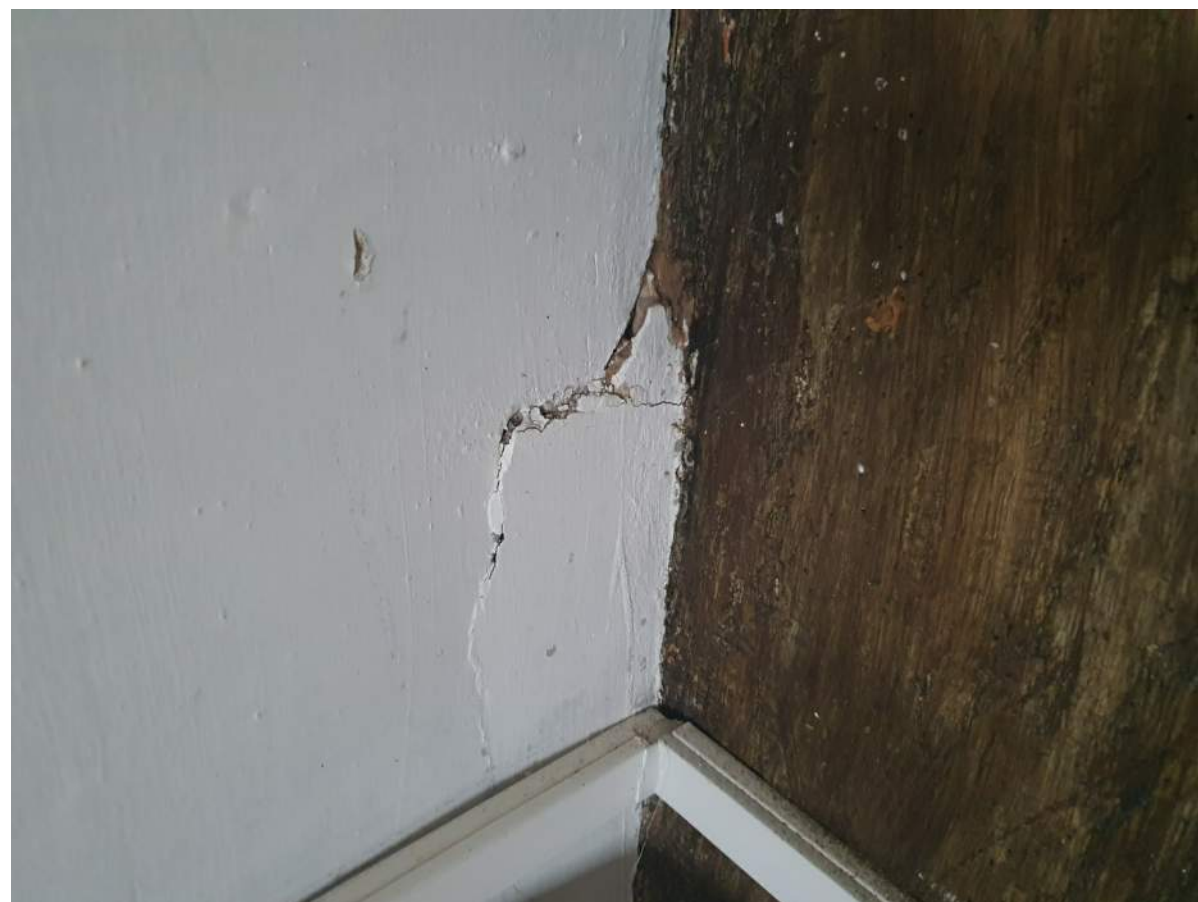
Photo (2)

Hairline crack to arch apex.  
Photo 2. Monitor

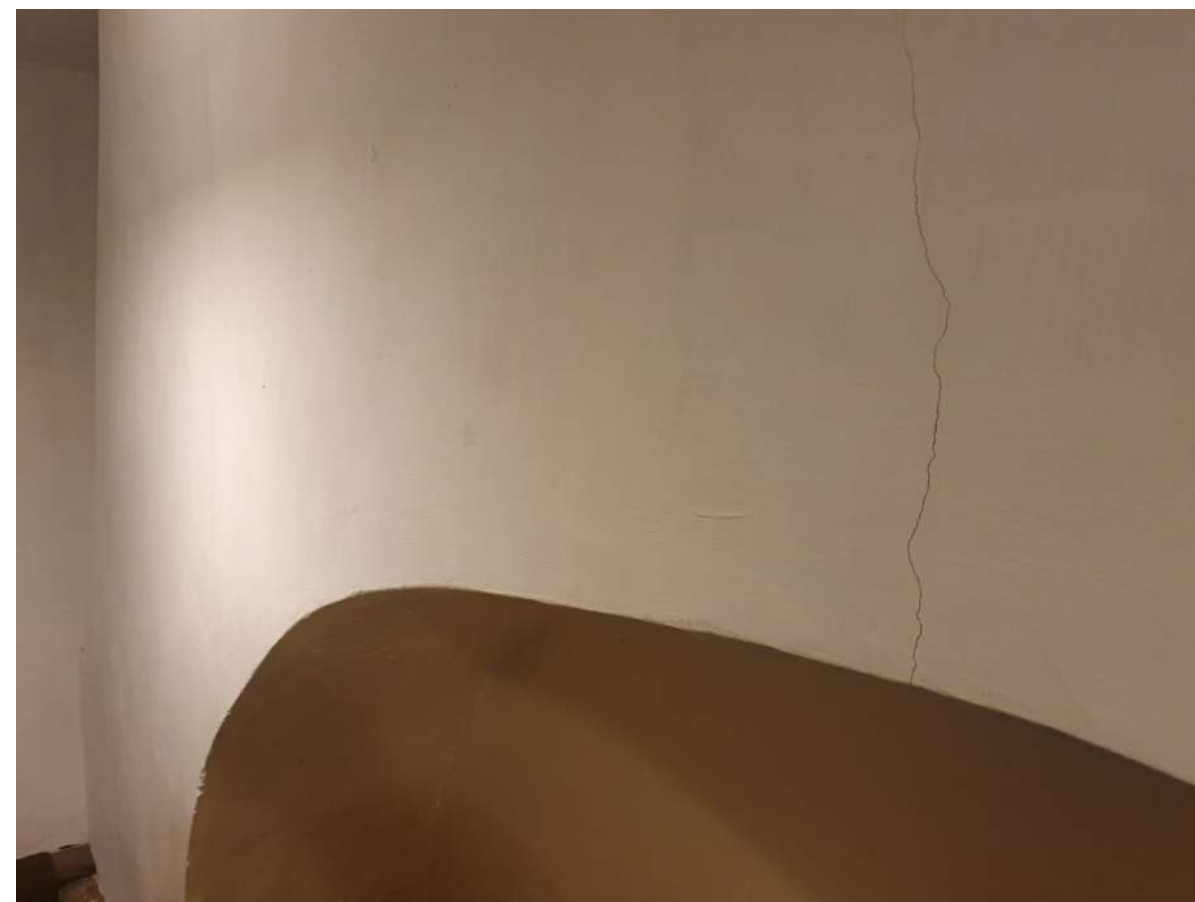
Photo (3)

Diagonal racking cracks  
Photo 3. Monitor

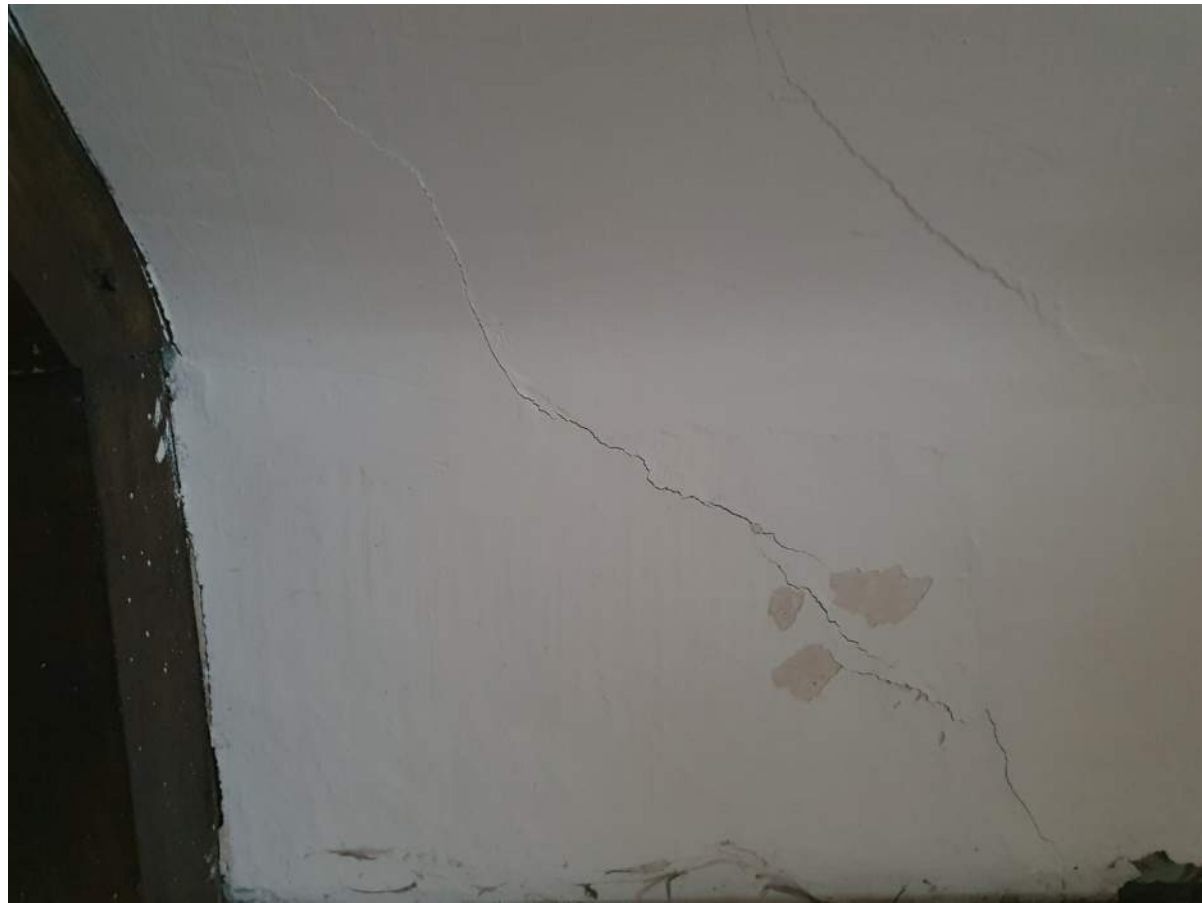
Photo (4)

Significant lateral displacement  
between external wall and stud wall.  
Photo 4. Provide Helifix Bowtie to tie  
wall to floor plate.

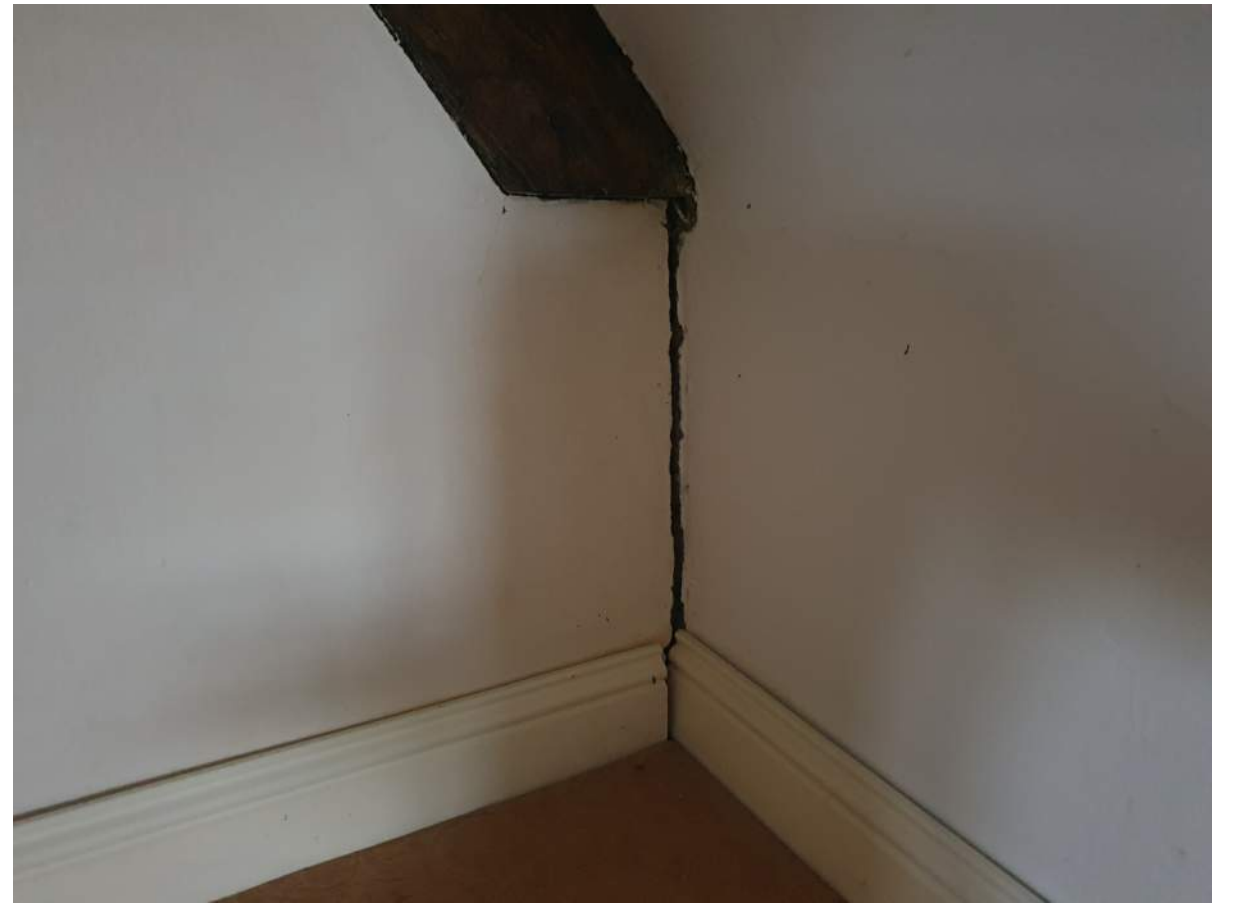
Photo (5)

Significant racking cracking.  
Photo 5. Monitor

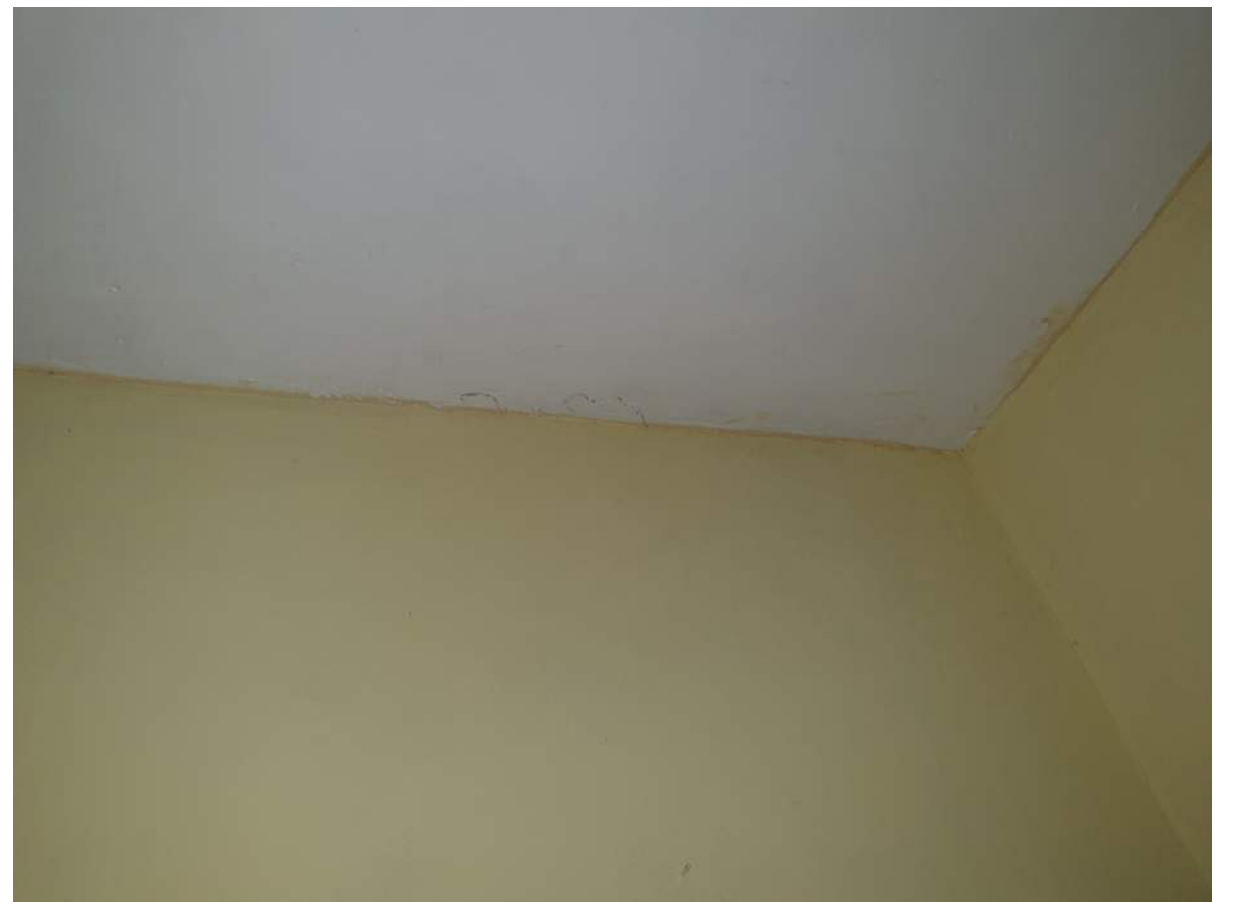
Photo (7)

Minor cracking to ceiling.  
Photo 7. Monitor

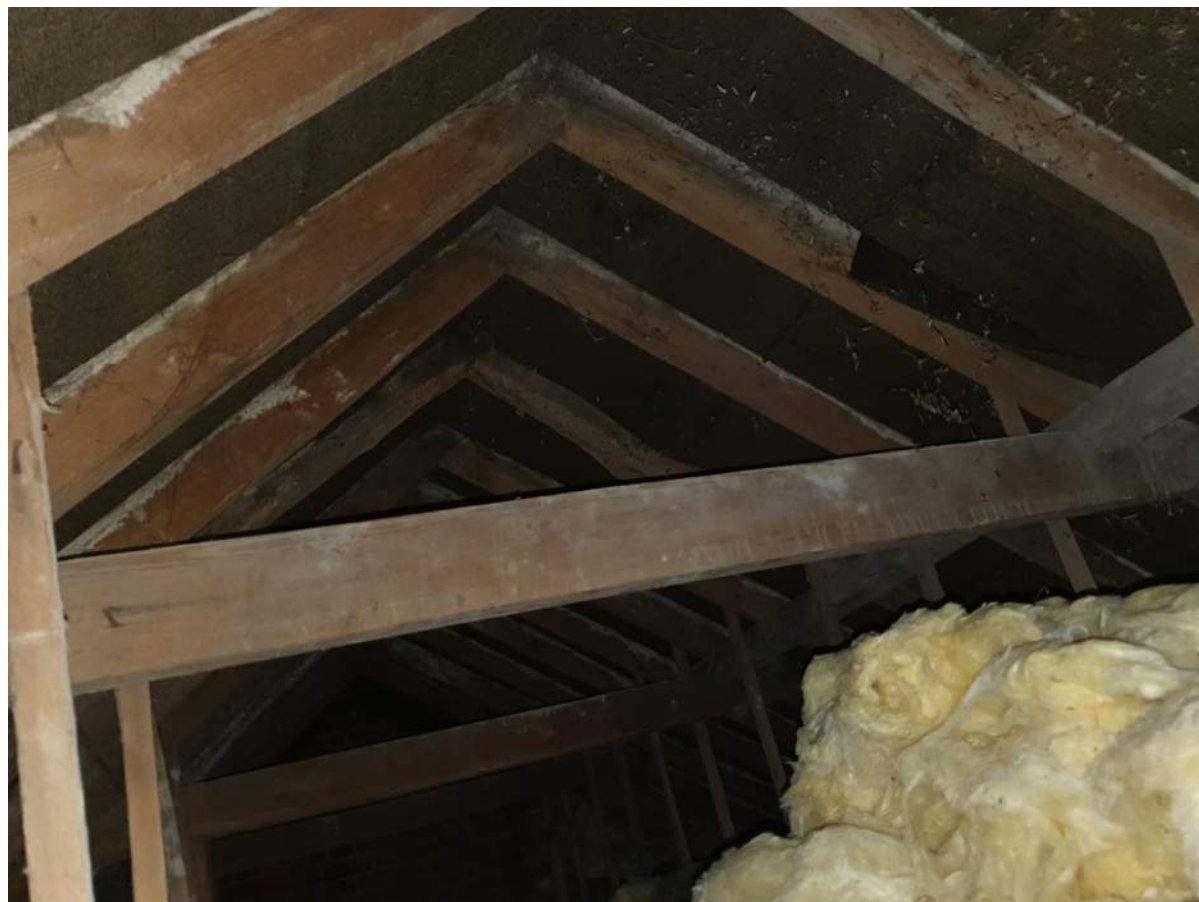
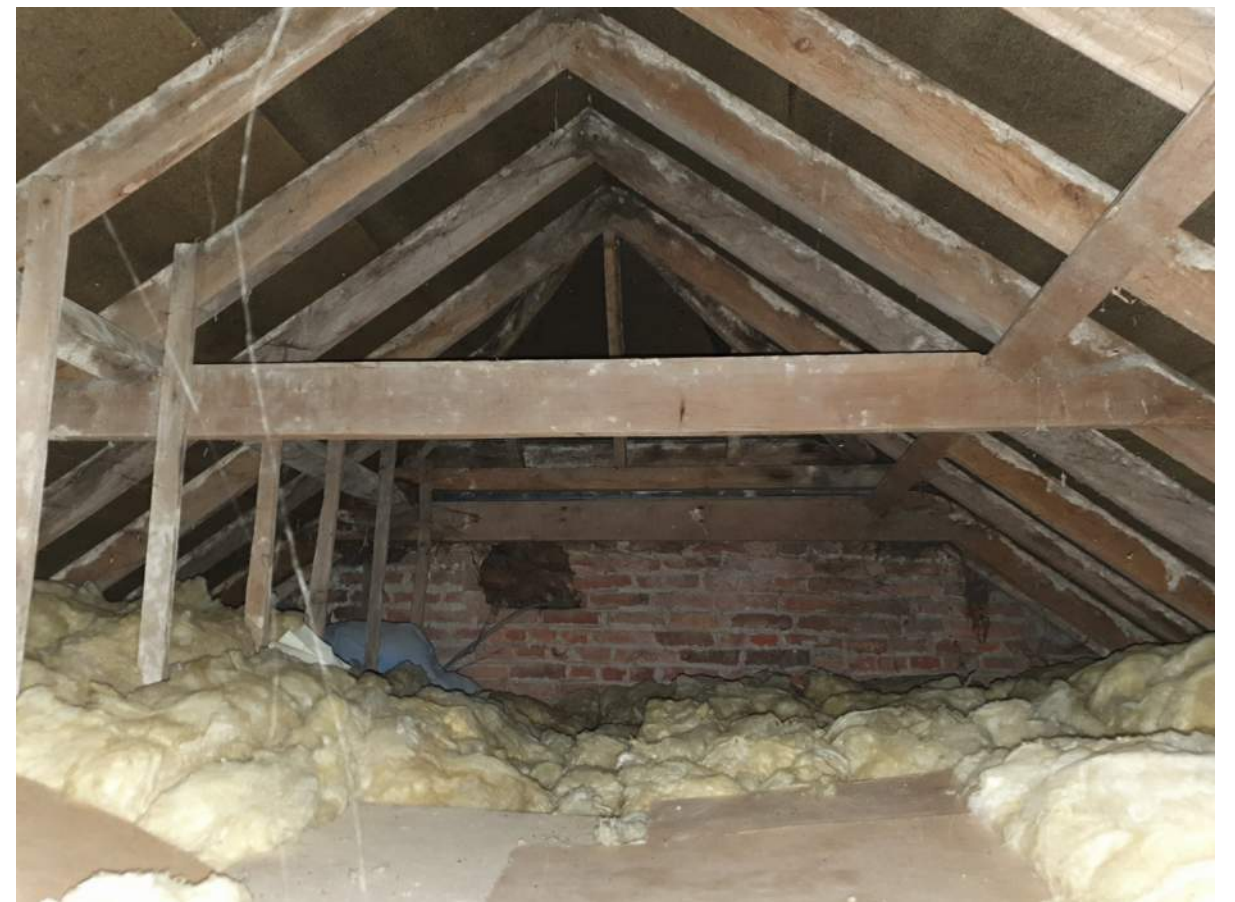
Loft hatch accessed. No apparent structural defects. Photos 10 and 11

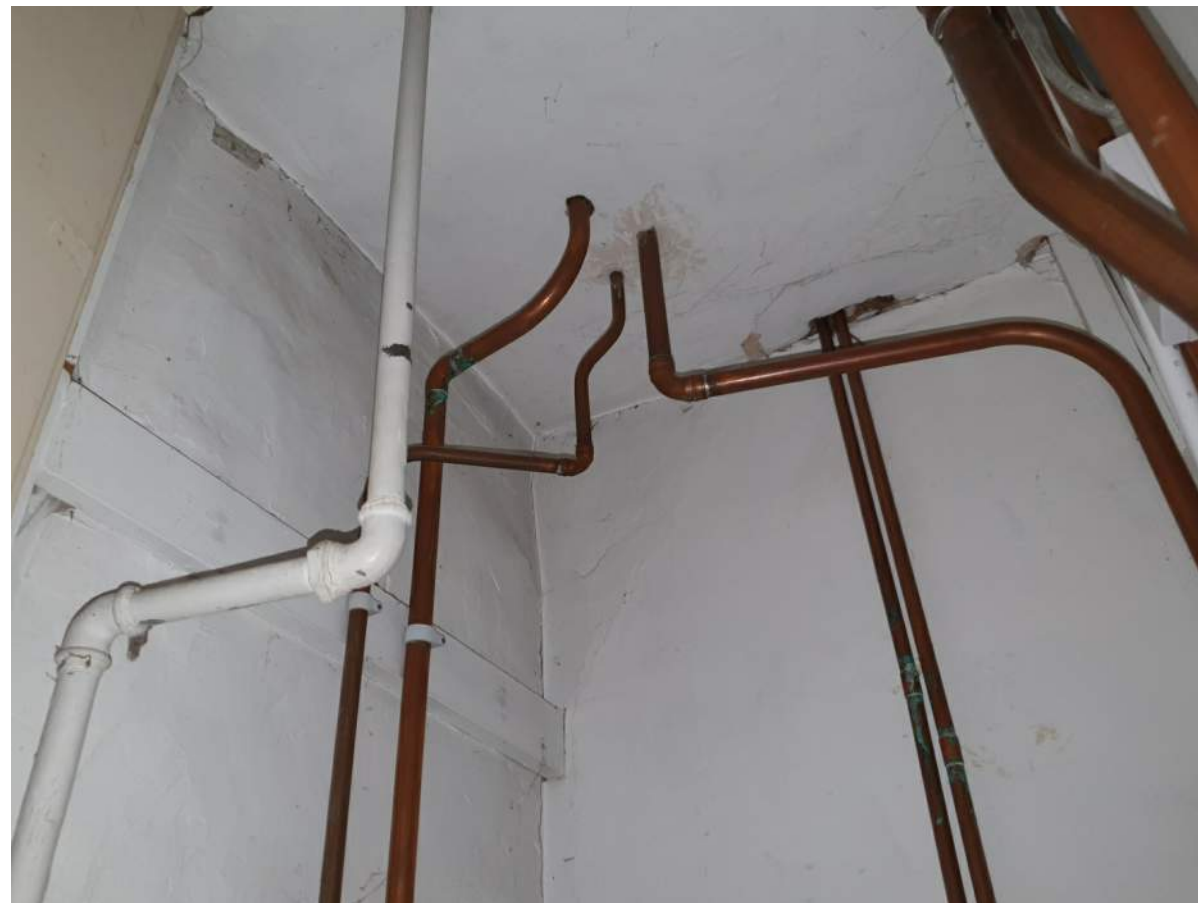
Photo (12)

Distortion of wall at high level inside the cupboard. Photo 12. Monitor

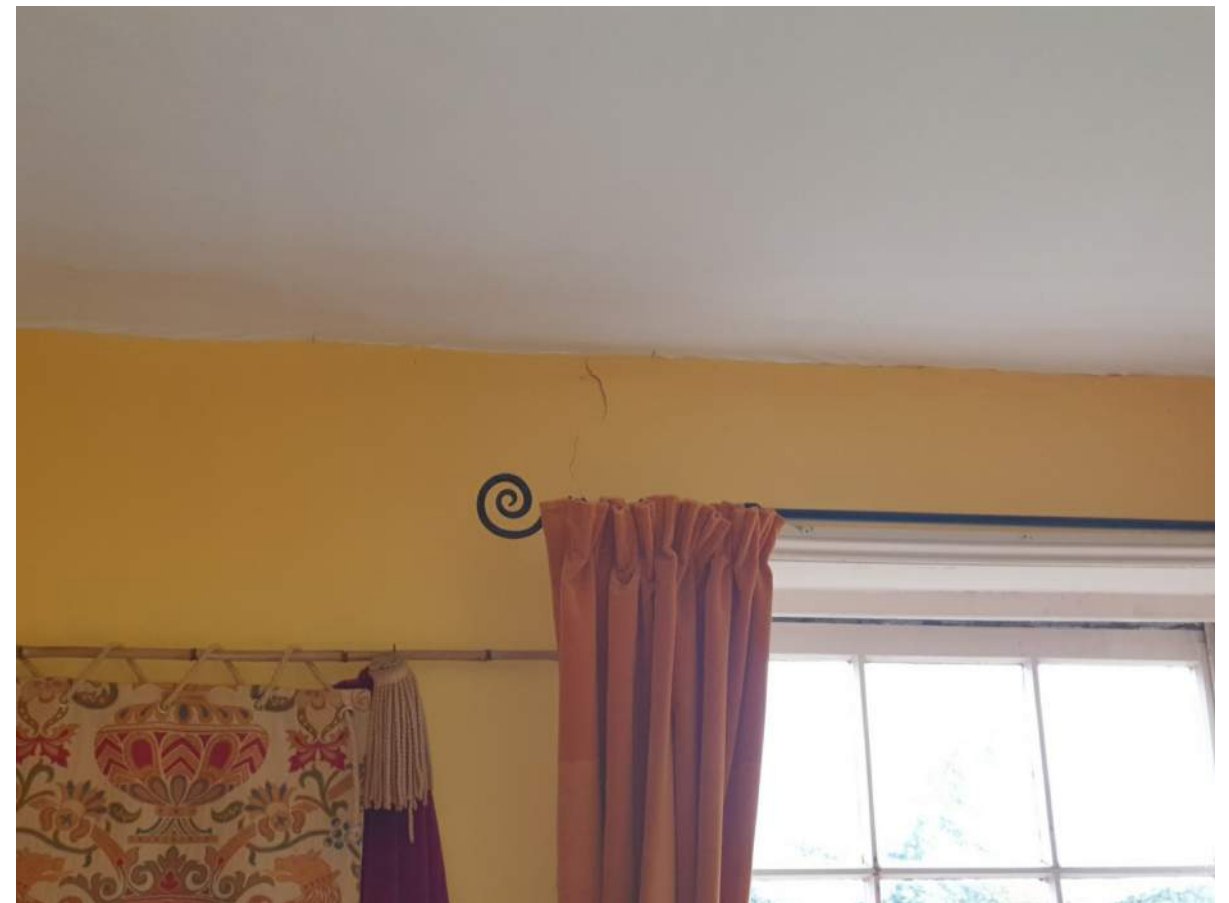
Photo (13)

Ruckling of paper at high level.  
Photo 13. Monitor

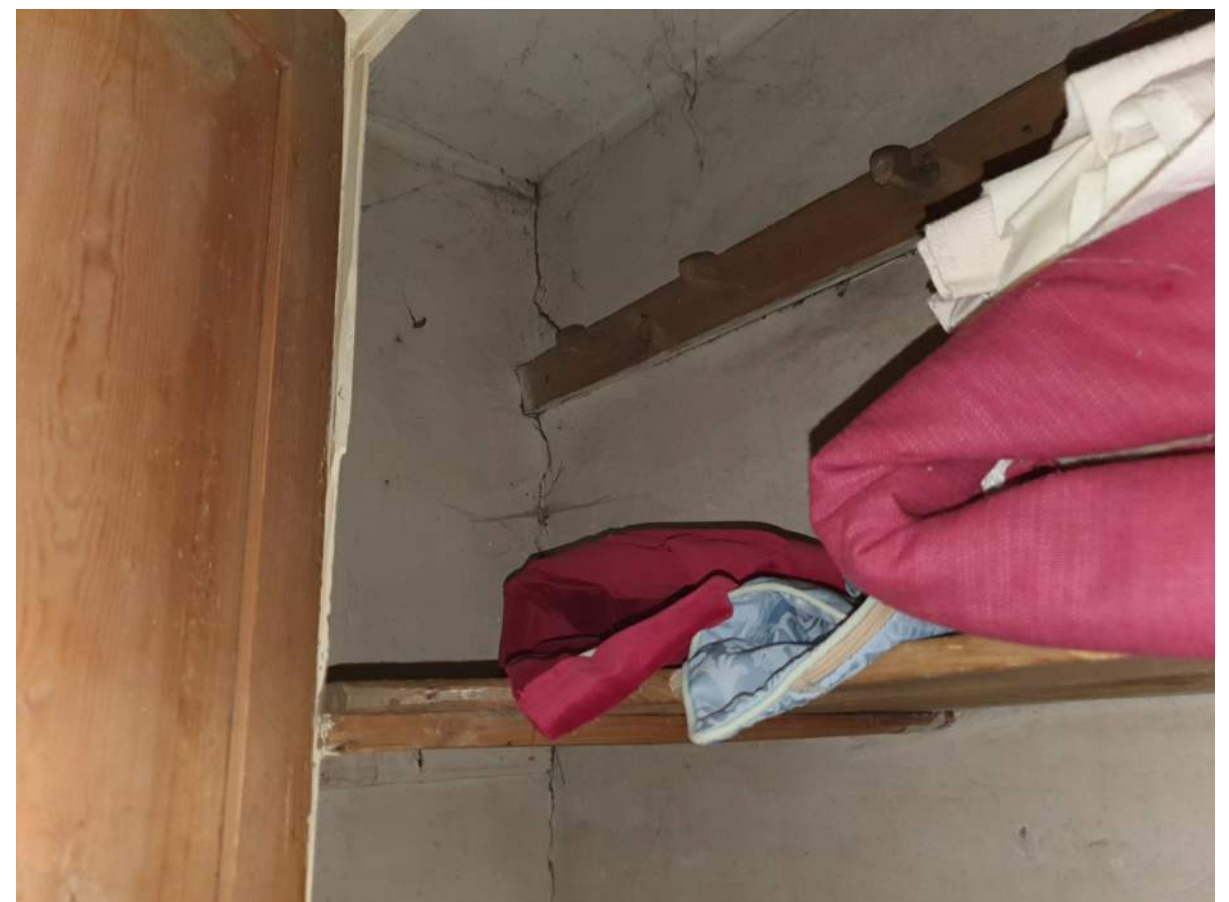
Photo (15)

Cracking inside cupboard.  
Photo 15. Monitor

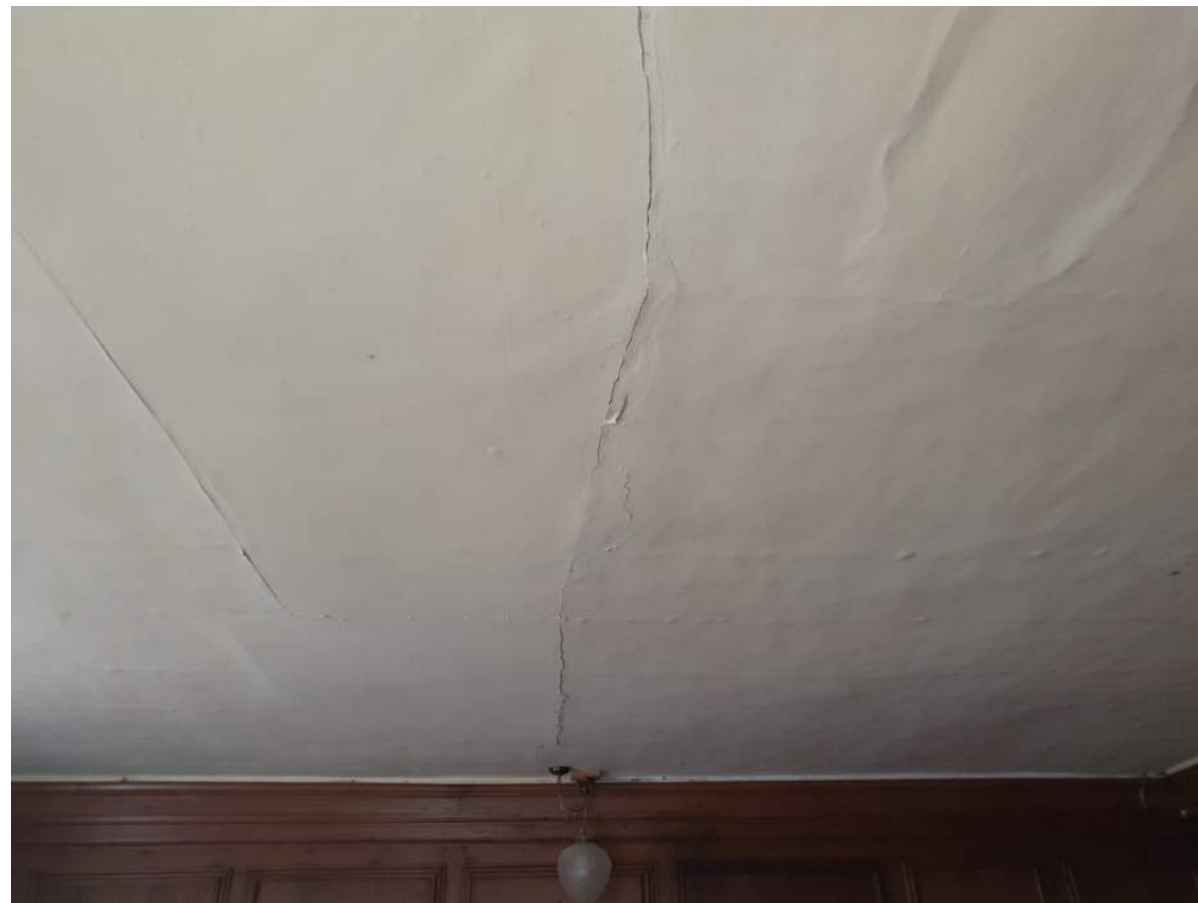
Photo (16)

Plaster crack to full width of room.  
Photo 16. Monitor

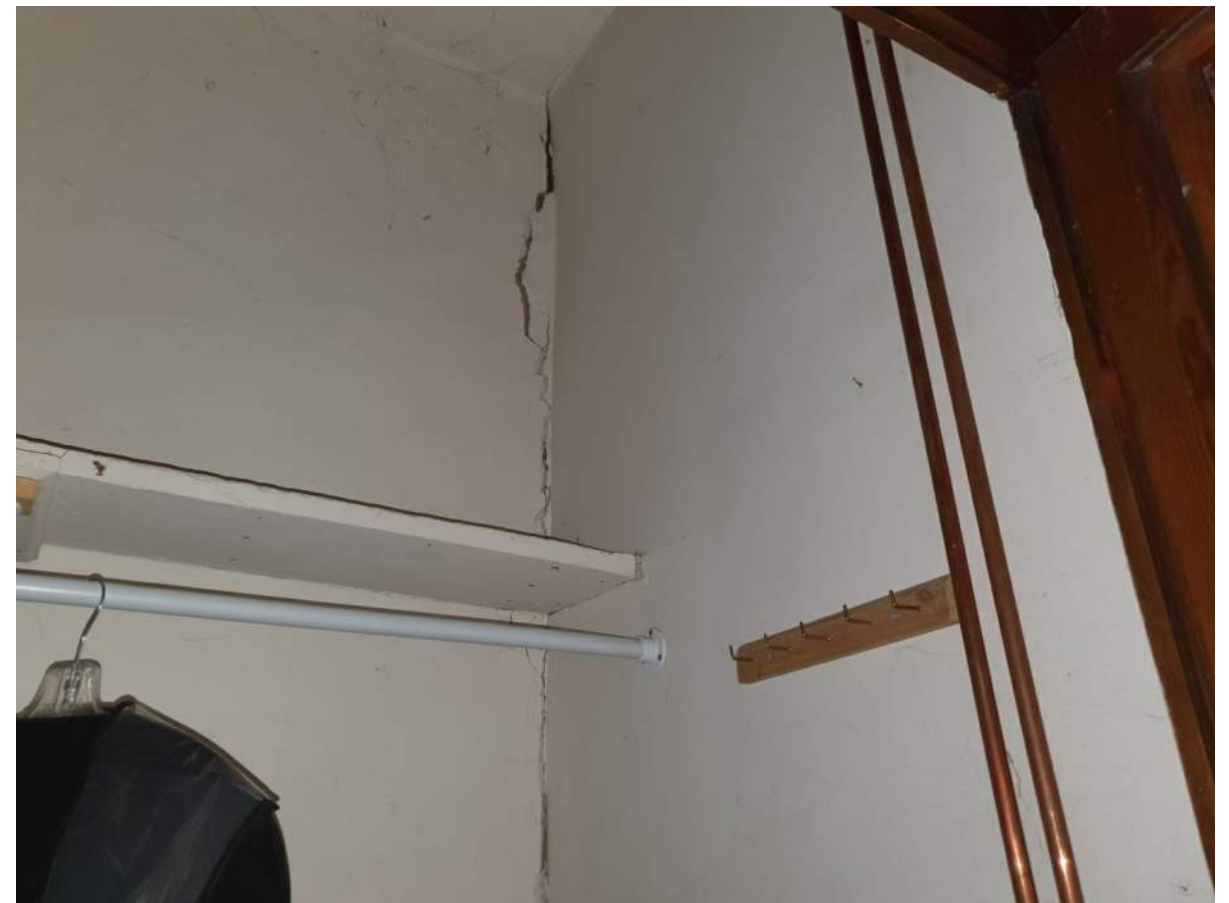
Photo (17)

Loose/damp plaster. Significant vertical crack. Photo 17. Monitor

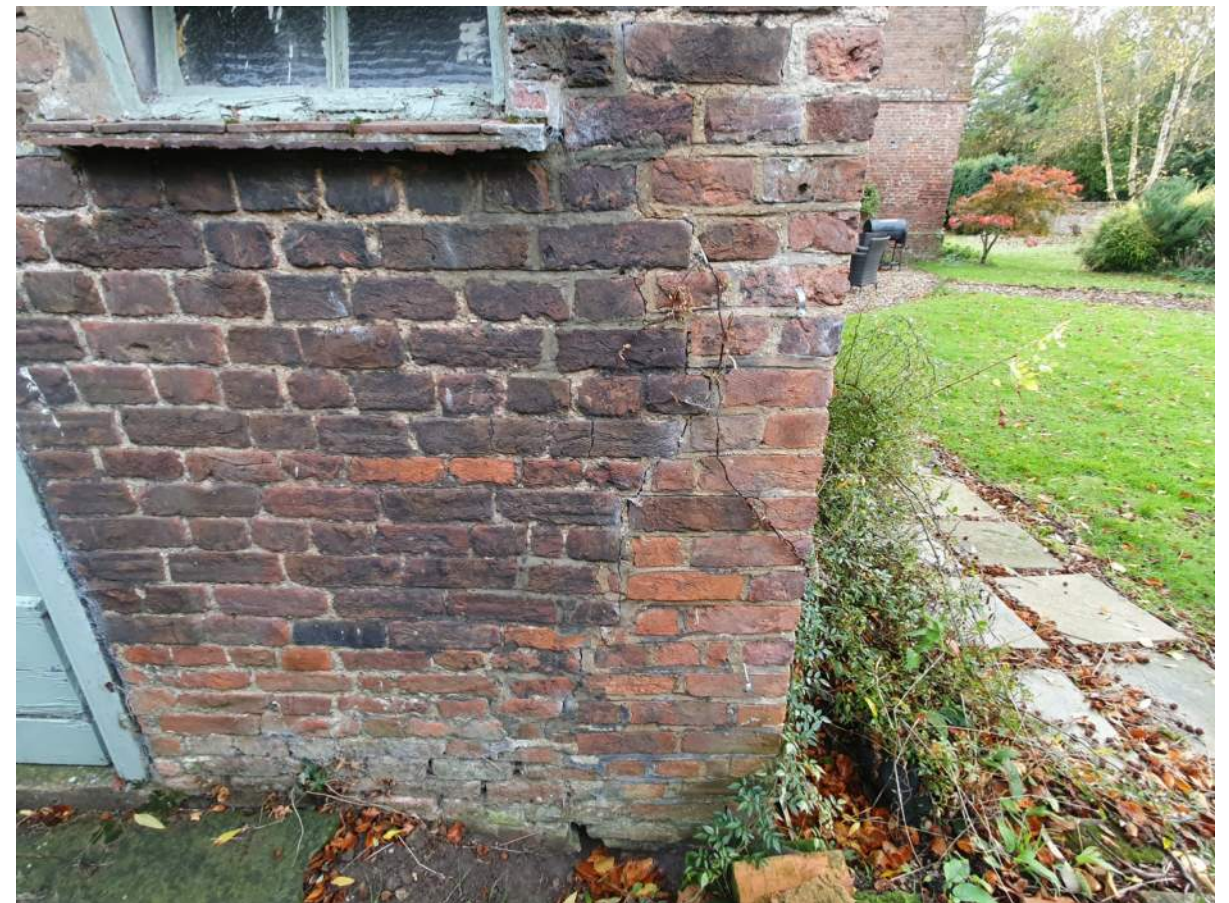
Photo (39)

Significant cracking. Photo 39.  
Repoint as temporary repair and monitor.

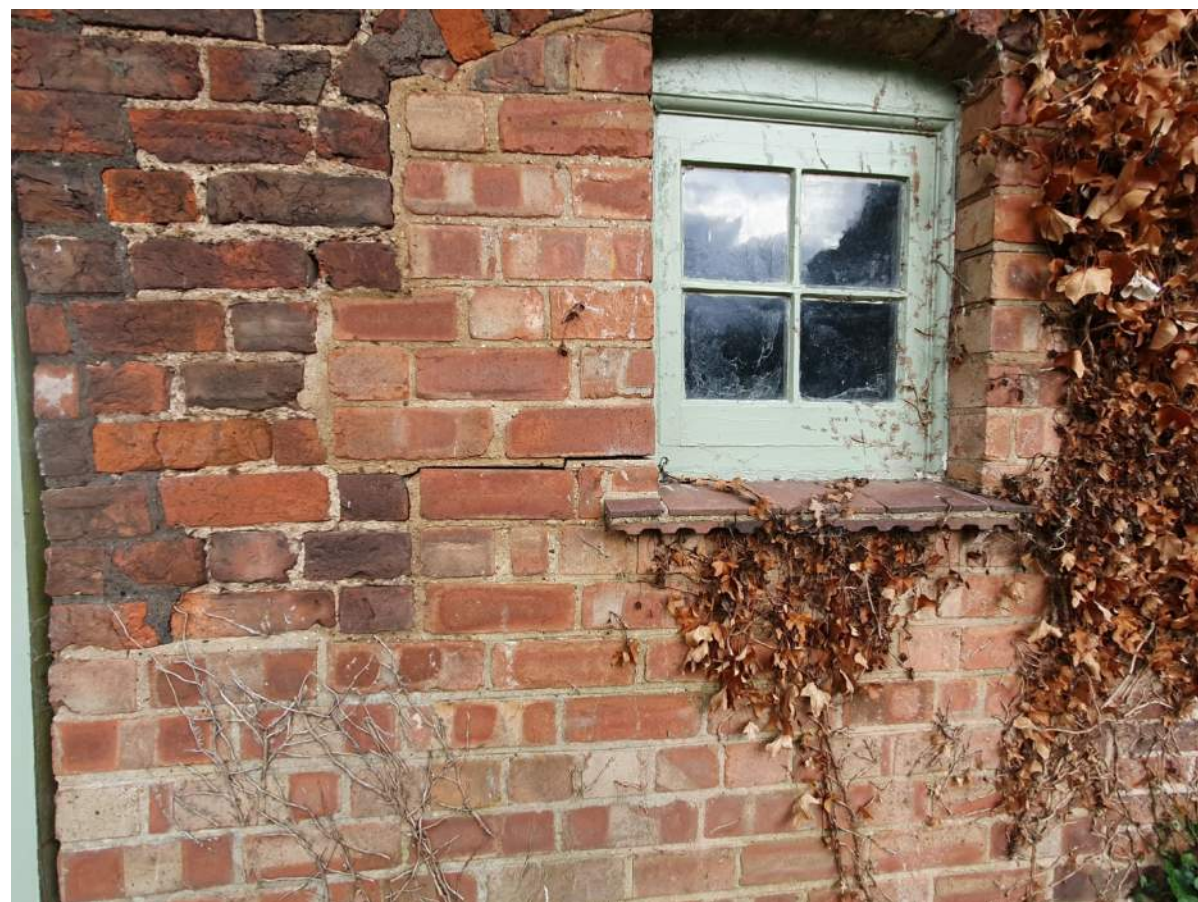
Photo (40)

Diagonal cracking likely related to historic  
discharge of rainwater. Photo 40.

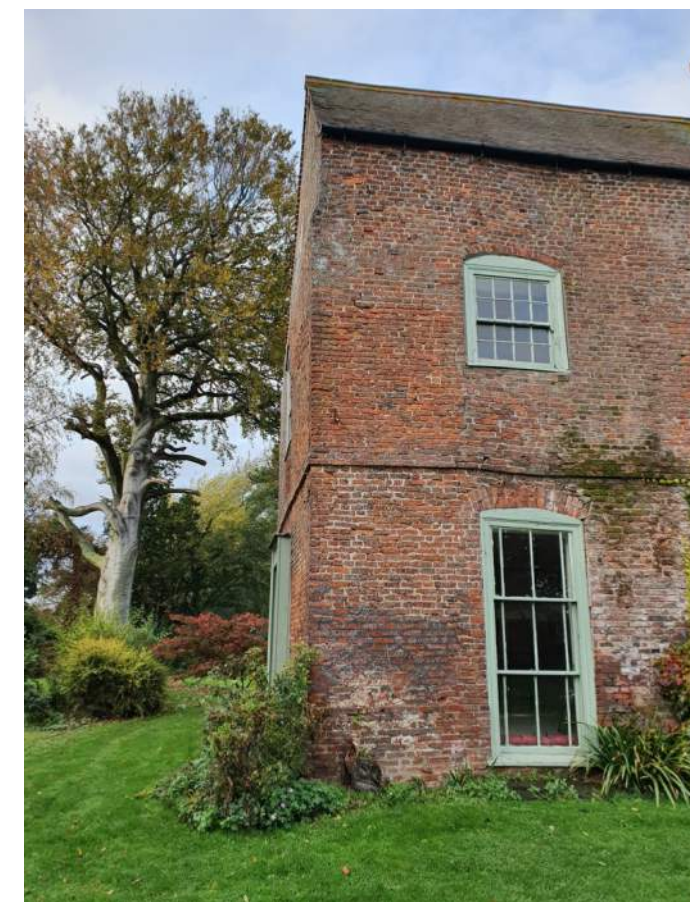
Photo (41)

Bedjoint lifted. Photo  
41. Likely corroding  
wall tie to infill. Expose  
and check.

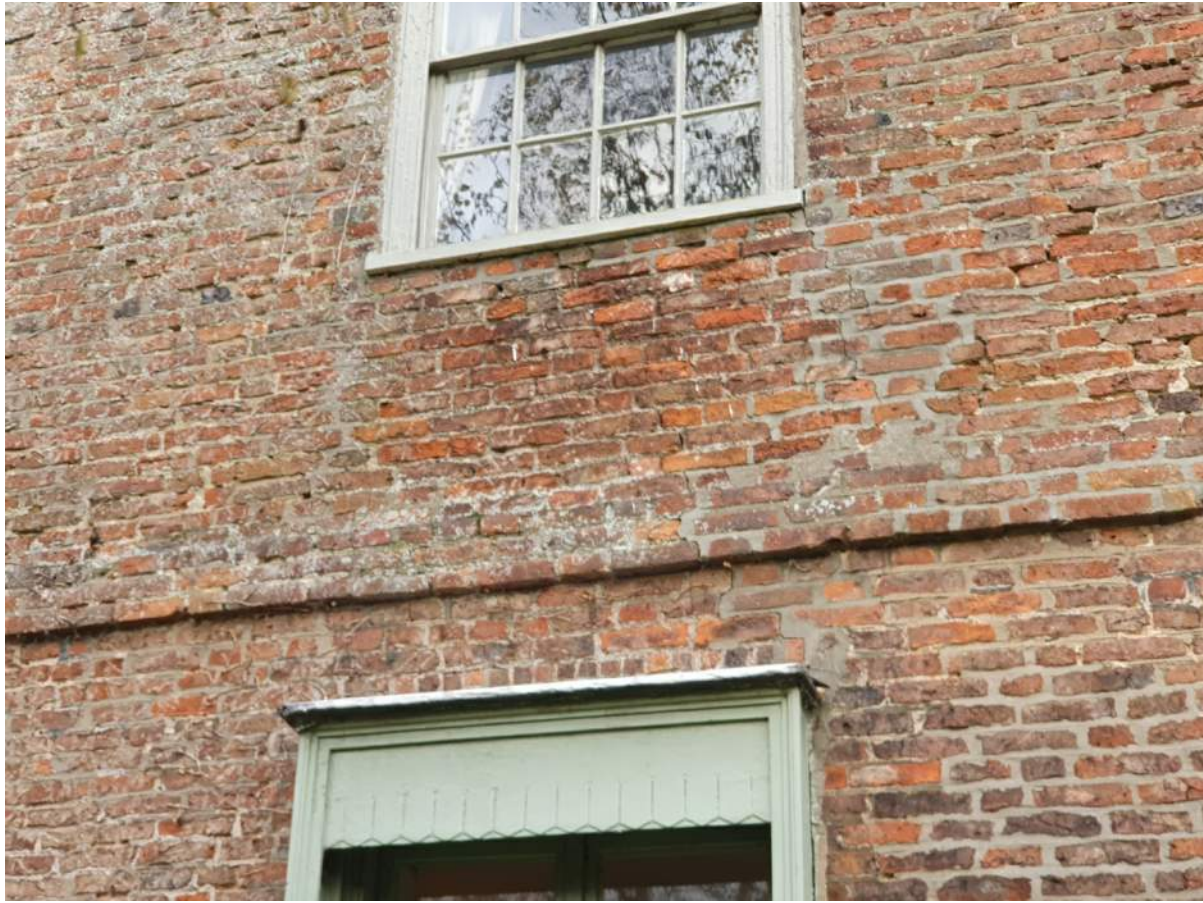
Photo (42)

Loose pattress  
plate. Photo 42.  
Pack and monitor.
