# **STUART GUY CONSULTING**

**Report number 13-12-01**

## **Environmental Risk Assessment of Land adjacent to Alexine**

### **Malting Lane, Donington, Spalding, Lincolnshire, PE11 4XA**

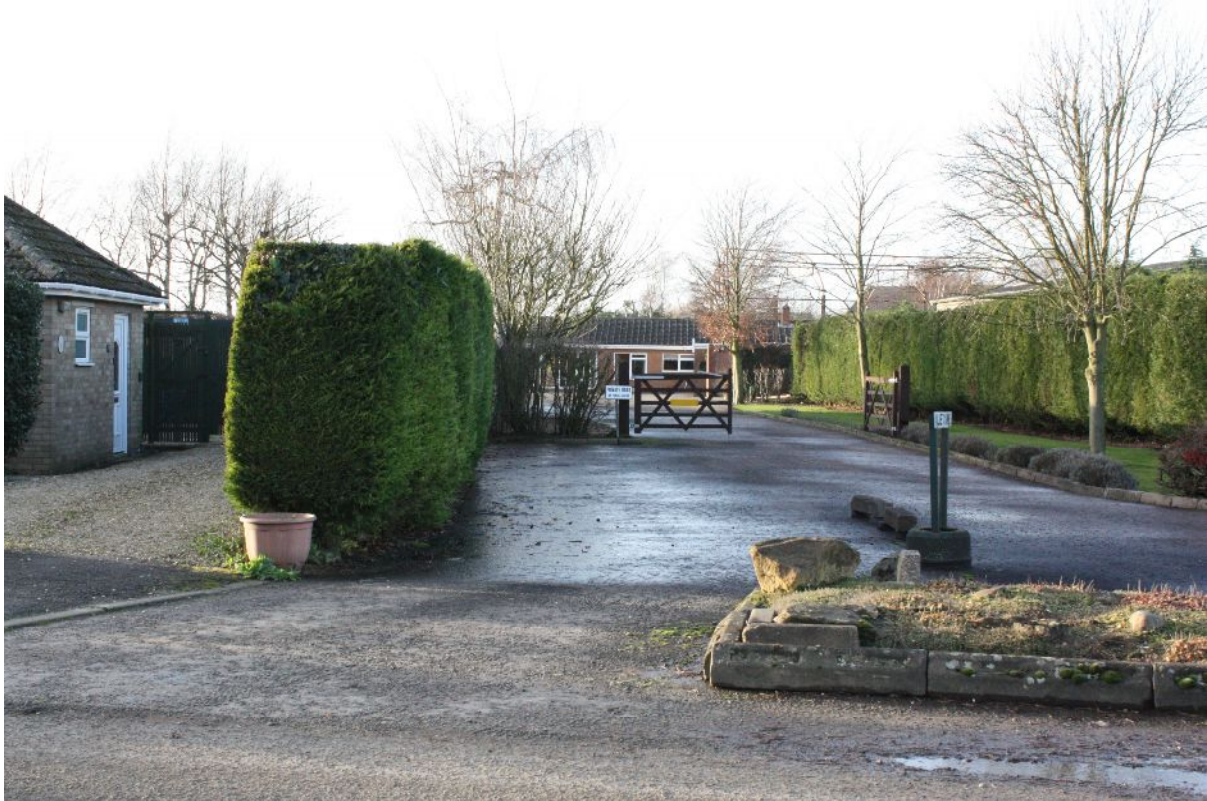
3.1 The site was visited when the weather was dry and sunny. It was located along a short lane to the west of Malting Lane (photo 1), the whole area being very flat. The bungalow, Alexine, is located on the western edge of the site (photo 2). The site owner, Sandy Dear, explained the history of the site. The bungalow was constructed in 1977 and in 1978 Sandy started a road haulage business with two lorries (flatbed with curtain sides) moving farm produce. In 1982, Sandy acquired more land to the south of his drive and that was concreted over (photos 3 and 4) together with the land to the east of the bungalow (photo 2) for use as a lorry park for 15 lorries. The concrete had about 2 cm gaps between each slab, presumably to act as drainage. Sandy was in business with his brother and the expansion was mainly his brother's idea. The lorries were only on site until 1985 when Sandy transferred the business to his brother (late night noise annoyed neighbours) who removed the lorries from the site.

Photo 1 Short lane from Malting Lane to site

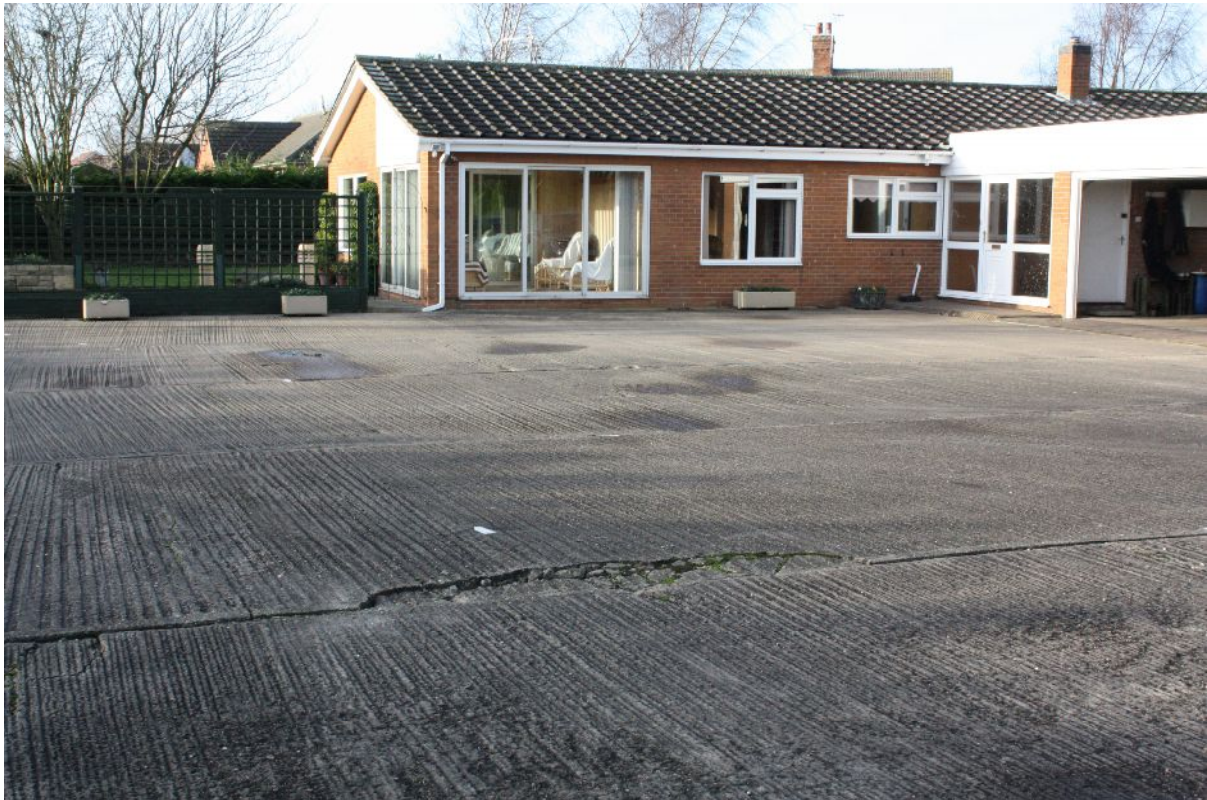
Photo 2 Bungalow 'Alexine' at north western edge of site

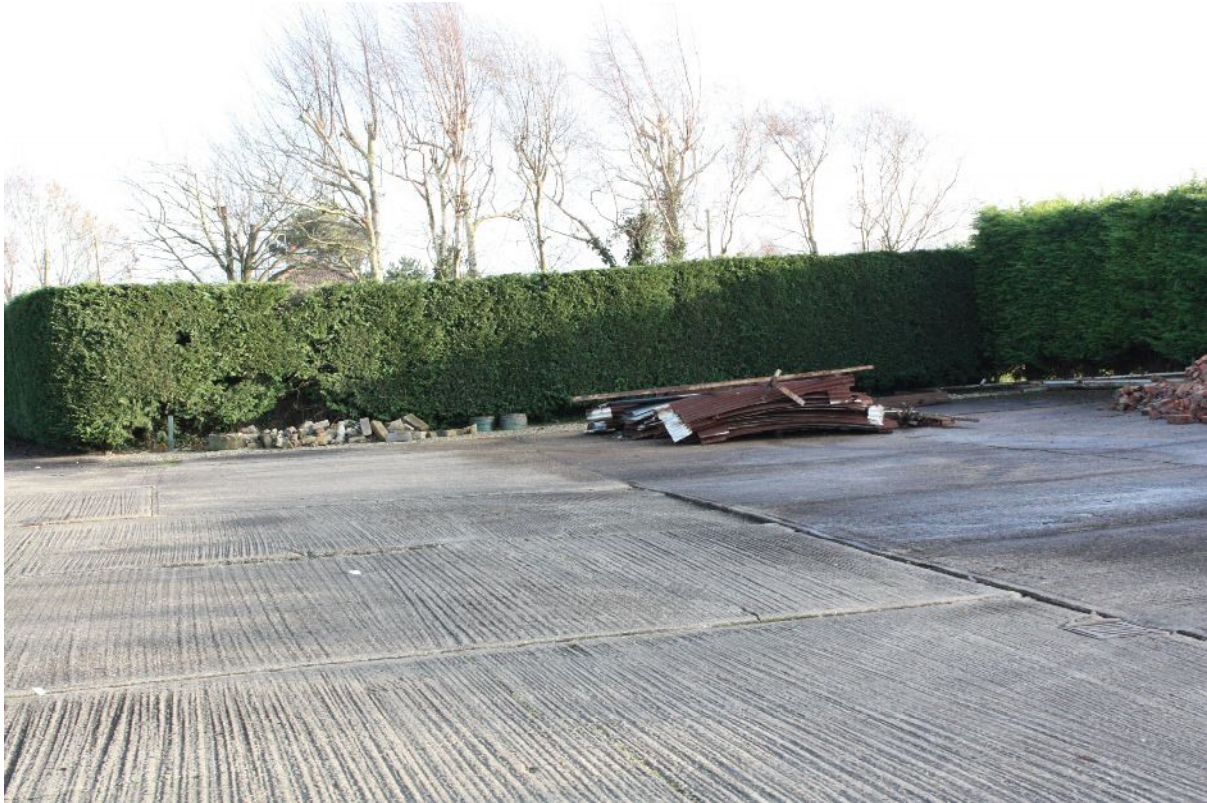
3.2 Sandy continued his haulage business with a single lorry until December 2004, from whence no lorries have been on site. In 1978 a 1,000 gallon above ground diesel tank was installed on the right of the drive looking towards Malting Lane just where the additional land started (photo 3). This was removed and a 5,000 gallon tank installed on the other side of the entry lane (photo 5) when the number of lorries on site increased to 15. When the 15 lorries were removed from the site in 1985, the diesel tank went with them and Sandy used clients diesel to fill his single lorry. No diesel tank has been on site since 1985. On the southern boundary, there was a plastic sheet that sat on the soil (it had gravel on it originally, but most had been removed) and on lifting it the soil under it was fine silty sand.

Examination of the concrete slabs did not show any signs of oil staining and the soil around the sides, especially that near the oil tank locations, also did not show signs of oil staining.

Photo 3 Land to the south of original site, with diesel tank located to left in front of hedge

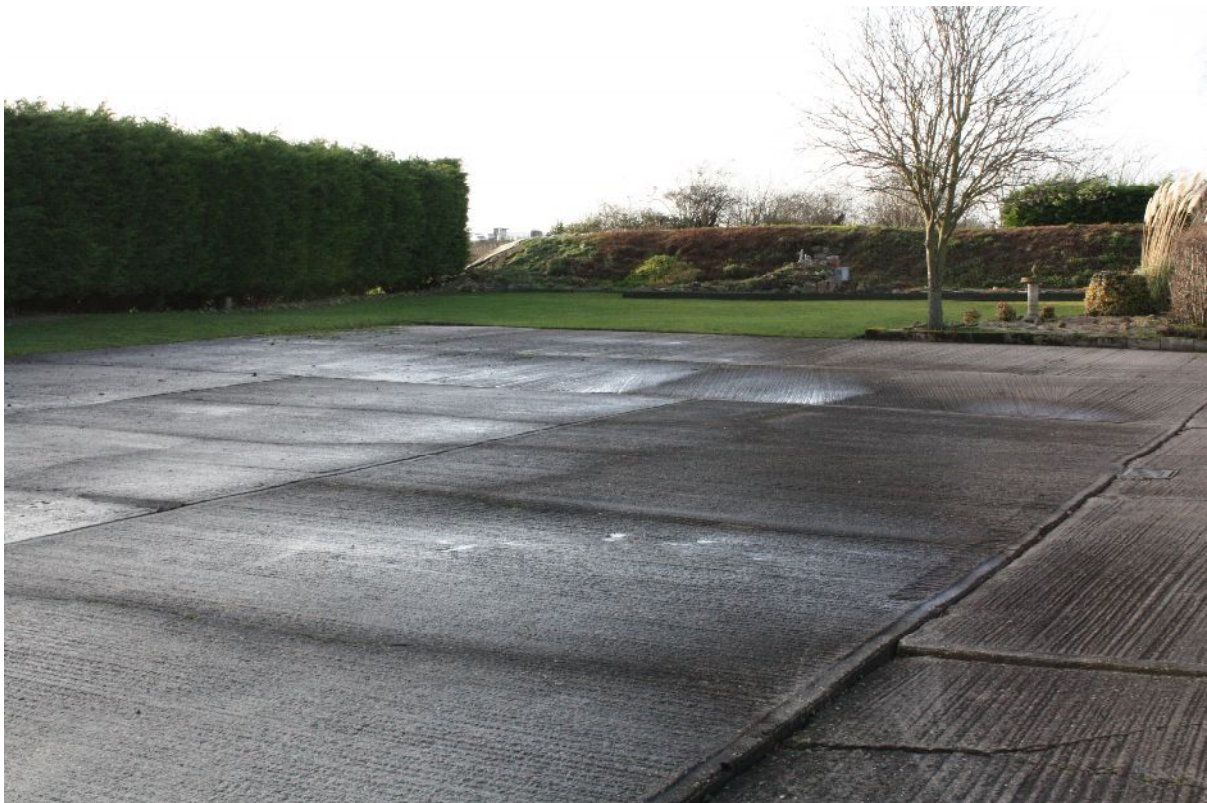
Photo 4 Land to the south of original site, looking west, used as lorry park

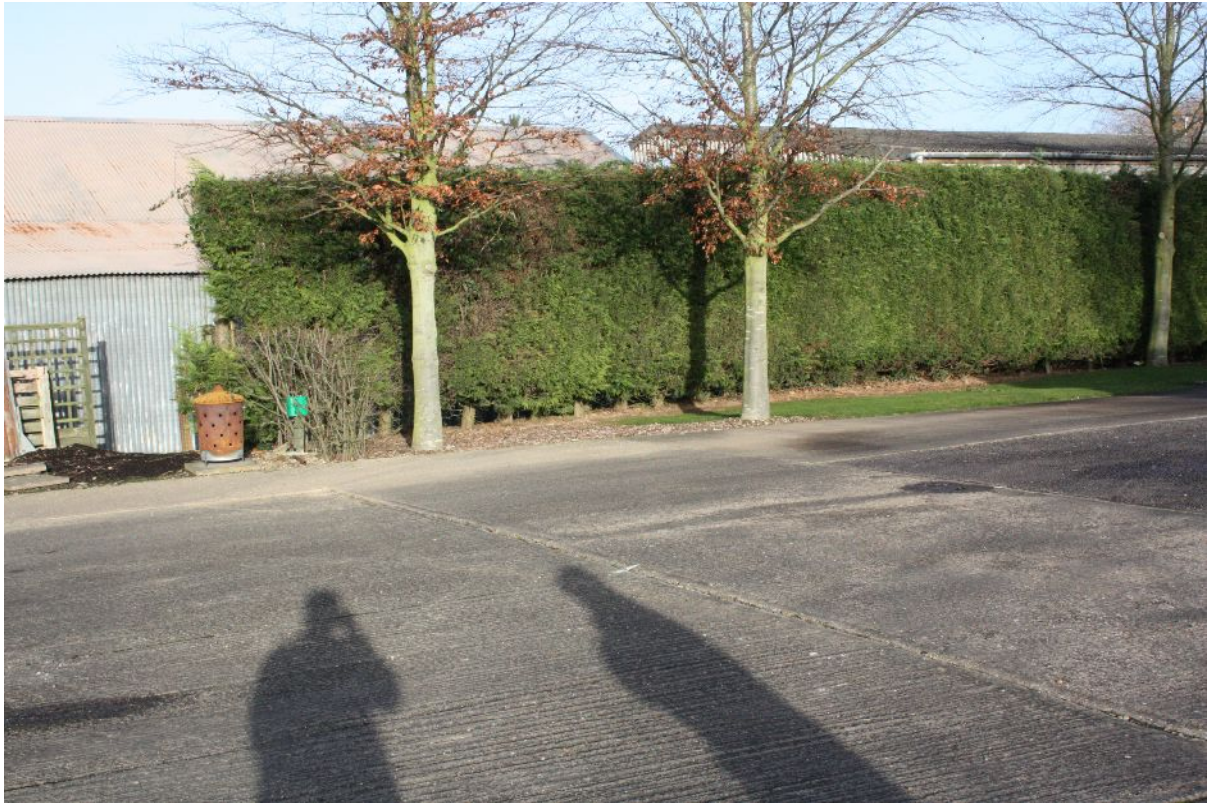
Photo 5 Location of 5,000 gallon diesel tank where brazier is now

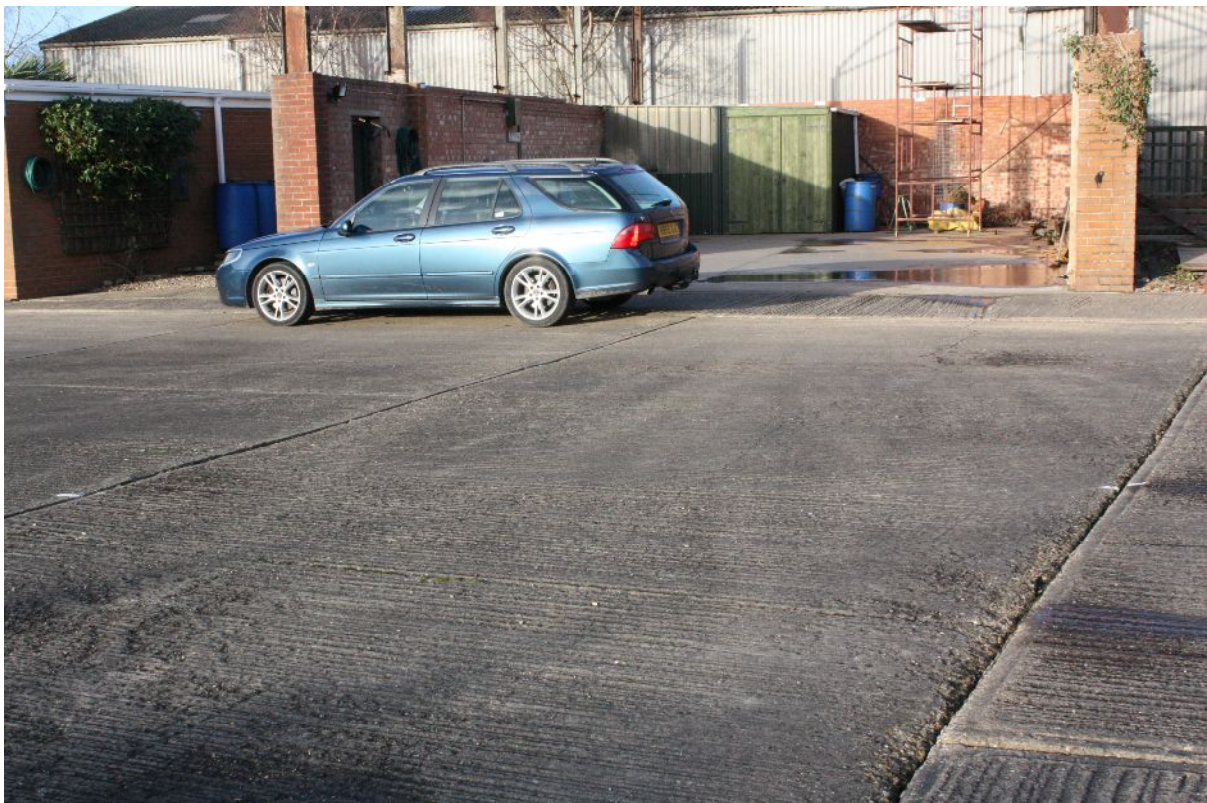
3.3 The lorries were washed down on site, but they were steam cleaned and maintained at a garage (Birdells?) in the High Street in Donington. Oil changes were made on site in the barn that has been partially dismantled (photo 6), but great care was taken to ensure that no oil or diesel was spilled on the concrete or anywhere else in front of the bungalow. Mr and Mrs Dear lived next to the lorry facility and did not want any oil contaminated area so close to it.

Photo 6 Remains of barn in which oil changes were done on lorries

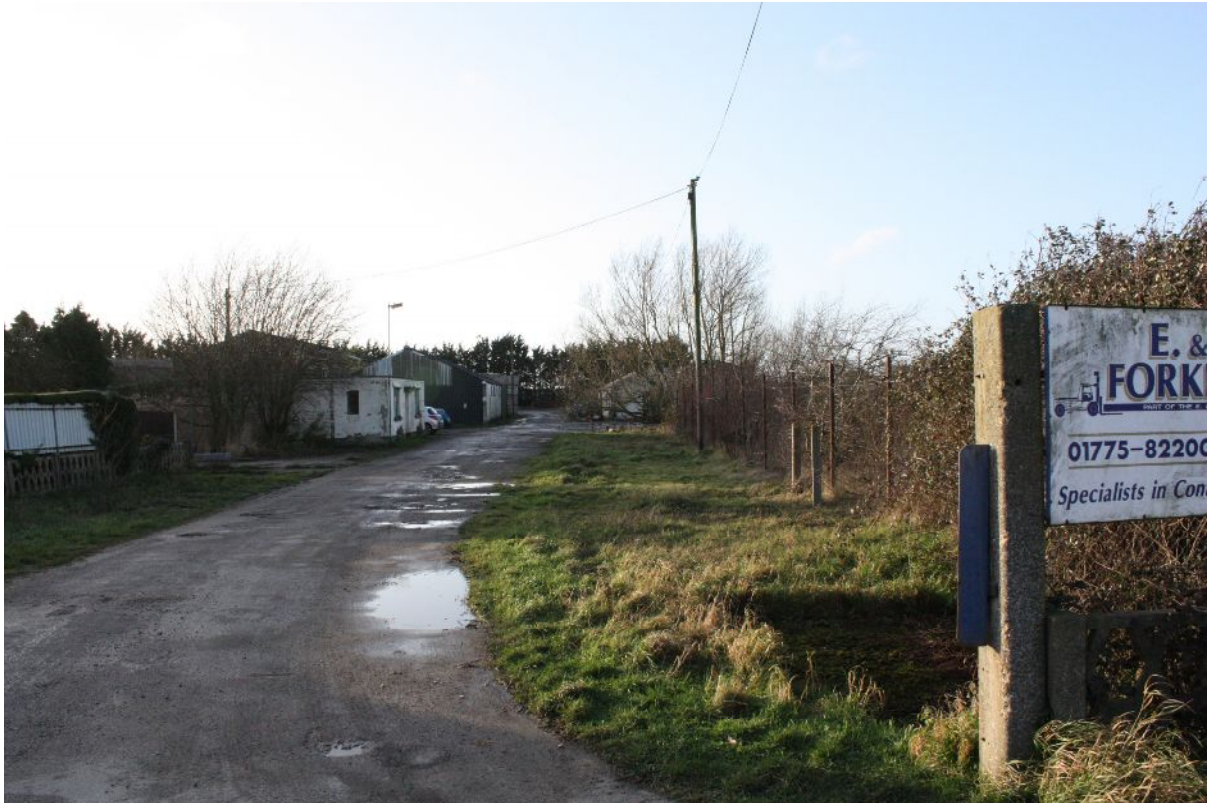
3.4 Sandy confirmed that the business to the south of the site (Concrete Products then and later forklift sales) caused a pollution incident in 2009, but that was noted in the Sitecheck Data report. Sandy explained that the buildings to the north of the site are part of a farm facility and that it has a large diesel tank located some 100 m to the north of the site boundary. Apparently it is not visible from the road, which I confirmed by walking along Malting Lane. However, Sandy explained that it was a modern two compartment double skinned tank that is very unlikely to leak. Also, there is a large house between the site and the tank surrounded by immaculate large lawns and if any large leak had occurred, then those lawn would have been contaminated first.

3.5 A walk along Malting Lane did not reveal any other potentially contaminating processes, other than the former concrete products site that is now abandoned (photo 7).

Photo 7 Former concrete products where hydrocarbon pollution incident occurred in 2009
