# Asbestos Survey

**Asbestos Survey Report  
for  
The Red Cow Hotel  
High Street  
Donnington, Lincs  
PE11 4TA**

**28 January 2021**

**Authorised: ..... Date: 2 February 2021  
Survey Report No – 20861**

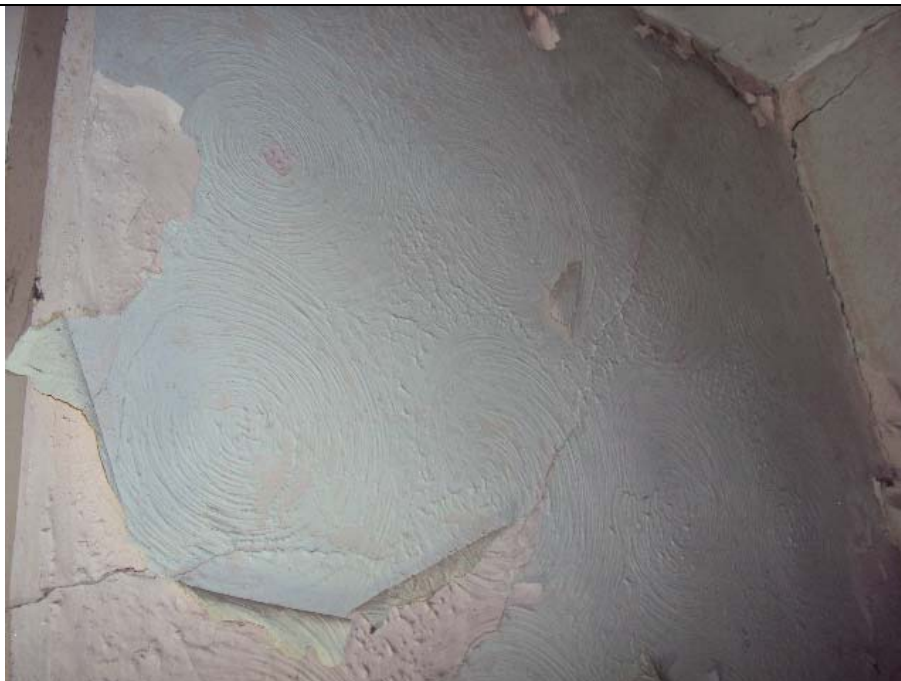
| | Sample No | <i>RCH/01/001</i> |

| | <b>This sample does not contain Asbestos</b> | |
| | Room / Area | <i>01 - Entrance</i> |
| | Component | <i>Textured coating</i> |

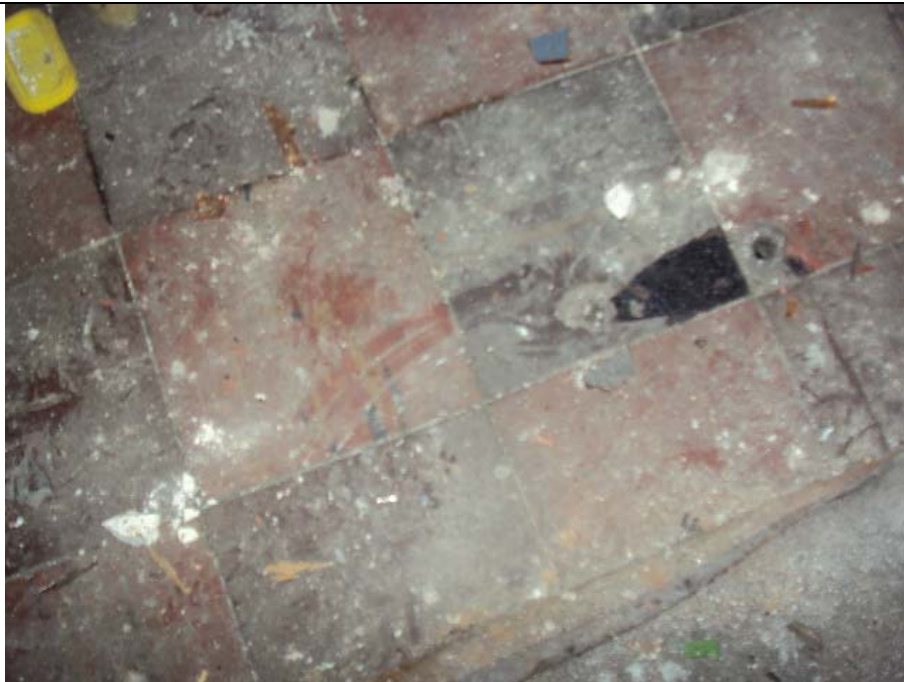
| | Sample No | <i>RCH/04/002</i> |

| | <b>This sample contains Asbestos</b> | |
| | Room / Area | <i>04 - Function room</i> |
| | Component | <i>Floor tiles</i> |

| <b>Survey Results</b> | | Approximate Total Area | <b>60 M sq</b> | Asbestos Type | <b>Chrysotile</b> |
| Location | <b>Internal</b> | Licensed Material | <b>No</b> | Product Type | <b>Plastic Product</b> |
| Comments | <b>Remove prior to the refurbishment works.</b> | | | | |

| Laboratory Sample Ref. | Sample Location and Description | Asbestos Fibre Type | Presumptive Product Type |
|---|---|---|---|
| BS298826 | RCH/04/002 - Floor tiles<br>(the asbestos is also in the adhesive) | Chrysotile | Plastic product |

**This is a non-licensed asbestos containing material, but when removed must be disposed of as hazardous waste.**

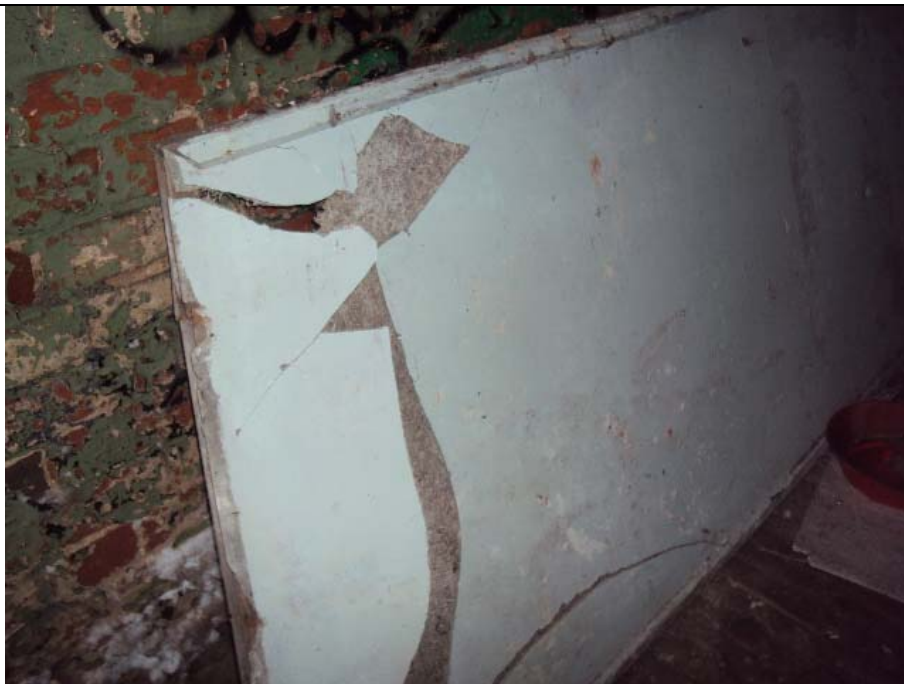
| | Sample No | <i>RCH/09/003</i> |

| | <b>This sample contains Asbestos</b> | |
| | Room / Area | <i>09 - Stable</i> |
| | Component | <i>Cladding panel</i> |

| <b>Survey Results</b> | | Approximate Total Area | <b>6 M sq</b> | Asbestos Type | <b>Chrysotile</b> |
| Location | <b>Internal</b> | Licensed Material | <b>No</b> | Product Type | <b>Cement Product</b> |
| Comments | <b>Remove prior to the refurbishment works.</b> | | | | |

| Laboratory Sample Ref. | Sample Location and Description | Asbestos Fibre Type | Presumptive Product Type |
|---|---|---|---|
| BS298827 | RCH/09/003 - Cladding panel | Chrysotile | Cement product |

**This is a non-licensed asbestos containing material, but when removed must be disposed of as hazardous waste.**

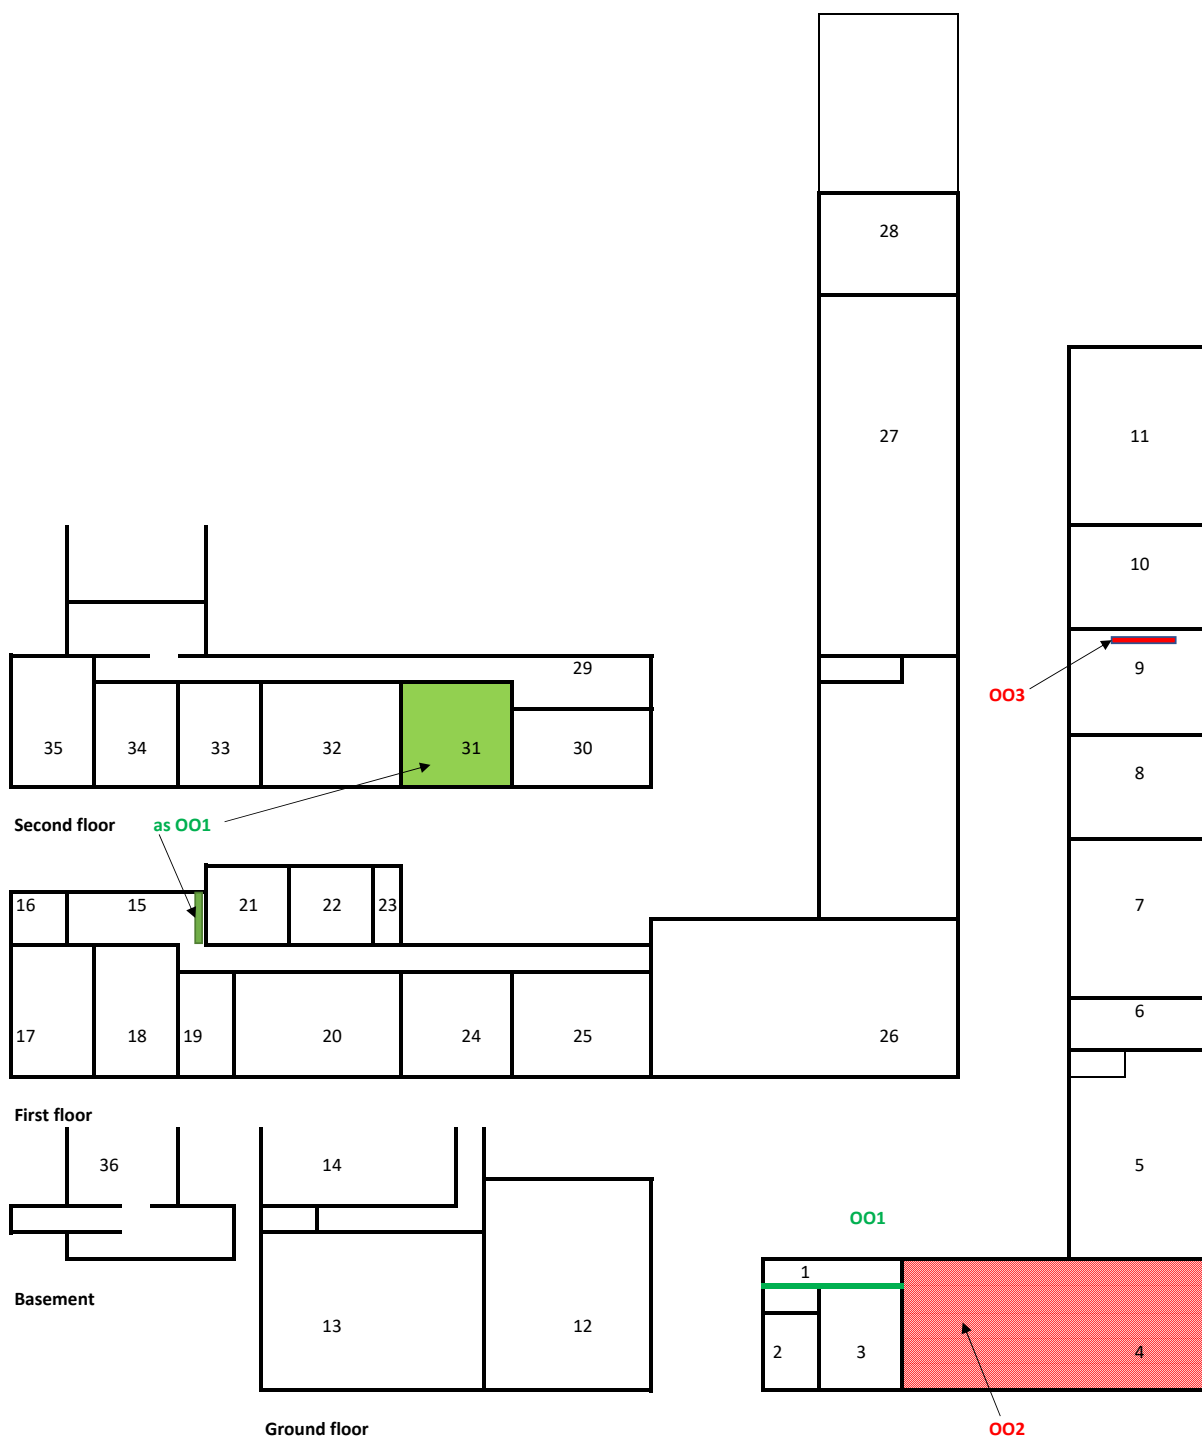
## Red Cow Hotel, High Street, Donnington

Areas highlighted in red indicate an Asbestos Containing Material Present

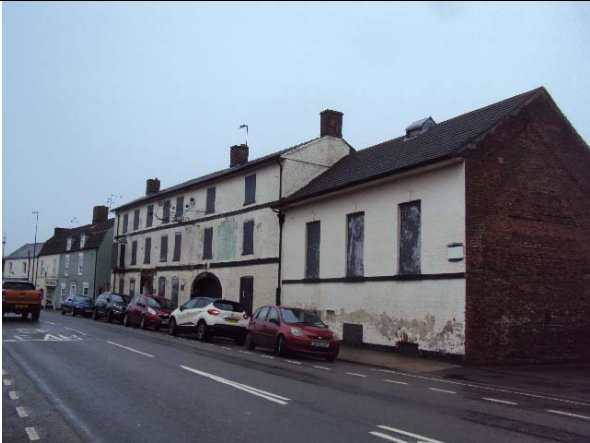
| 1 | | External view - clay roof tiles, render on brick walls, cast iron rainwater goods, timber fascia/soffit boards. No asbestos containing materials seen here. |

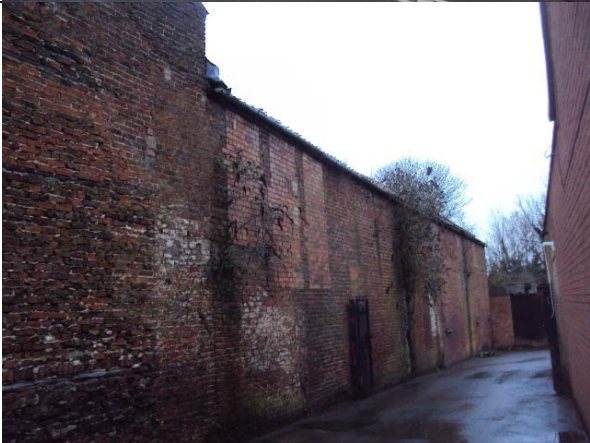
| 2 | | Solid brick walls to side elevation. No asbestos containing materials seen here. |

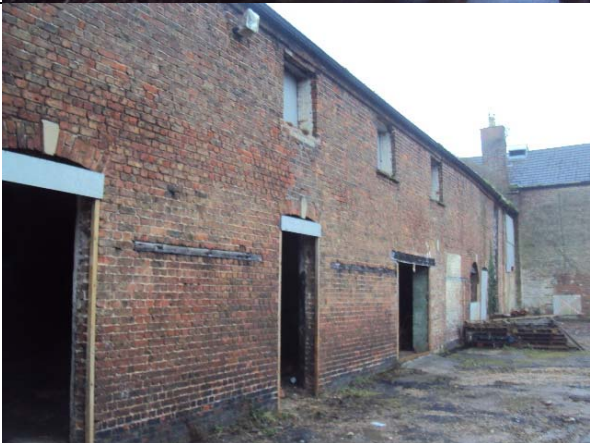
| 3 | | Clay roof tiles, solid brick walls, cast iron rainwater goods. No asbestos containing materials seen here. |

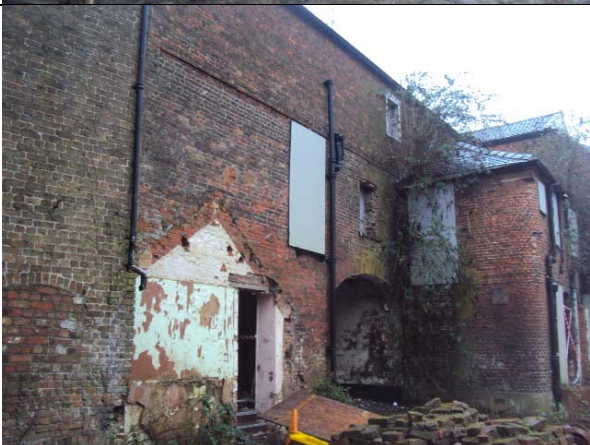
| 4 | | Brick walls, cast iron rainwater goods. No asbestos containing materials seen here. |

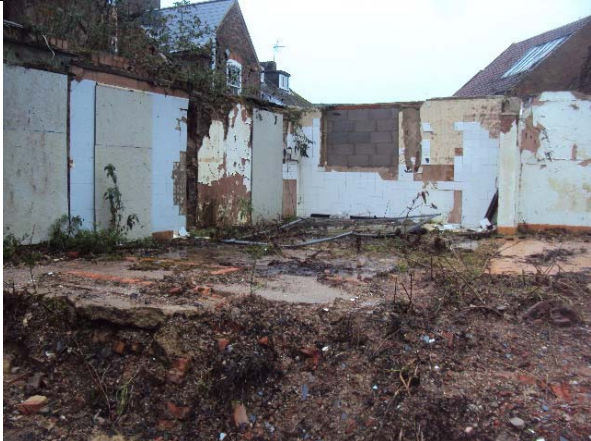
| 5 | | <p>Some areas have been partly demolished. Inspections made. No asbestos containing materials seen here.</p> |

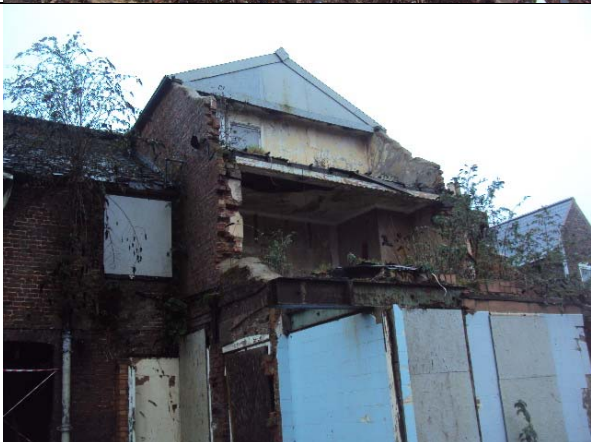
| 6 | | <p>Again, some areas have been partly demolished. No asbestos containing materials seen here.</p> |

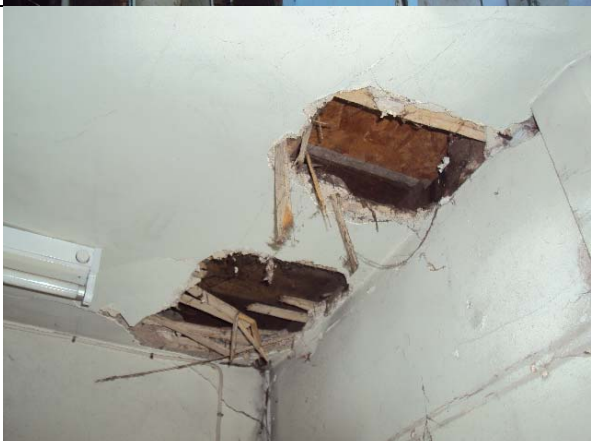
| 7 | | <p>Plaster on reed to most ceilings. No asbestos containing materials seen here.</p> |

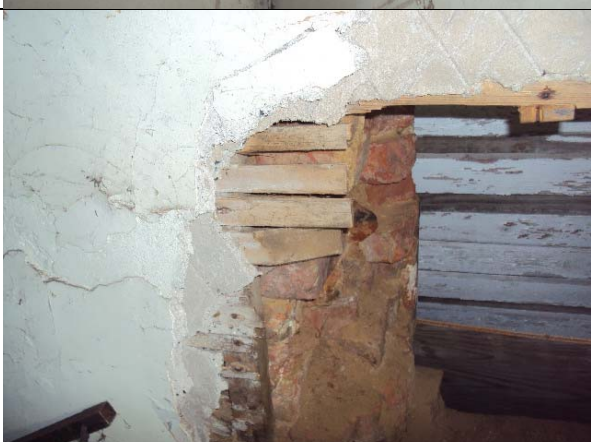
| 8 | | <p>Lathe and plaster on solid brick walls. No asbestos containing materials seen here.</p> |

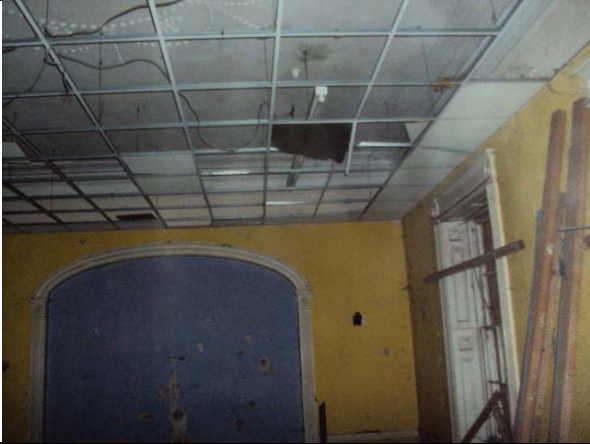
| 9 | | Fibreboard suspended ceiling tiles in metal suspension grid to function room. No asbestos containing materials seen here. |

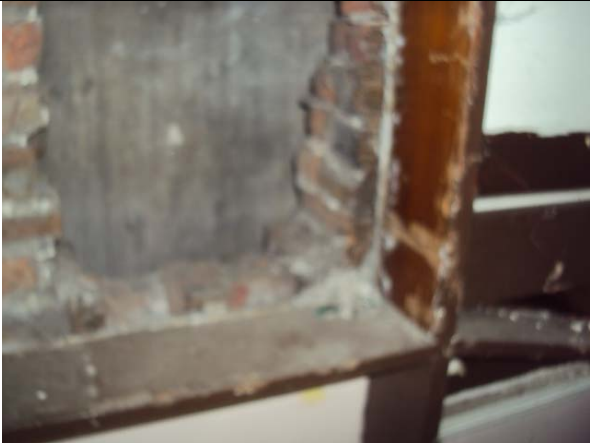
| 10 | | Solid brick walls, plaster finish. No asbestos containing materials seen here. |

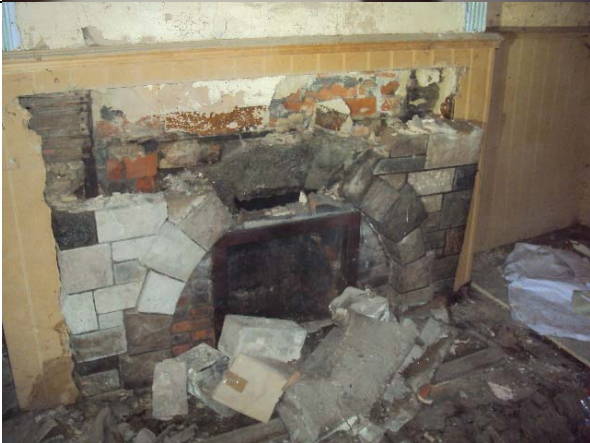
| 11 | | Fireplaces inspected. No asbestos containing materials seen here. |

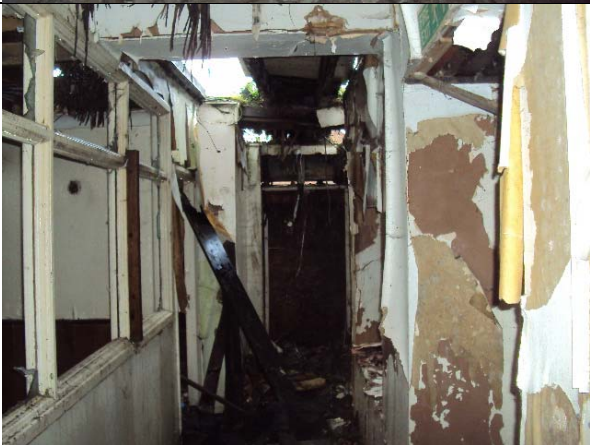
| 12 | | Some timber stud partitions clad in plasterboard. No asbestos containing materials seen here. |

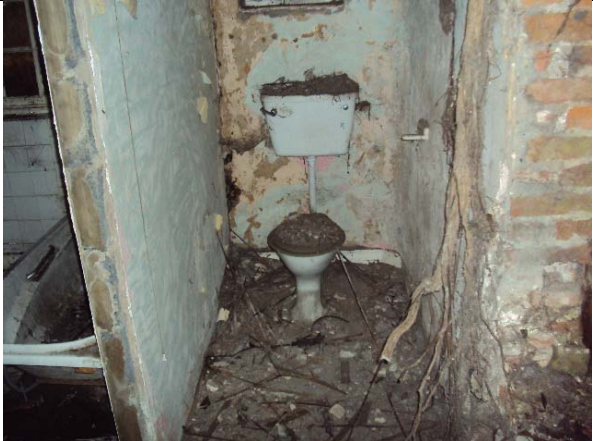
| 13 | | China sanitary ware. No asbestos containing materials seen here. |

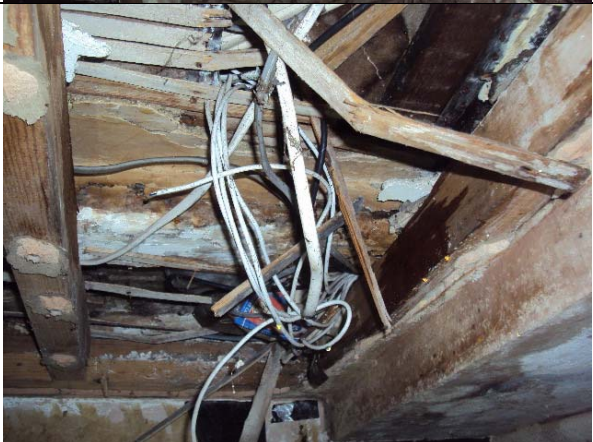
| 14 | | Timber joists, rafters throughout. No insulation seen. No asbestos containing materials seen here. |

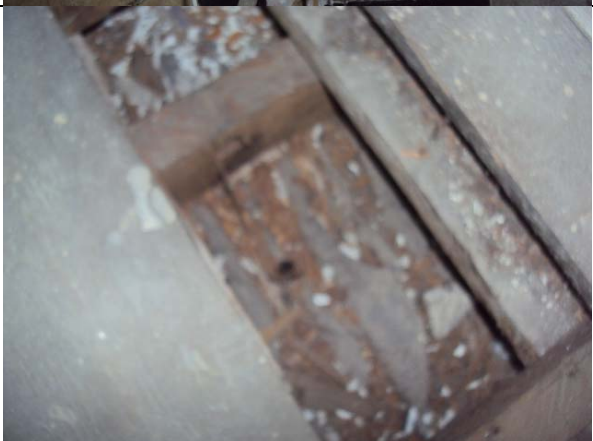
| 15 | | Suspended timber floors inspected. No asbestos containing materials seen here. |

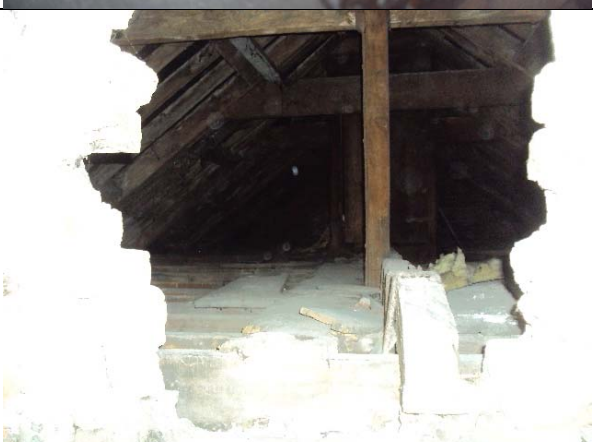
| 16 | | Roof void inspected. No asbestos containing materials seen here. |

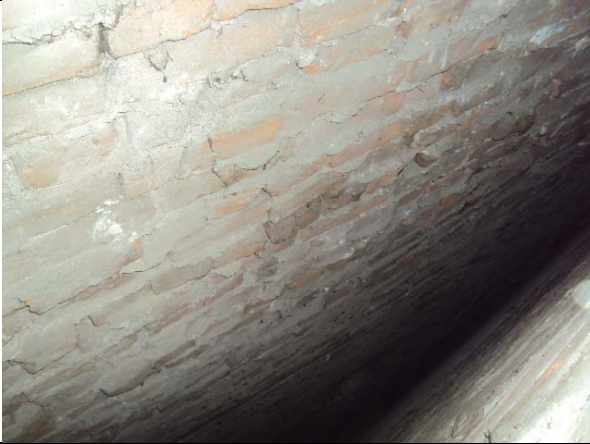
| 17 | | All voids viewed where possible. No asbestos containing materials seen here. |

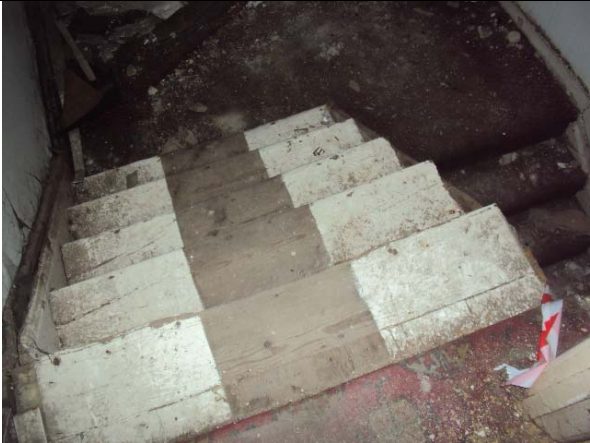
| 18 | | Timber stairs in most instances. No asbestos containing materials seen here. |

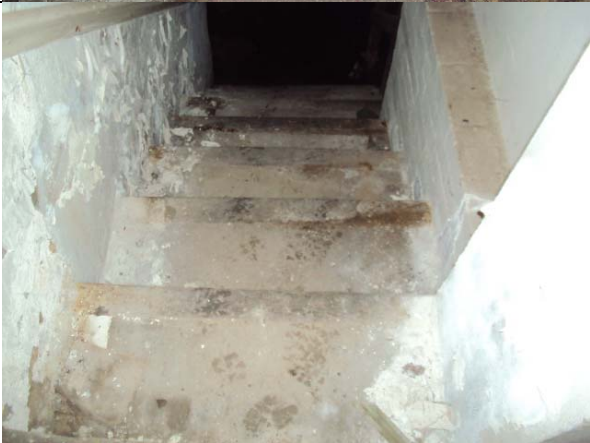
| 19 | | Concrete stairs to basement. No asbestos containing materials seen here. |

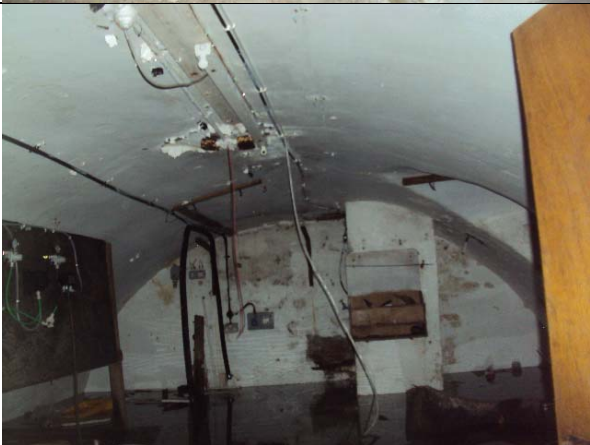
| 20 | | Basement was flooded so no safe access. Brick vaulted ceiling. No asbestos containing materials seen here. |

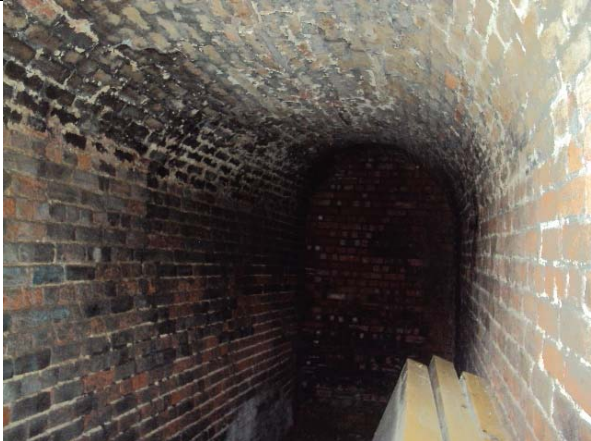
| 21 | | Outbuildings with solid brick walls. No asbestos containing materials seen here. |

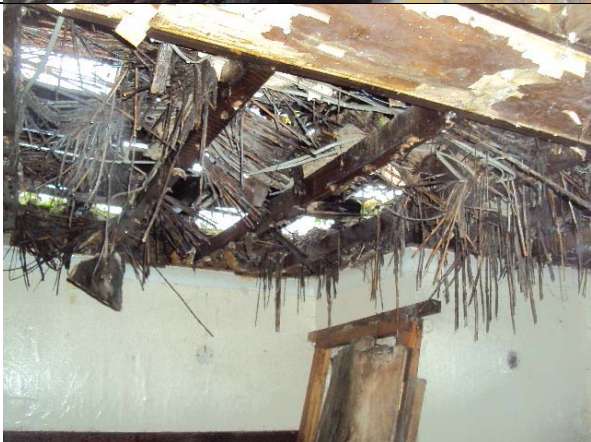
| 22 | | Some areas were not fully accessed for health & safety reasons. No asbestos containing materials seen here. |

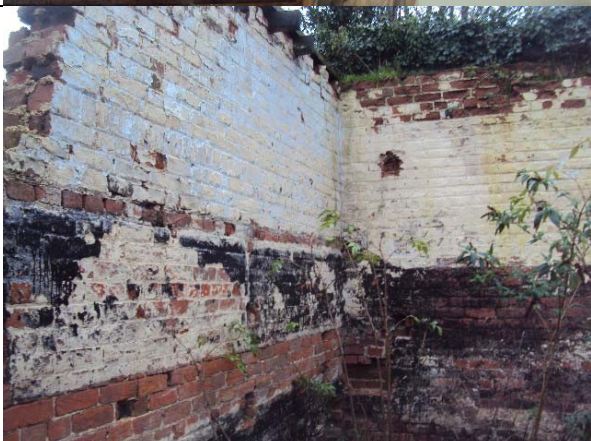
| 23 | | Some areas have been partly demolished. Brick walls with concrete floors. No asbestos containing materials seen here. |

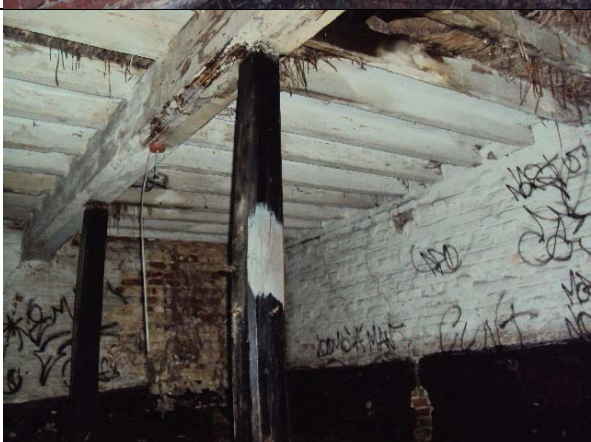
| 24 | | Timber joists to suspended floors. No insulation products found. No asbestos containing materials seen here. |
