**ARCHAEOLOGICAL MONITORING AND RECORDING AND HISTORIC BUILDING SURVEY AT FORMER RED  
COW HOTEL, 8 HIGH STREET, DONINGTON, LINCOLNSHIRE**

Planning Reference: H04-1190-17  
NGR: TF 20915 35710  
AAL Site Code: DOHS 20  
Museum Accession Number: 2020.178  
OASIS Reference Number: allenarc1-416605

By  
Allen Archaeology Ltd  
Report Number AAL 2021045

April 2021

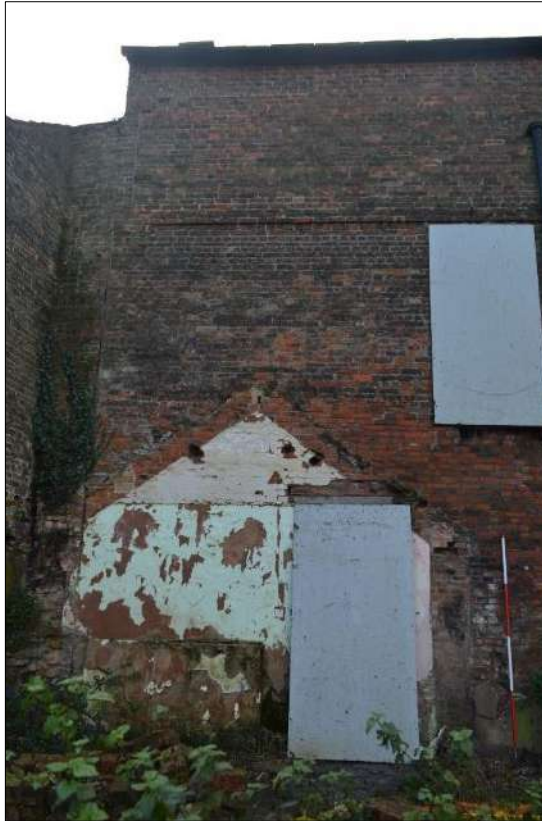
- 6.9 A change in the brickwork on the second floor may be evidence of the alleged refronting. The English Garden Wall bond on the second floor is set with three courses of stretchers between each course of headers (Plate 8). The floors below display a mix of English bond with alternating single rows of stretchers and headers and randomly laid courses mixing header and stretchers. This doesn't necessarily indicate different phases of repairs, instead the rear of the building was never in the public view and therefore the difference in bricklaying may either evidence rationalising of the brick stock where possible different craftsmen. Apprenticeship may have even been practiced at the rear of the structure.

*Plate 8 (shot 64): Scarring of removed structure on the north elevation, also showing ragged joint on second floor. Looking south, 2m scale*

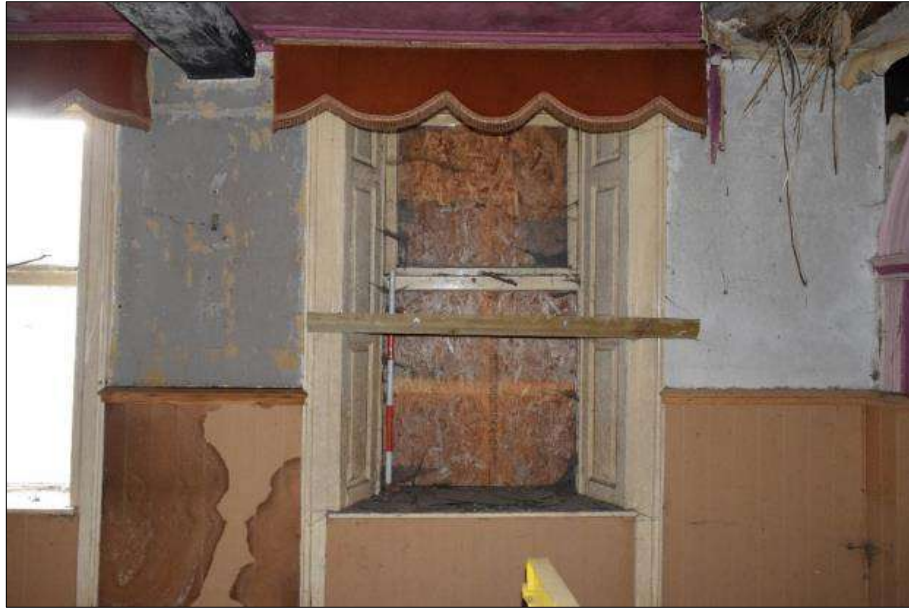
*Plate 15 (shot 191): Close up of window with shutters. Hole in the ceiling displays plaster over reeds. Looking south, 1m and 0.5m scale*

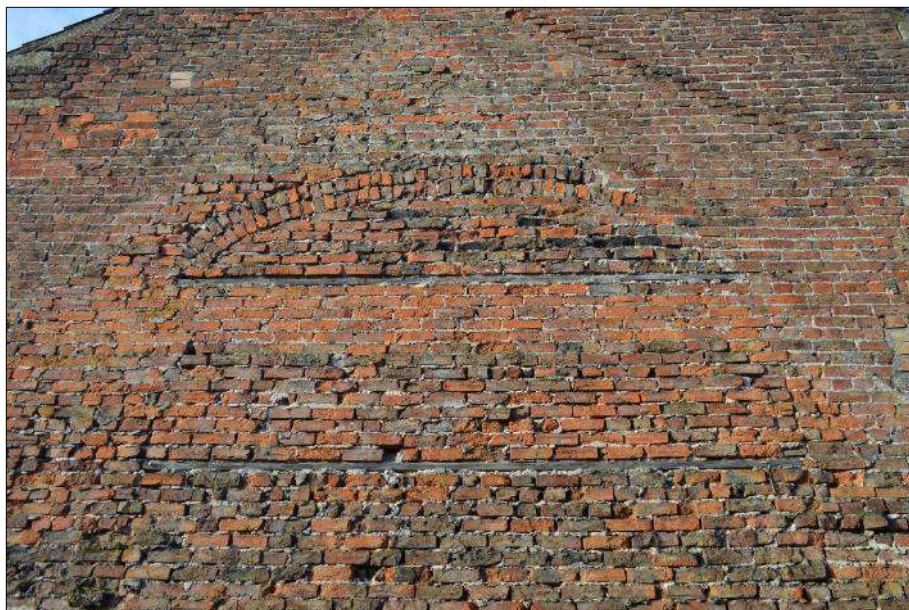
*Plate 34 (shot 4): Close-up of broken brick arch and blocked opening. Looking west-northwest*

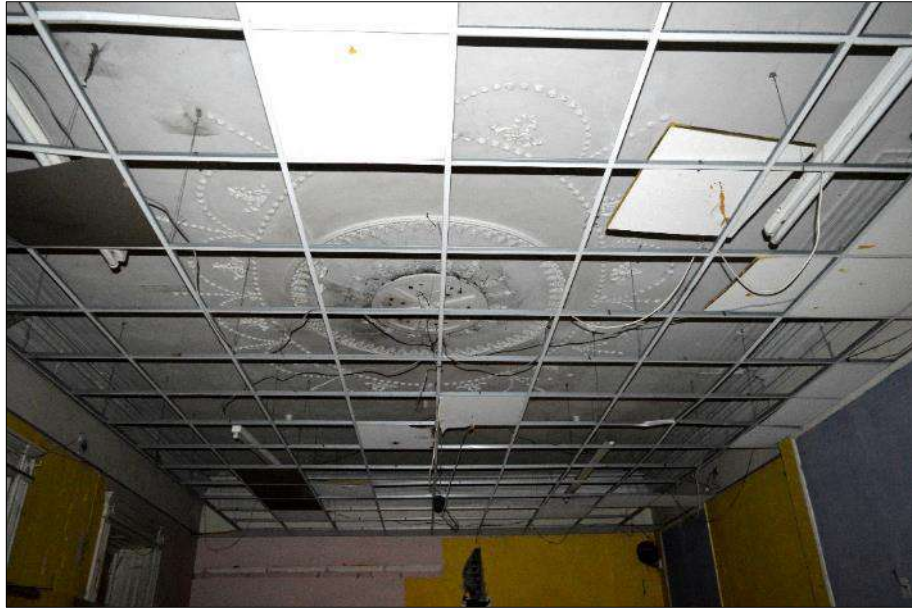
- 6.38 Above the framework of the modern suspended ceiling (partially removed) is a plastered ceiling, displaying floral motifs of possibly lilies, buds and leaves (Plate 43 and Plate 44). A thick, moulded, plastered cornice surrounds the ceiling. The original ceiling rose is partially hidden by a later rose from which an electric light - probably a chandelier - was hung. The impact of this modern feature on the older ceiling is unknown. These features appear to be late Georgian in style but a suitable specialist/conservator would be able to confirm their authenticity and also provide advice on how best to preserve them (if at all possible).

*Plate 43 (shot 160): Plastered ceiling with floral motif and plastered cornice. Looking west-northwest*

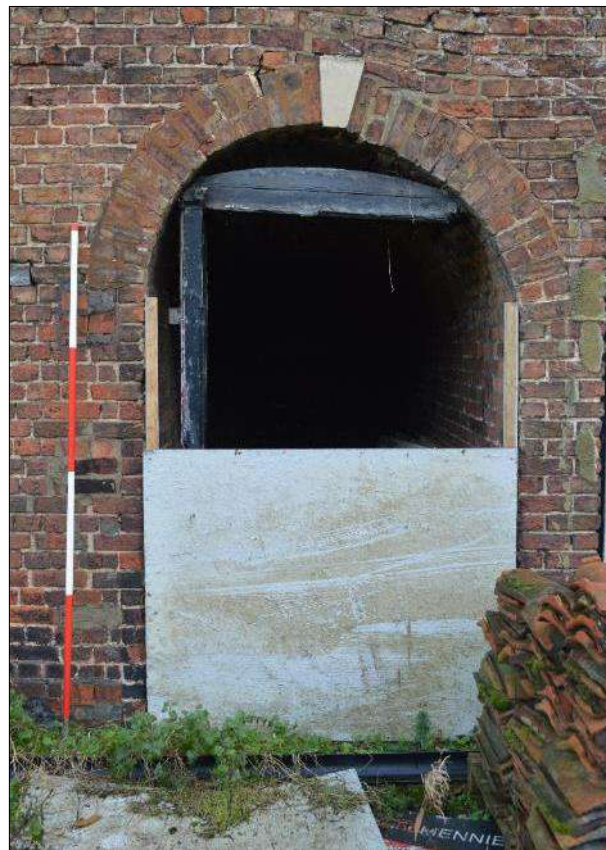
- 6.46 The archway (C0.6) was not blocked from the west side as it was on the east and may have been used later as a storage room (Plate 57). The wall above has been undermined causing a slump of the arch.

*Plate 57 (shot 56): Slumping archway. Looking east-southeast, 2m scale*

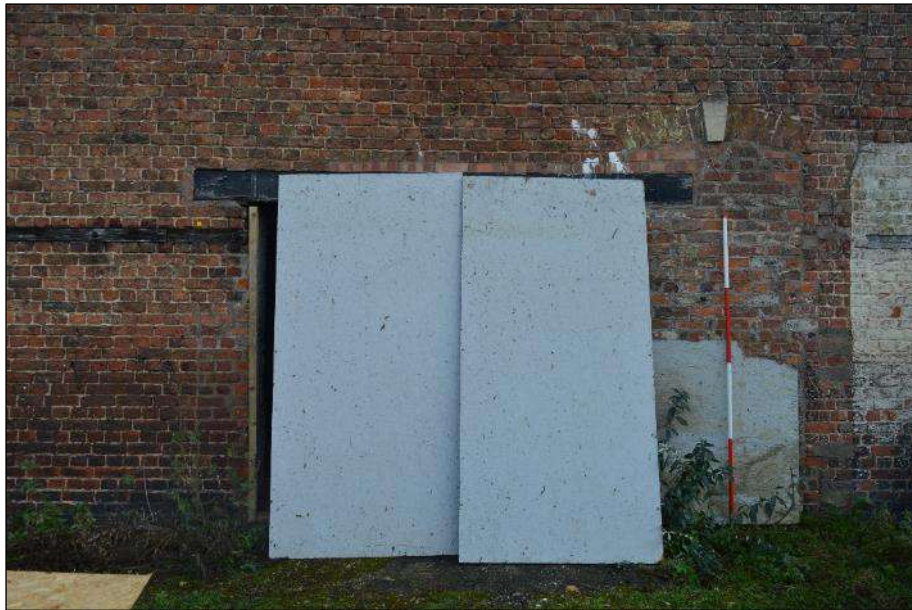
- 6.47 The stable doorway to C0.5 has been replaced with a wider opening, a seemingly fairly recent alteration in order to perhaps allow for vehicular access.

*Plate 58 (shot 52): Bricked up doorway replaced with boarded up cart opening. Looking east-southeast, 2m scale*

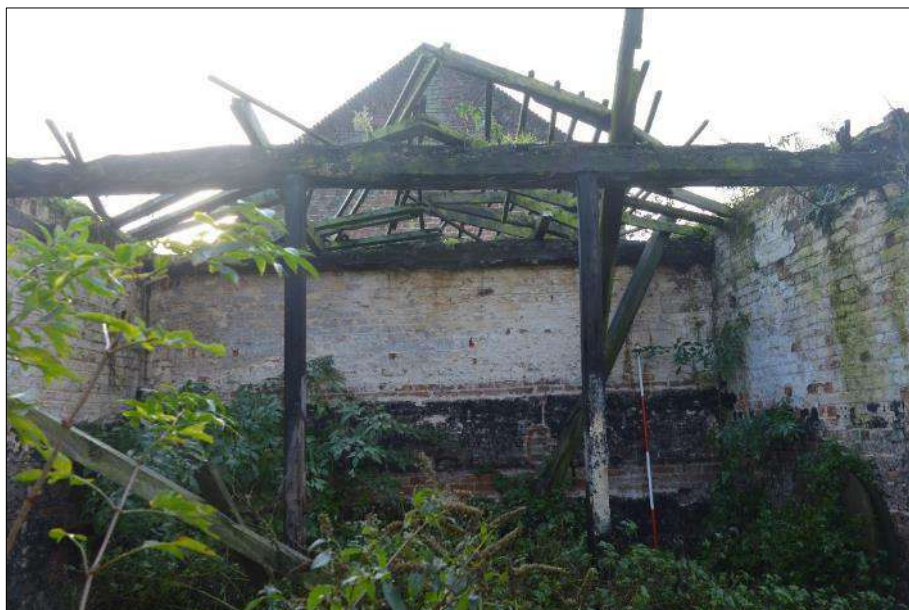
*Plate 61 (shot 38): General view of C0.1 showing collapsed rafters. Looking south-southwest, 2m scale*

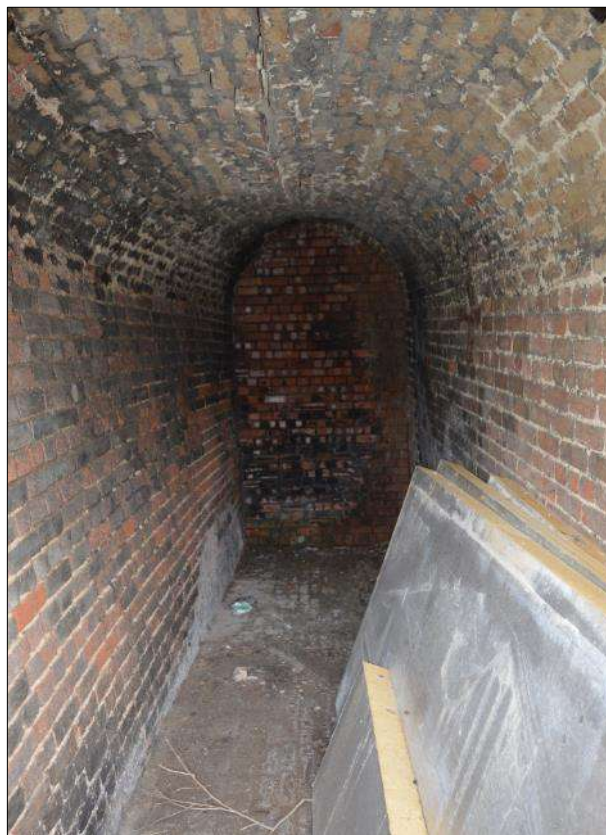
- 6.56 The former archway and current storage, C0.6, showed no other features other than a vaulted ceiling and brick floor (Plate 70). The ceiling has had some modern repairs with cement-based fill instead of lime, thus having had little effect to stop the persistent cracks in the brickwork.

*Plate 70 (shot 117): Blocked off archway C0.6. Looking east-southeast*

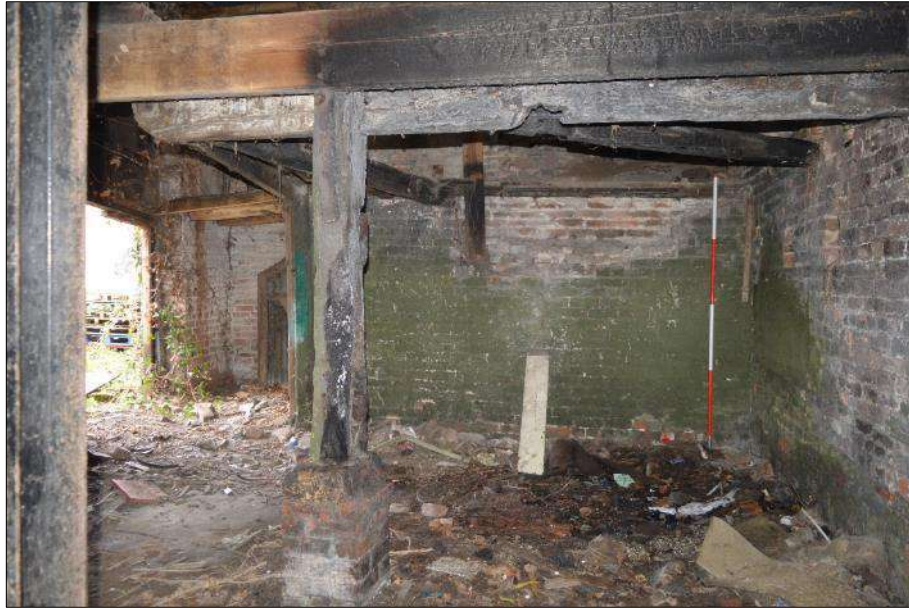
- 6.58 Beneath the debris in C0.7, is the original brick floor. The seemingly ad hoc 'loft', C1.1, does not cover the entire space of the ground floor, but rather comprises a network of branching timbers, linking a mezzanine floor in the south to the mezzanine floor in the north and being supported by the east wall. Some of the timbers show signs of burning (Plate 73).

*Plate 73 (shot 123): Heat affected timbers of C0.7. Looking north, 2m scale*

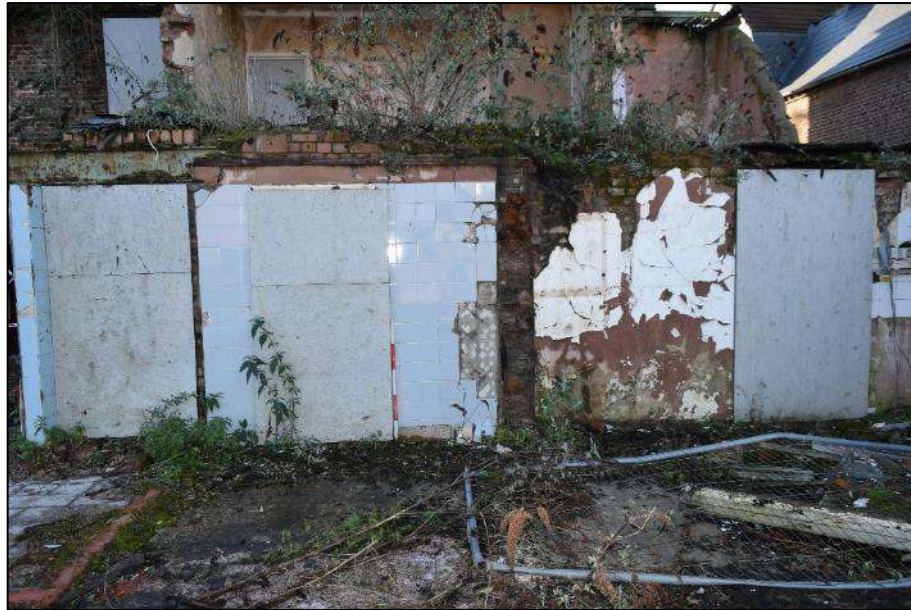
*Plate 86 (shot 203): General view of demolished areas of D. Looking south, 1m scale*

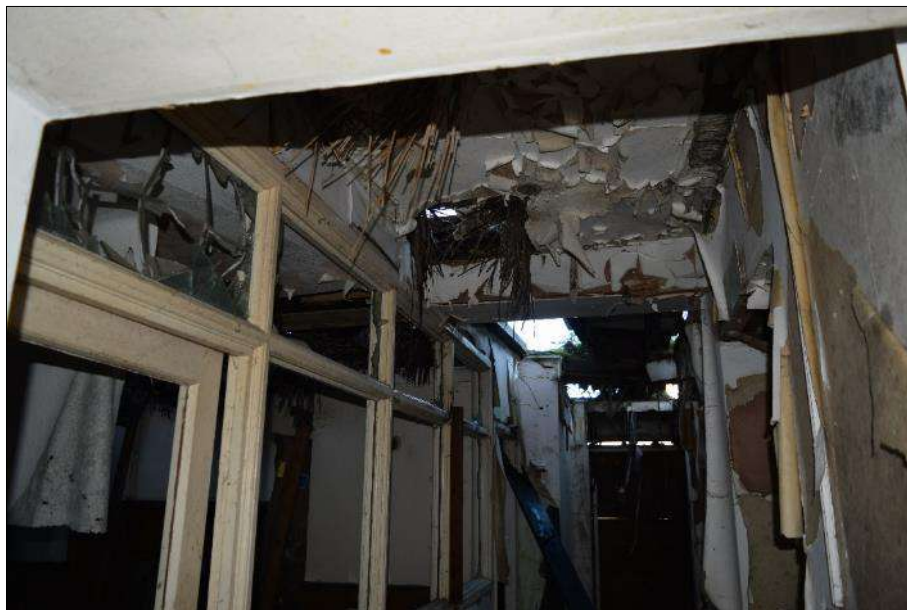
- 6.68 Little could be viewed of the surviving interior. A second function room could be seen on the western side of a corridor and past the glazed panelling, north of the main pub. The corridor ceiling was badly damaged revealing early reed material overlain by plaster, as seen in Structure A (Plate 87).

*Plate 87 (shot 200): Ground floor corridor and function room, showing reeded and plastered ceiling. Looking northwest*
