# TREE DECAY DETECTION SURVEY & ASSESSMENT

The Thomas Cowley High School, Donington

Robert C Yates

19<sup>th</sup> May 2022

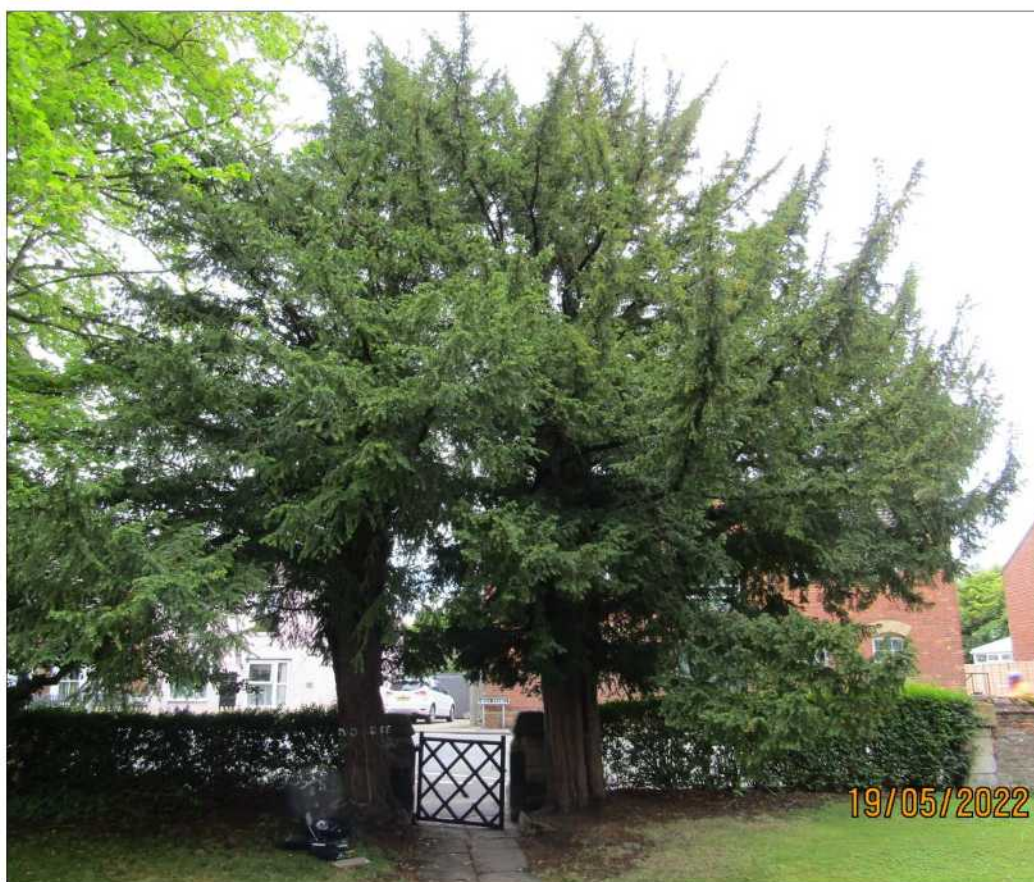
**3.1 The subject tree** is a mature English Yew (*Taxus baccata*). It is located to the front of the school reception building, adjacent the highway, and is one of a pair of similar trees – See Fig.1. It is approximately 10 metres in height and is of good vitality. It has previously been subject to a crown reduction on at least one occasion. The main area of concern is the lower main stem, in which there is a large cleft with exposed heartwood and fruit bodies of the fungal species *Laetiporus sulphureus* – See Fig.2. This fungus causes a brown rot type of decay, whereby the cellulose is preferentially degraded.

Fig.1 Subject tree (to left), looking southwest

- 4.1** Reduce crown height by 2.5 metres and spread to north, east and south aspects by 3m (*Note: It would be prudent and appropriate to include the adjacent Yew tree, thus managing the crowns of both trees*). Re-test with similar diagnostic equipment in three years' time.
- 4.2** The crown reduction work is to be undertaken subject to local authority approval, by a suitably qualified professional, in accordance with British Standard 3998 (2010) 'Tree Work – Recommendations'.

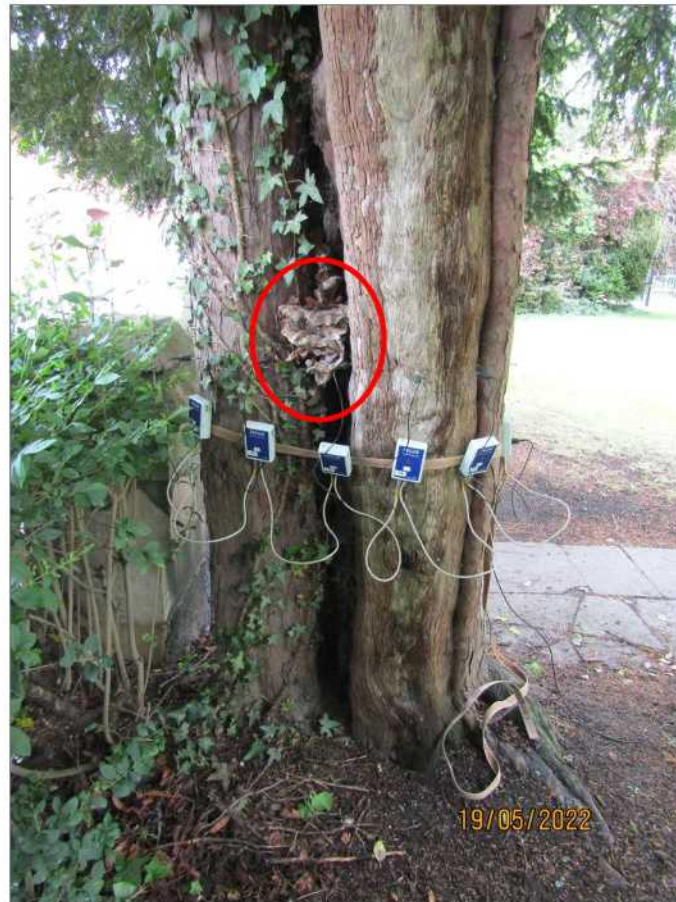
**3.2** The Sonic Tomography equipment was installed at 120cm above ground, comparative to the height of the fungal fruit body (See Fig.2). The resulting image, which can be seen in Fig.3, confirms that there is 62% decayed wood, with a further 11% early stage decay. To further confirm the result of the sonic test, the Resistograph (IML Resi-PD400) was used at two locations, corresponding with PiCUS sensors 1 & 3/4 – See Appendix 1 for results.

*Fig.2 Lower stem looking northwest, with sonic device in-situ (fungal fruit body circled)*

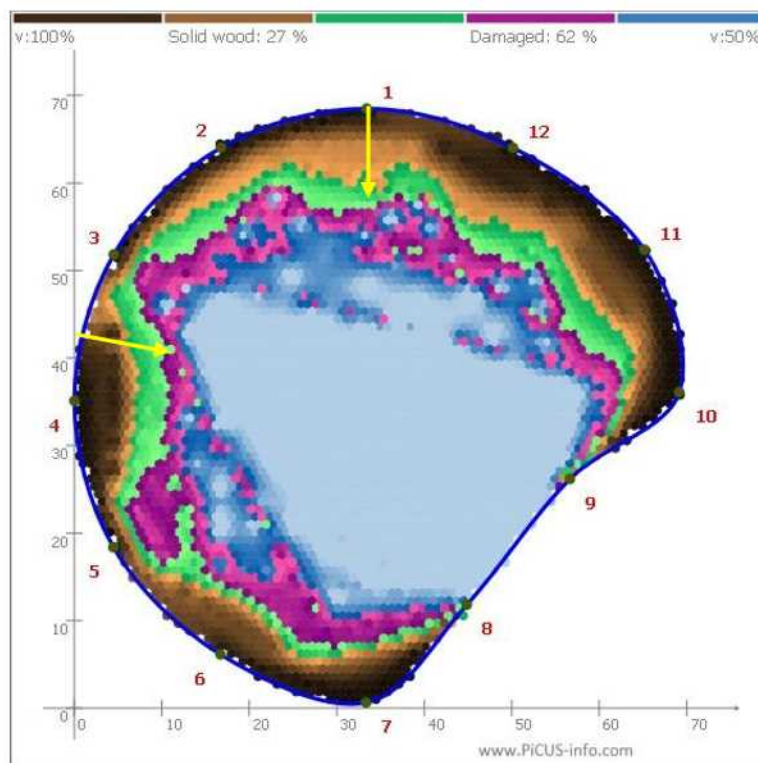
*Fig.3 Tomogram from 120cm above ground level (North to top)  
Resistance measurement locations superimposed as yellow arrows*

- 3.3** We are able to conclude that there is a large volume of internally decayed wood or cavity, which if it were not for the relatively small size of the crown, would be of certain detriment to the tree's structural integrity. The amount of decay will not, however, allow for any future growth, and hence maintaining the crown at the same or lesser volume will be essential if the risk of a stem fracture is to be adequately mitigated.
