**Condition Survey  
Report**

**Timber & Metal Windows**

**Thomas Cowley High School  
School Lane  
Donington  
Spalding  
PE11 4TF**

**October 2022**

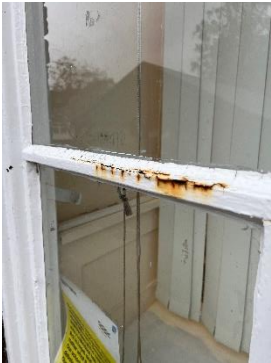
The timber windows are not thought to be part of the original school construction, however they are thought to be 50+ years old, exceeded their service lifespan and are beyond economical repair. The windows are suffering from prolonged timber rot. - **Condition Category D1**

| <p><b>Figure: 3</b><br/>Location: Original Building<br/>Defect: Rotten defected timber window</p> | <p><b>Figure: 4</b><br/>Location: Original Building<br/>Defect: Rotten defected timber window</p> |

It is recommended that the timber and steel windows installed throughout the English Block and Original Building are replaced with new, modern double glazed aluminium windows that meet the current Building Regulations.

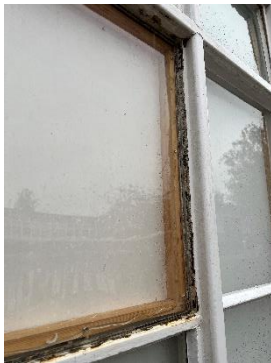
During our inspection, it was apparent that a number of single glazed steel and timber windows had repaired with both timber and metal mullions and transoms in an attempt to protect the building elements from deteriorating further - **Condition Category D1**

| <p><b>Figure: 5</b><br/>Location: Original Building<br/>Defect: Example of previous repairs to dilapidated timber windows</p> | <p><b>Figure: 6</b><br/>Location: Original Building<br/>Defect: Evidence of prolonged timber rot to timber windows</p> |

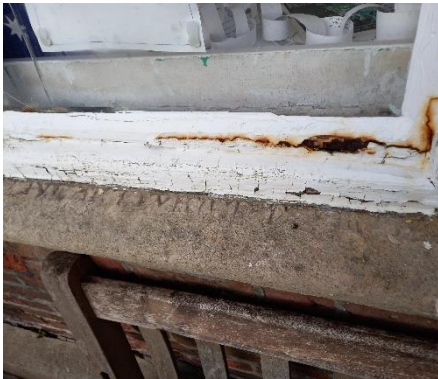
**Figure: 7**  
Location: Original Building  
Defect: Further evidence of prolonged timber rot to timber windows

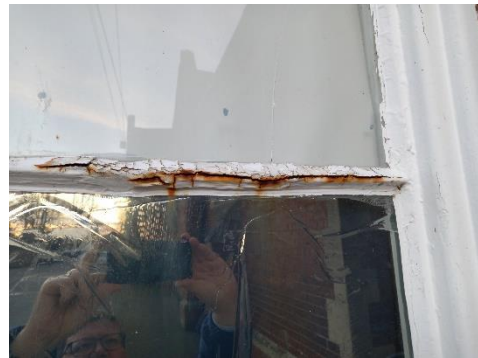
**Figure: 8**  
Location: Original Building  
Defect: Life expired and dilapidated timber windows

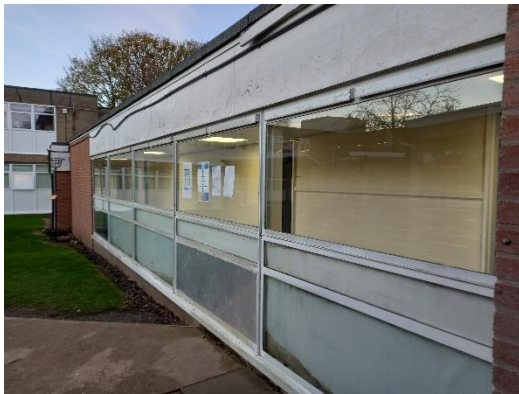
The steel windows are thought to be 50+ years old. The units are clearly aged and have far exceeded their serviceable lifespan. The steel frames are dilapidated, with paintwork flaking and debonding throughout. Cement and silicone seals have perished/weathered. - **Condition Category D1**

**Figure: 9**  
Location: English Block  
Defect: Aged and life expired steel windows

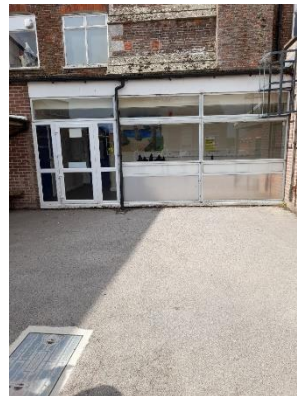
**Figure: 10**  
Location: Original Building  
Defect: Aged and life expired steel windows

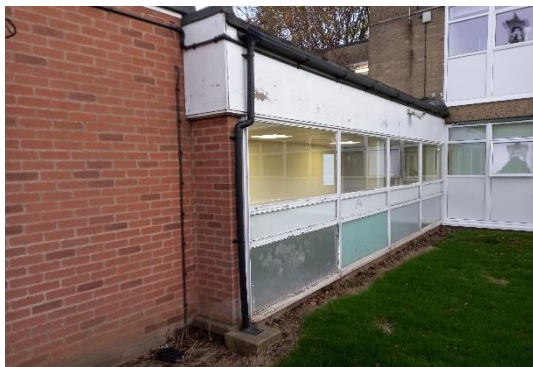
**Figure: 11**  
Location: English Block  
Defect: Aged and life expired steel windows

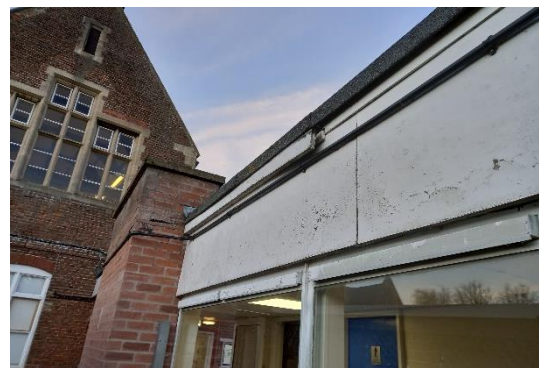
**Figure: 12**  
Location: English Block  
Defect: Aged and life expired steel windows & timber fascia board

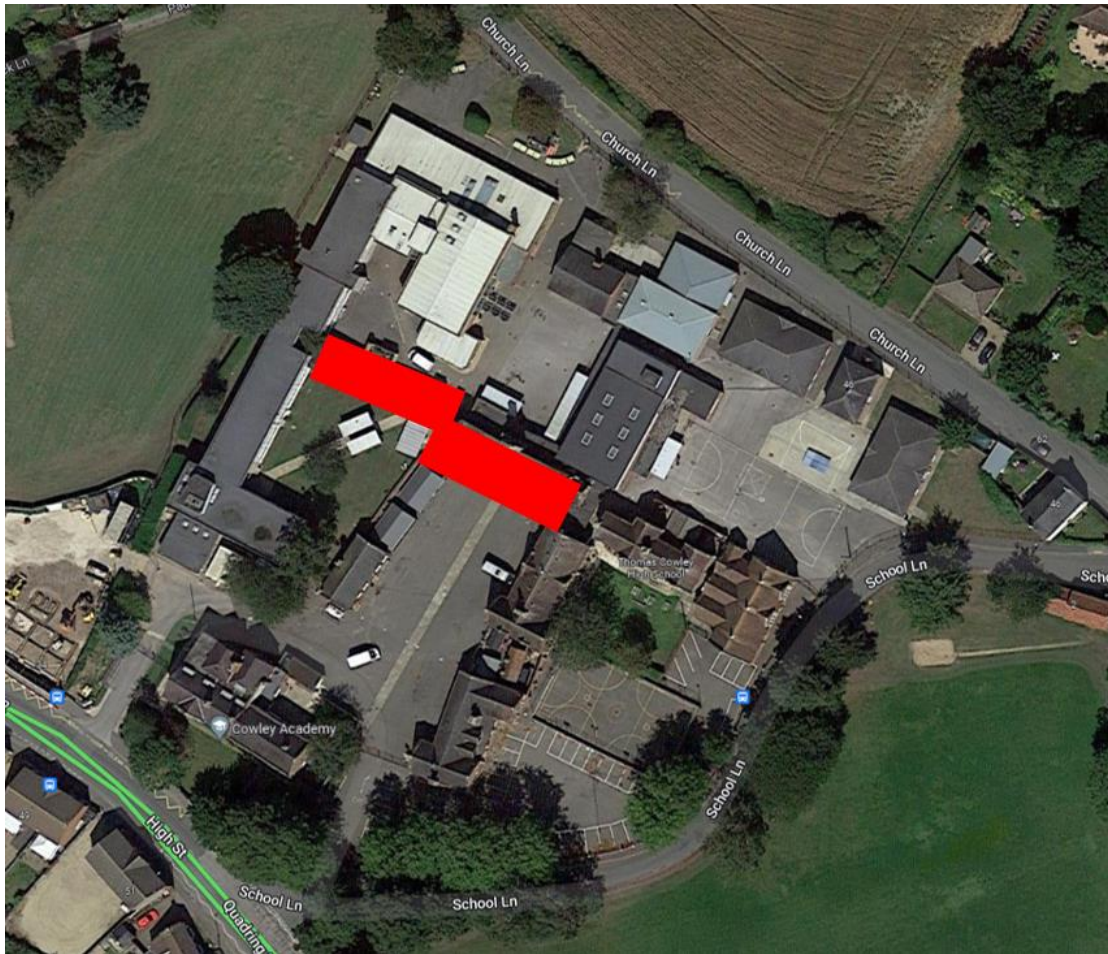
Areas of school affected by  
deteriorated timber/steel  
windows
