**Risk Assessment of Soils in plots 3 & 4 adjacent to Alexine**

**Malting Lane, Donington, Spalding, Lincolnshire, PE11 4XA**

Report number 13-12-01/2

Date 2<sup>nd</sup> October 2016

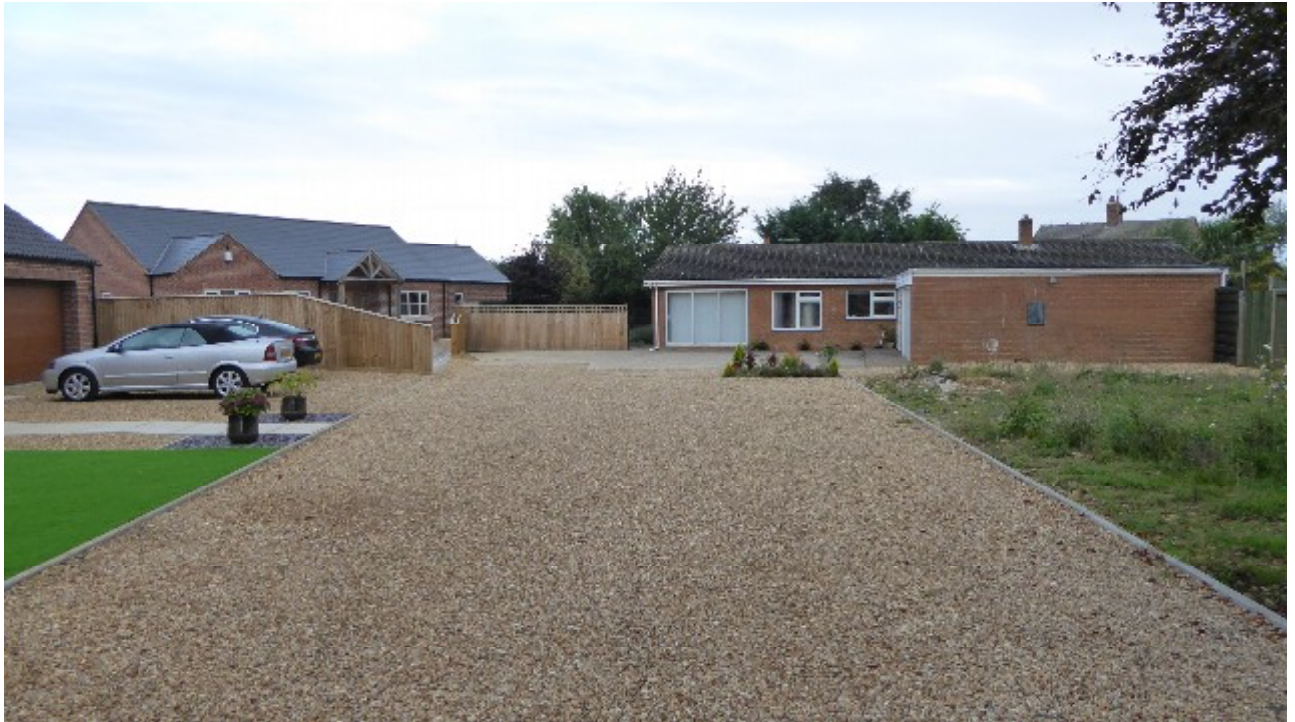
3.2 Two bungalows had been constructed on the site in the south eastern corner and on the eastern boundary (photo 1). The new development plan is to construct one bungalow on the northern boundary (plot 1, photo 2) with the garden area to the south (photo 3) and one bungalow on the western boundary (plot 2, photo 4) next to the original bungalow.

Photo 1 Old bungalow to right, new ones to corner and left

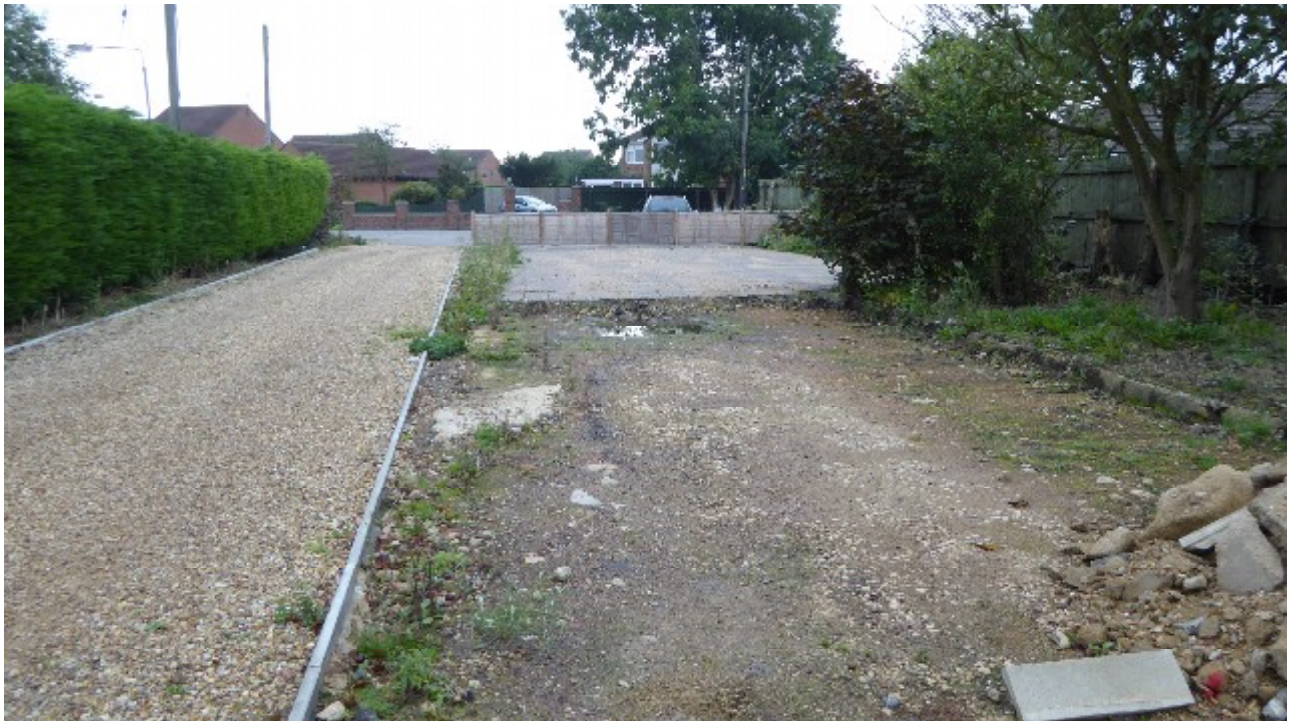
Photo 2 Plot 1 leading from road into site

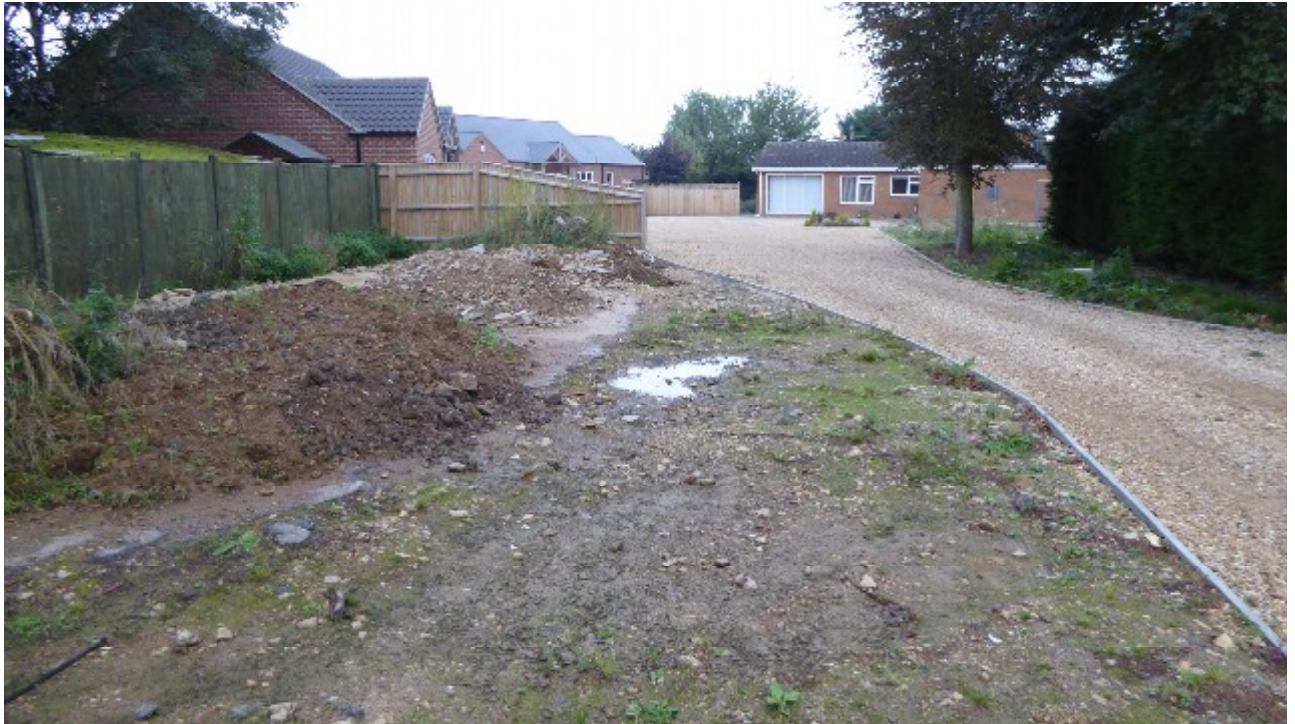
Photo 3 Plot 1 looking onto rear garden and into site

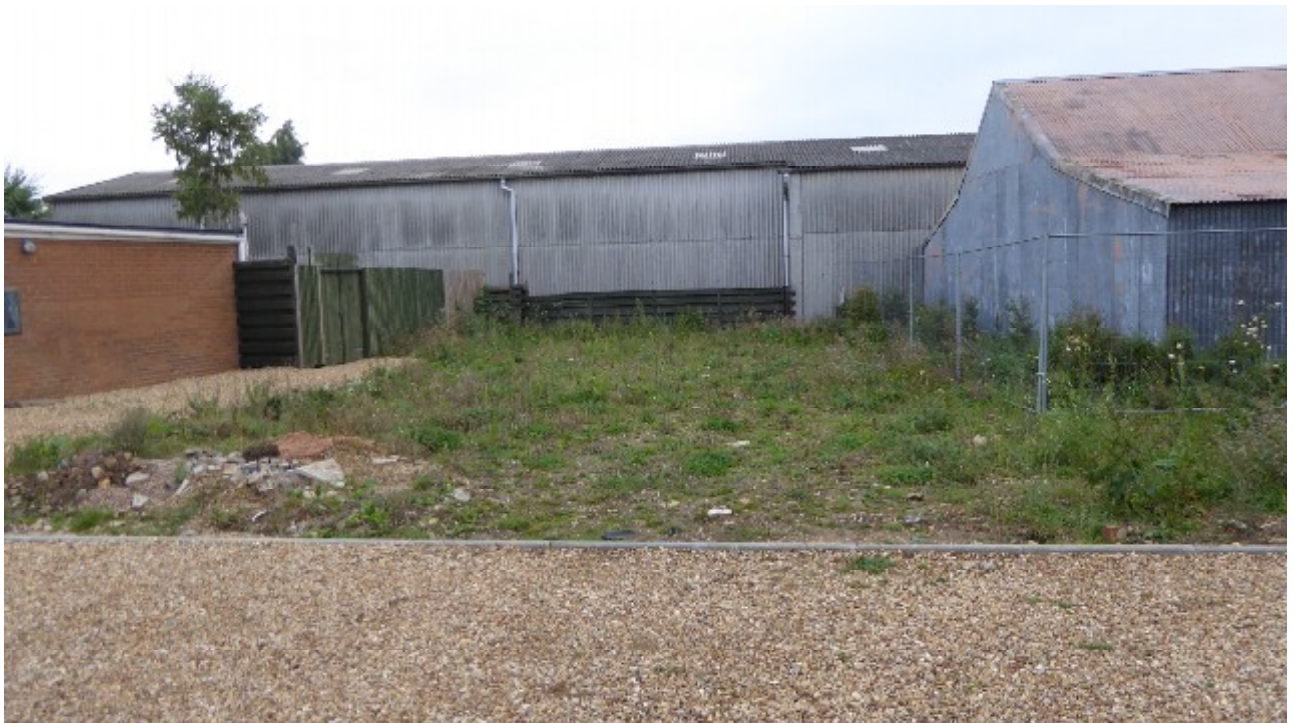
Photo 4 Plot 2, the former barn and concrete floor have been removed

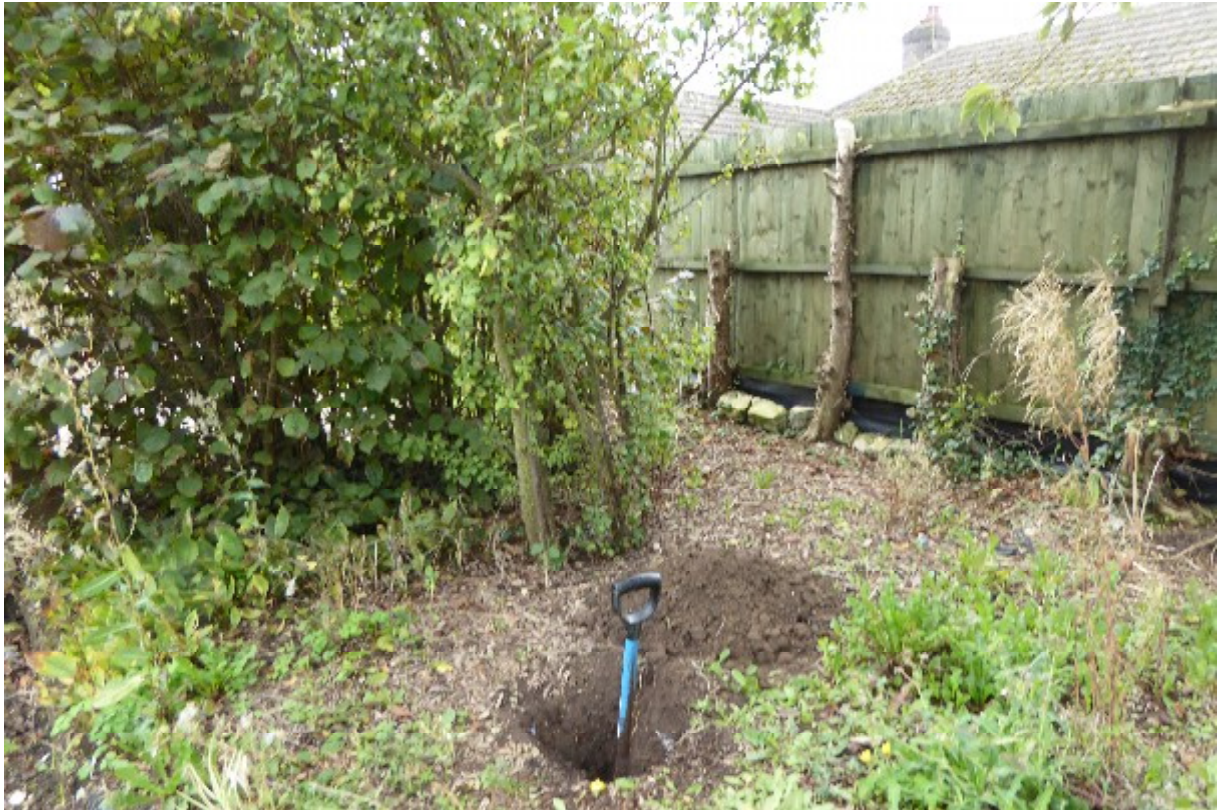
3.3 Two hand dug holes down to about 400 mm (except for HD1b where compacted stones and large slabs prevented digging any deeper than 300 mm) were sampled and mixed in a bucket before taking the sample for analysis. HD1a and b (photos 5 & 6) were quite difficult to excavate, but with the use of the fork and the pick axe, two holes were eventually achieved. However, the area that was to be the garden could not be hand dug as after trying four different places and using the pick axe for about 20 minutes, it was obvious that the hard core was extremely well compacted and could not be dug out by hand. The neighbour from the adjacent completed house (plot 3) came out and explained that the pile of soil at the end of plot 1 (photos 7 & 8) originated from the drive of his bungalow, so the soil from that pile was sampled.

4.2 The soil from the neighbour's drive and the soils on plot 2 reported low concentrations of TPH, but the soil sample from HD1 in the front of plot 1 (mainly on the footprint of the bungalow or the paved area) reported slightly elevated TPH of 227 mg/kg. However, that was all in the >C<sub>20</sub> fractions. The soil sample from the pile excavated from the neighbour's drive (stock 3) reported very low concentrations of TPH.

4.3 The soil from plot 2 reported low concentrations of PAH, but the sample from HD1 (plot 1) reported elevated PAH (with benzo(α)pyrene being above the Category 4 value of about 4 mg/kg) that is consistent with small amounts of heavy oil being present. The sample from the soil excavated from the neighbour's drive reported very low concentrations of PAH.

5.2 Three of the four soil samples taken from plots 1 & 2 were very uncontaminated and presented no risk of harm to the occupiers of the houses. One soil sample (HD1 from plot 1) reported slightly elevated petroleum hydrocarbons (TPH), mainly in the heavy fractions, and slightly elevated polycyclic aromatic hydrocarbons (PAH). These components are not volatile, migrate only slowly through water transport and are typical of used lubricating oils; indeed it could have originated from the heavy machinery that was used to remove the concrete slabs.

Photo 5 HD1a on soft area to eastern side of plot 1

5.3 The strategy to provide clean capping appears to be vindicated by this investigation and once the hardcore has been excavated and top soil applied, the very small risk of harm from contamination will have been mitigated. The excavation should remove all hardcore and soil to about 600 mm and be replaced with clean sub soil and top soil of at least 300 mm.

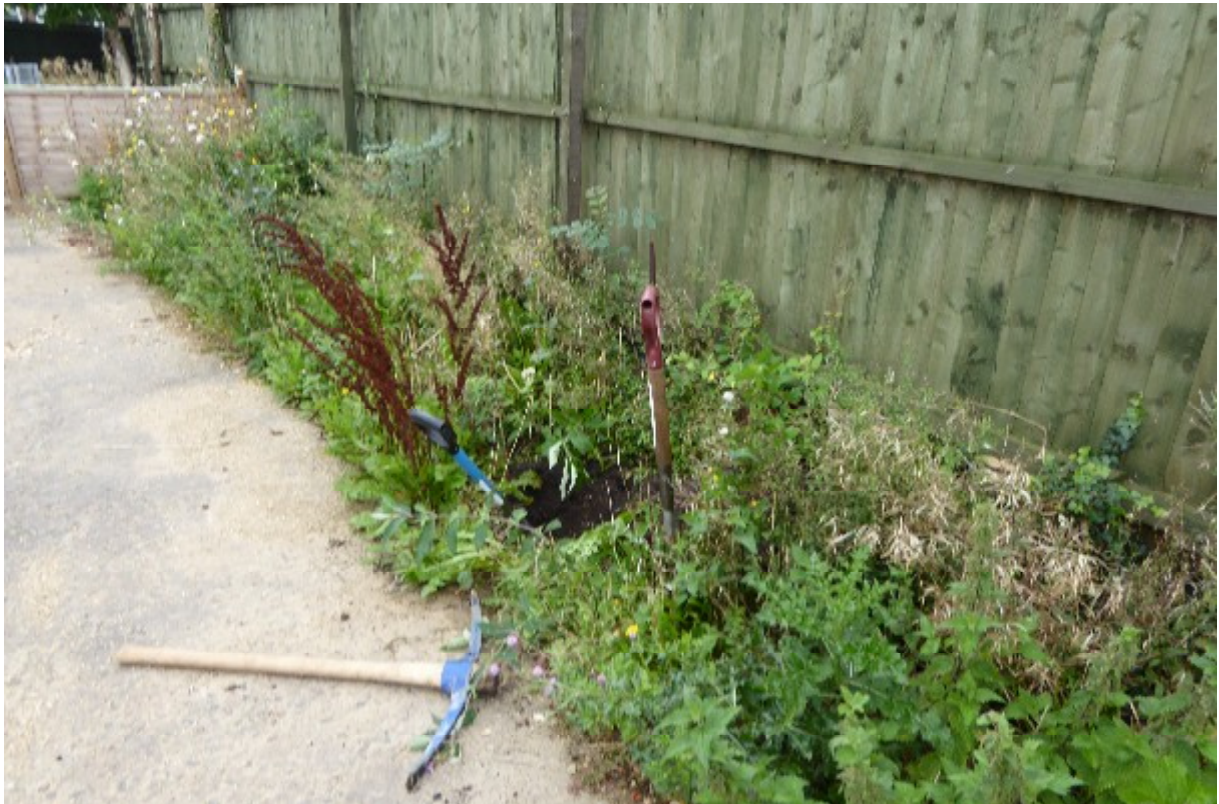
Photo 6 HD1b near north of plot 1 on soft area to eastern side

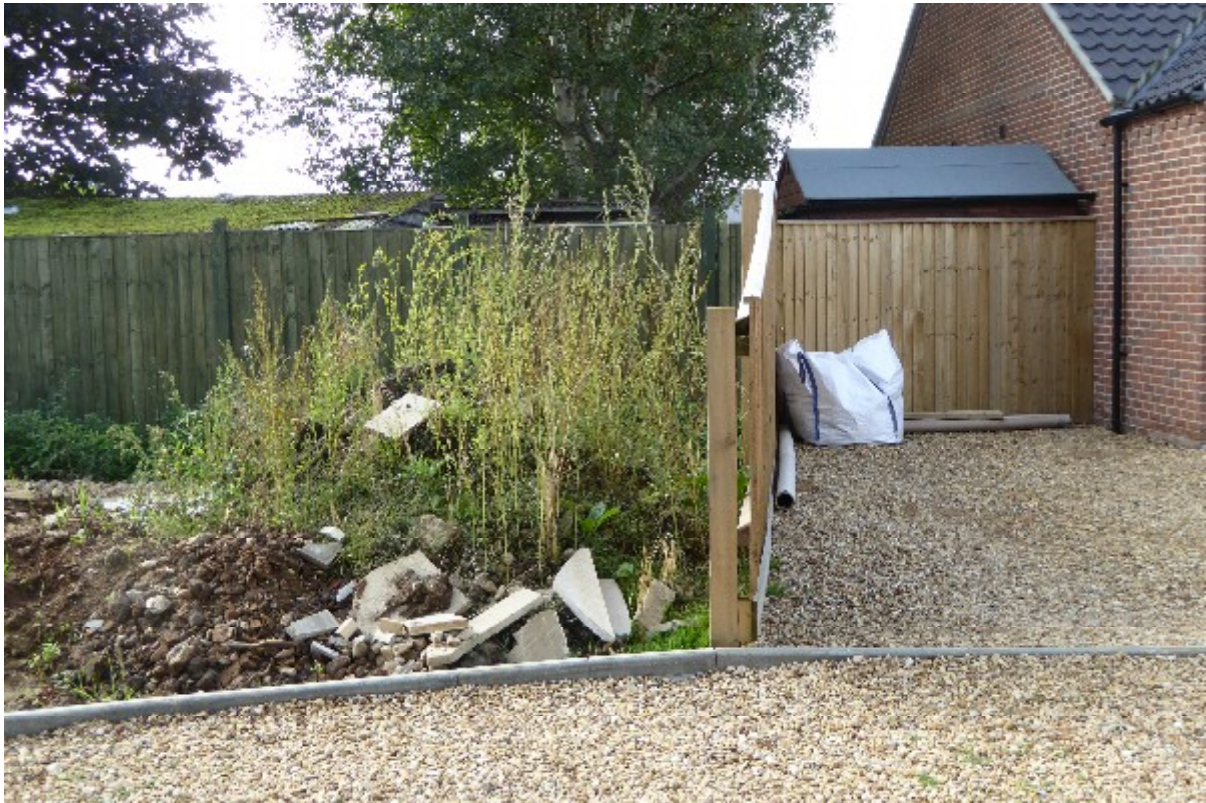
Photo 7 Stock pile 3 arising from excavation of driveway to right

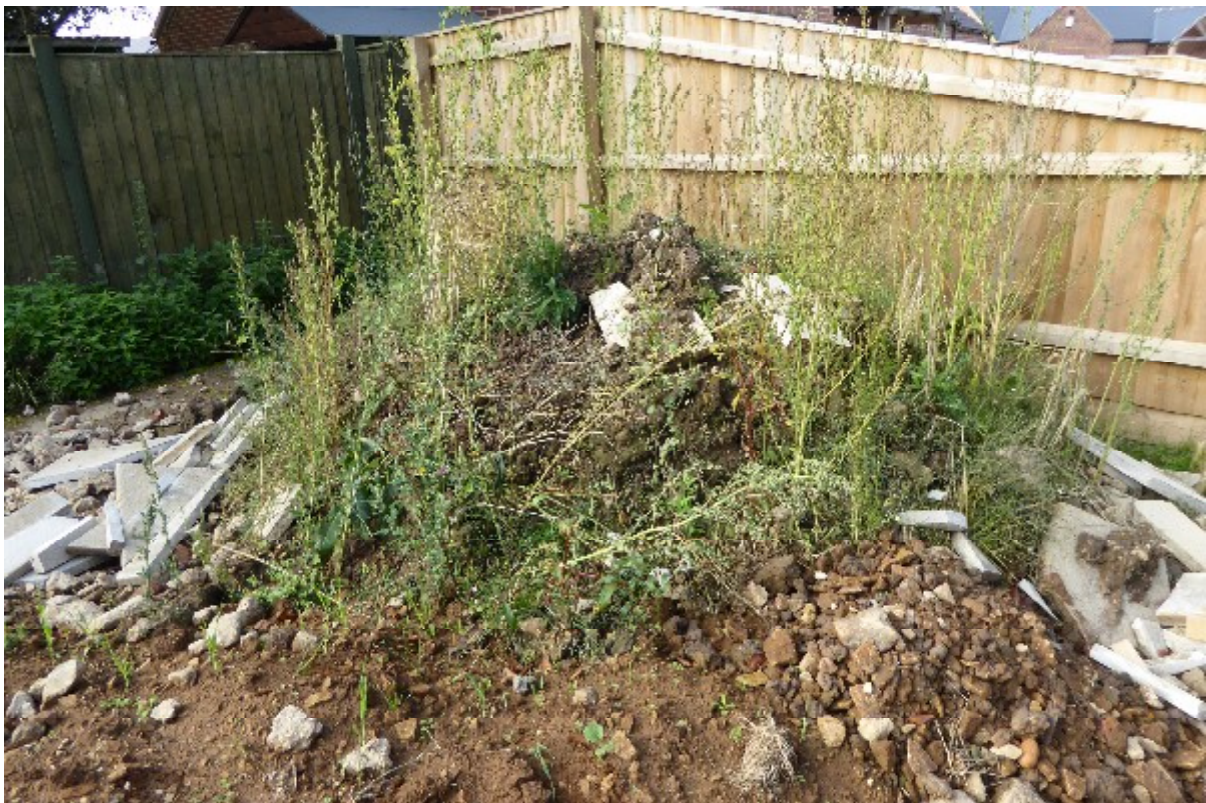
Photo 8 Stockpile 3 arising from excavation of adjacent drive

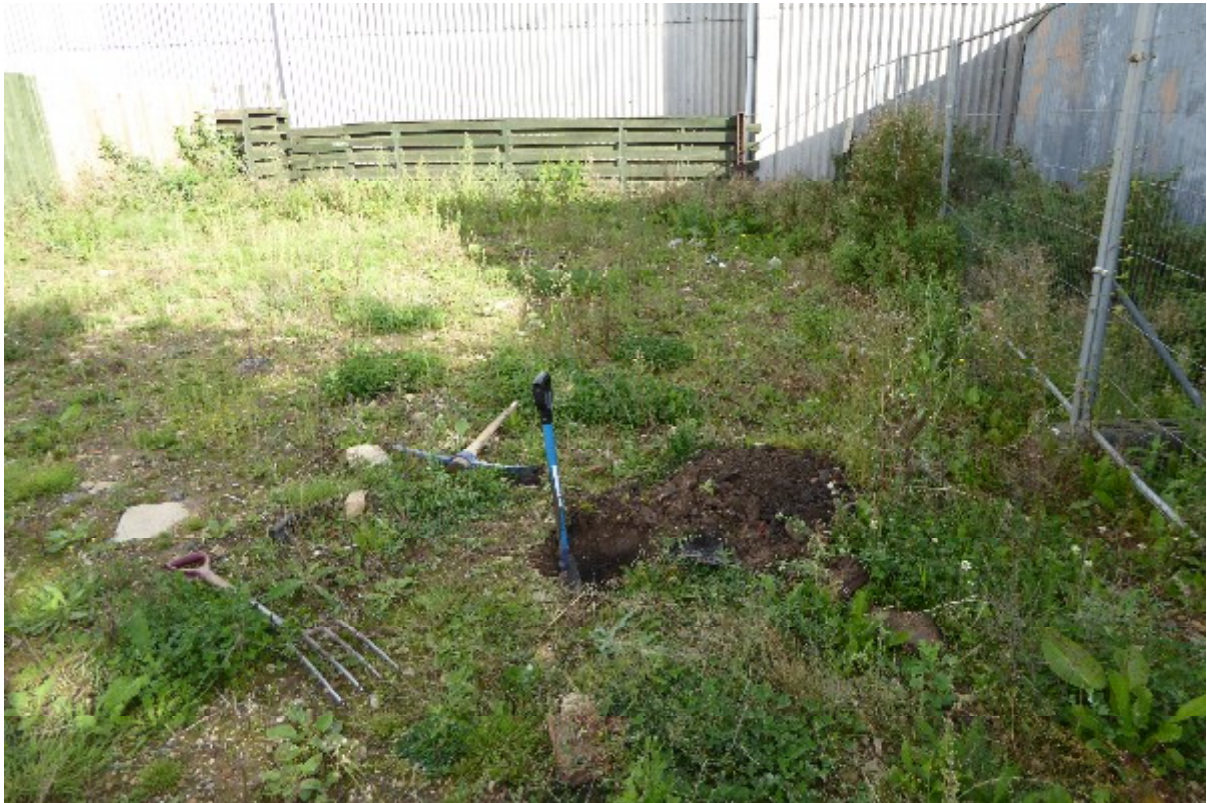
3.3 The soil in plot 2 was slightly better in that it was mixed with stones and fragments of slabs and concrete, but it was not compacted. Two holes were hand dug on the footprint of the house (HD2a and b – photos 9 & 10) and from the garden area (HD3a & b – photos 11 and 12) and samples taken from each pair of holes, mixed and sampled.

Photo 9 HD2a on plot 2 near drive and northern boundary

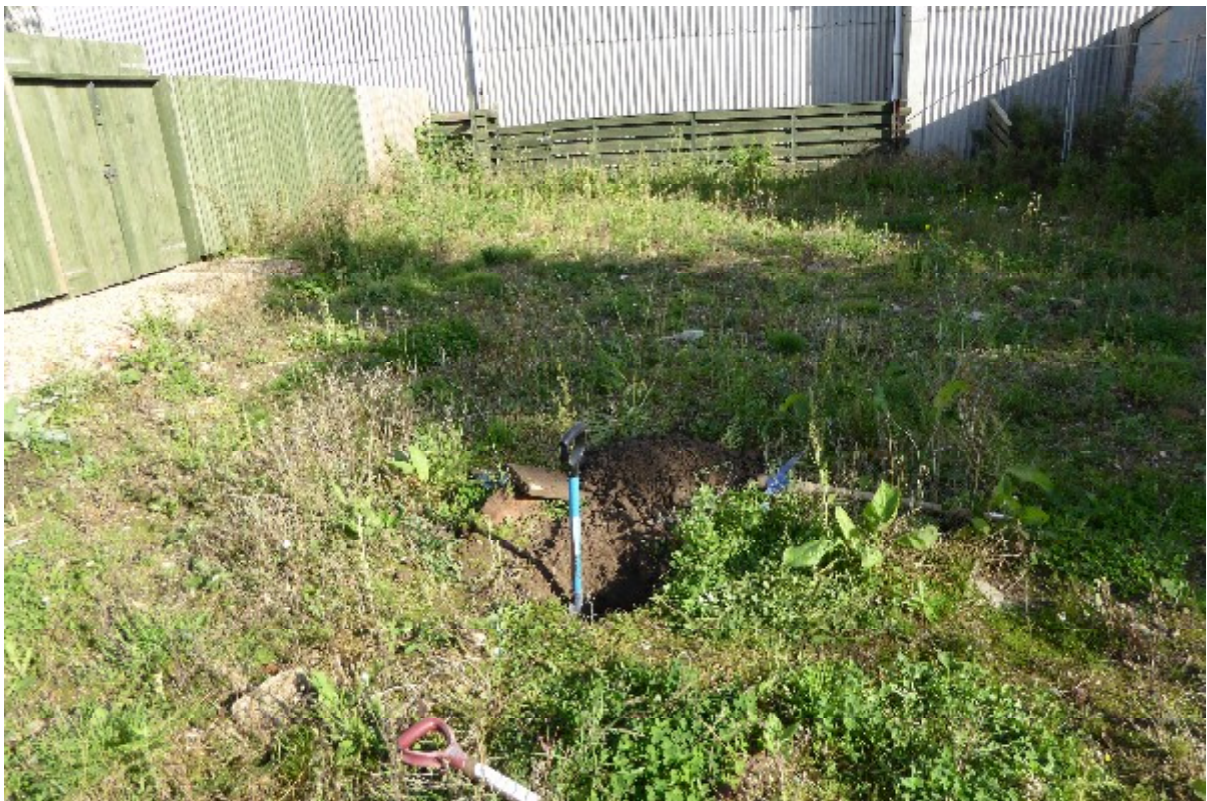
Photo 10 HD2b on plot 2 near road and southern boundary

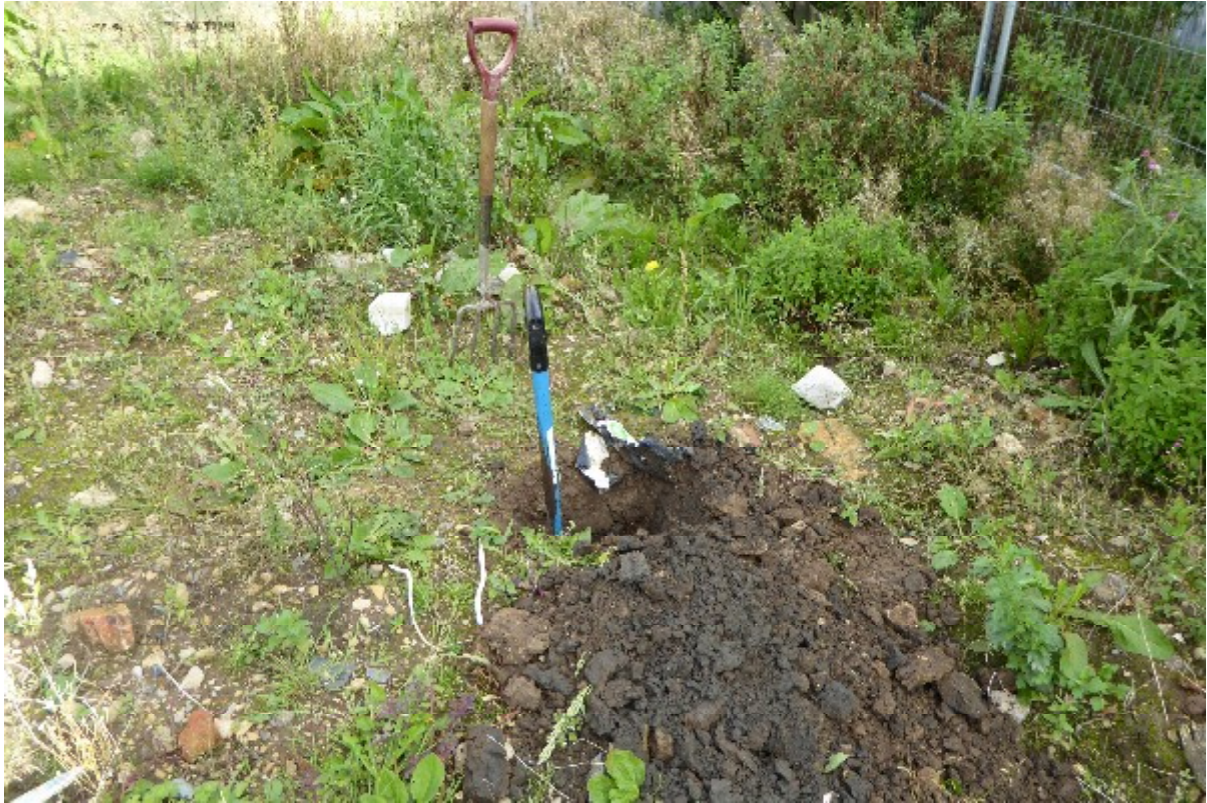
Photo 11 HD3a near rear of plot 2 and southern boundary

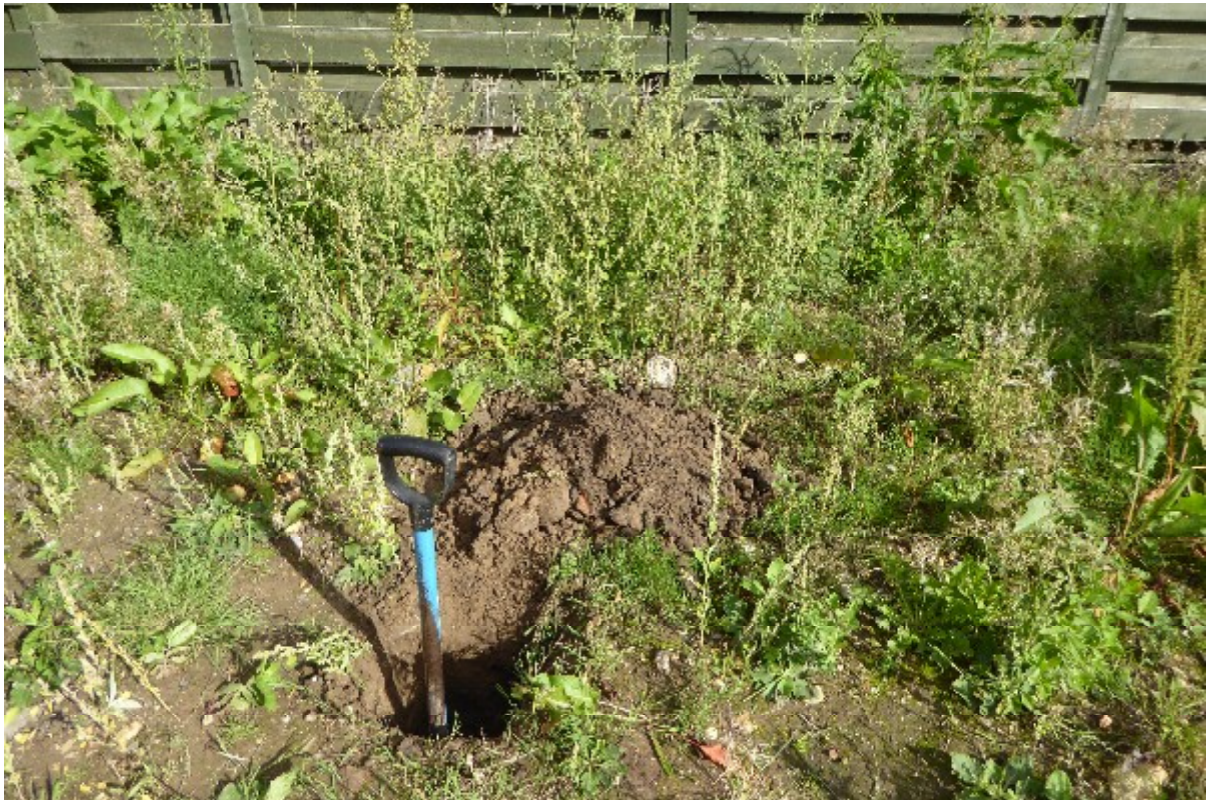
Photo 12 HD3b near rear of plot 2 and northern boundary
