**PRELIMINARY STRUCTURAL REPORT  
UPON  
REDUNDANT BARN  
AT  
MONTAGUE HOUSE  
123 FLEET ROAD  
FLEET HARGATE  
HOLBEACH  
PE12 8LD**

**Ref: 40418**

**OCTOBER 2018**

## **SUPPLEMENTARY REPORT**

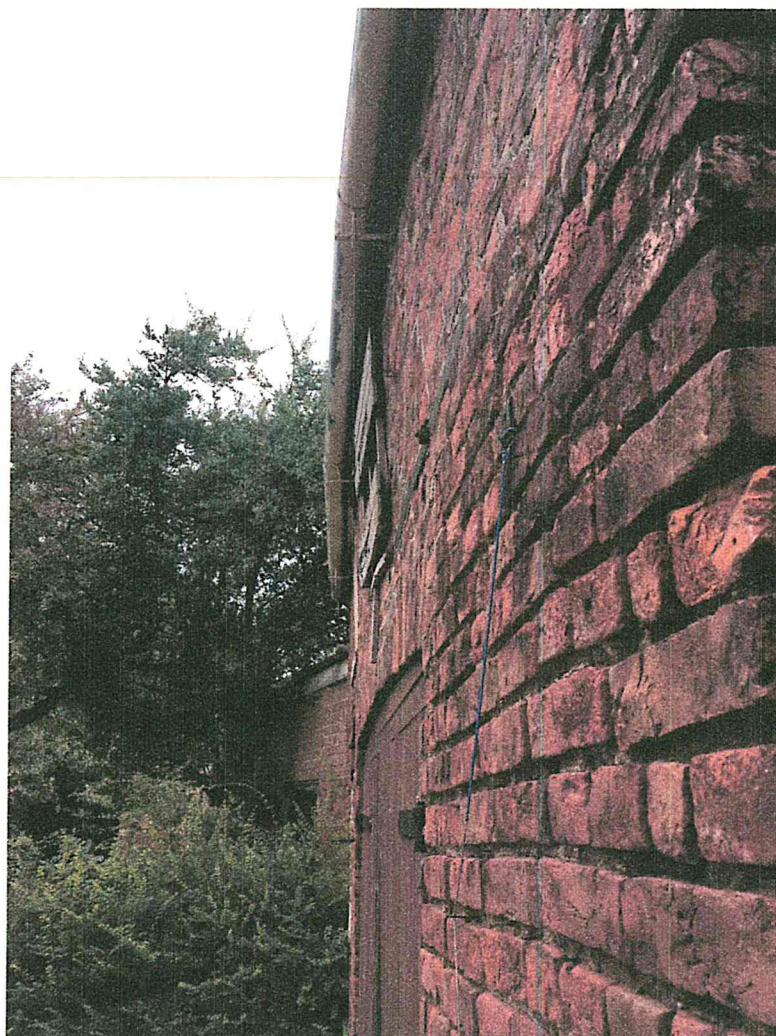
**PHOTOGRAPH 1**

When viewed externally a distinct bow was noted to the Western elevation, which also leaned outwards at eaves level – see photograph 1. Pattress plates are also present at first floor level.

This has resulted in the outward lean along the Western elevation, and the horizontal fracture and failure of the Eastern elevation.

The Eastern and Western elevations should be removed to first floor level, and rebuilt using existing bricks. It will be necessary to rebuild limited areas of the gable walls, however the gable walls can remain ensuring temporary shoring is introduced during renovation works. It is suggested that a roofing felt is incorporated whilst retiling the roof.

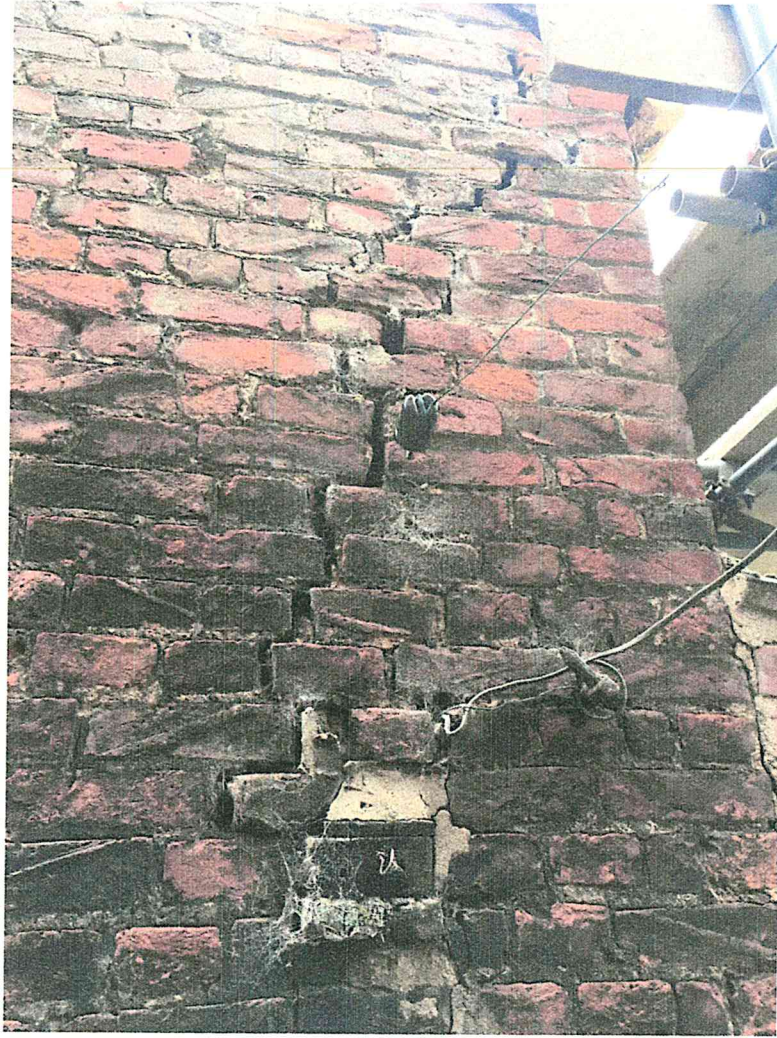
**PHOTOGRAPH 2**

To the corner of the South gable wall a large crack extends diagonally downwards from eaves level – see photograph 2.

Furthermore localized rebuilding below first floor level will be required to both corners of the South cable wall and around windows to the Western elevation.

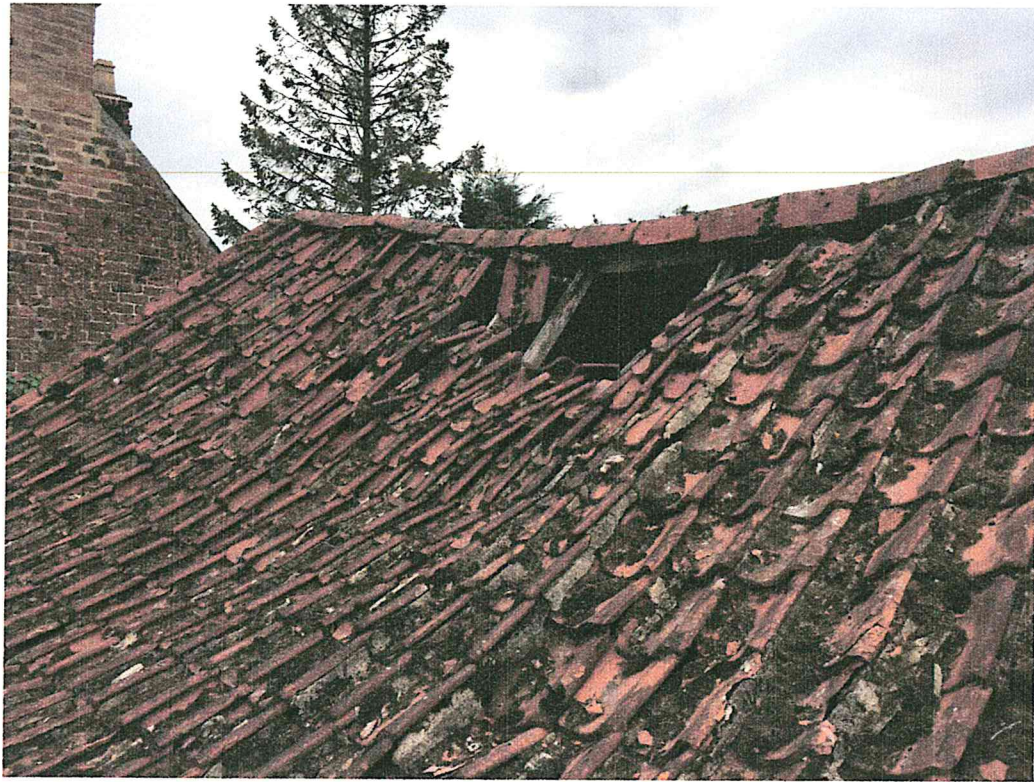
**PHOTOGRAPH 3**

The ridge line is sagging considerably, with many tiles missing and loose – see photograph 3.

The condition of the timber roof framing is beyond repair and should be renewed throughout.

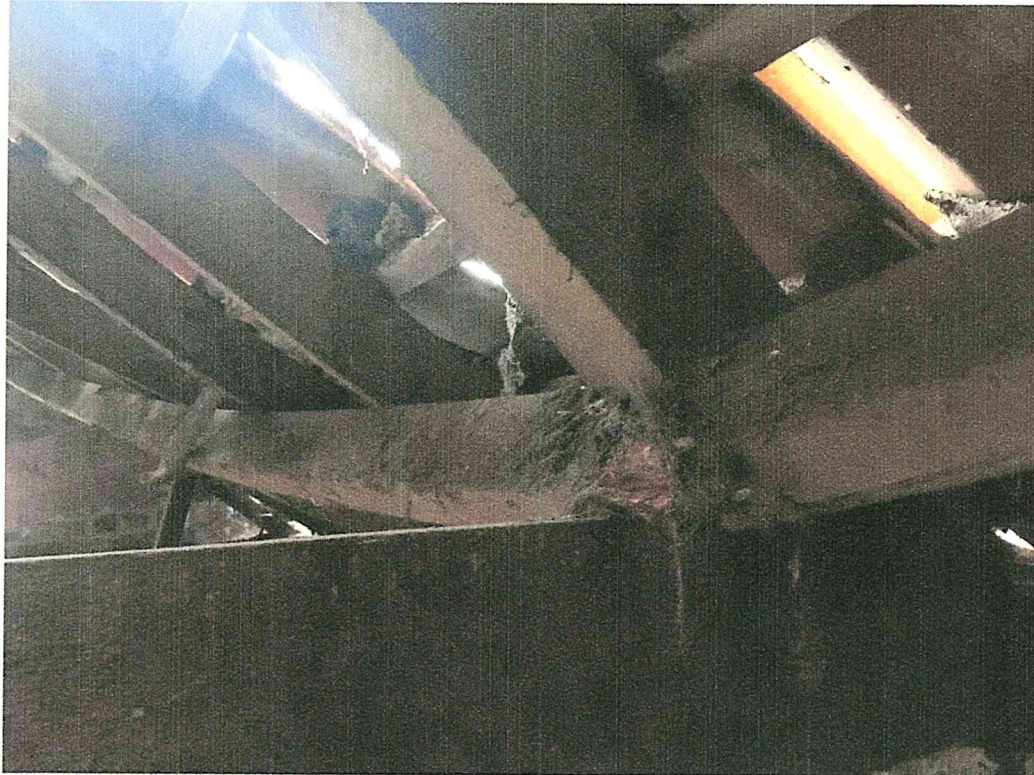
**PHOTOGRAPH 4**

Internally, the roof timbers are in a very poor condition with alarming amounts of deflection visible in purlins and rafters, together with split collars – see photographs 4 & 5.

Although the barn has not benefitted from any maintenance for many years, the main structural problem is how the timber roof framing was constructed in the first instance.

With no effective tie at eaves level, to resist the horizontal load from the rafter, this load is transferred to the brickwork, which is unable to resist the load.

Measures must be taken to prevent horizontal loads being transmitted to the brickwork at eaves level. This could take the form of suitably sized purlins spanning between gable walls. We are of the opinion that steel beams would not be appropriate in this Listed Building. Consequently timber purlins or flitch beams should be provided.

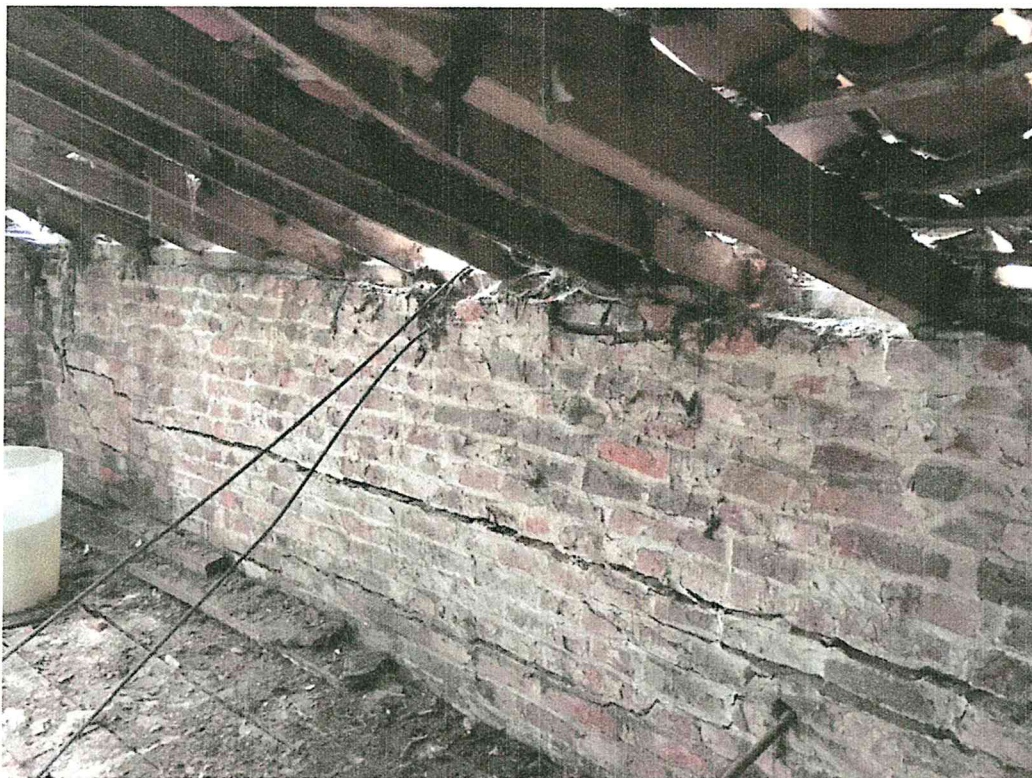
**PHOTOGRAPH 6**

Along the Eastern elevation, a large horizontal crack extends along the full length of the wall, with the wall leaning outwards – see photograph 6.

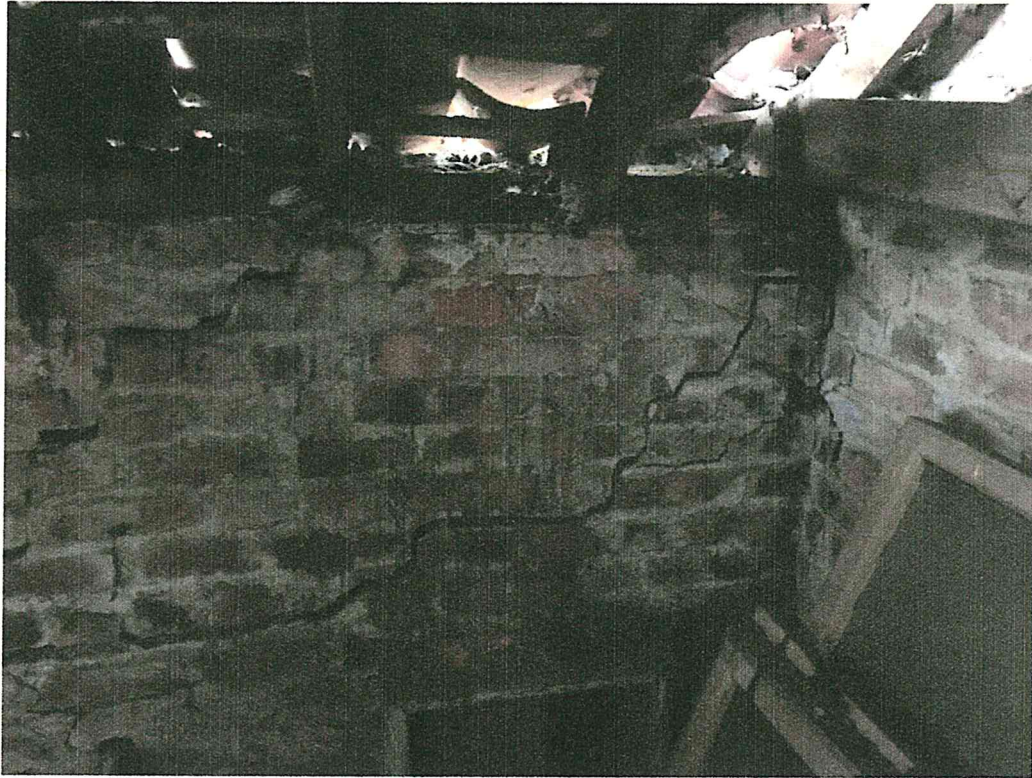
**PHOTOGRAPH 7**

Horizontal displacement of the wall was also noted at the junction with the gable wall – see photograph 7.

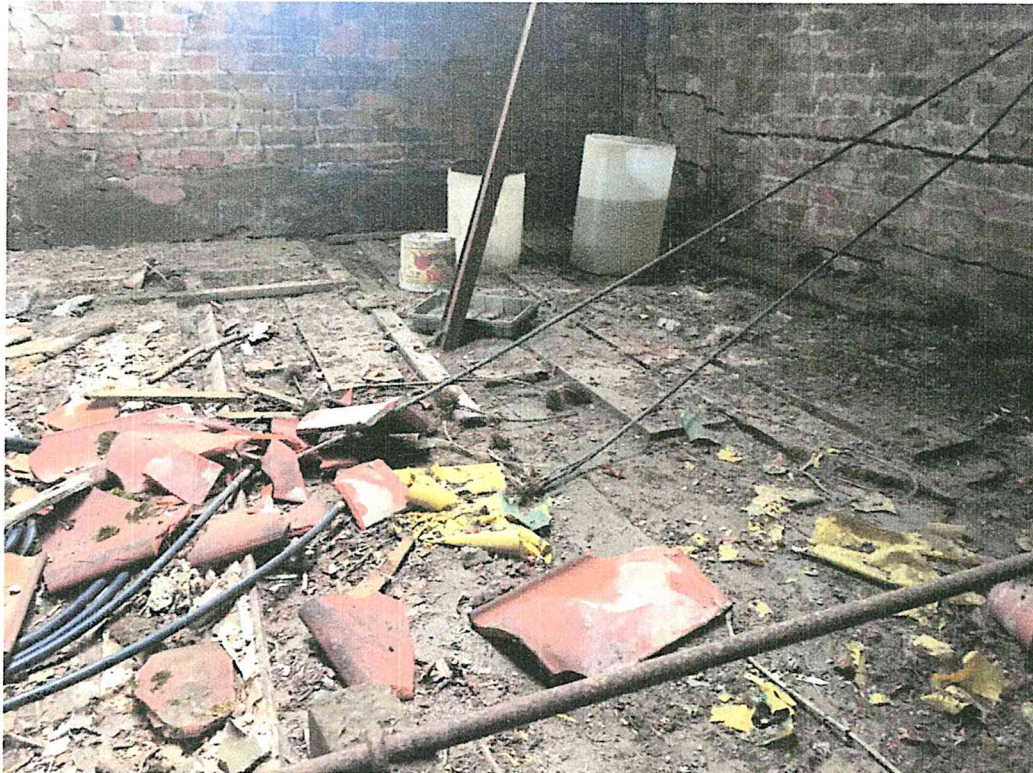
**PHOTOGRAPH 8**

Steel cables have also been introduced, which are wrapped around the wall plate and fixed to the timbers of the first floor. Unfortunately this cable was broken and frayed at the ends – see photograph 8.

Over the years, attempts have been made to prevent the outward movement of the flank walls, which has clearly failed.

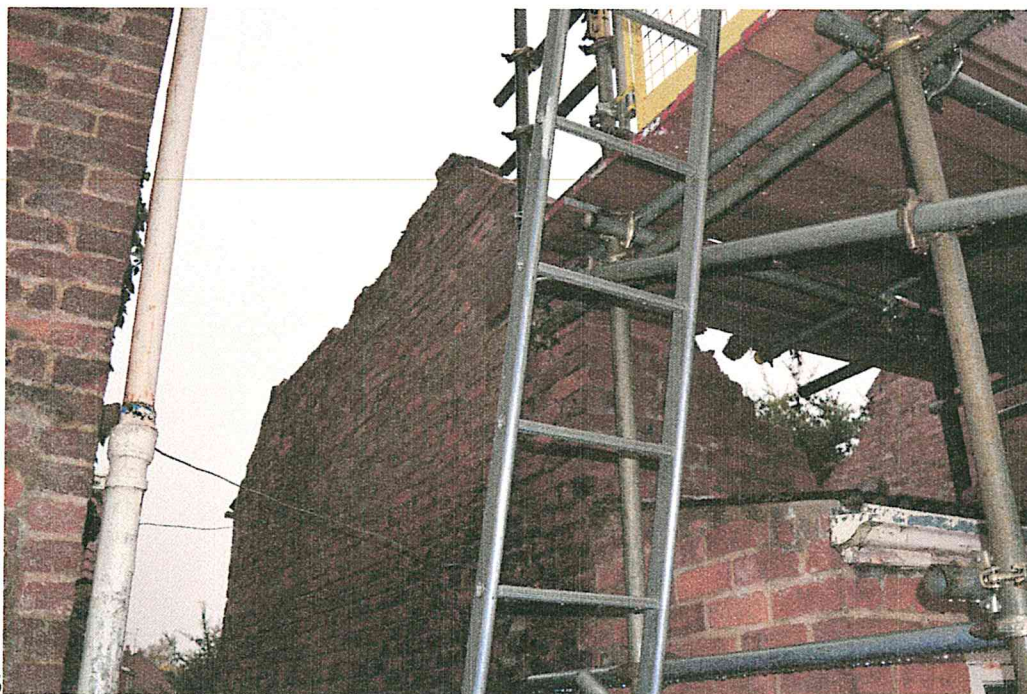
**PHOTOGRAPH 9**

Photograph 9 shows the South gable wall partially removed and now unsafe.

It will now be necessary to reduce both gable walls to eaves level prior to rebuilding.

It is now recommended that temporary shoring is introduced to gable walls to prevent further collapse.

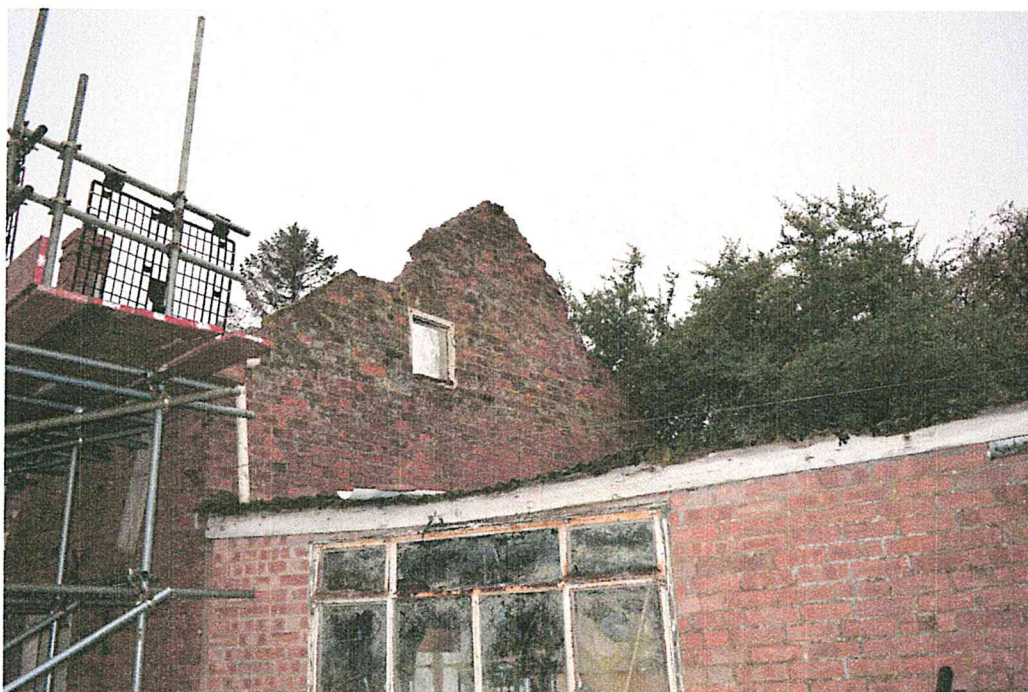
**PHOTOGRAPH 10**

Photograph 10 shows large areas of the North gable wall with brickwork removed.

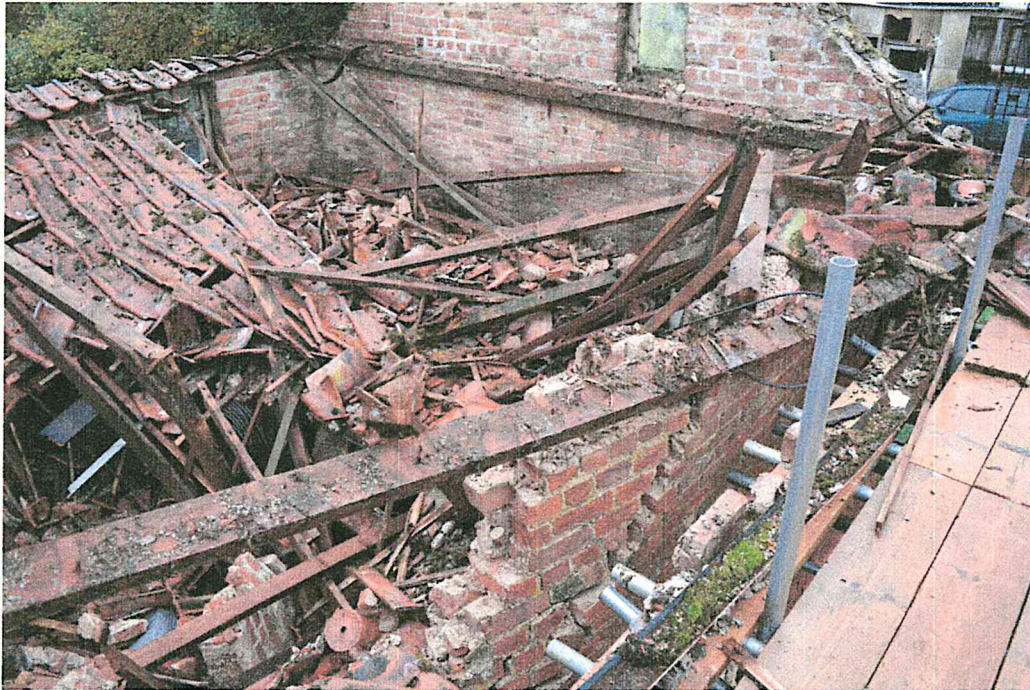
**PHOTOGRAPH 11**

Photograph 11 shows the Eastern wall now collapsed to first floor level, together with the whole roof no longer in place.

It will also now be necessary to incorporate a new timber first floor within the restoration scheme.

All new floor members and timber roof framing should be tied to new walls in accordance with Building Regulations.

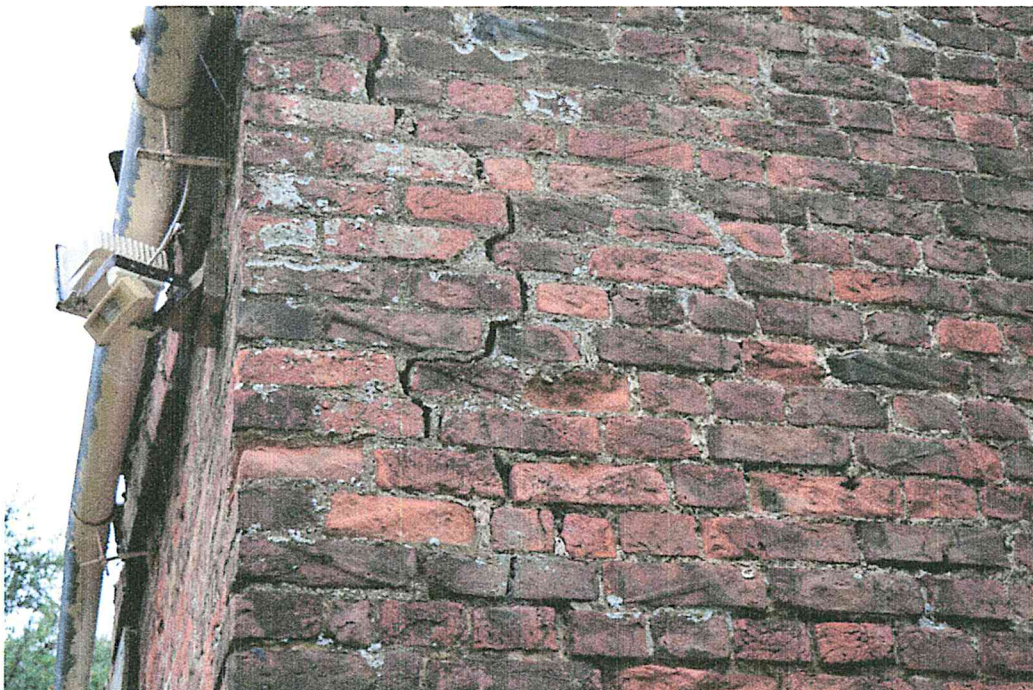
**PHOTOGRAPH 12**

Photograph 12 shows additional cracking to the South gable wall
