**PRELIMINARY STRUCTURAL REPORT**

**EXISTING BARN**

**MILL BANK**

**Ref: 20621**

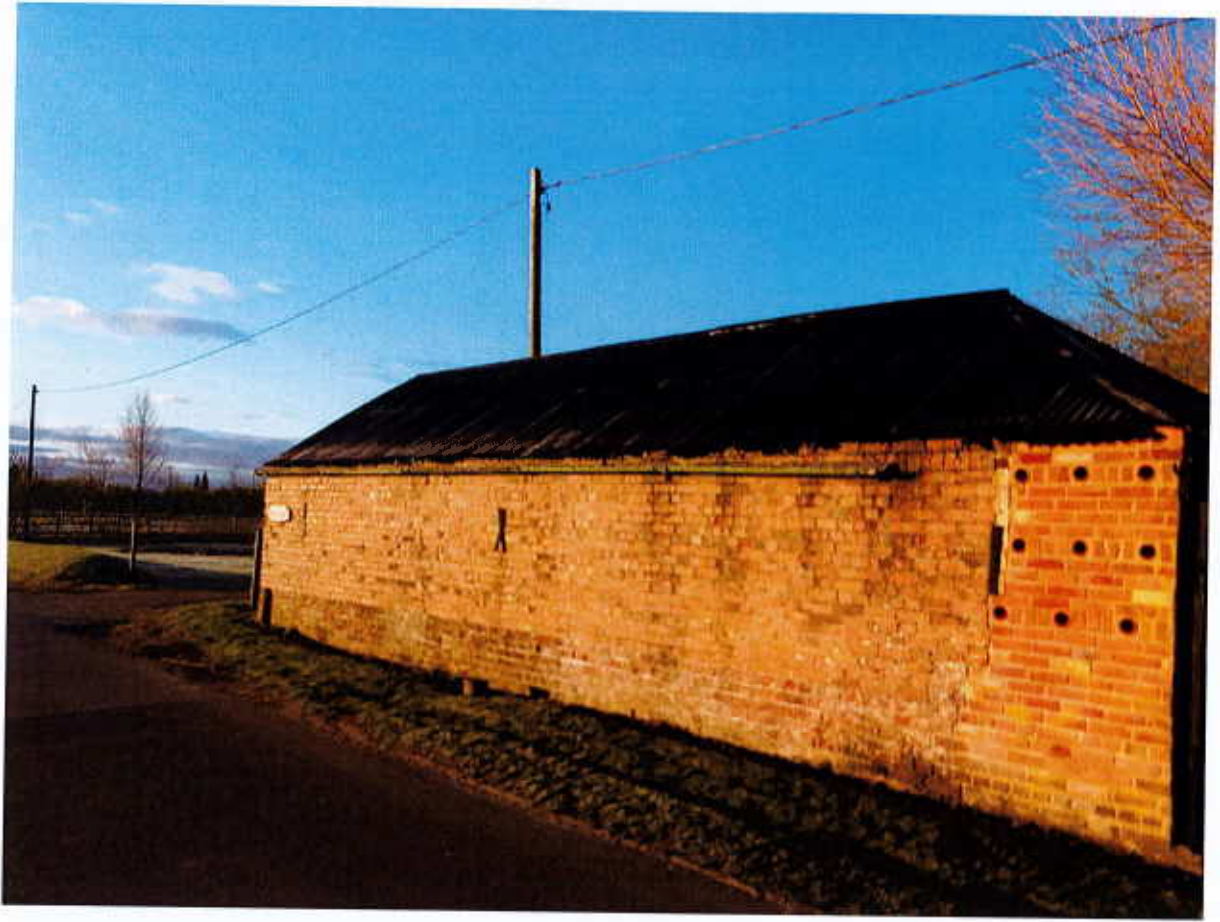
PHOTOGRAPH 1

Along the front elevation varying types of brickwork was noted, particularly at the right hand corner – see photograph 1.

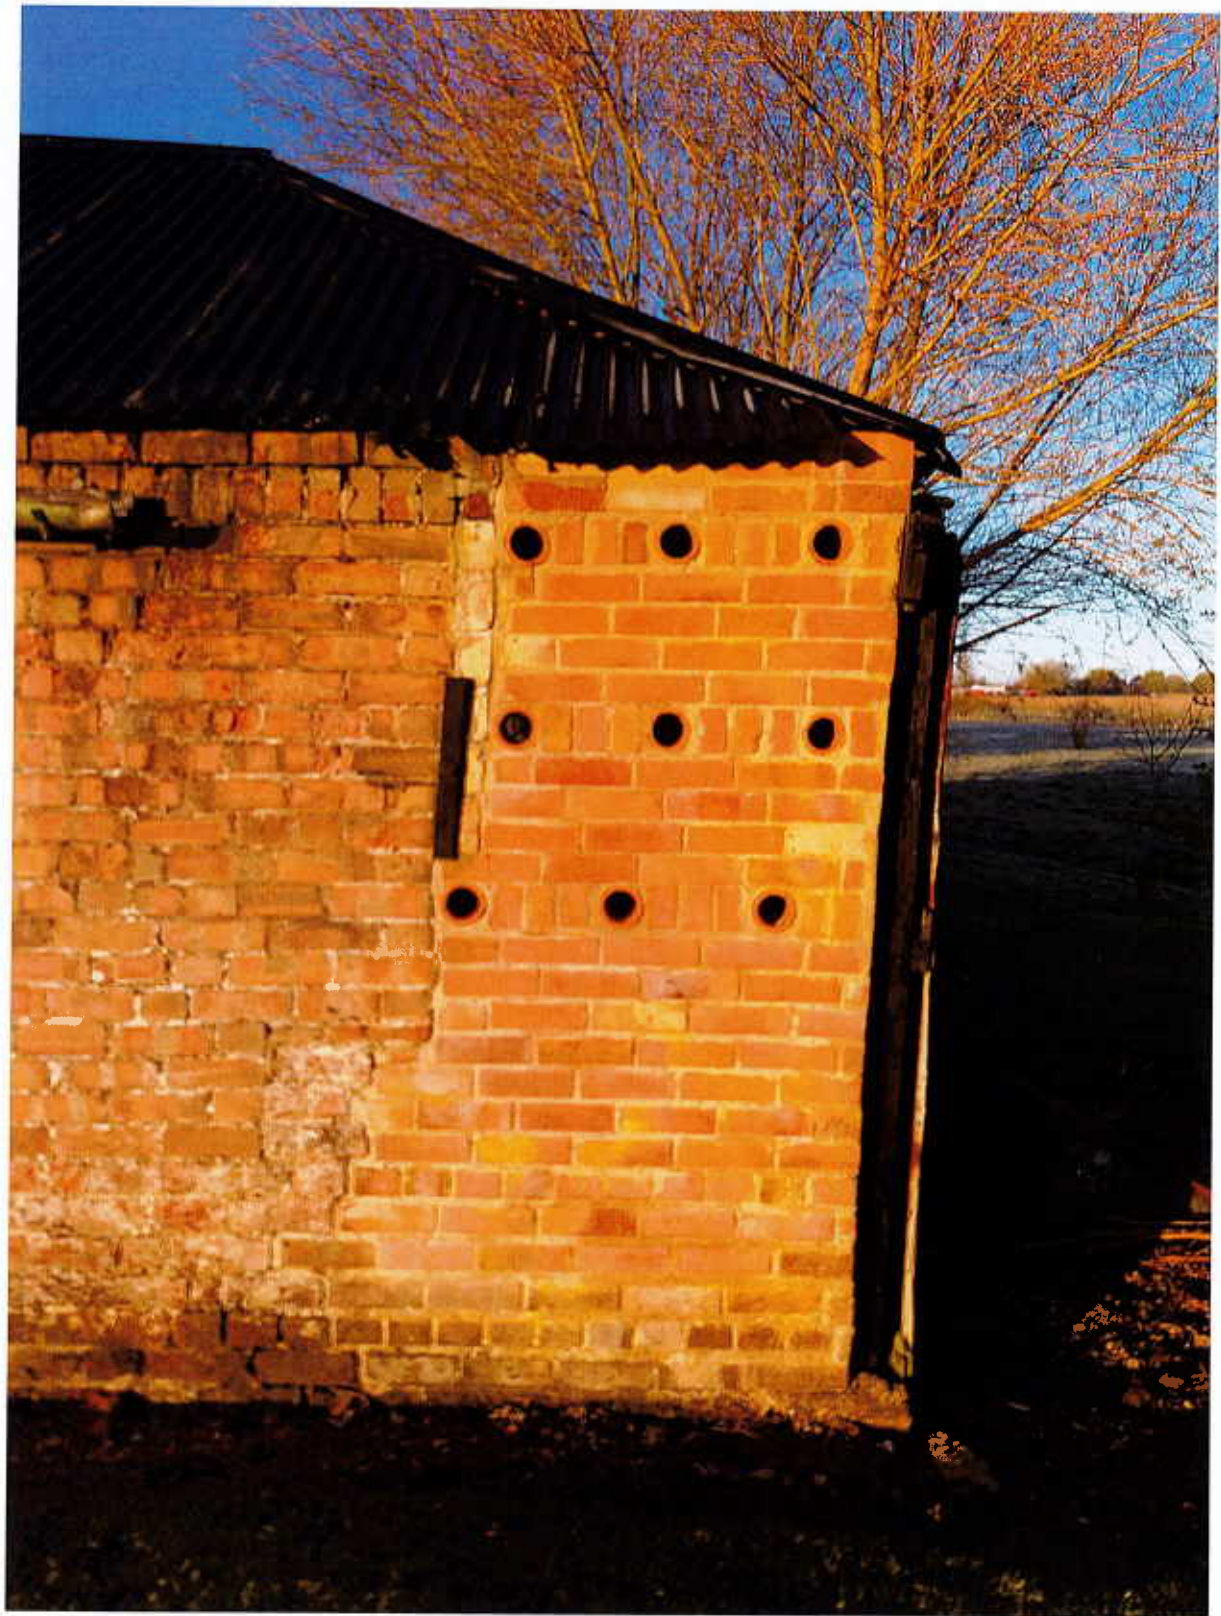
PHOTOGRAPH 2

Slightly sloping new bricks have been added – see photograph 2, with a large vertical crack present midway along the wall – see photograph 3.

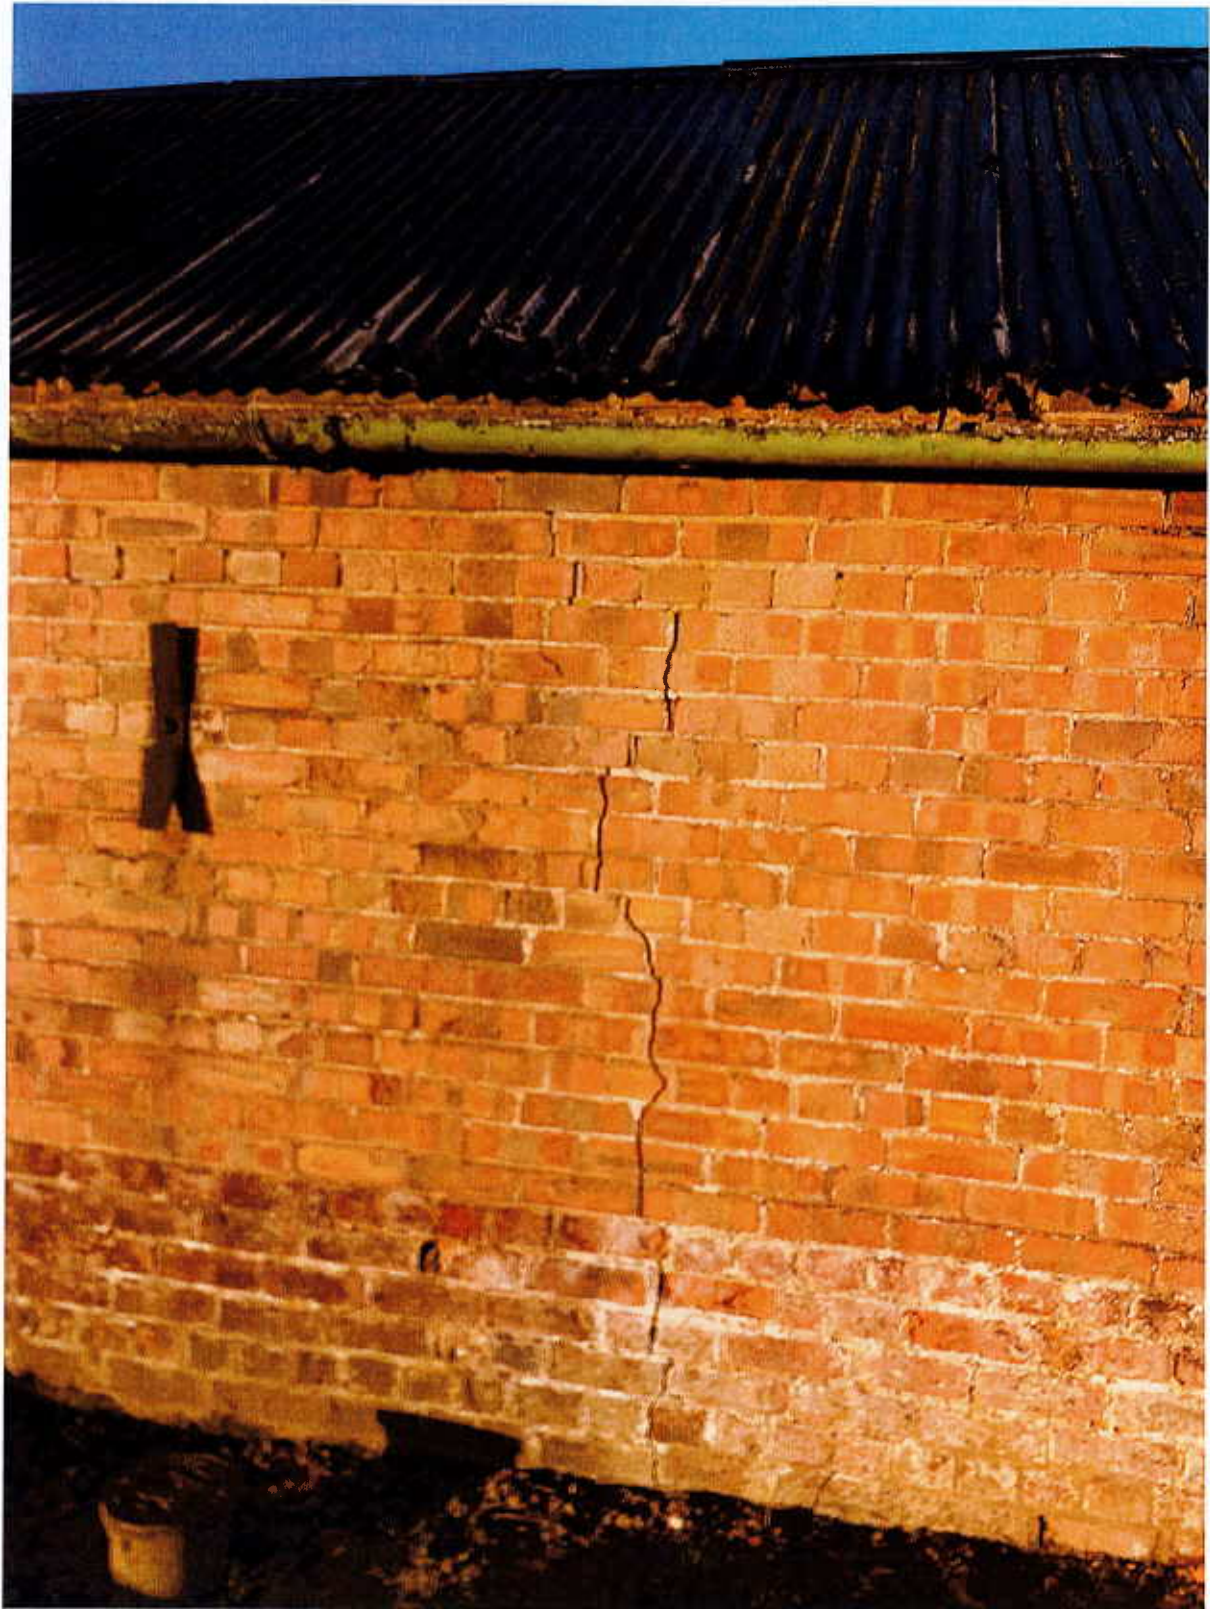
PHOTOGRAPH 3

With the exception of the vertical crack to the front elevation, the walls remain relatively straight and true and have benefitted from the timber roof framing that is in good condition considering the type and age of the building as a whole.

It is envisaged that the front right hand wall will need to be rebuilt from the location of the vertical crack to the right hand corner.

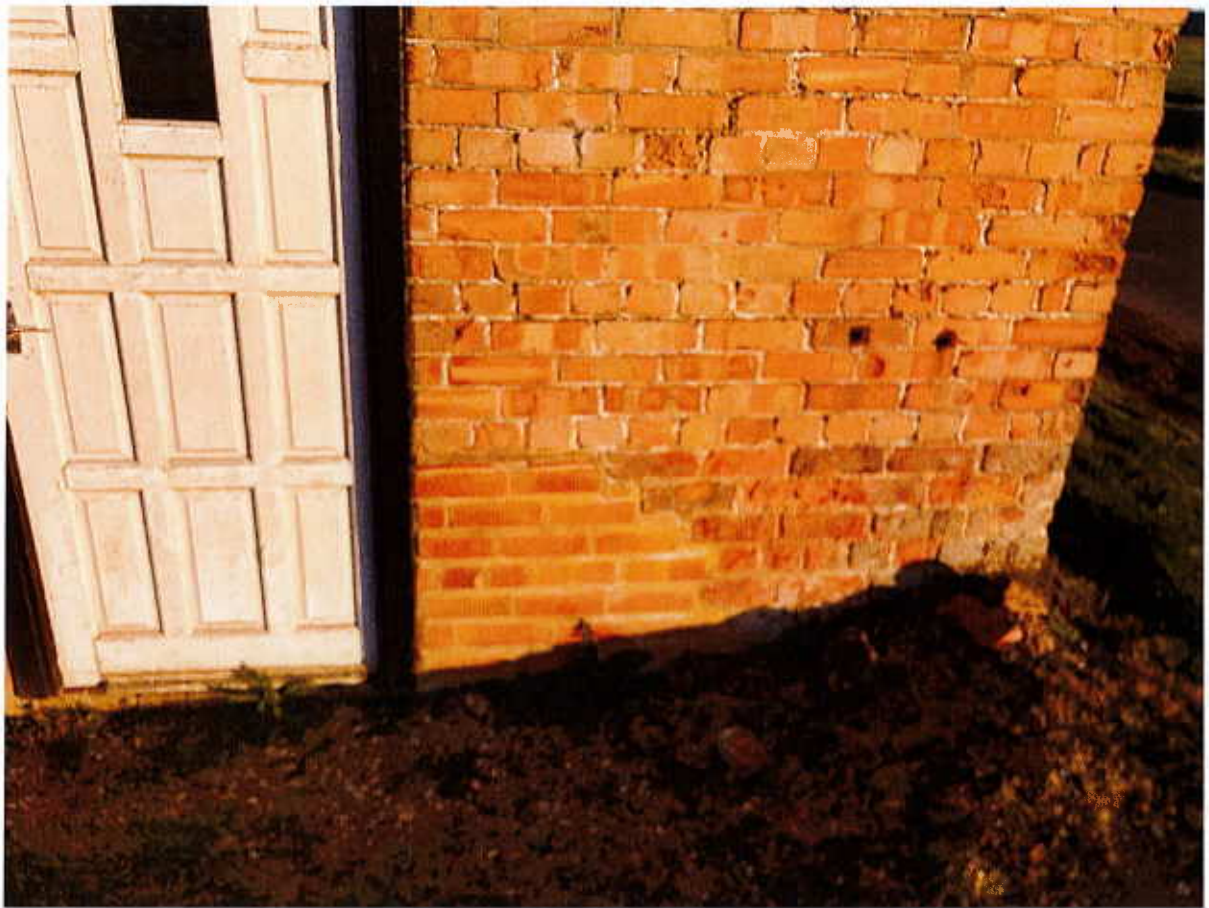
PHOTOGRAPH 4

Further signs of new brickwork was noted to the left hand gable wall, with new bricks visible to both sides of the doorway – see photograph 4.

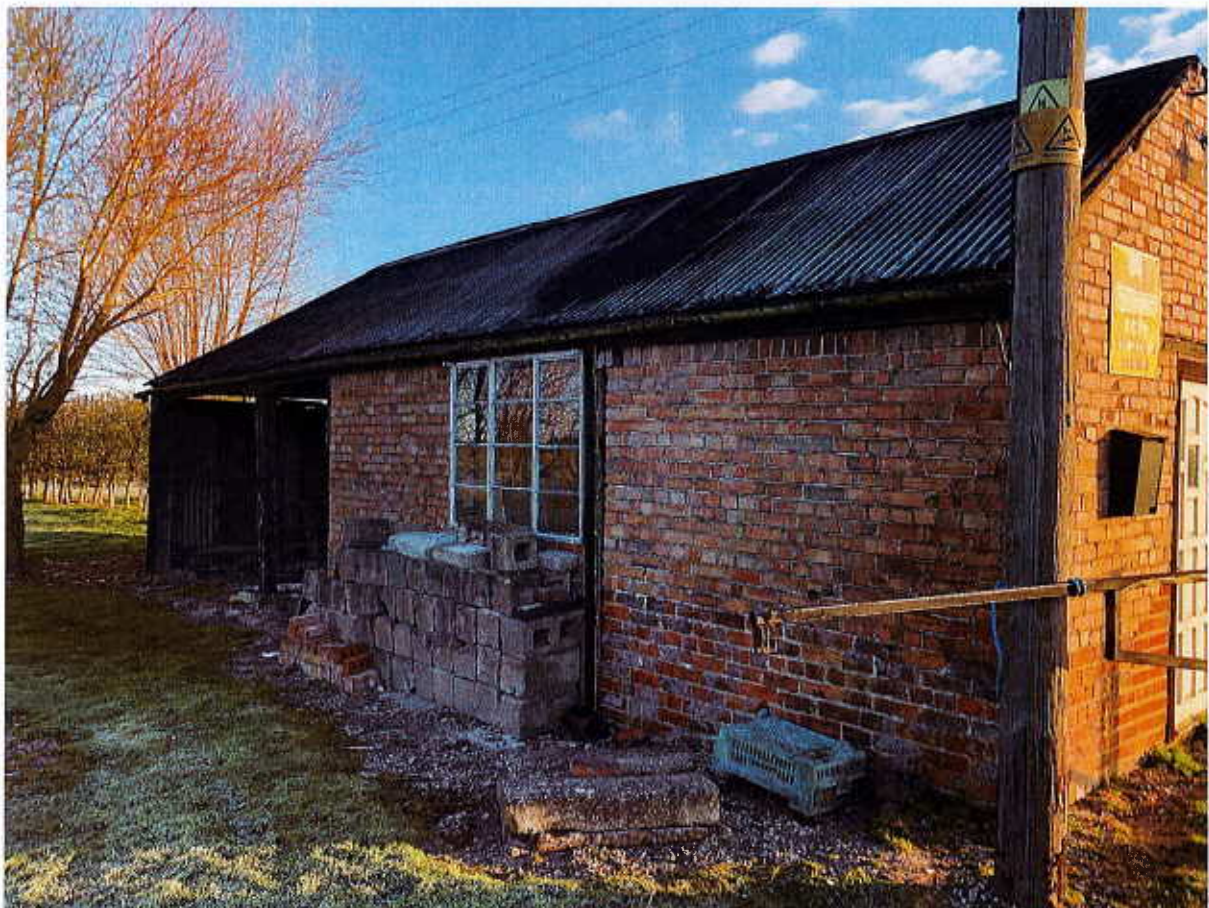
PHOTOGRAPH 5

The rear elevation – see photograph 5, has infill brickwork between timber framing, with the left hand portion remaining open.

Unfortunately the timber columns to the rear and gable elevations are decayed and not vertical.

The timber supports to the West gable and rear elevation should be removed, with support to the roof structure provided by new masonry walls and piers.

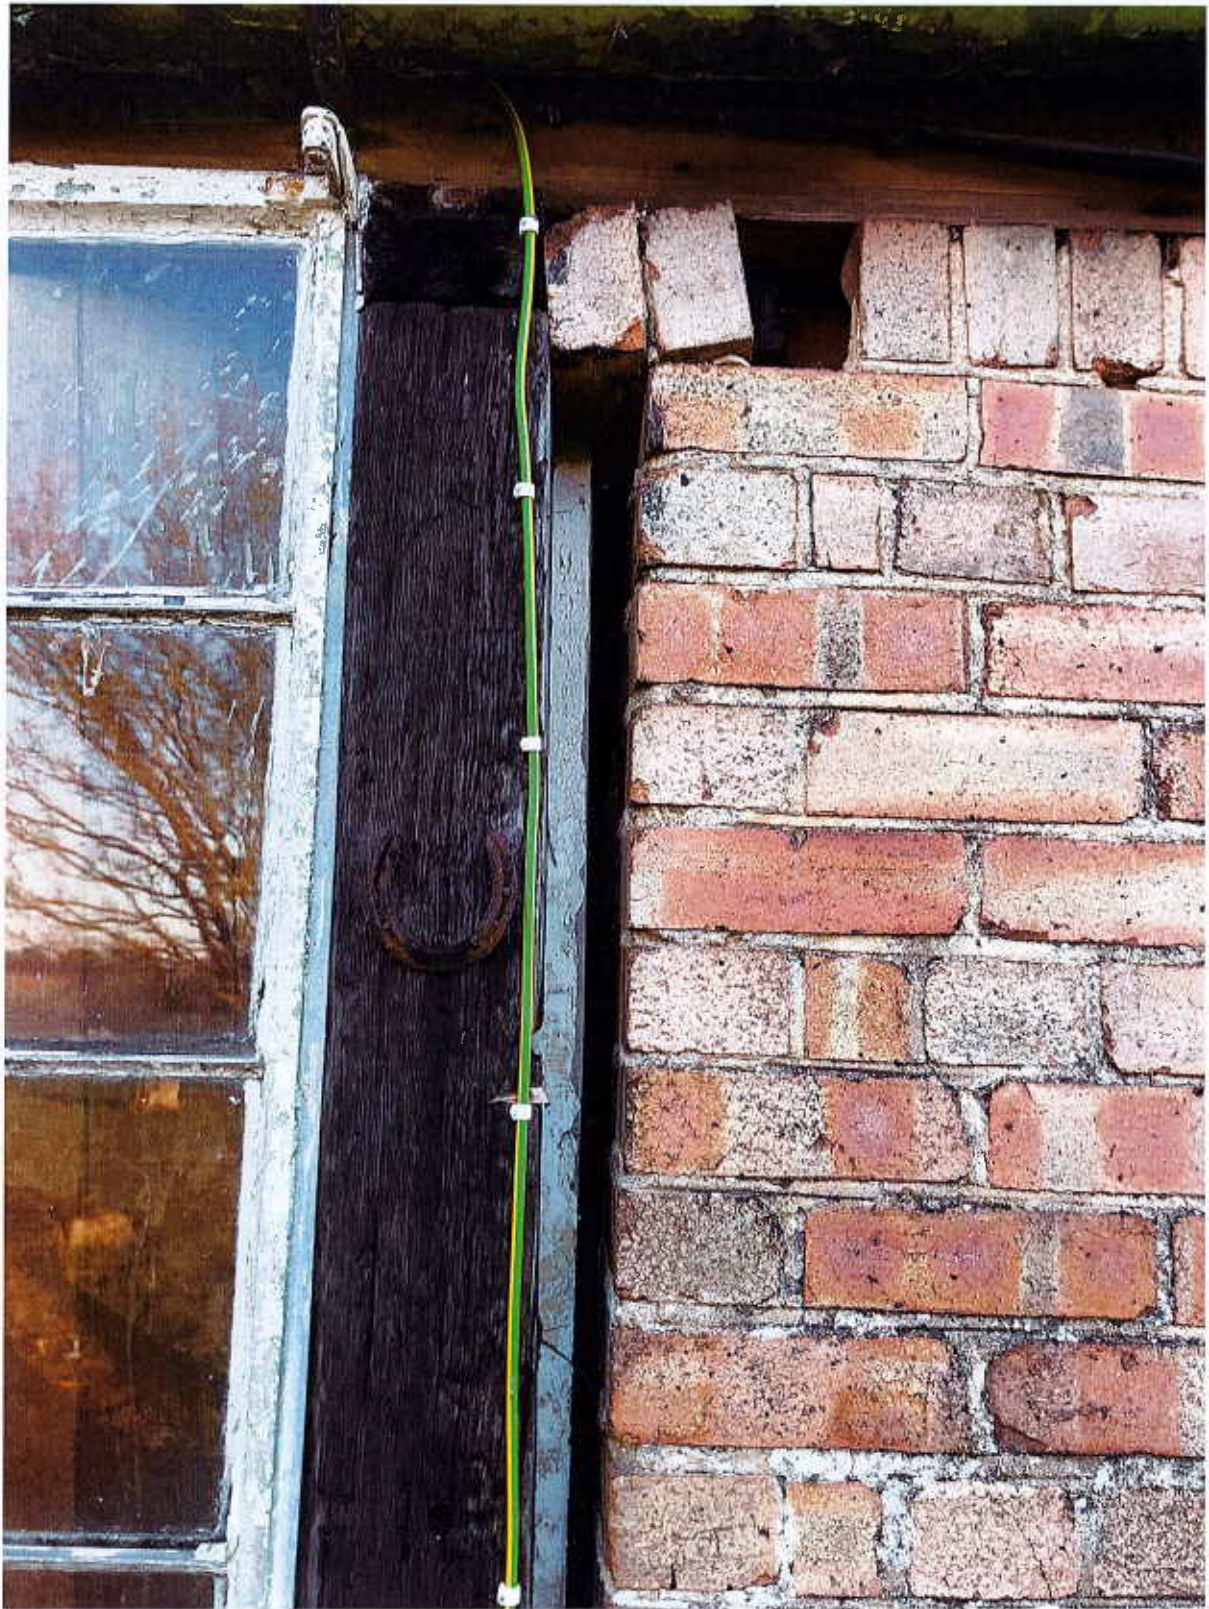
PHOTOGRAPH 6

A vertical gap between the timber posts and the wall was also visible – see photograph 6.

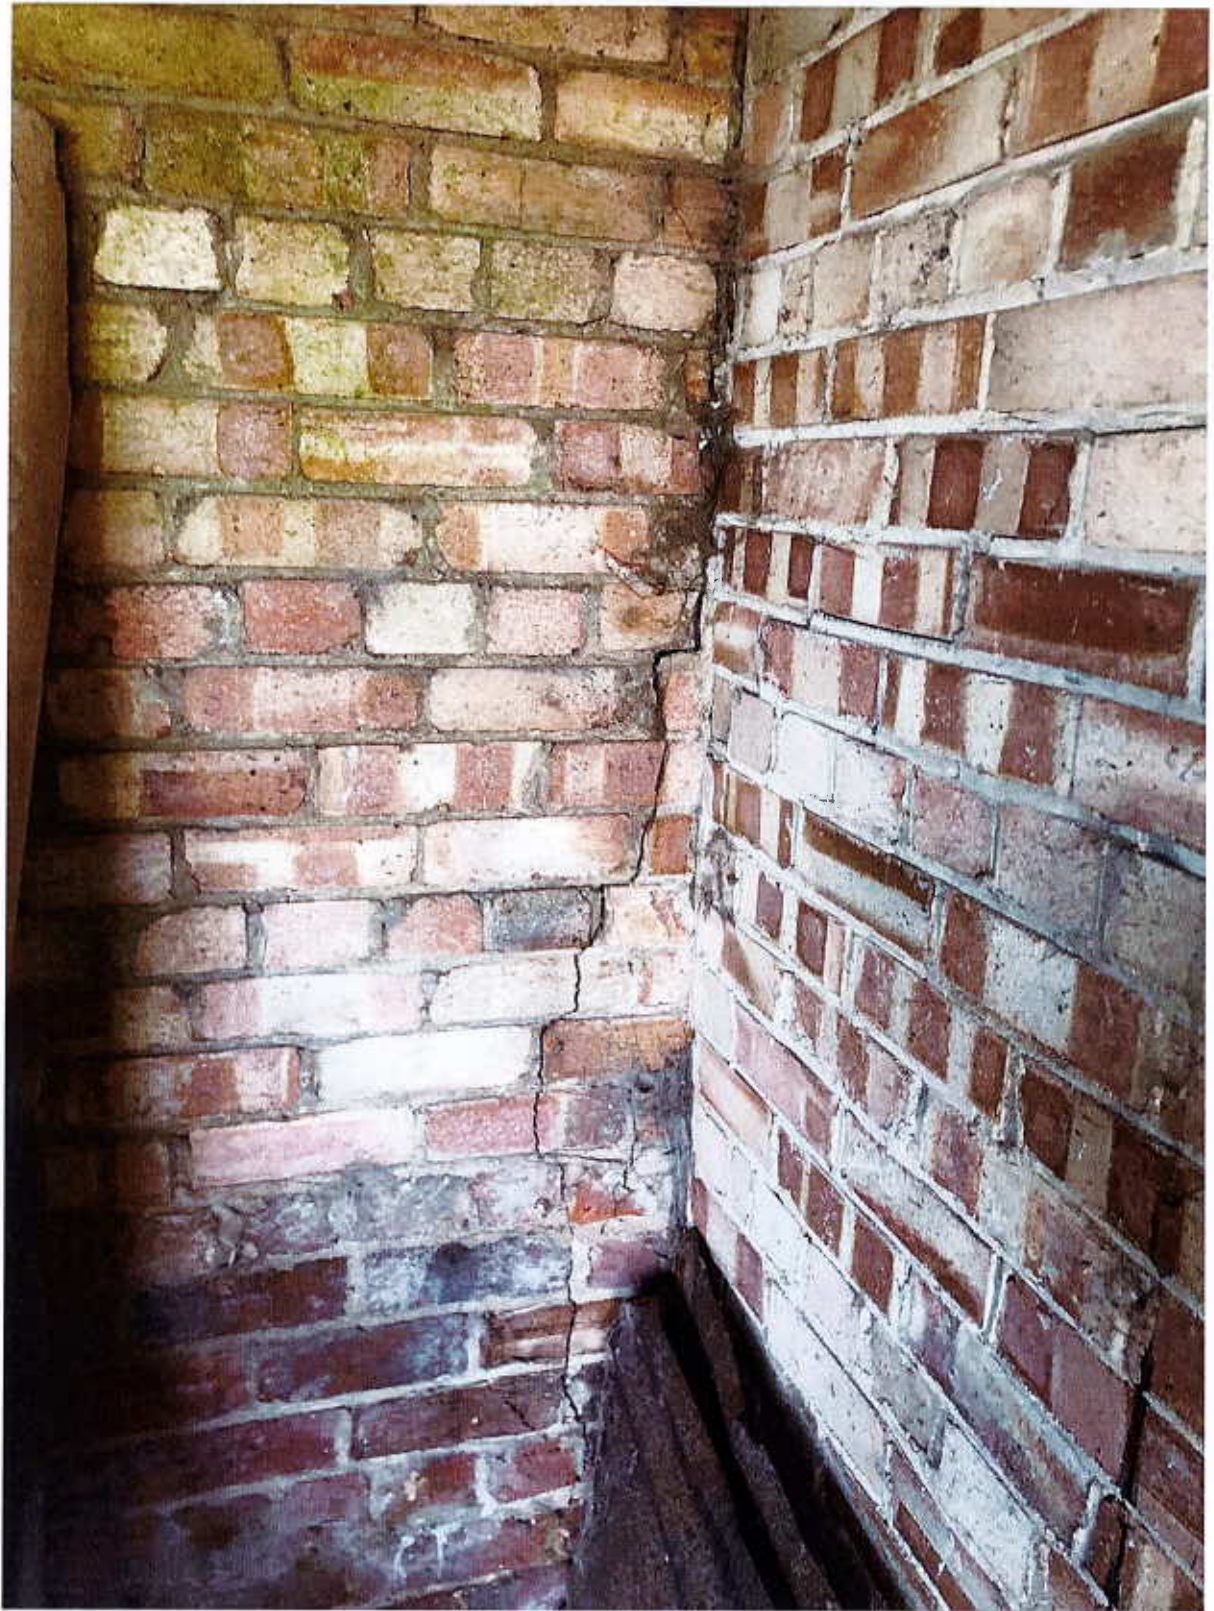
PHOTOGRAPH 7

The previously mentioned cracking to the front wall was noted internally – see photograph 7.

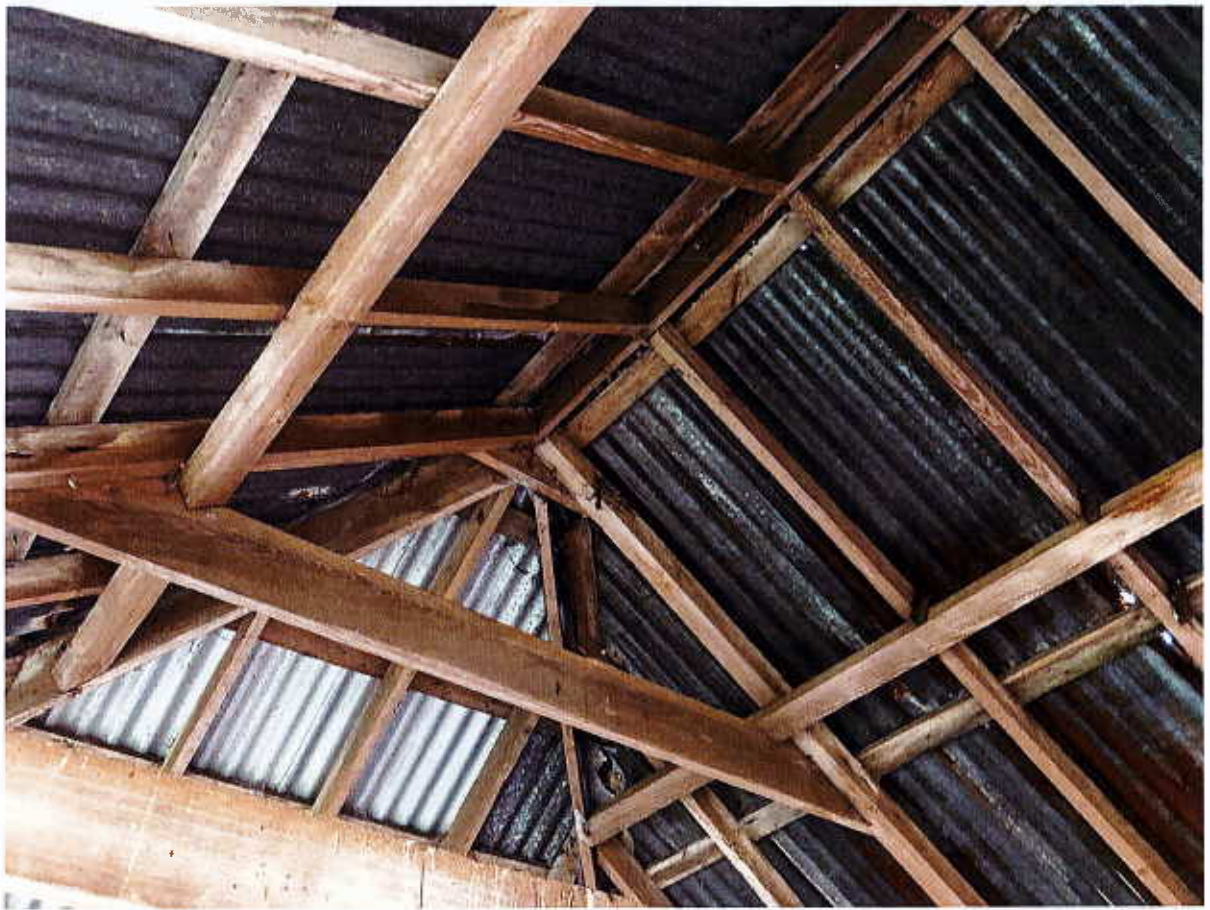
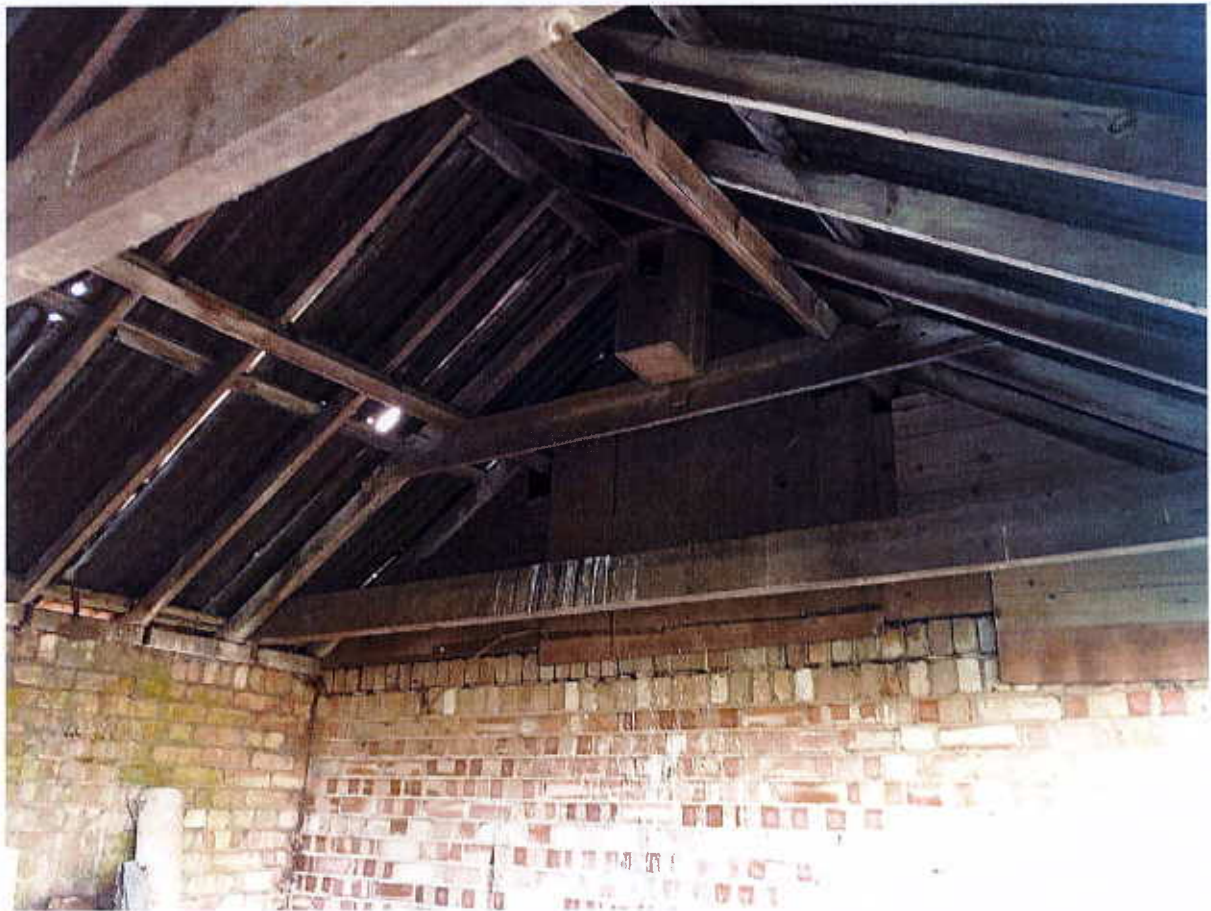
The timber roof framing supporting single skin corrugated steel cladding is in relatively good condition, with collared frames and horizontal ties at eaves level in places – see photographs 8 and 9.

The existing timber roof framing could remain, but checked to ensure no decay is present and it is able to support the load from a new covering.
