## STRUCTURAL APPRAISAL REPORT

### Existing Barn (Barn Two):-

Sycamore Grange,  
Cross Drove,  
Gedney Hill,  
Lincolnshire.  
PE12 0PZ

| <b>Reference:-</b> | JC/23/09/7277-2 | <b>Issued:-</b> Nov 2023 |

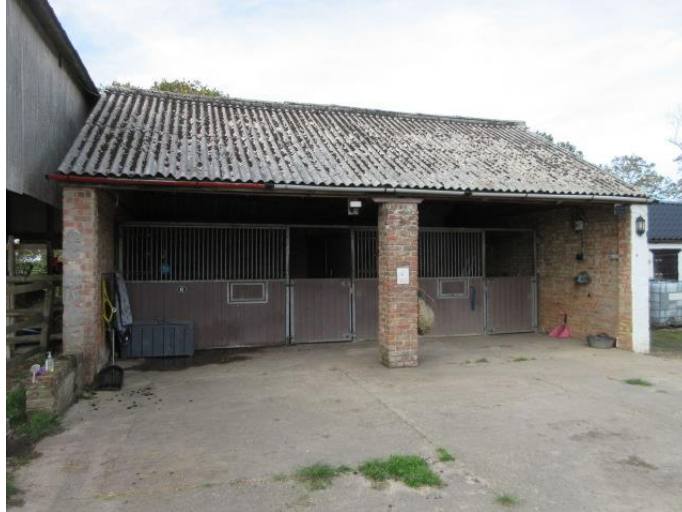
**Photograph # 1** (Main 'Stable' Barn - Front, East Facing Elevation)

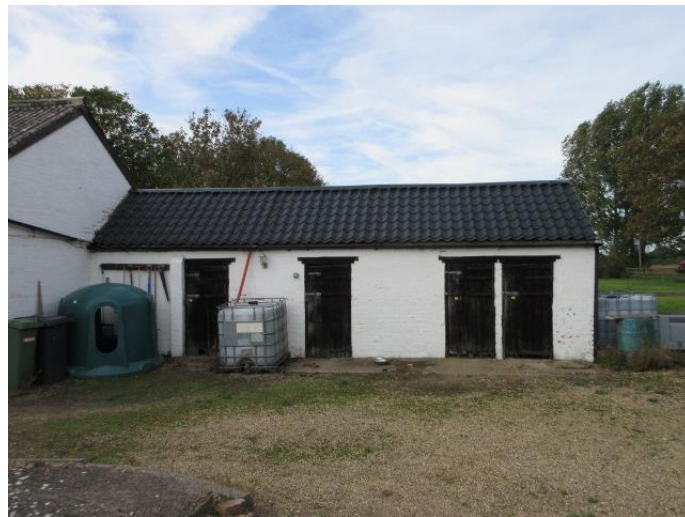
**Photograph # 2** ('Store' Barn - Front, East Facing Elevation)

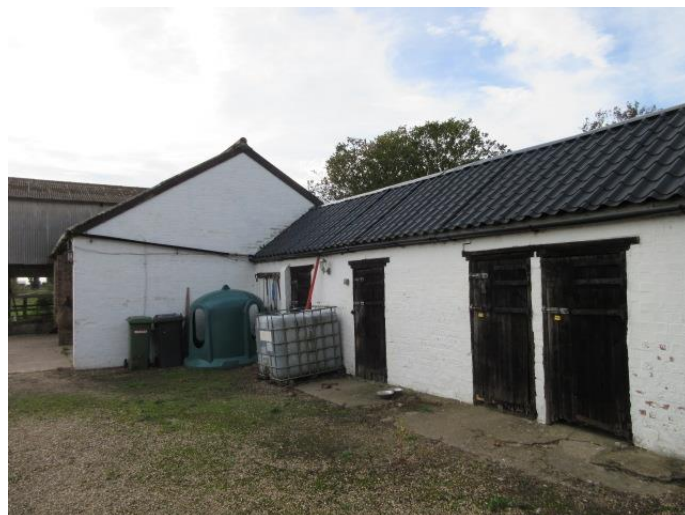
**Photograph # 3** (Main 'Stable' Barn North Facing Gable Elevation)

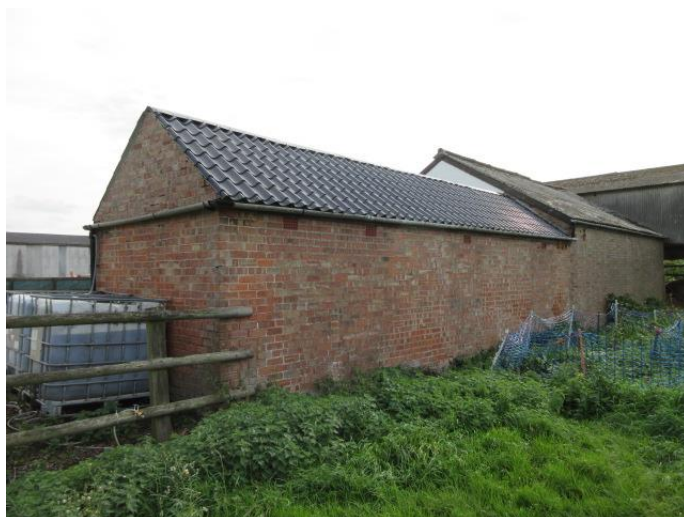
**Photograph # 4** ('Store' Barn - North Facing Gable Elevation / West facing Rear Elevation)

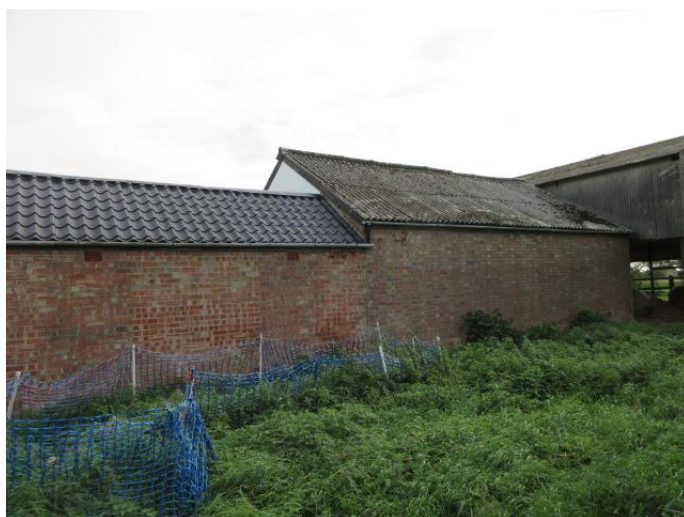
**Photograph # 5** (Rear, West Facing Elevation)

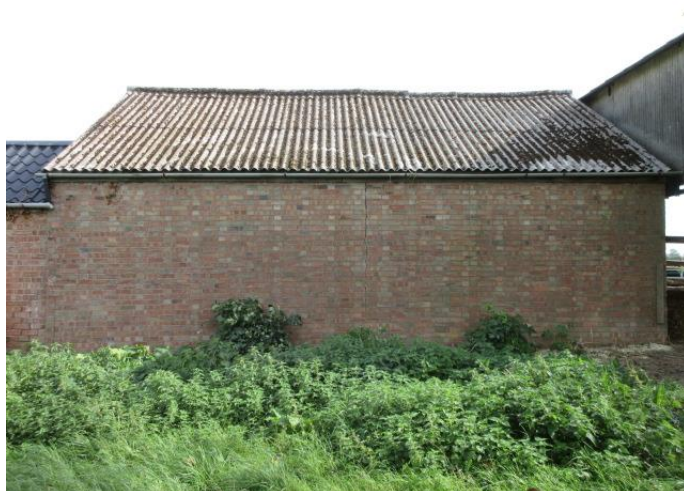
**Photograph # 6** (Main 'Stable' Barn - Rear, West Facing Elevation)

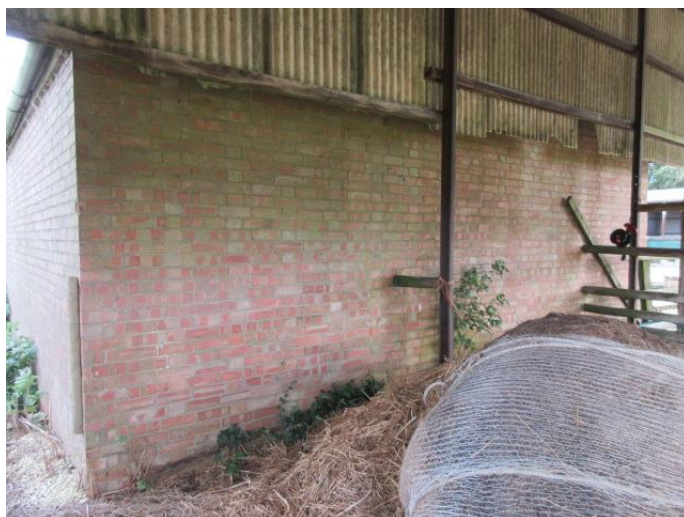
**Photograph # 7** (Main 'Stable' Barn - Gable, South Facing Elevation)

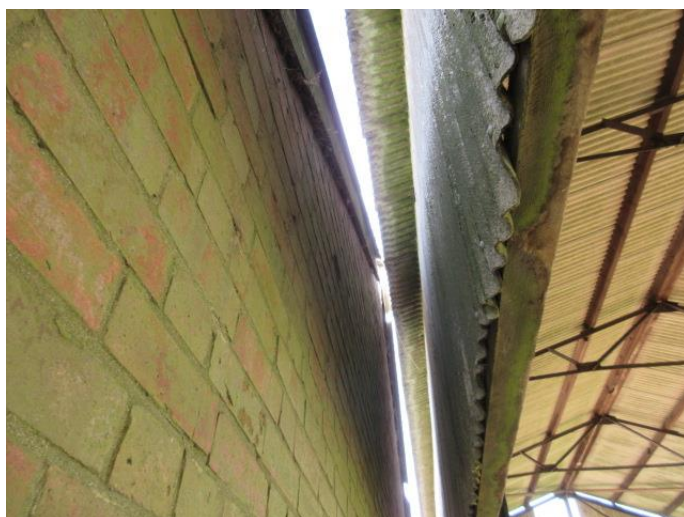
**Photograph # 8** (Main 'Stable' Barn - Gable, South Facing Elevation)

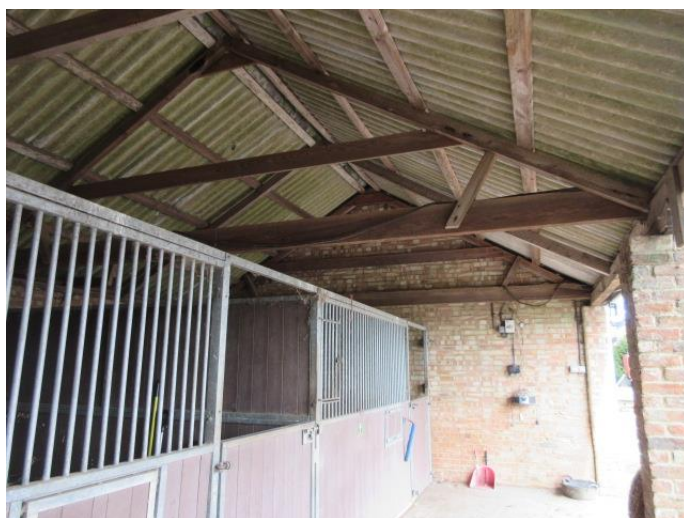
**Photograph # 9** (Typical Roof / Eaves Timber Beam onto Central Pier)

- 5.5 The original Timber beam / pier arrangement forming the front elevation of the main barn should be enhanced via the constriction of infill panels between the pier and gable walls in order to form an enclosed structure as part of any conversion.

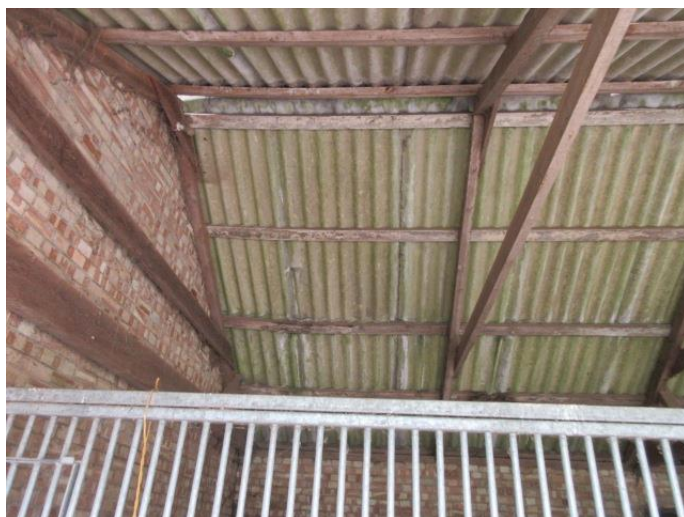
- 4.4 The existing roof structure to the main barn was noted to be slender in construction and supported only a lightweight roof covering. Whilst the roof has provided its primary function during its lifetime of offering protection from the weather and elements to the internal fabric, it was noted that the roof timbers were exhibiting deflection and distortion.
- The existing roof structure is not deemed suitable to be incorporated within a conversion.

**Photograph # 10** (Typical Roof)

- 5.4 The existing roof structures will need to be replaced. We recommend that all new roof structures are of cut roof construction to an Engineers design, or alternatively a prefabricated roof truss system by specialist supplier could be adopted. The new roof structures should be supported onto the new inner leaf blockwork and may need to incorporate extended rafters to achieve the required fascia detail over the original masonry wall at eaves.

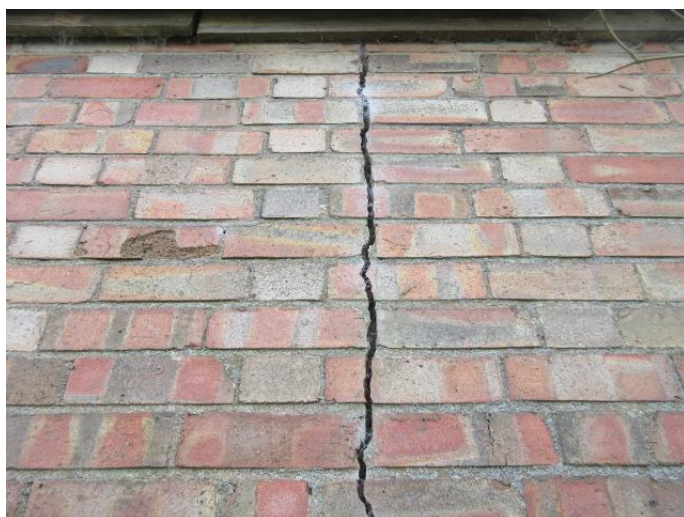
**Photograph # 11** (Main 'Stable' Barn - Localised Cracking to Rear Elevation)

- 5.6 Elsewhere the performance of all walls that accommodate fractures can be improved by low key stitching using the 'Helifix' masonry repair system, which involves installing remedial 'Heli-bar' rods into the bed joint of the masonry at regular vertical centres over any open cracks. Similar Helifix systems can be used to improve the tie between any new cross walls and junctions with the external elevation walls. Any areas of hard cement re-pointing previously carried out on any brickwork that is to be retained should be carefully removed and replaced with a sympathetic soft lime based mortar. Other areas of weathered masonry joints should be repointed in a similar fashion. Any timber lintels / backing timbers that are present over any openings should be replaced throughout.

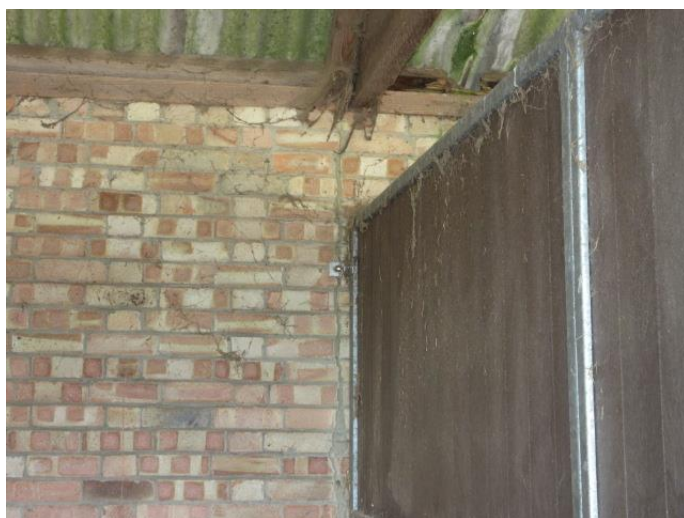
**Photograph # 12** (Localised Cracking to Rear Elevation - Internal Brickwork – Crack Formerly Repaired)

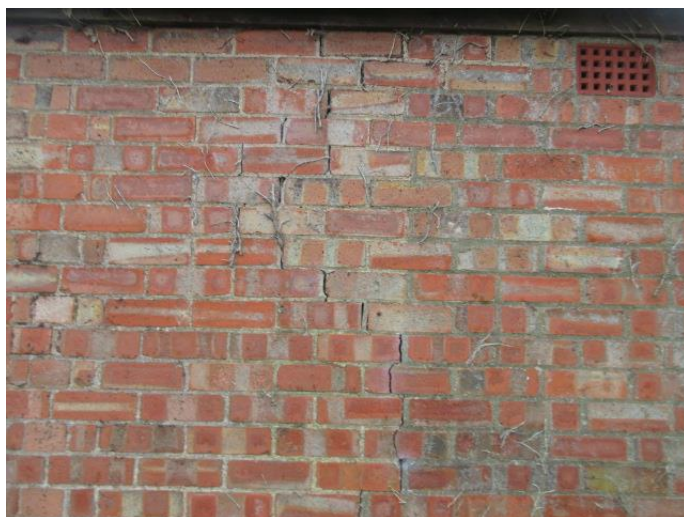
**Photograph # 13** ('Store' Barn - Localised Cracking to Rear Elevation)

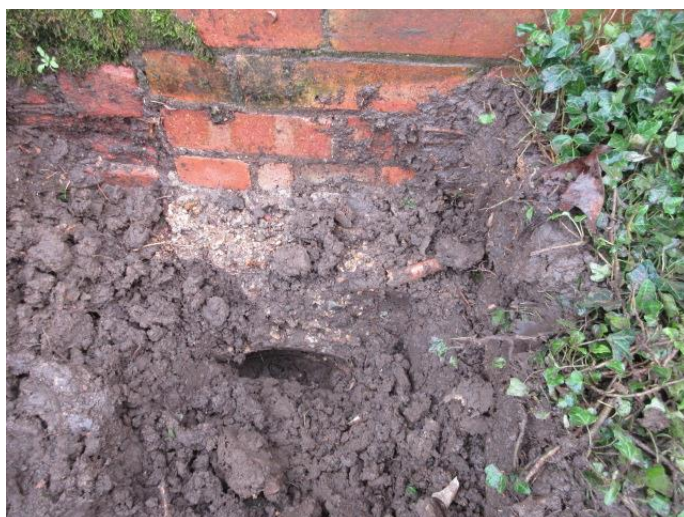
Foundations to the main barn consist of a continuation of the masonry wall below ground level approx. 275mm supported off a 175-200mm thick, rough cast concrete foundation system bearing onto the ground strata below. The overall depth of the foundation system below ground level was in the order of 500mm.

**Photograph # 14** (Main 'Stable' Barn - Typical Foundation)

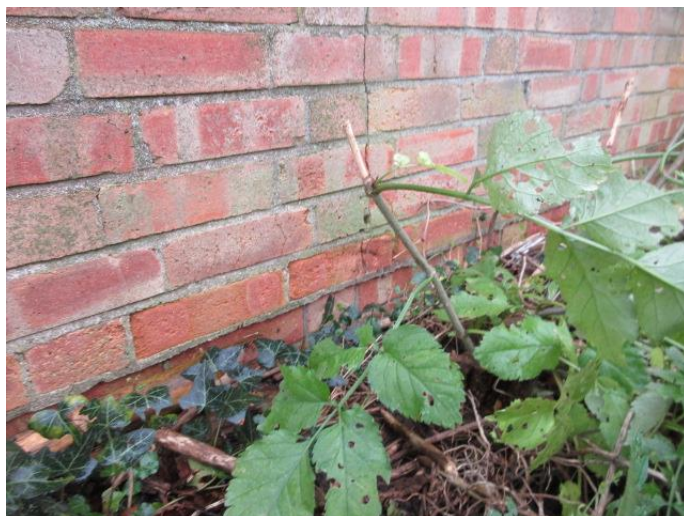
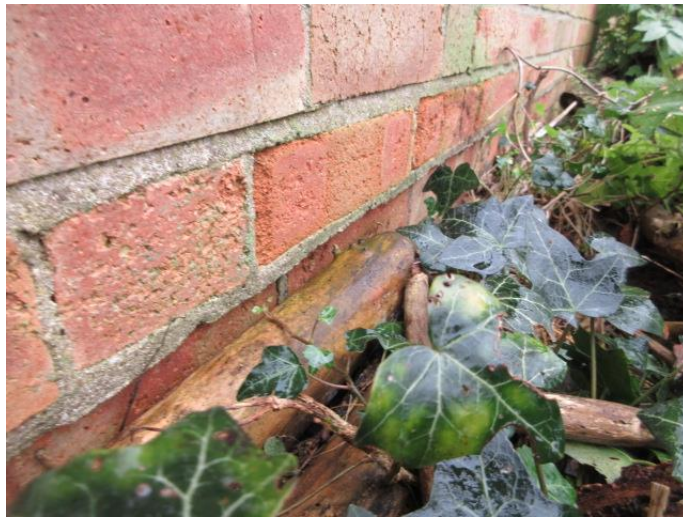
- 4.3 The existing foundations to the barns are relatively shallow and appear to have suffered from historic movement. The long, rear elevation (West facing) of the main barn has been subject to a small degree of lateral movement whereby the masonry panel has slipped slightly on the slate dpc at approximately mid panel. Both the rear wall of the main barn and the smaller barn does accommodate some localised cracks, suggesting that a degree of vertical movement has also been accommodated by the foundations supporting this wall.

The cause of the movement to the foundations and subsequent cracking to the wall is likely to be principally due to the shallow depth of the foundation and associated variations of moisture within the clay based soils, however consideration also has to be given to the general relaxation and deflection of the supported slender hand cut roof structure which will have exerted a degree of stress upon the wall and subsequent foundations.

**Photograph # 15** (Main 'Stable' Barn – Rear Masonry Panel – Horizontal Movement on DPC)

**Photograph # 16** (Main 'Stable' Barn – Rear Masonry Panel – Horizontal movement on DPC)

In order to protect the existing rear elevation walls from further distortion it will need to be enhanced with a series of remedial works, including an improvement in their overall restraint. Ideally any layout proposed at conversion stage should introduce some cross wall at regular centres that tie perpendicular into the rear elevation at regular centres, or alternatively a series of steel frames may be required if an open plan arrangement is desired.

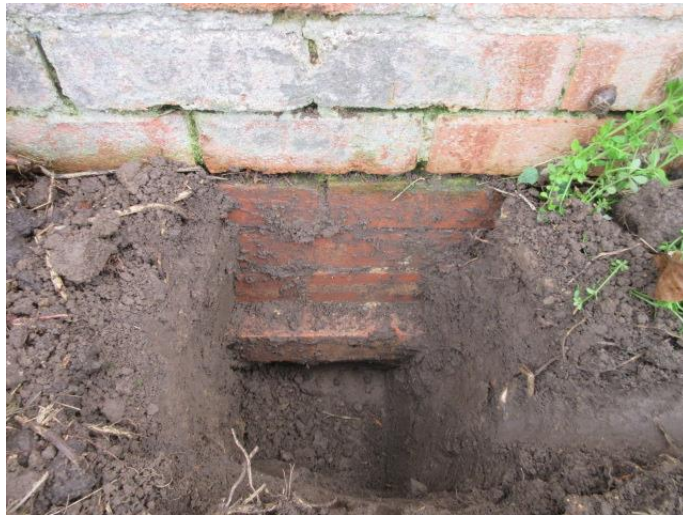
Foundations to the smaller barn consist of a continuation of the masonry wall below ground level approx. 300mm, which projected using a single 75mm corbel at its base bearing onto the ground strata below.

**Photograph # 17** ('Store' Barn - Typical Foundation)
