ANTHONY-JOHNSON

Harrington Hall Farm
Holbeach
PE12 8NW

Overview:

It is proposed that an existing barn structure be converted to residential use. The purpose of the survey was to therefore consider the condition of the structure and its suitability for conversion with limited alterations and without introduction of additional structural elements.

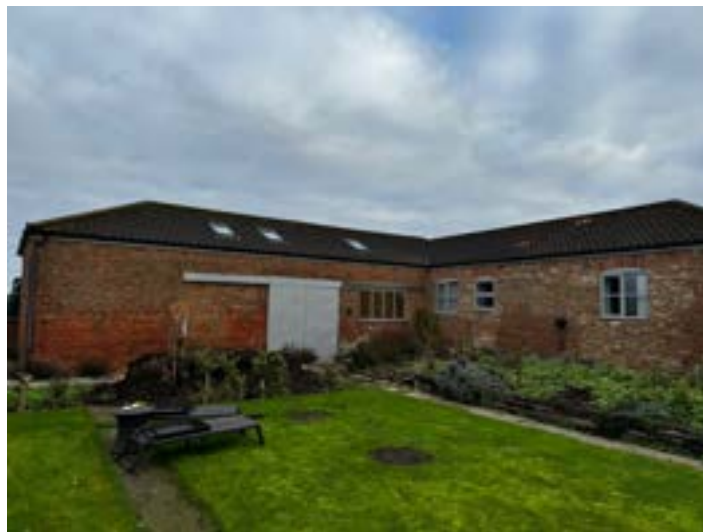
The existing structure is single story, formed of brickwork to external elevations with a duo pitch roof formed of concrete pan tiles laid to falls and concrete ridge tiles. The roof structure is noted as being intact, functioning as originally intended and lacking any defects. The roof structure is served by a series of uPVC rainwater goods that are fixed to uPVC fascia boards to the perimeter of the structure.

Image 1.0: external view of Barn structure

All rainwater goods appear intact and functioning as originally intended with down water pipes evident throughout.

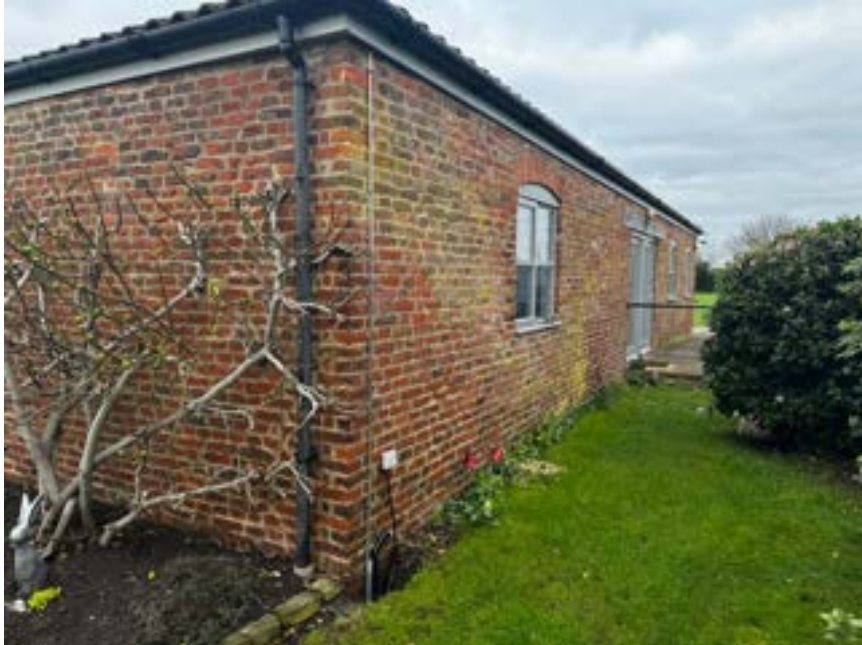
Brickwork the exterior appears in good condition with no significant defects evident. Brickwork has been laid with a Common bond to coursing, indicating a solid 9 inch masonry wall. Openings are provided with header bricks set as soldier courses, suitably arched to form brick lintels.

Image 2.0: View of Structure with Fig tree to elevation. Pit at corner return of building allowed for partial inspection of foundations.

Brickwork throughout was noted as running straight and true with no bellying or vertical deviation. Weathering to external faces was found to be limited and limited loss of mortar was evident reflecting a structure that has been suitably maintained.

Partially exposed foundations were found to extend down a minimum of 4 brick courses below ground level. The lack of excessive movement in external elevations, coupled with the age of the building indicates that the structure is suitably founded with adequate depth and width to external elevations.

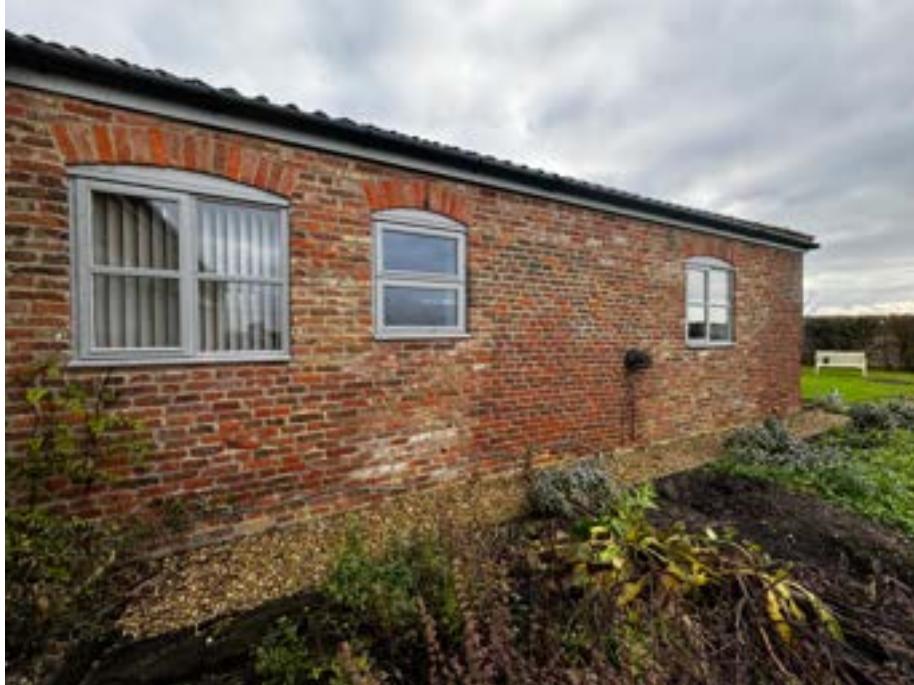
Part of the structure had already been converted to former office space serving the farm and this was found contain uPVC glazing with suitable finishes reflective of a structure that likely meets current building regulations. The remaining barn structure incorporates original glazing and doors.

Image 3.0: External view of section previously converted.

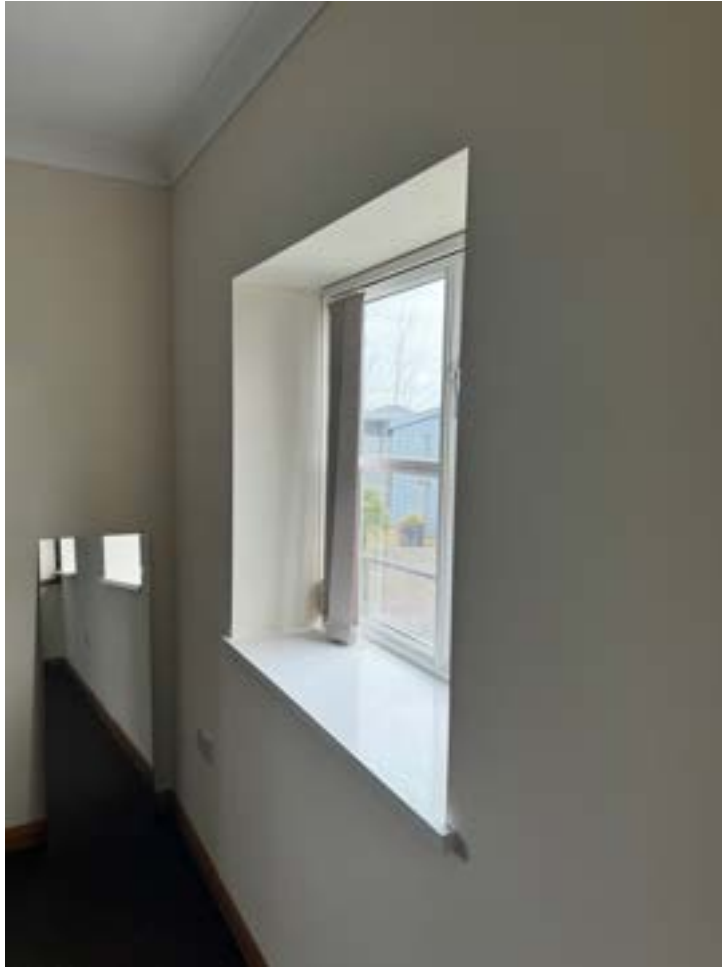
Internally to the converted section of the barn the prior office space is fully lined with plasterboard set to internal faces of the original masonry. The depth of walls is indicative of dry lining having been added, likely with sufficient insulation to exceeded current regulations.

Image 4.0: Deep walls to converted section of barn.

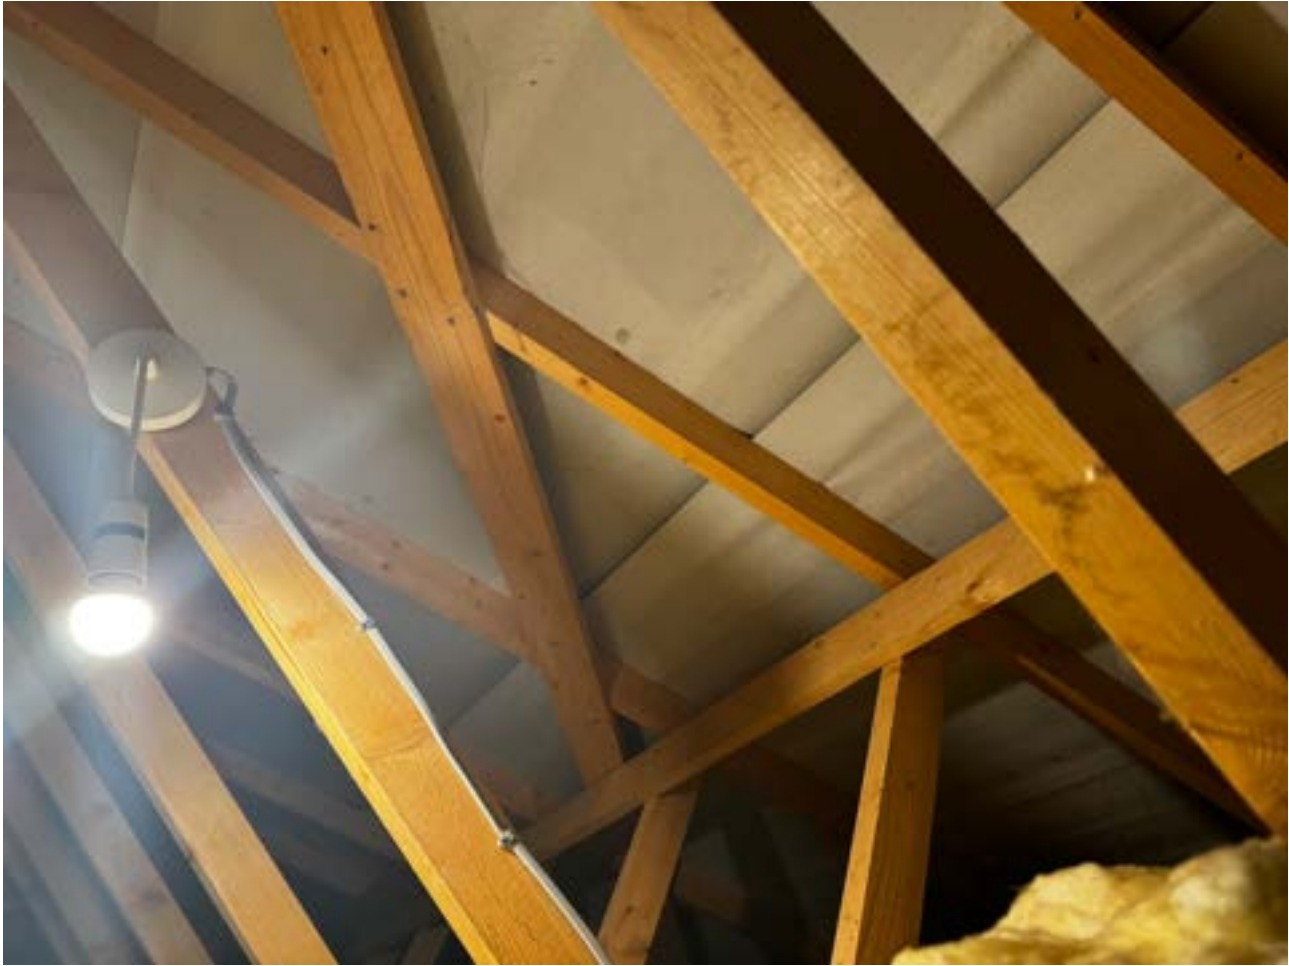
The roof structure to the office space has previously been replaced with factory formed gang nail trusses. A suitable breathing membrane is set to the head of the trusses and insulation has been laid between trusses to the head of the ceiling with a depth that is likely commensurate with current regulations.

Image 5.0: Internal view of attic void, with breather membrane to gangnail trusses. Insulation clearly visible in image

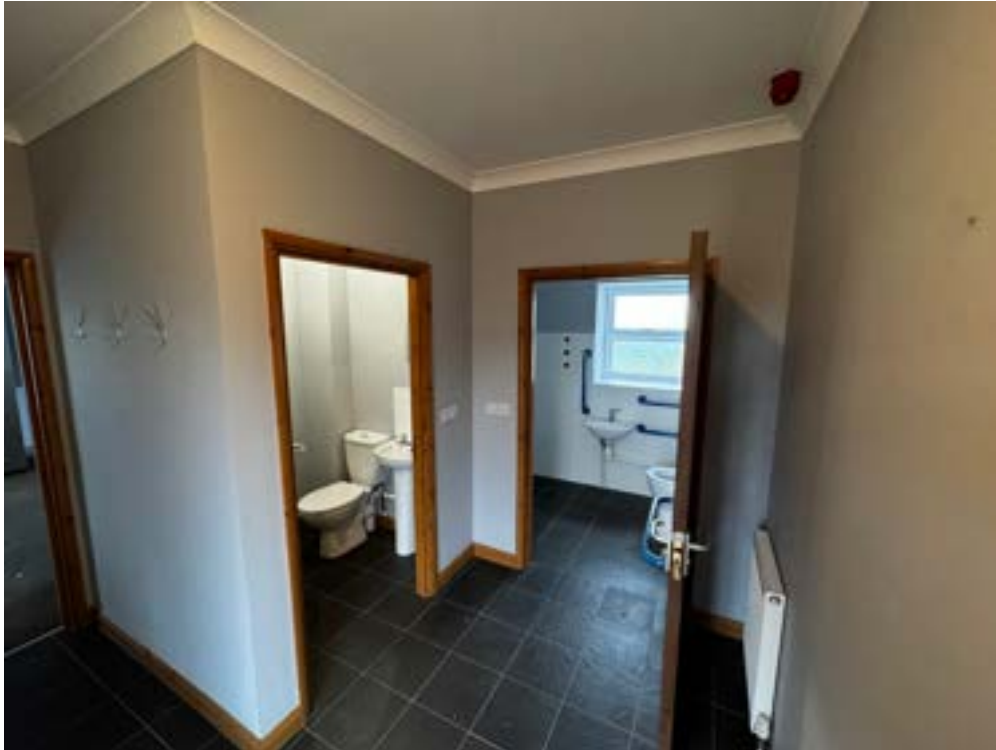
A shower cubicle and toilet are already incorporated within the converted section of the barn with the shower having been introduced as a health and safety requirement so as to meet employee regulations associated with the former use of the barn structure. The presence of sanitaryware indicates the existing presence of suitable drainage and treatment facilities to site. Similarly, the presence of offices indicates the presence of electrical supply.

Image 6.0: View of Facilities to converted section of barn

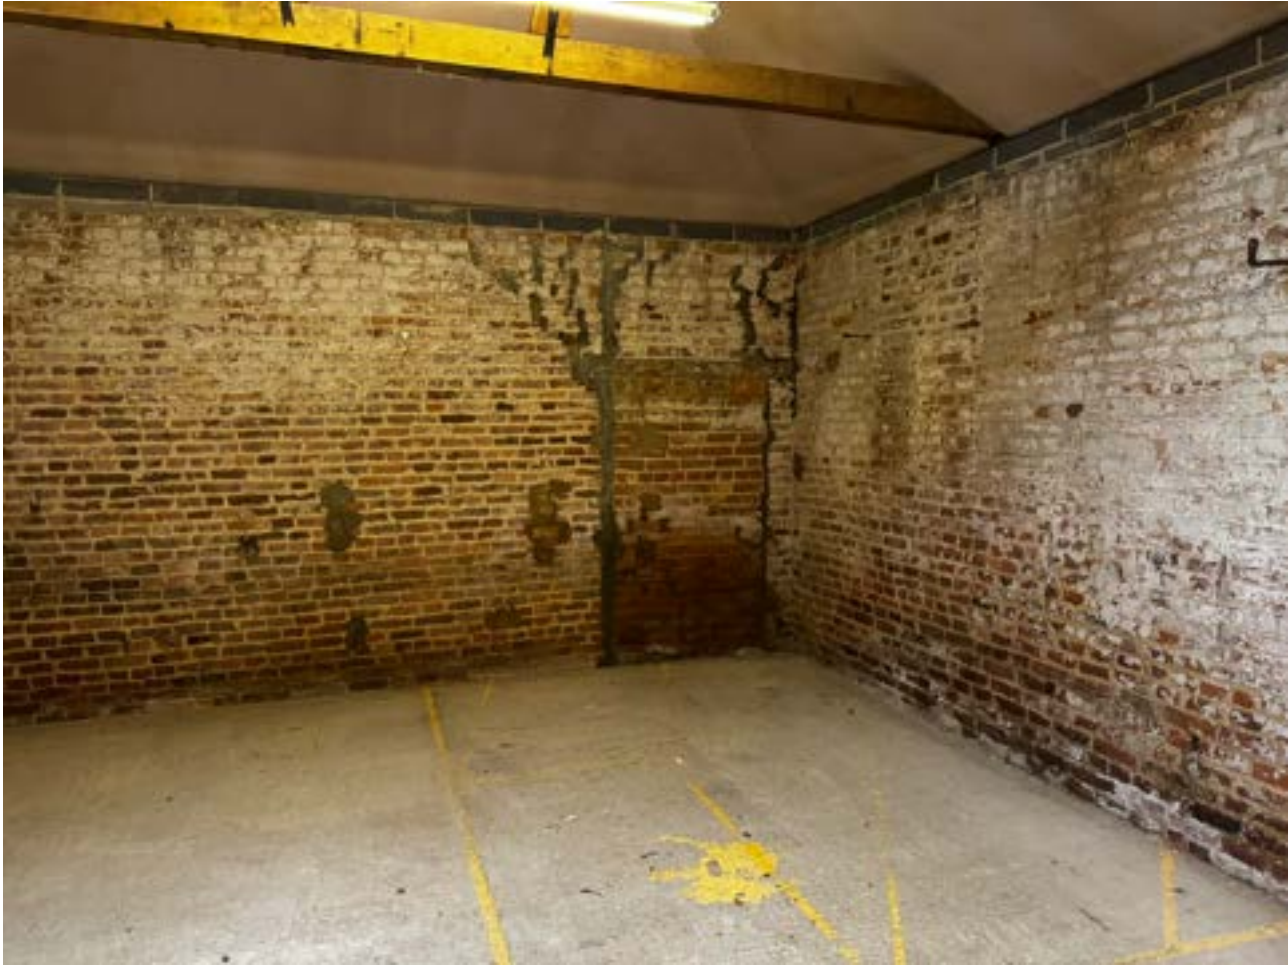
The remaining un-converted section of the barn is noted as having a concrete floor cast internally with the floor being intact and in good condition with no deviation, undulations or cracks present. The ceiling to the barn has been covered with a plasterboard and exposed timbers forming intermediate trusses within the barn structure are noted as being in good condition with no deflection or deterioration to the timbers.

Image 7.0: View of barn structure with concrete floor

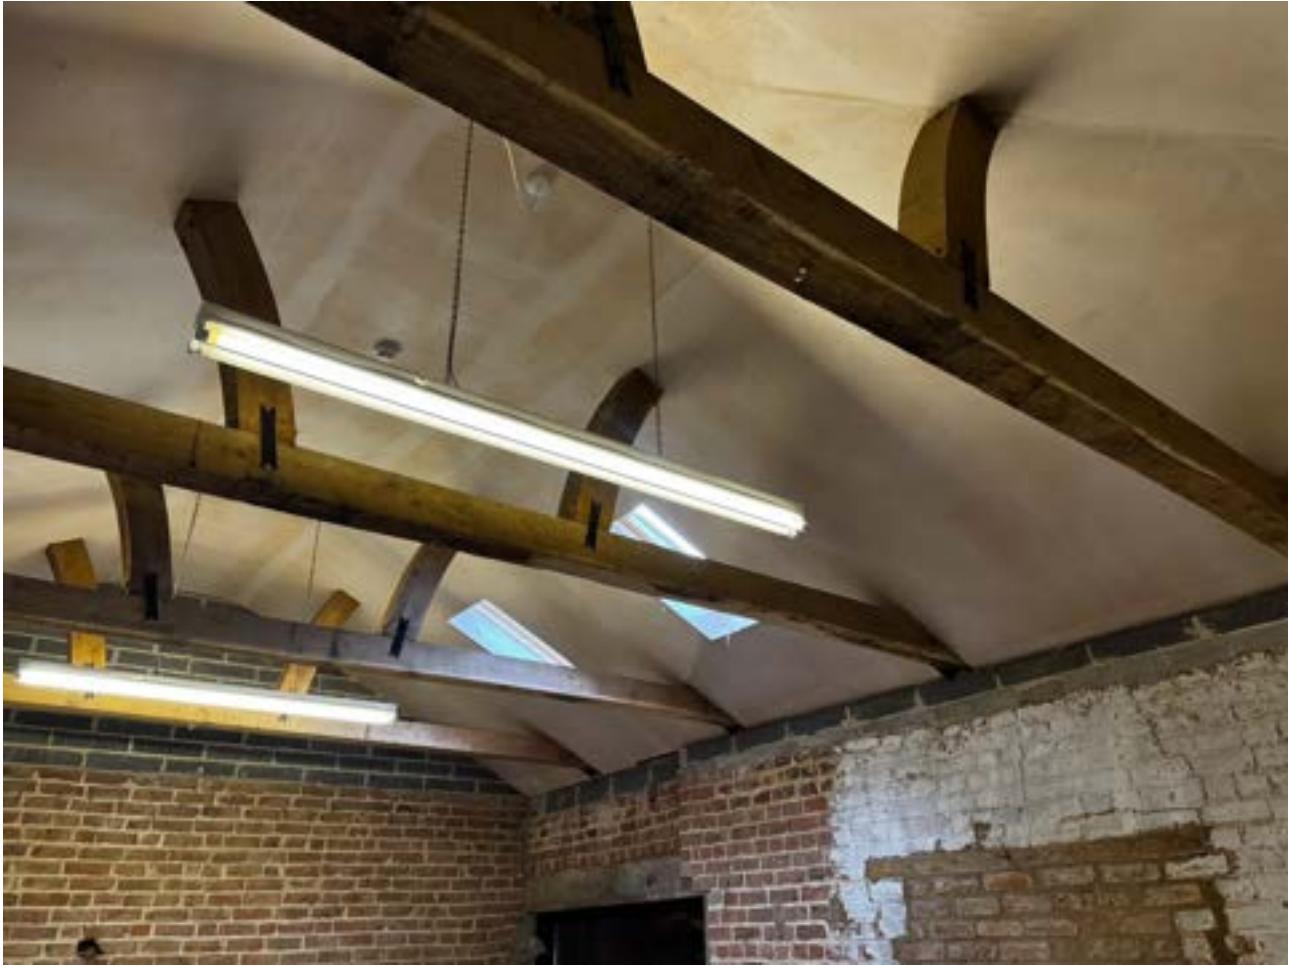
Timber sections are considered robust and suitably formed, set to the head of a blockwork course running the perimeter of the barn. The ceiling to the barn is vaulted with plasterboard rising up to the underside of existing rafters. The plasterboard was noted as being in good condition with no cracks, deflection or deterioration evident.

Image 8.0: View of ceiling to unconverted section of barn structure

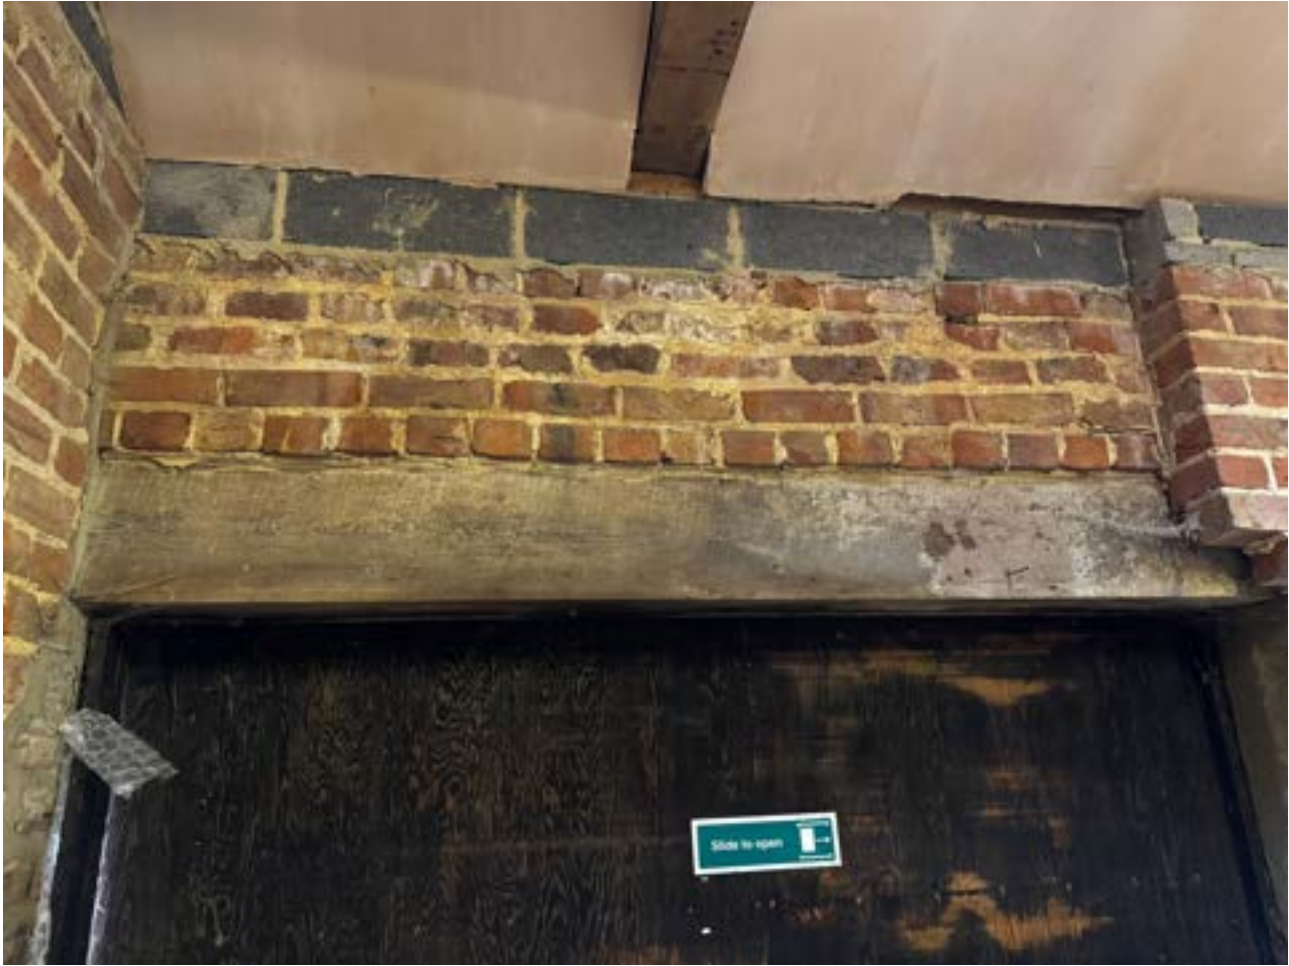
Lintels to the head of openings within the barn structure are formed from timber and these are noted as being robust with no deflection or deviation evident. End bearing of the timber lintels appears sufficient with no crushing or cracking of brickwork directly below the lintels.

Image 8.0: Timber lintel set to head of sliding door opening into barn
