# ANTHONY-JOHNSON

Old Dairy,  
Harford Gate,  
Gedney Broadgate.

## Overview:

It is proposed that a pair of former farm buildings be converted to residential use and the purpose of the survey was to discern their structural suitability and outline any significant defects that may impair their functionality.

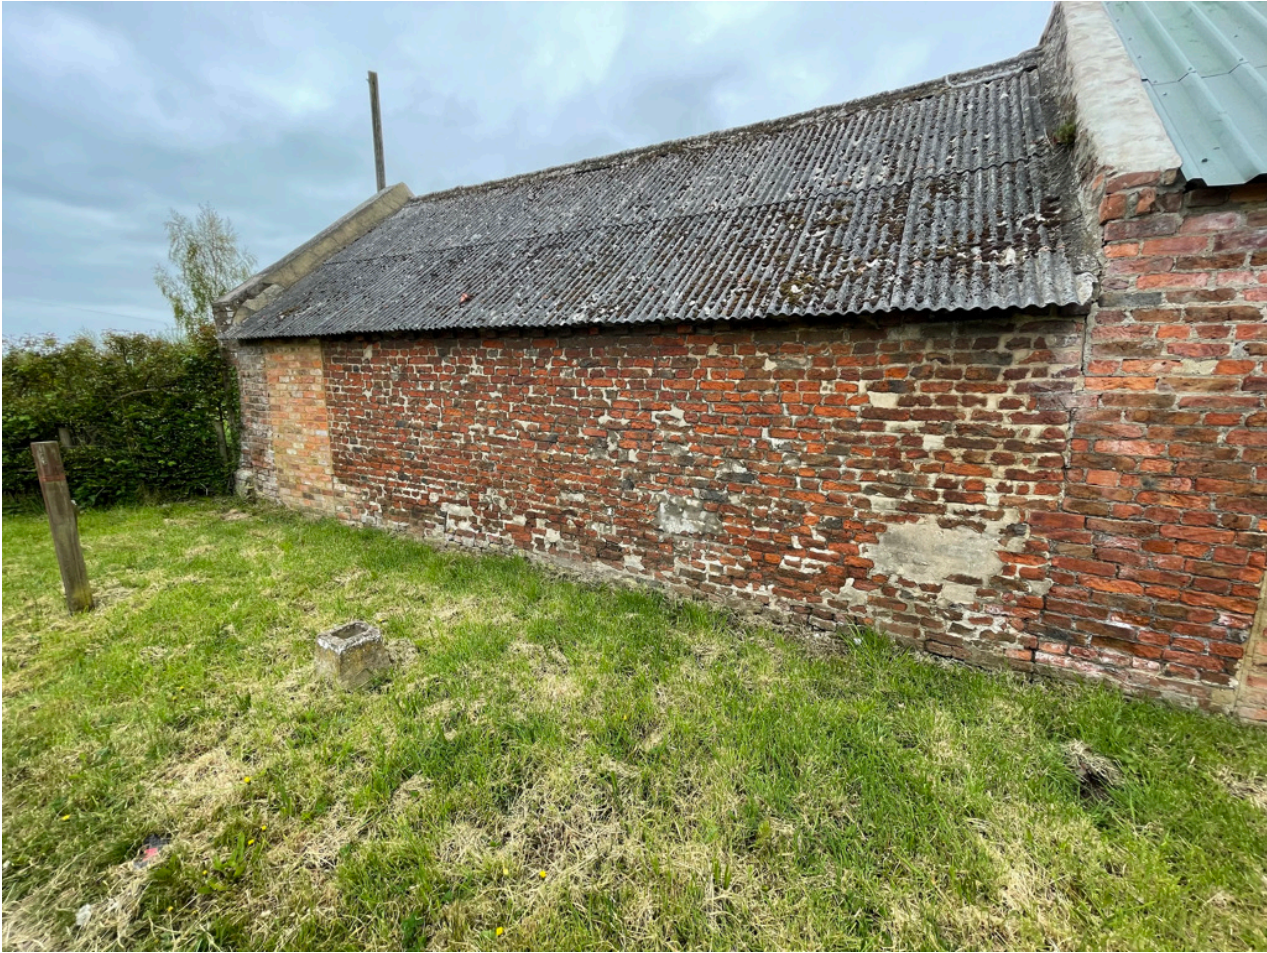
Image 1.0: Original Barn, with extension visible to right of image.

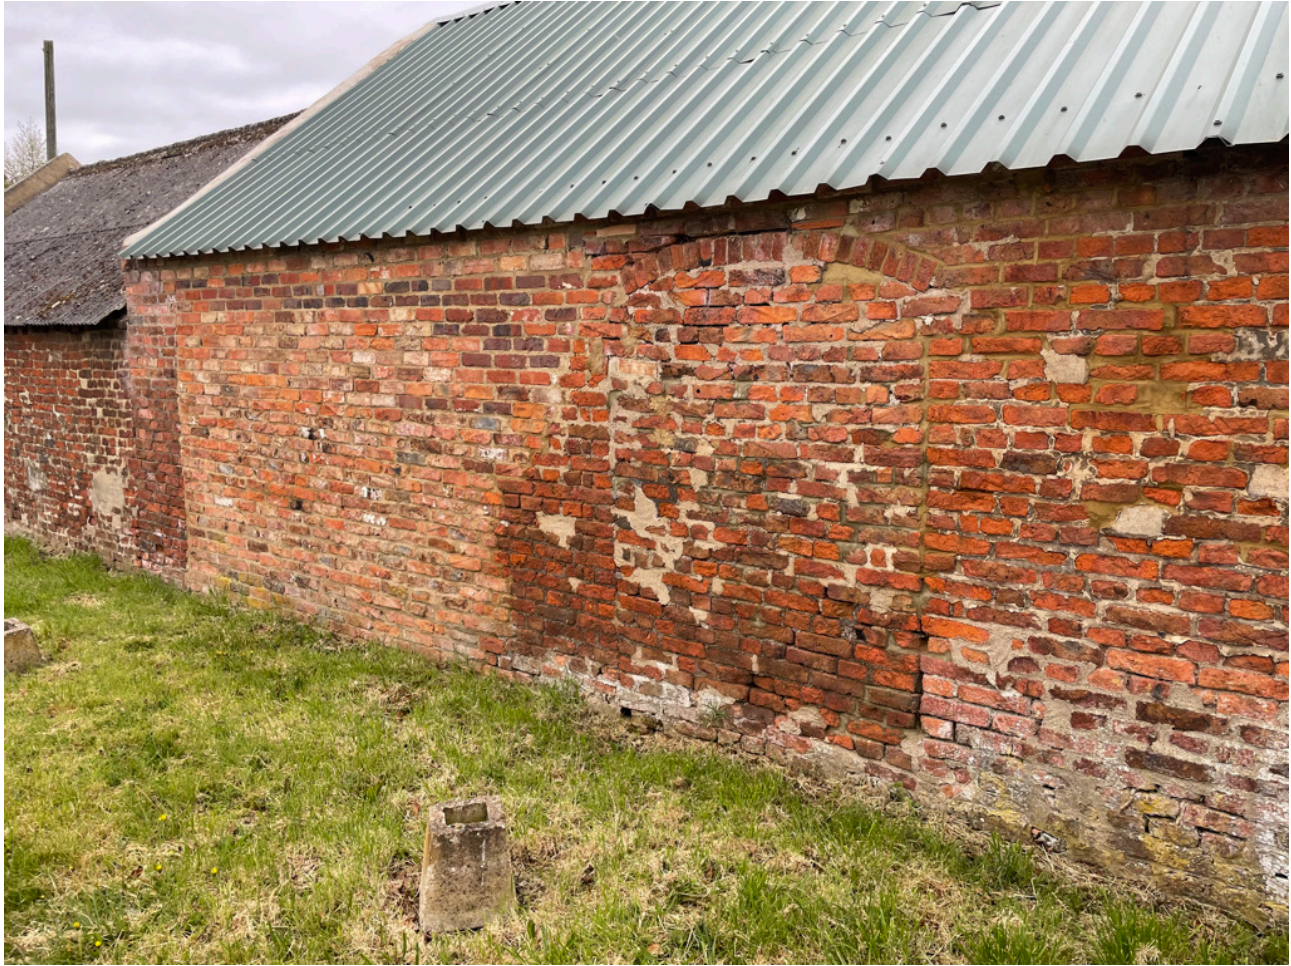
In the newer section of the barn, a masonry arch set to the side elevation facing the road indicates a former entrance route and this has clearly been bricked up as have windows to this elevation. Notably the lack of cross bond or “toothing” set a clear vertical join between both wall panels preventing the transfer of loads and as a result limited shrinkage and thermal cracking should be expected along the juncture.

Image 2.0: Masonry arch to head of former opening, now infilled.

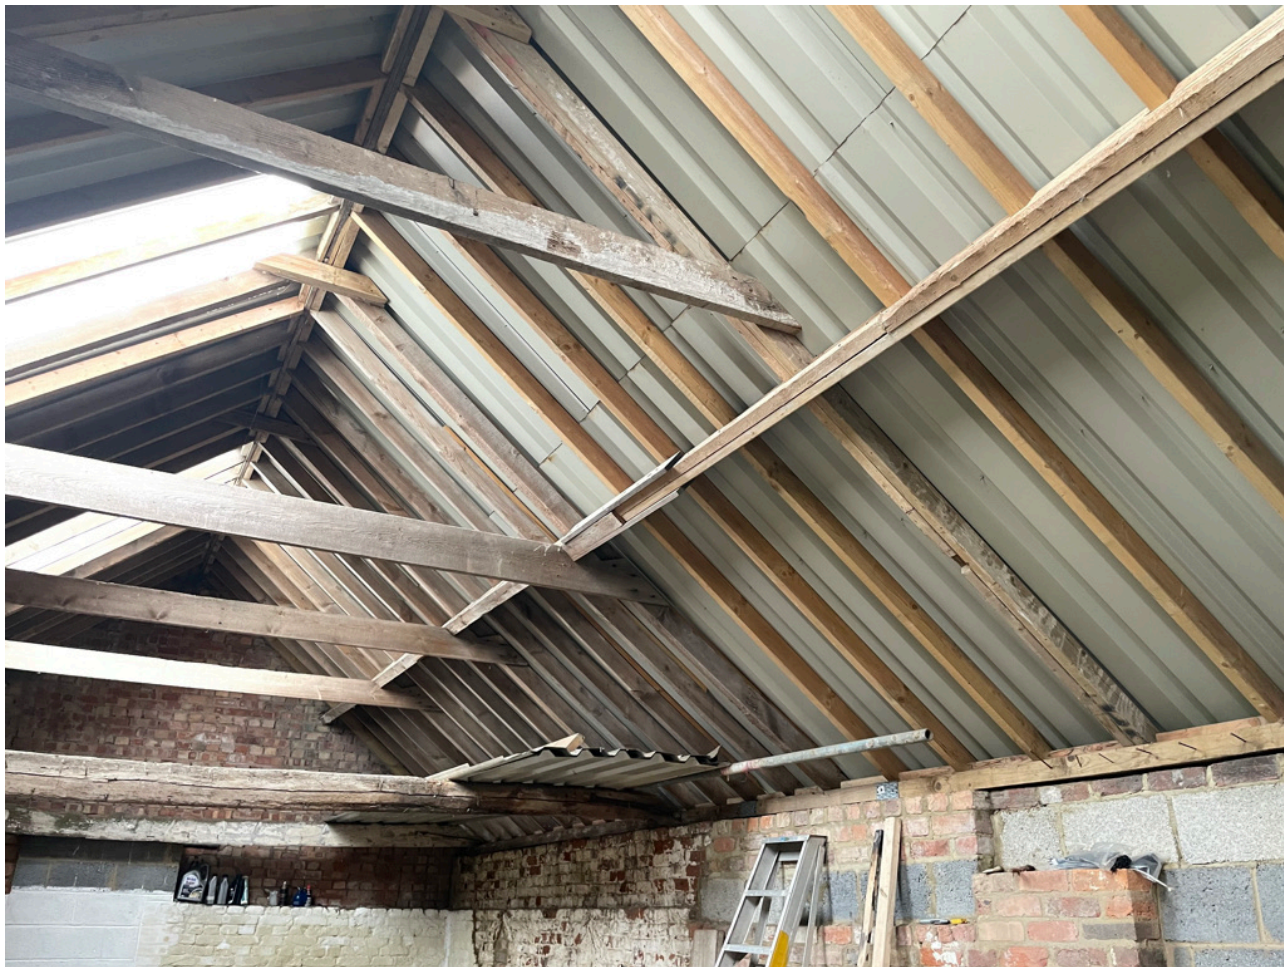
Internally, to the single story barn the higher roof is formed of rafters laid to falls, at suitable centres, sets between eaves level wall plates, purlins set mid span and ridge. Rafters appear to have been set at close centres, reflecting a structure that is superior to the corrugated steel sheeting it provides support to. High-level binders are set above the purlin line and provide restraint against spread in the roof structure.

Image 3.0: Roof structure to newer section of barn with corrugated steel sheeting

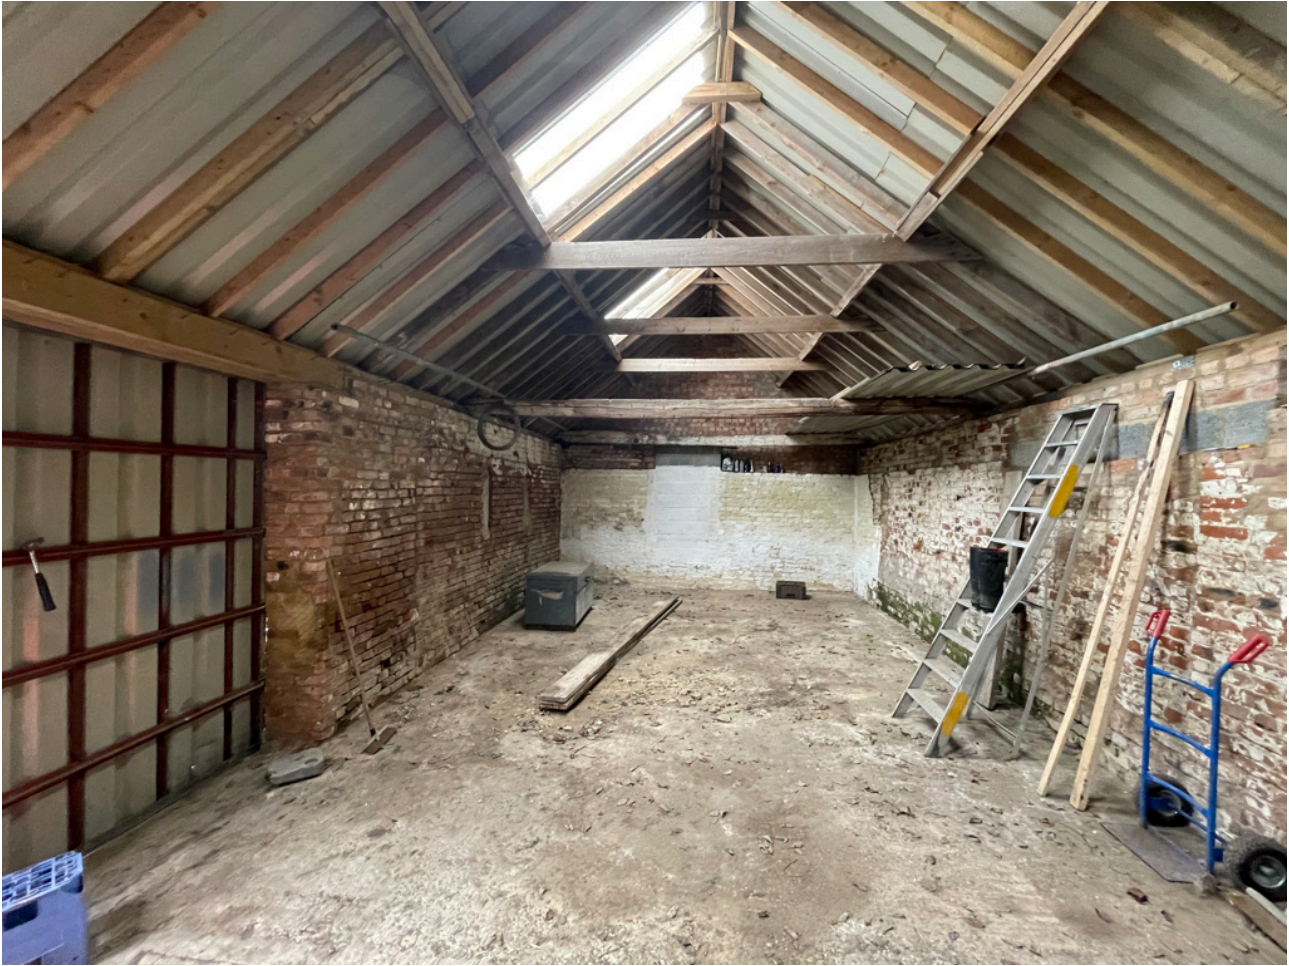
The floor within the entire barn is finished with concrete, forming a suitable slab with limited cracking, reflective of restraint cracking. A timber framed opening set within the original Gable provides access to the lower section of rear (original) barn.

Image 4.0: View internal to newer section of Barn.

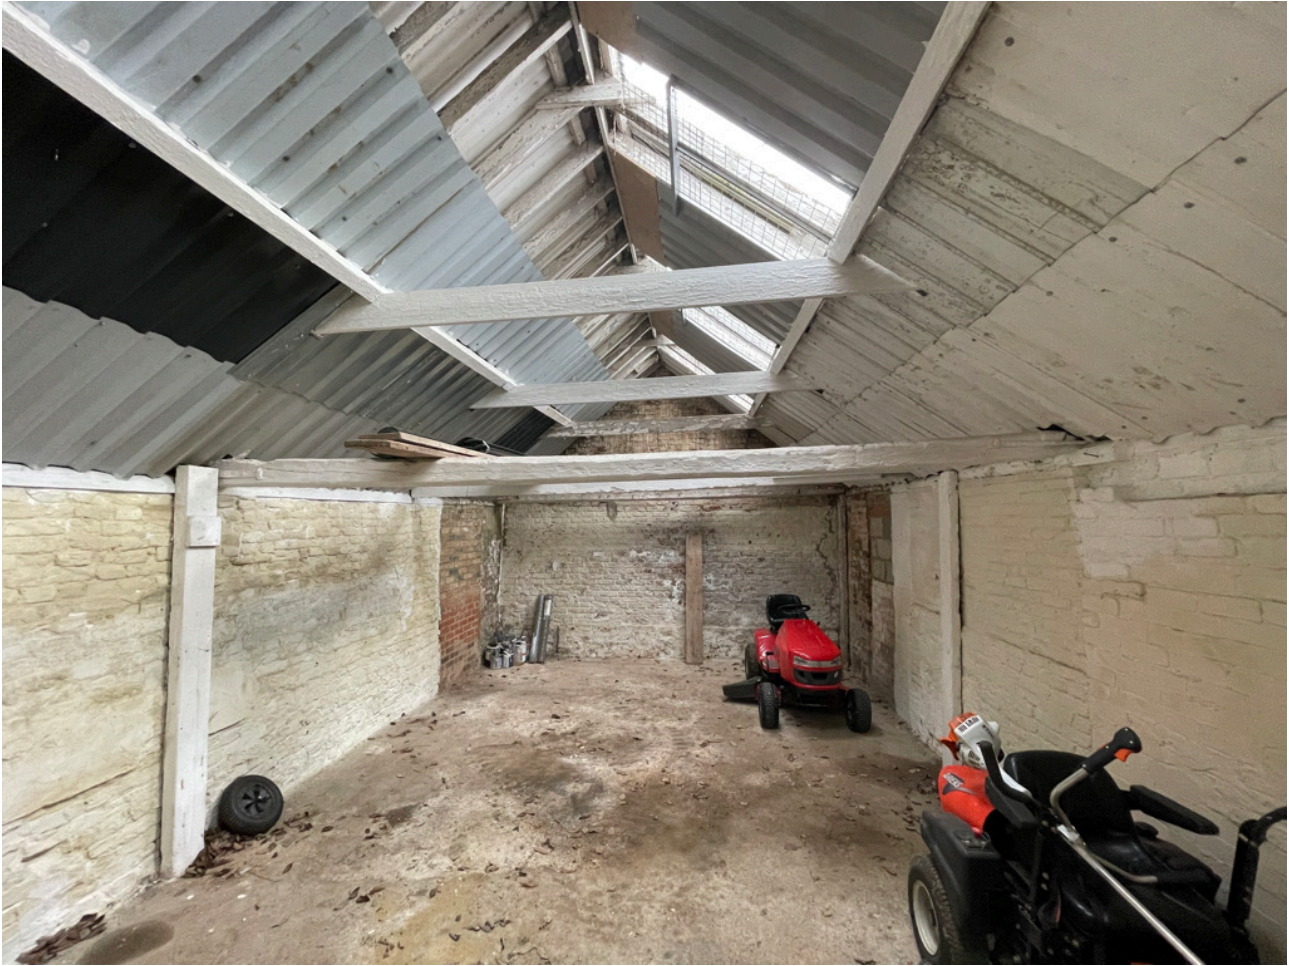
The rear section of the single story barn was found to be formed with a hand cut timber roof with wall plates restrained by large timber sections, set at one third centres, along the length of the barn.

Image 5.0: Rear section of “original” duo-pitch barn

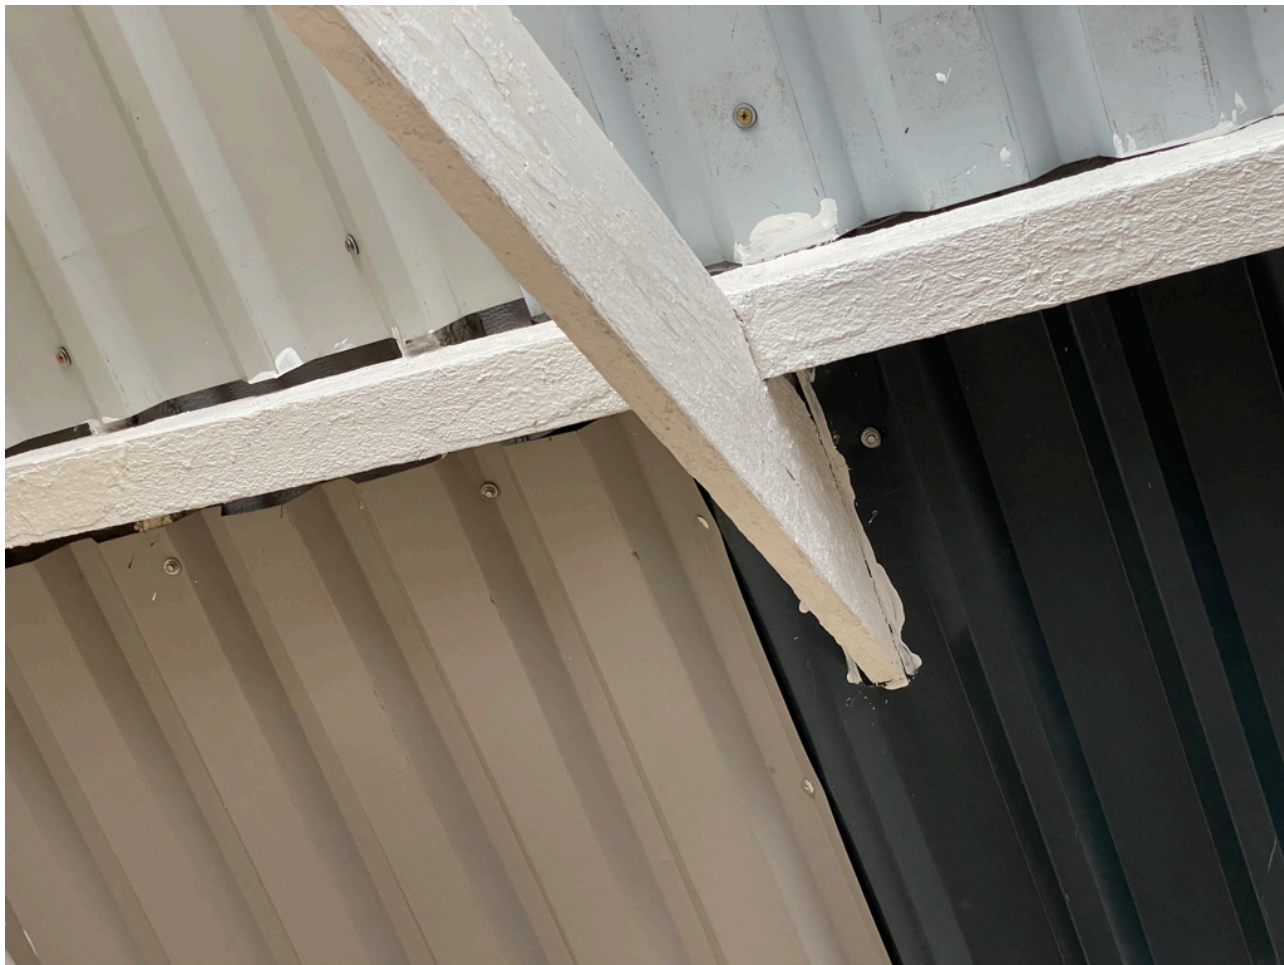
A Purlin runs either side of the pitch roof with ceiling binders correctly set to the underside and notched so as to provide restraint to the purlins, reducing their effective lengths. Rafters, laid to falls run from eaves to Purlin to Ridge-board, with high level stiffeners set to coincide with Purlin binders. Timbers have been whitewashed and ceiling binders incorporate cast-iron restraint straps which are clearly slung over and down the outer face of the wall plate to restrain it. The underside of the ceiling is partially clad in corrugated steel sheeting and multiple roof lights provide natural lighting, internally to the structure.

Image 6.0: Purlin, correctly restrained by ceiling binder

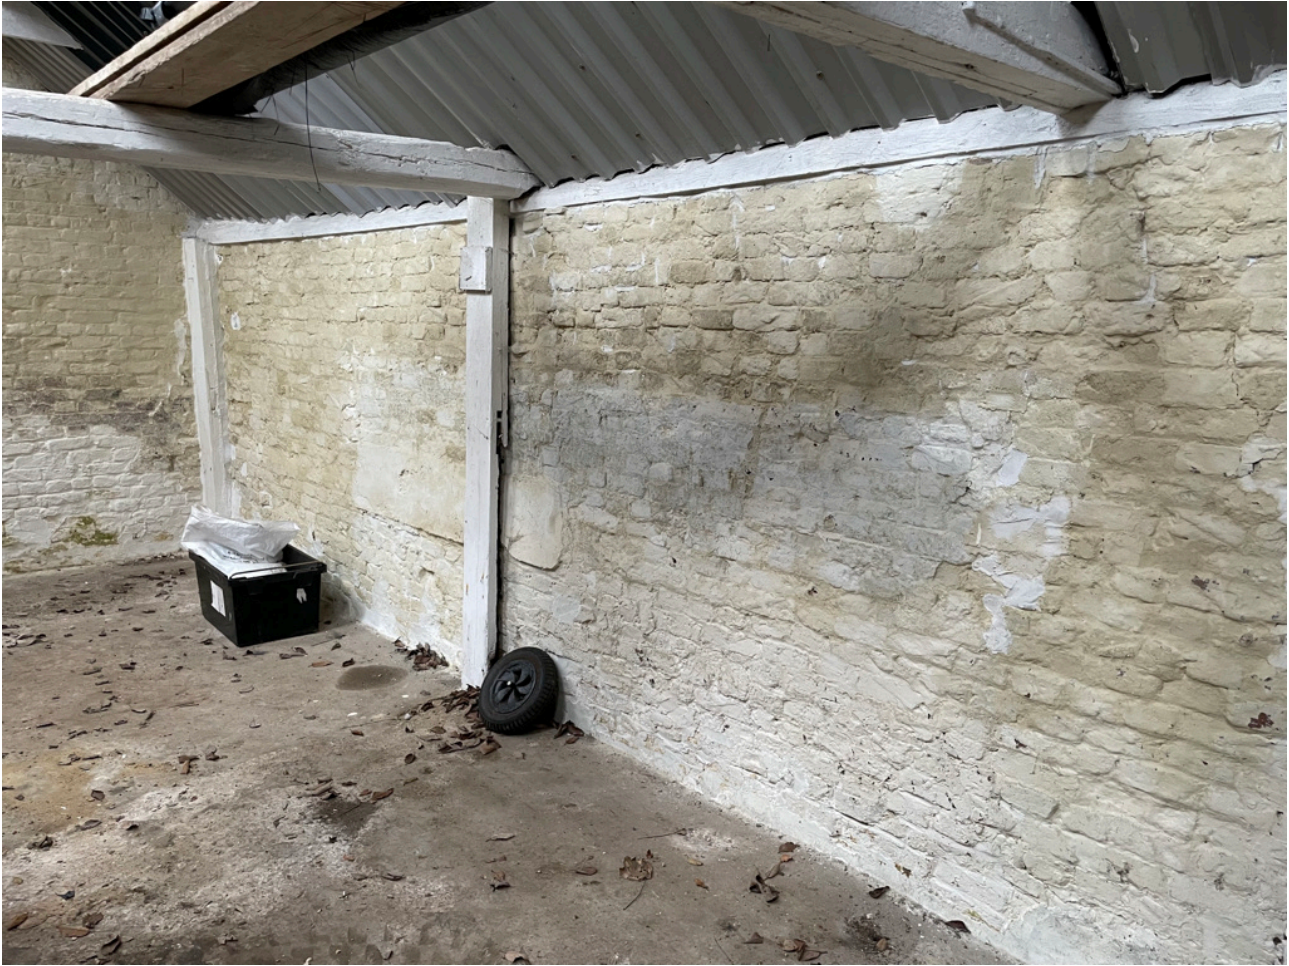
The floor finish, although concrete, is clearly older than that to the adjoining single story barn and some surface erosion has occurred. The slab remains intact and appears Crack-Free with no significant variation in floor level reflecting a slab that has been cast to good ground.

Image 7.0: View of side wall and finished floor

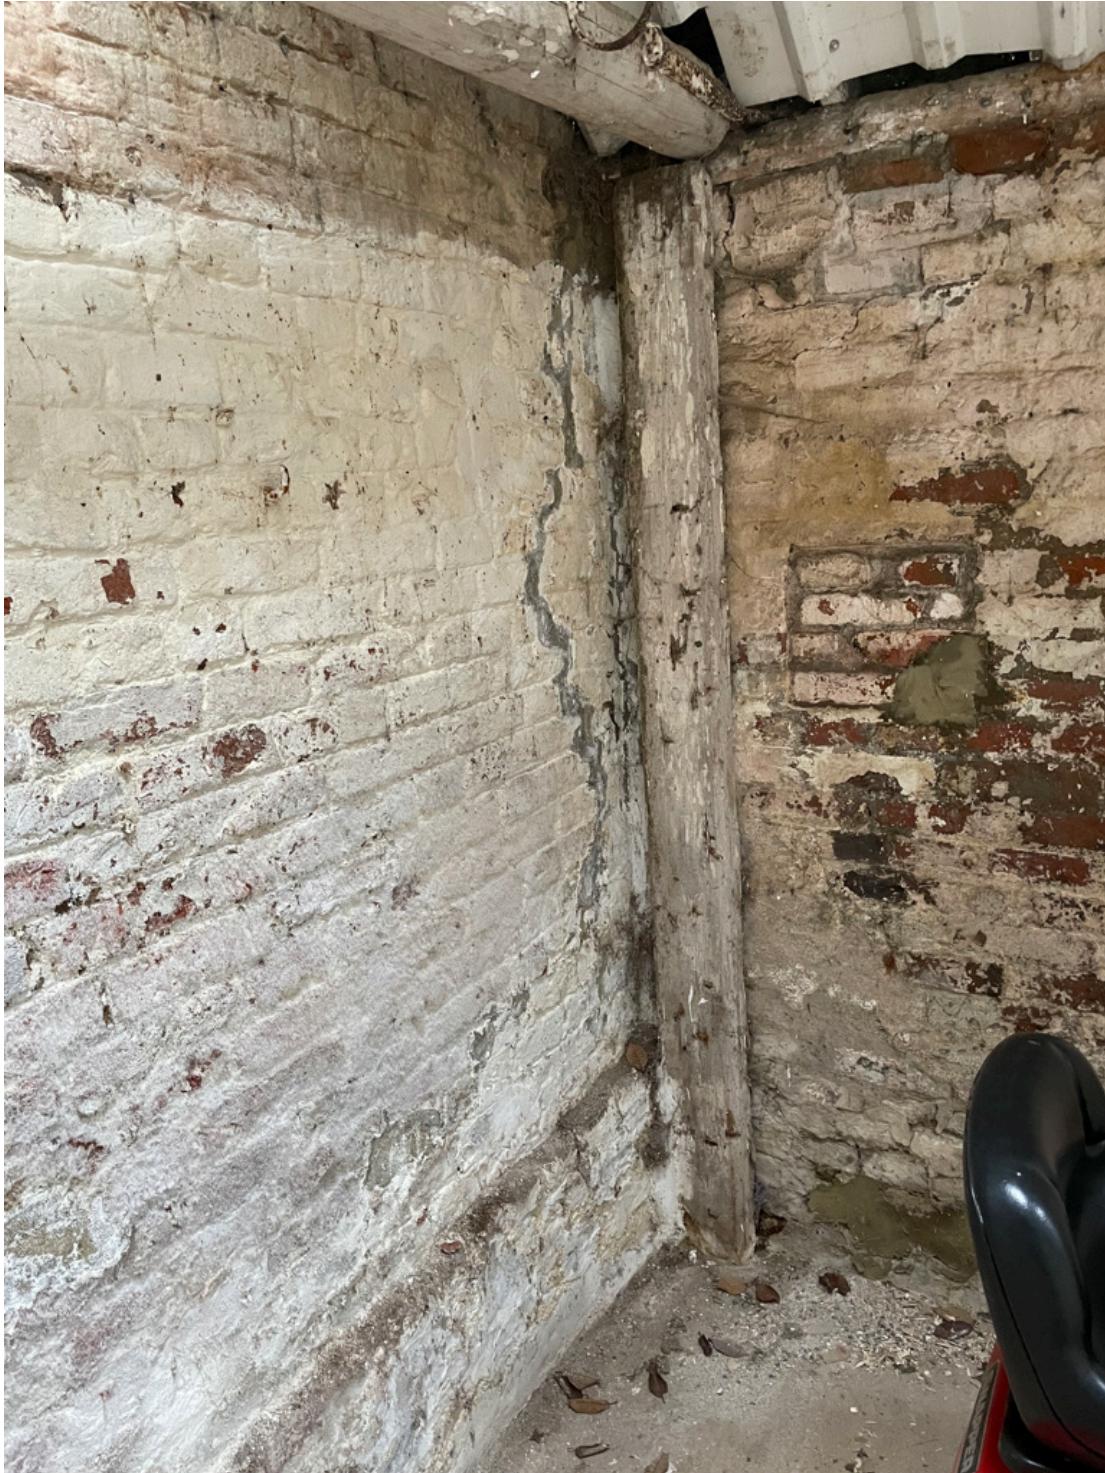
The far gable end was noted as having a crack running local to the corner return with side elevation and whilst it was not possible to discern the cause of this internally, a downpipe set directly outside of this location was found to be draining directly to the ground and has likely resulted in the washing out of fines, causing some limited movement in the structure.

Image 8.0: Crack to rear gable

The crack appears historic in nature with render to the exterior not reflecting the extent of movement that is occurred internally. On this basis, it is considered that the movement is historic and likely not ongoing. The location and size of the crack is not reflective of a defect within the structure and has no direct bearing upon structural elements or their continued functionality in the building's present form.

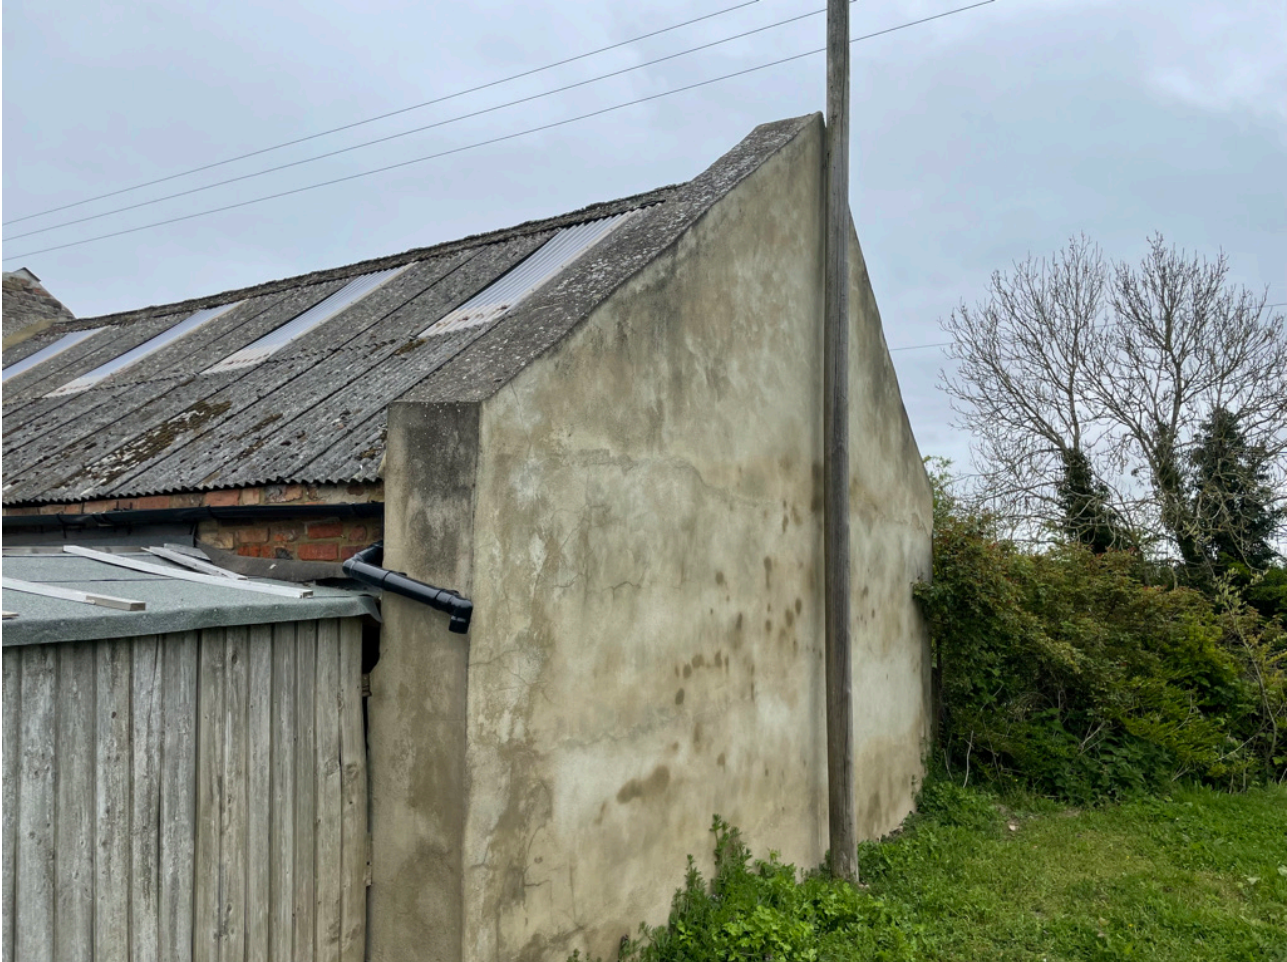
Image 10.0: External view of Gable

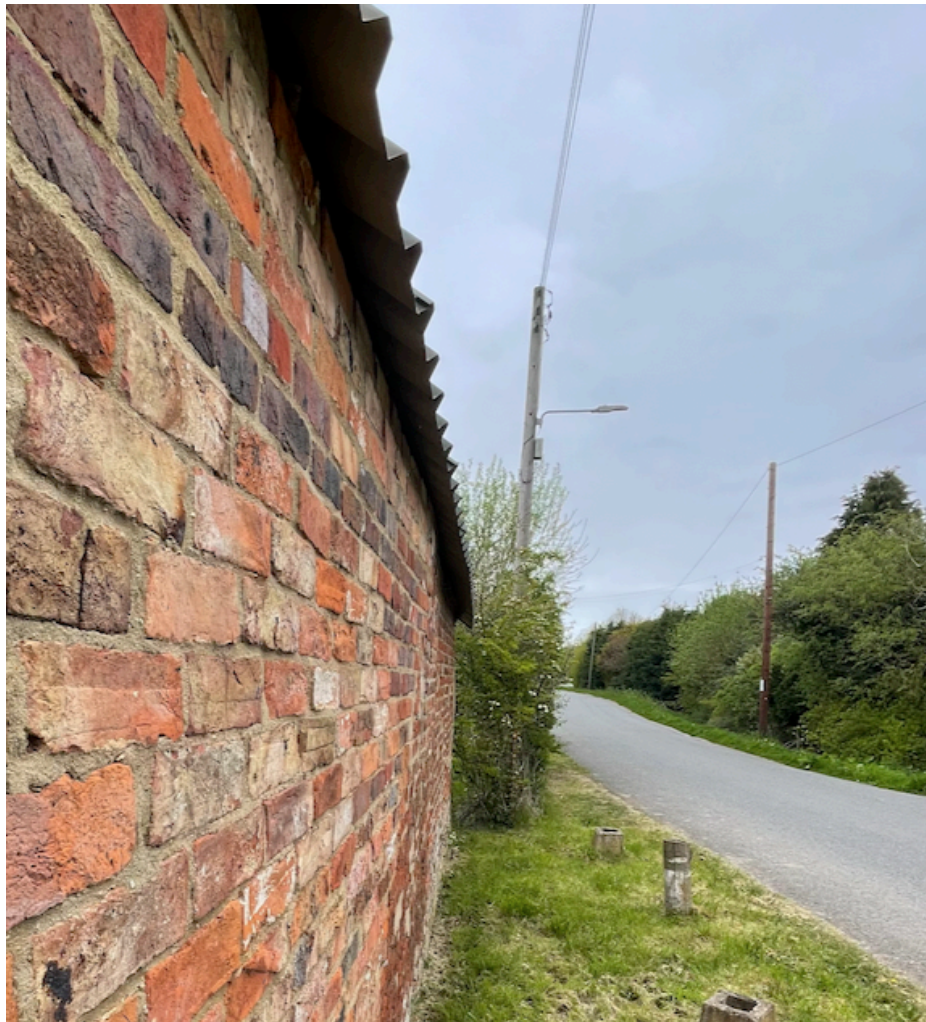
Historic deviation within the wall panel set facing the road was however observed and this is further reflected in the end bearing of ceiling binder relative to wall plate. The deviation however was found to arise local to the large infilled brick arched door opening and is likely the result of combined wind suction on a limited wall panel coupled with poor restraint to the head of the wall panel given the lack of cast-iron strap. Given the lack of recent cracking within masonry and mortar, coupled with weathering mechanisms that indicate historic repair to mortar, it is considered that movement is long-standing and not ongoing.

Image 11.0: Head of masonry deviating outward, local to weaker arch location

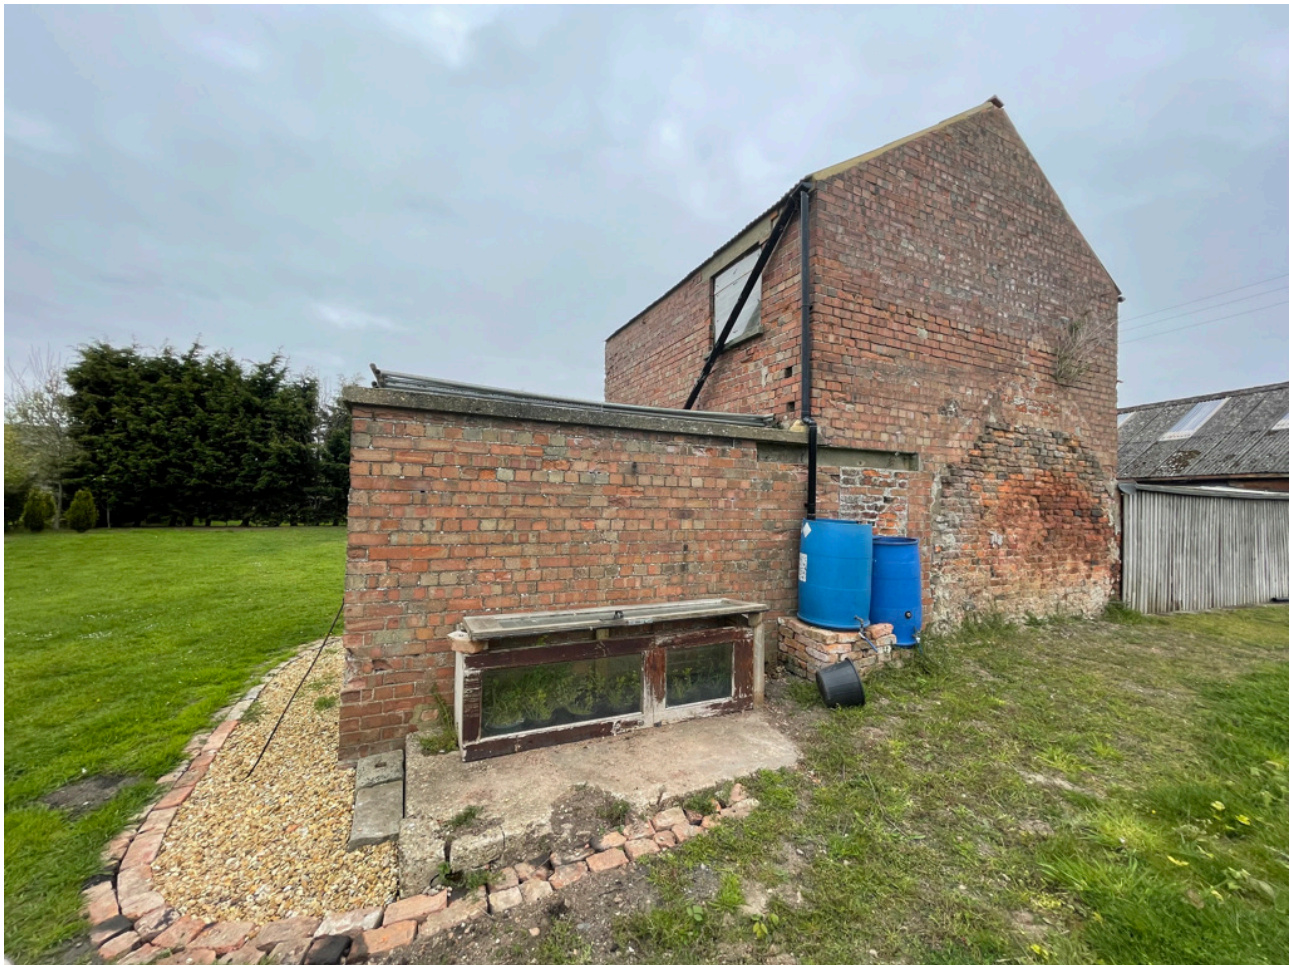
The two storey barn, set within the complex of structures was reviewed with a view to conversion and this was found to comprise a masonry structure rising up to eaves level with solid 9 inch brick walls rising fully to ridge line. A further side extension abuts the building, terminating with flat roof formed local to first floor. The flat roof appears to be formed of a concrete slab, cast in situ and visual inspection indicates that it lacks a watertight finish.

Image 12.0: Two storey structure with single storey extension.

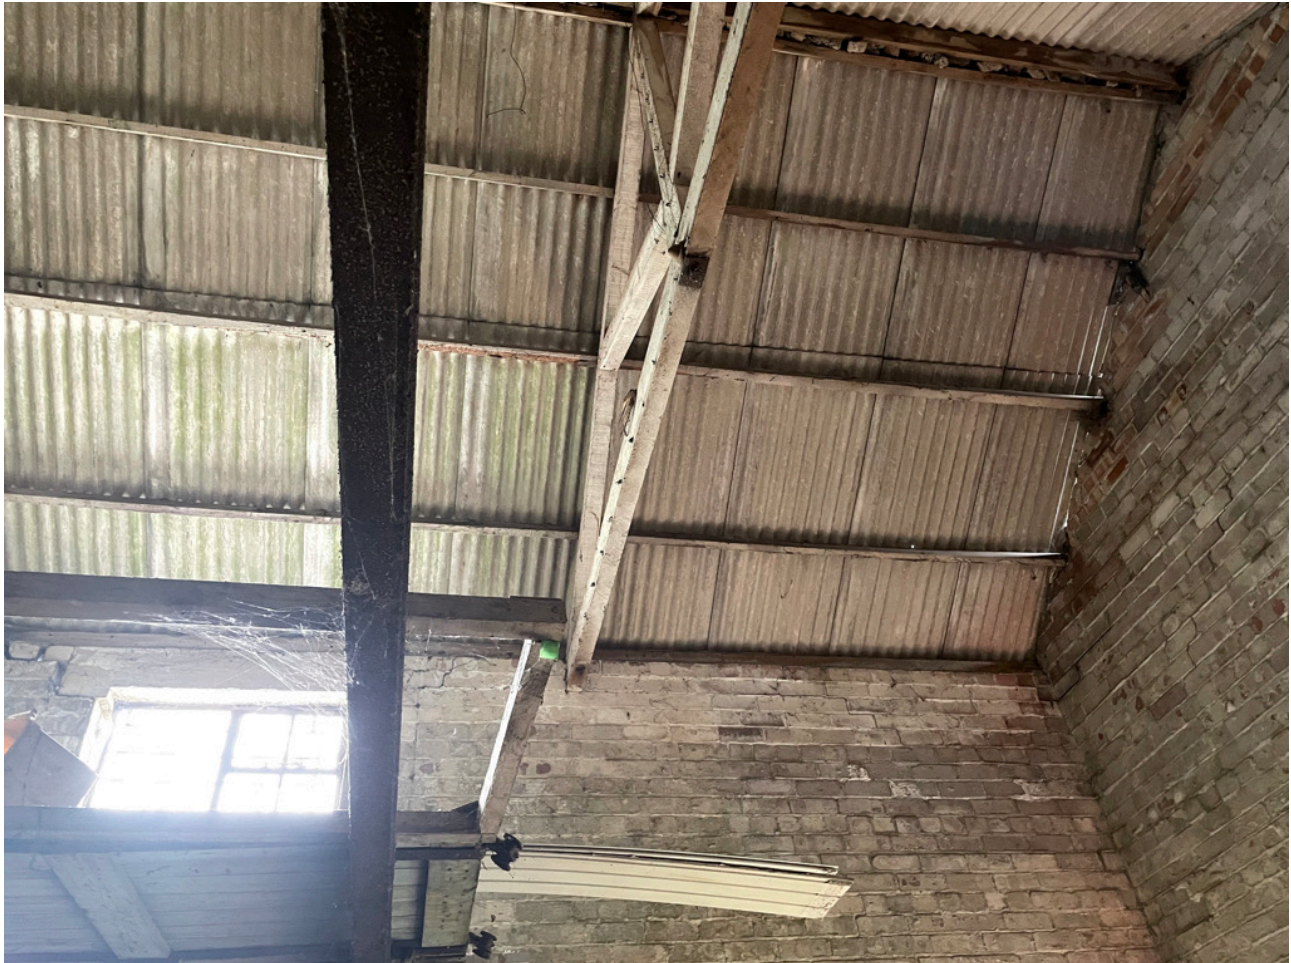
complete condition and continues to function as originally intended. It is noted that purlins have deflected in the plane of the slope and this is likely the result of their slenderness, about their minor axes. The single truss, splitting the span of the purlins remains intact and functioning as originally intended

Image 13.0: Purlins to underside of corrugated cement roofing sheets

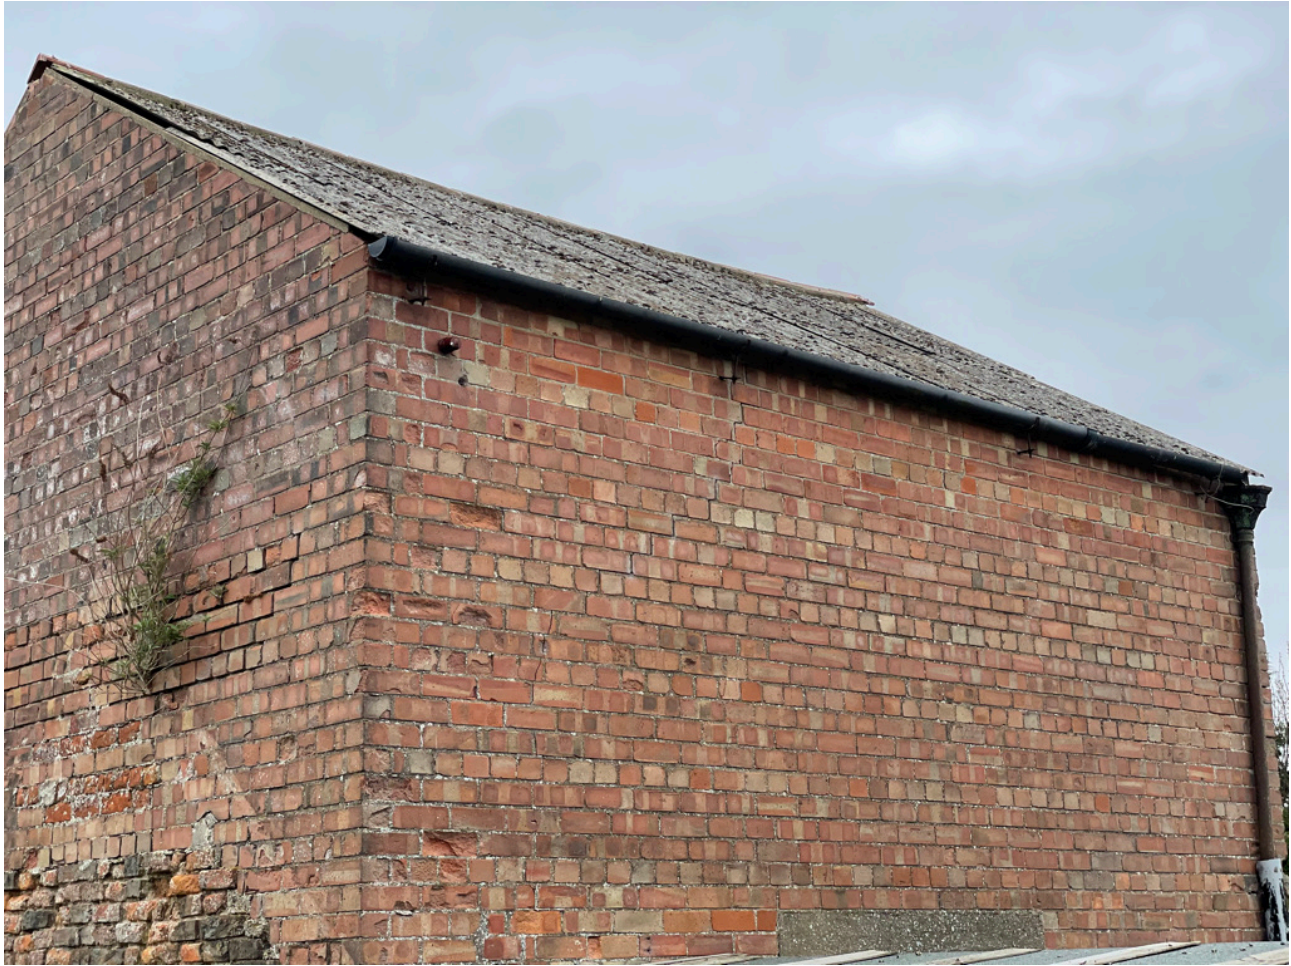
Brickwork was found to be in good condition with deterioration limited to the loss of facing to numerous bricks.

Image 14.0: Spalling to external brick faces

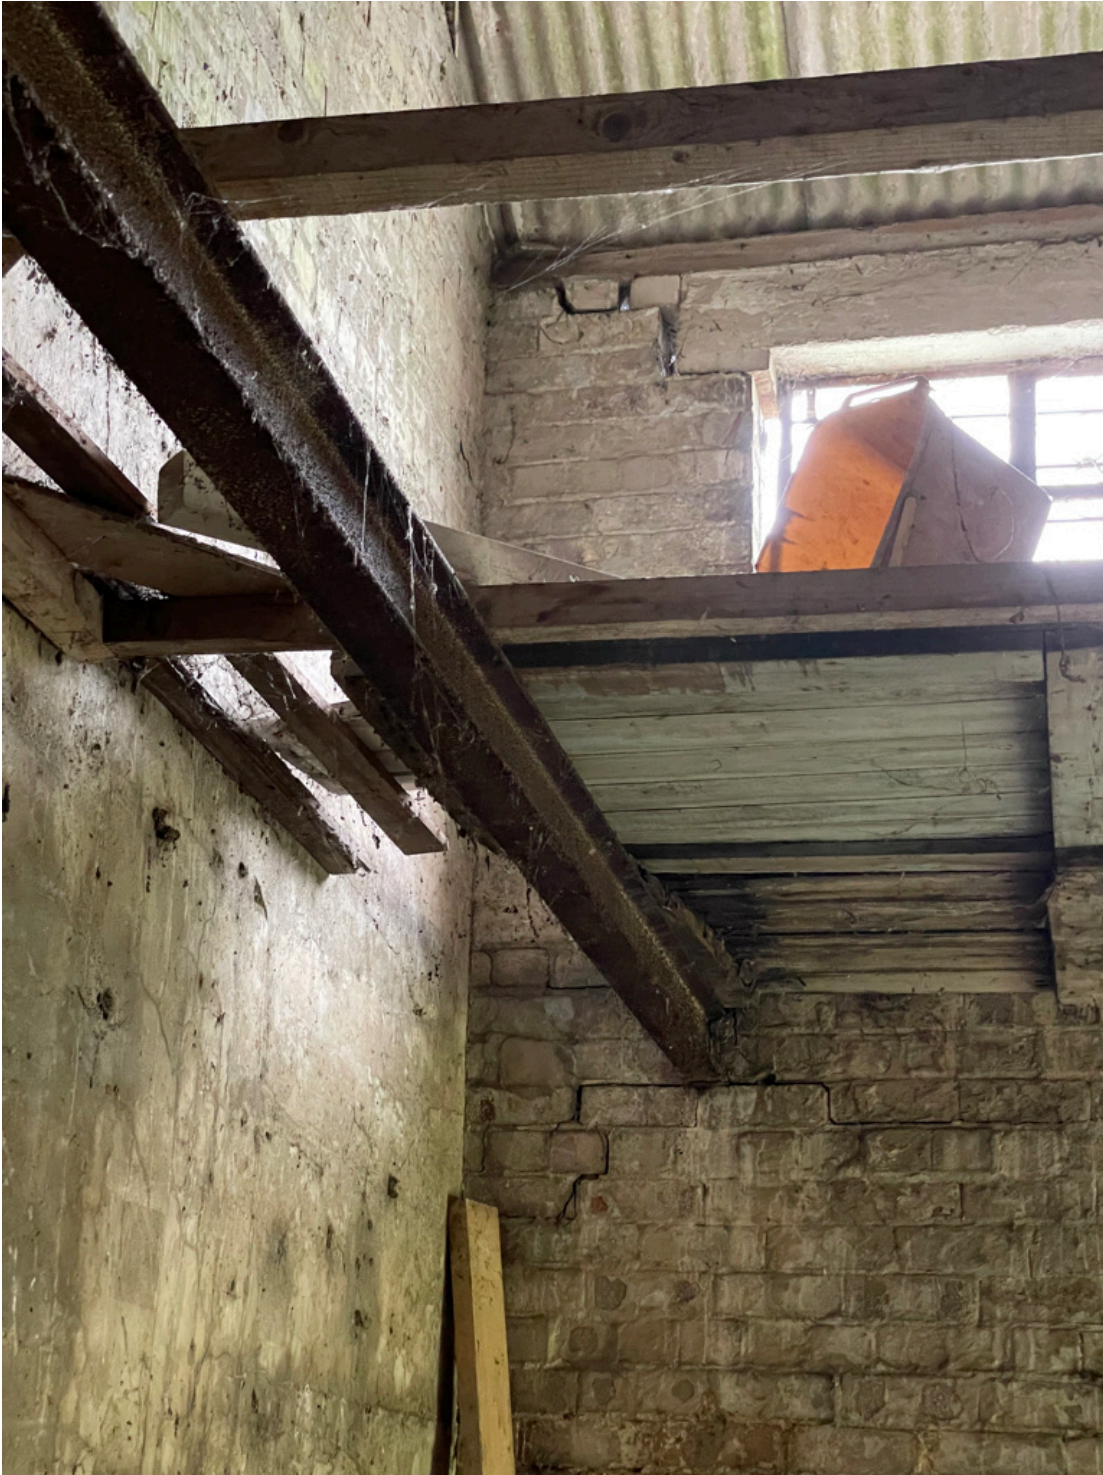
Walls however continue to function as originally intended with no deviation evident, either vertically or sufficiently to the horizontal. One deviation was noted to the rear Gable with a rotation having developed at the corner return with the side window. Movement of the side elevation is evident relative to the concrete lintel set above the first floor window with corner masonry having moved horizontally relative to end bearing.

Image 15.0: Crack to masonry on side elevation, local to single storey structure.

Limited lateral restraint is present within the structure given the limited mezzanine floor installed inside the building and to this end with The window set close to the corner return the stress concentration has developed through weakening within the wall panel and this is allowed for marginal movement in the structure.

Defects within the barn observed as part of the survey do not detract from its continued robustness. Stability is afforded in the vertical plane and the structure continues to transfer all loads into foundations in a correct manner. Cracks to masonry side elevations are limited and given they appear to mirror each other, about the rear gable wall, infer a minor rotation. Crack stitch reinforcement should be employed as a means to reinstate lateral restraint between abutting wall panels. The mode in which the cracks have formed is a reflection of poor restraint, local to a window opening, coupled with a lack of drainage for surface water. The latter should be repaired, so as to remove the primary mechanism. The former may be mitigated via crack stitch reinforcement.

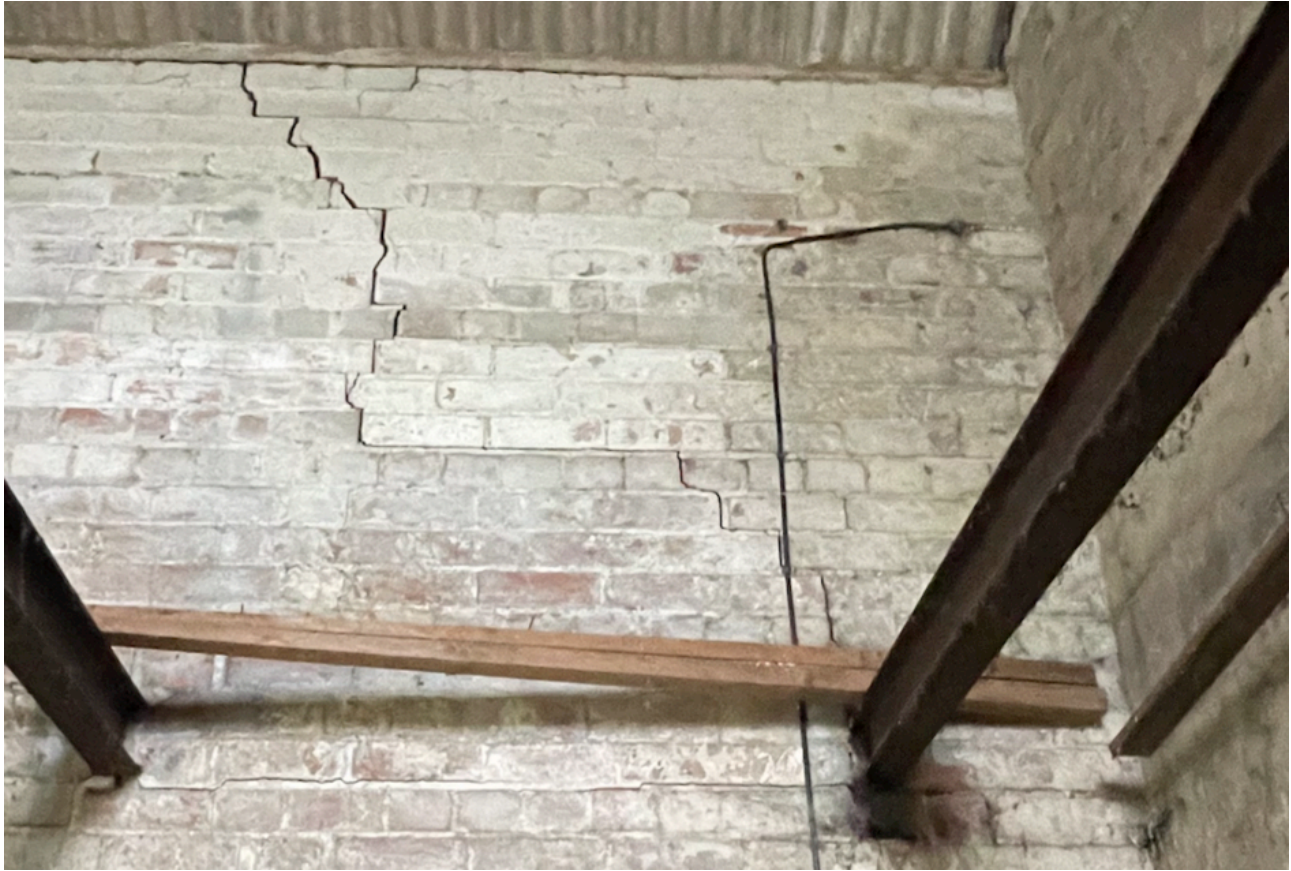
A further limited stepped crack was found to have developed to the opposite side elevation.

Image 16.0: Stepped cracking to opposite side elevation

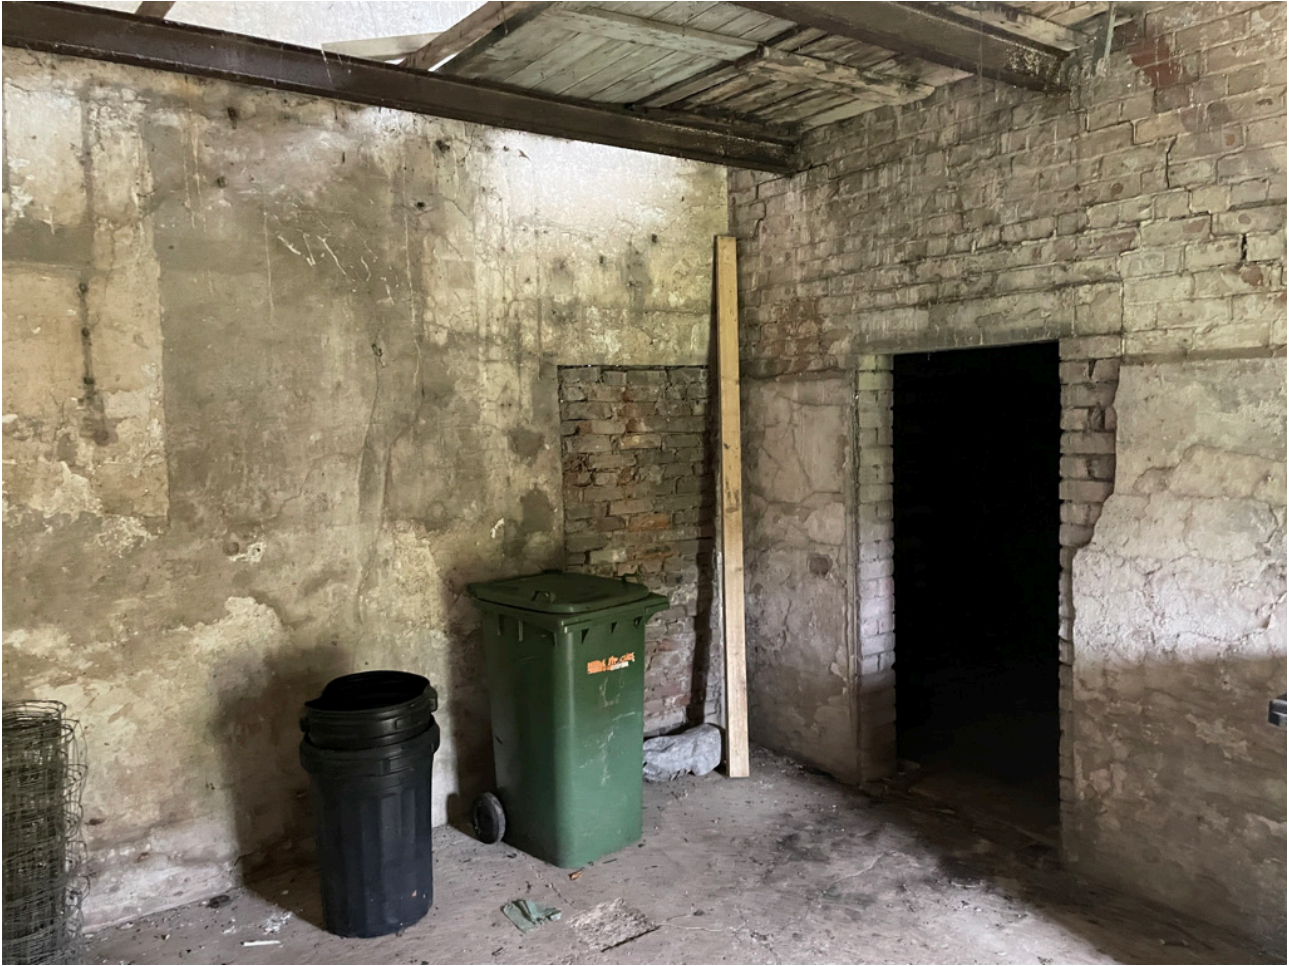
Render was found to have been applied to a number of the internal elevations, with limited hairline cracking and some spalling internally to the finishes. The inference being that the structure has not experienced significant or excessive movement local to ground level, or shifted in such a way as to cause damage or debonding to render, except to the locations identified above.

Image 17.0: Render to internal elevations at ground floor level.
