# ANTHONY-JOHNSON

Old Dairy,  
Harford Gate,  
Gedney Broadgate.

## Overview:

It is proposed that a pair of former farm buildings be converted to residential use and the purpose of the survey was to discern their structural suitability and outline any significant defects that may impair their functionality.

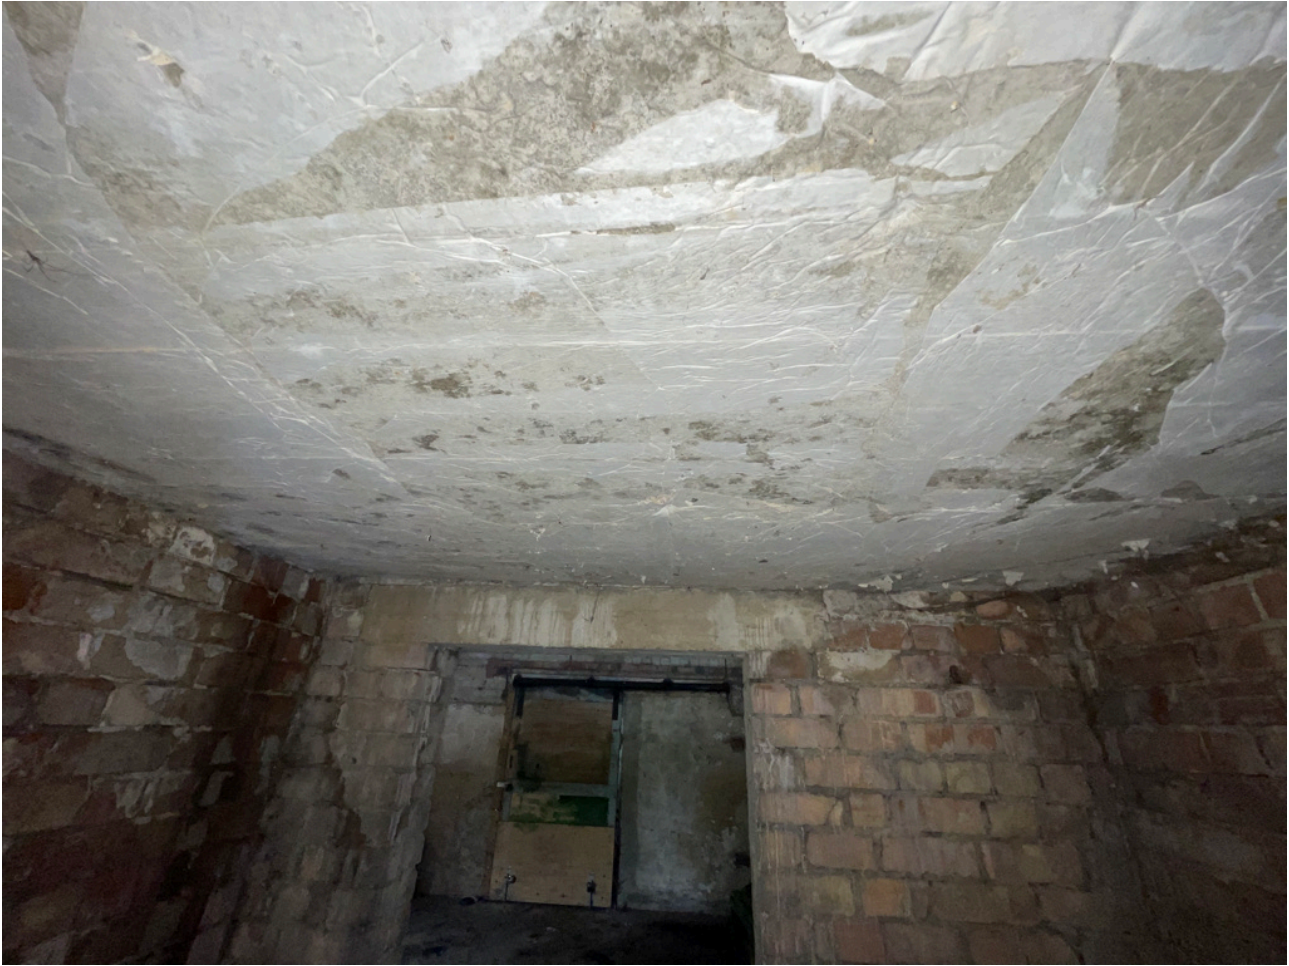
The adjoining single storey extension is noted as not being fully watertight. The flat roof to the structure abuts the two storey structure but lacks sufficient flashing to prevent rainwater from penetrating the juncture between head of roof and underside of supported masonry to opening. This observation is however, not detrimental to the short term suitability of the structure.

Image 18.0: water ingress to lintel set to head of doorway. Note polythene to underside of concrete slab, potentially reflective of a release mechanism for formwork to the cast-in-situ slab.

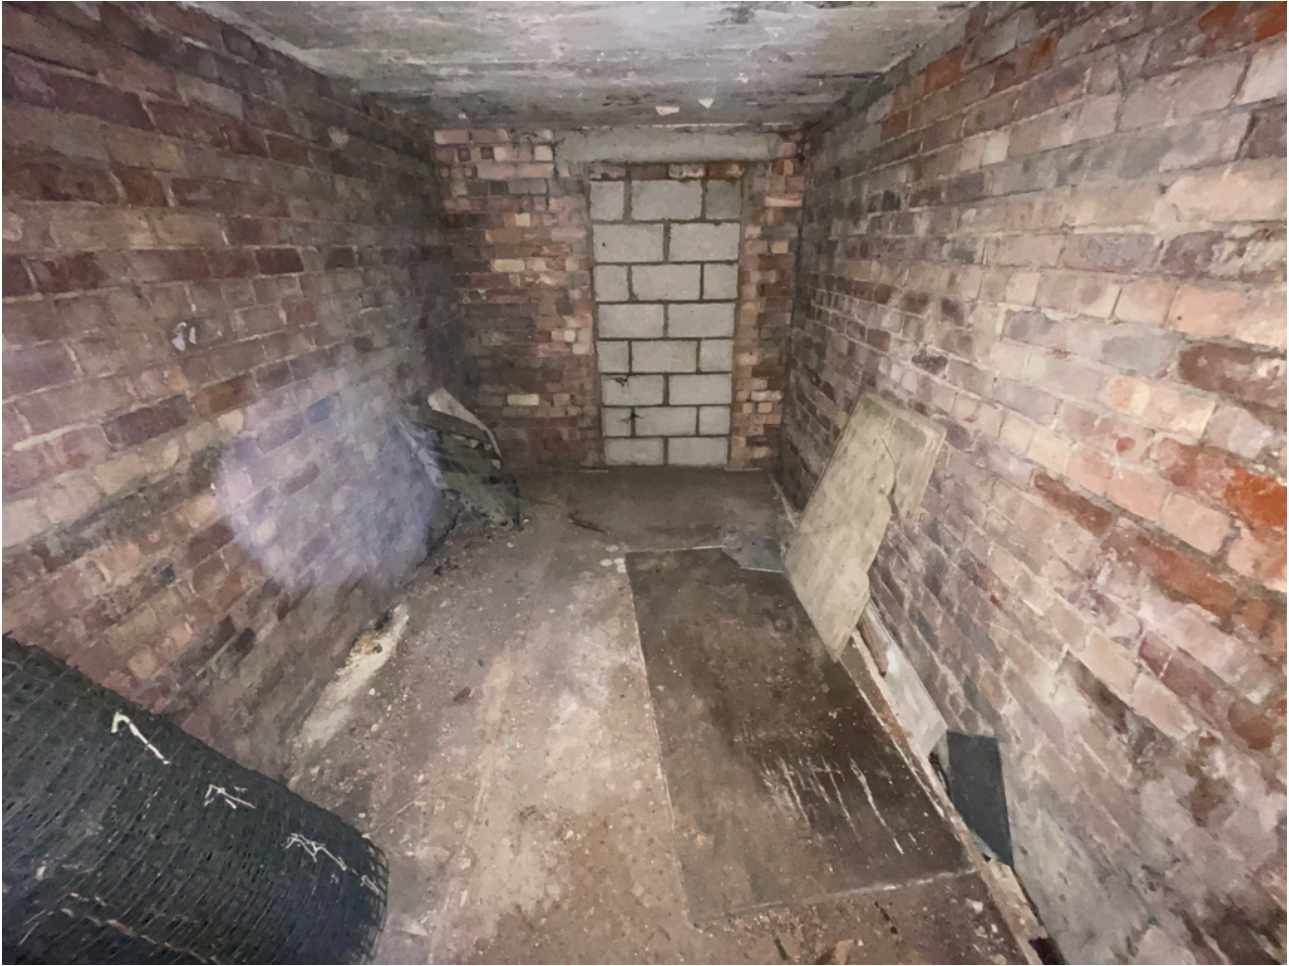
The concrete slab is noted in this instance as being of benefit to the single storey structure through the provision of an additional permanent line load to the head of masonry walls. Brickwork supporting the slab remains in continuous compression, reducing the potential for movement due to the application of the large line load.

Image 19.0: View towards opposite end of single storey section

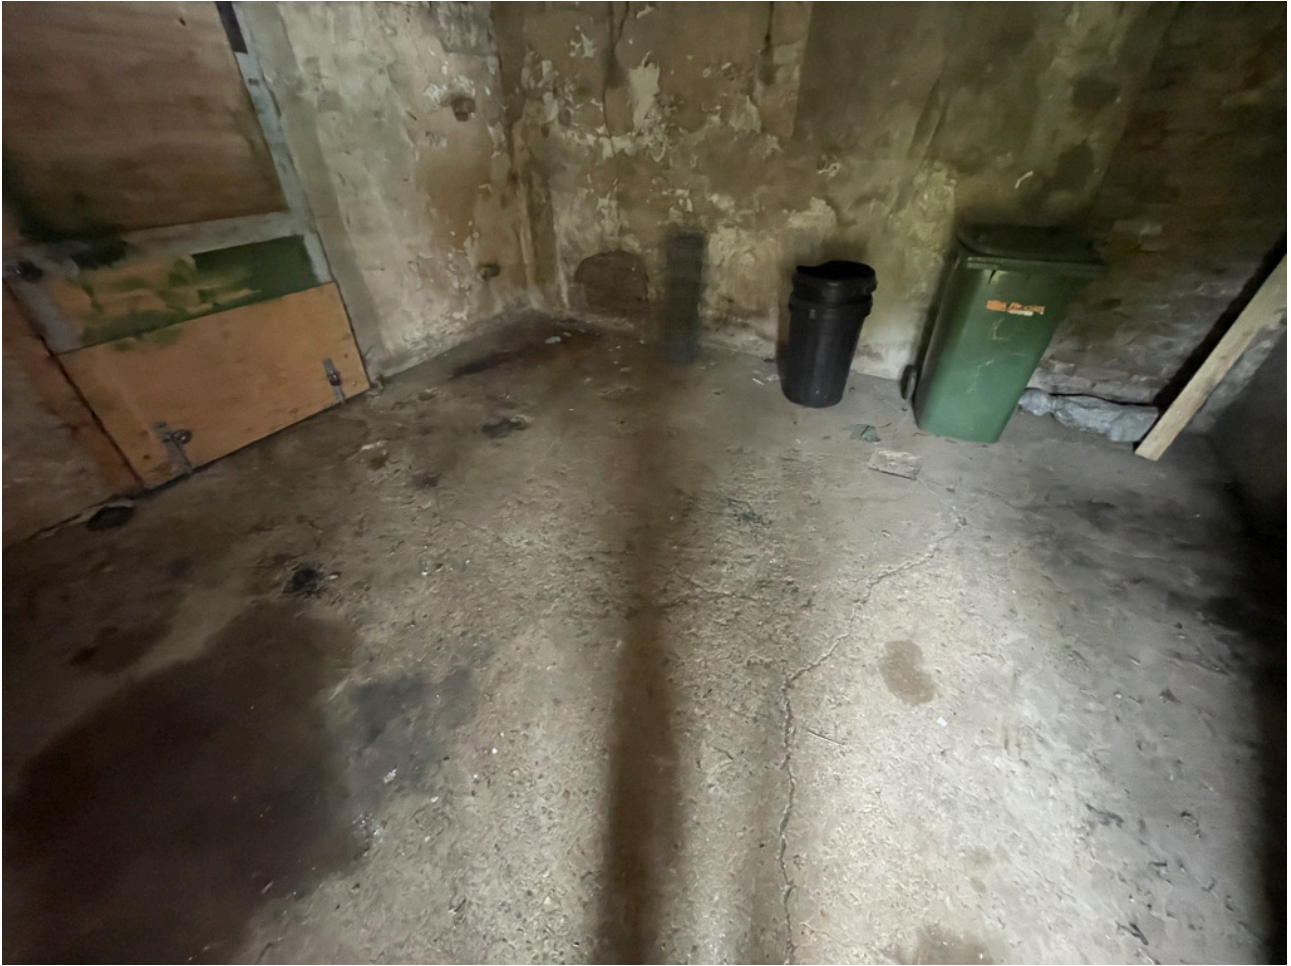
The floor slab to the main section of Barn was again found to be intact. Some wear was observed, with a single crack reflective of limited, long-standing, movement- likely restraint cracking, inherent to large slabs without intentionally formed crack induced expansion joints. Edges to the crack are reflective of movement being historic, with wear to the surface of the slab, local to the crack indicating areas of high traffic. Notably, the weaker smooth cement finish, inherent to cast in situ slabs with segregation upon casting has been worn away to part of the slab, revealing the underlying stronger concrete, with weathering.

Image 20.0: Concrete slab to main barn.
