**Project No. 8467a - BRICK BUILT BARN**

**Ref: Structural Inspection of Brick Built Barn at Broadgate Nurseries, Gedney Broadgate, Spalding**

The purpose of our visit was to undertake a structural assessment of a brick-built barn at Broadgate Nurseries and to subsequently prepare a letter type report to comment on its "fitness for conversion" and will form part of a planning application only.

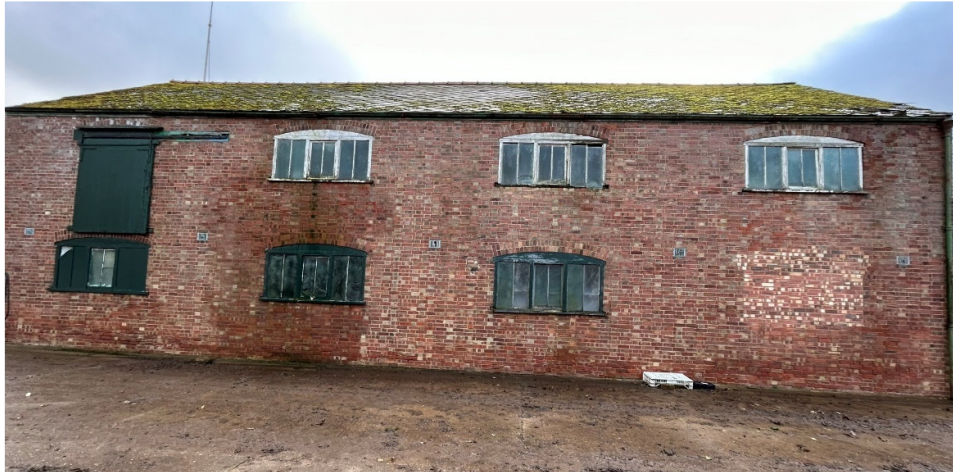
Pic 3 - North-west facing wall (side) Elevation

- The wall is constructed from red brickwork set in a lime-based mortar and is generally plumb.
- It is punctuated by timber framed window/door openings at ground and first floor level. One of the window openings has been infilled
- There are some areas of mild weathering, and the alignment of the brick coursing is good.
- There are a number of orientated/stepped fractures in the brickwork, notably above and below window openings – some of which are in the order of 3-4mm in width.
- There is some water staining partway along the elevation and a decayed timber beam above a first-floor loading door.

Cracks in the masonry walls can be readily repaired and any defective areas of masonry walls made good. Exposed (and decayed) timber beams built into the external walls should be removed/replaced.

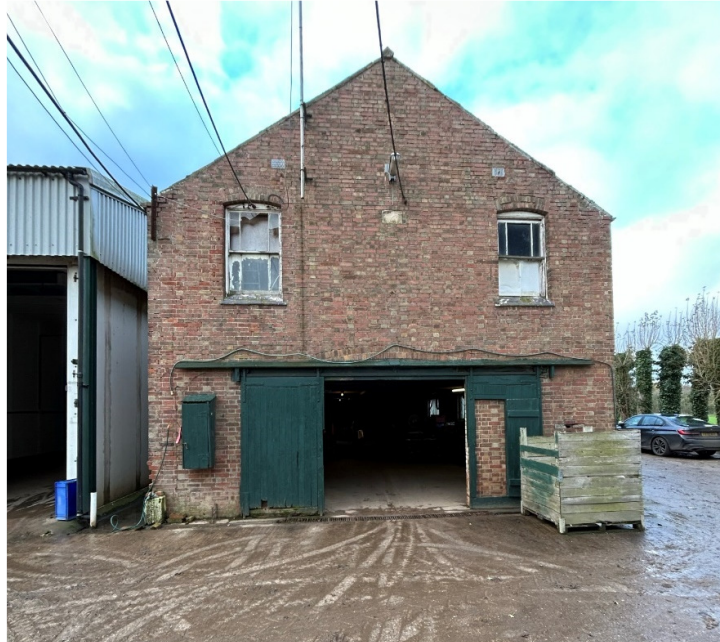
Pic 4 - North-east facing wall (gable) Elevation

- This gable wall is constructed from red brickwork set in a lime-based mortar and is generally plumb.
- This elevation includes a set of sliding timber doors giving access to the ground floor storage area and a pair of arched headed windows at first floor level.
- There is some mild weathering of the masonry on this elevation, but the wall is generally plumb and in good condition bearing in mind its age.
- There is a small area of loose brickwork at eaves level to the left of the elevation and the timber lintel beam above the doors is decayed.

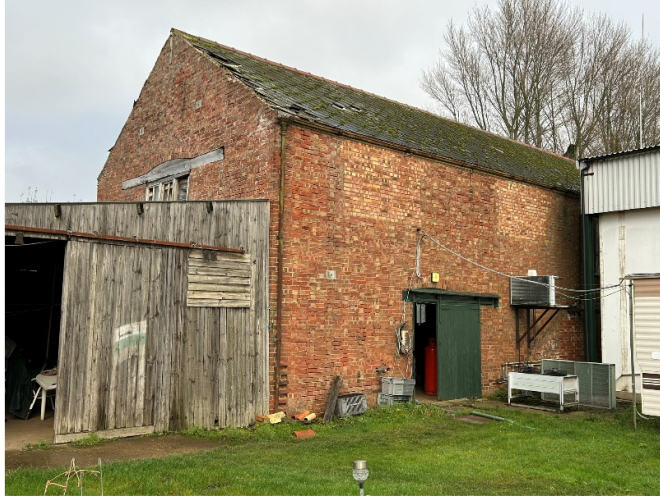
Pic 5 - South-east facing wall (side) Elevation

- Part of this elevation was partially obscured by an adjacent barn
- It is constructed from red brickwork set in a lime-based mortar and is generally plumb with some minor in plane distortion
- This elevation includes a door opening giving access to the ground floor storage area. Window openings have been bricked up.
- There is evidence of previous single storey buildings having abutted this side of the building, but these have long since been removed. Door openings into them have been bricked up.
- The elevation is reasonably well weathered and there are a few spalled bricks.
- Alignment of brickwork coursing is good.
- The timber lintel beam above the door exhibits signs of decay.

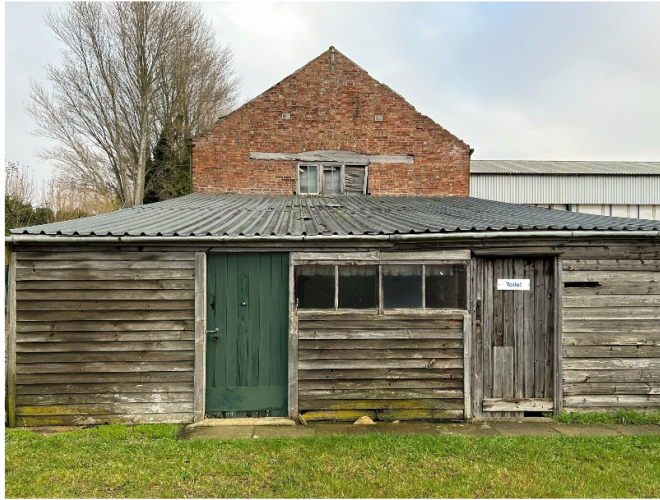
Pic 6 - South-west facing wall (gable) Elevation

- The majority of this elevation is sheltered by the attached timber framed part of the building. The upper part of this wall is exposed to the elements and shows some signs of the effects of weathering.
- There is a timber window serving the first-floor area above which is an arched head. There is also a timber beam built into this wall at window head level, but this is showing signs of decay etc.
- Above the window there is a vertical fracture in the masonry.
- When viewed from within the timber framed storeroom attached onto the end of the building, the brick wall appears to be in good order albeit most of it was obscured from view by stored racking/shelving etc.

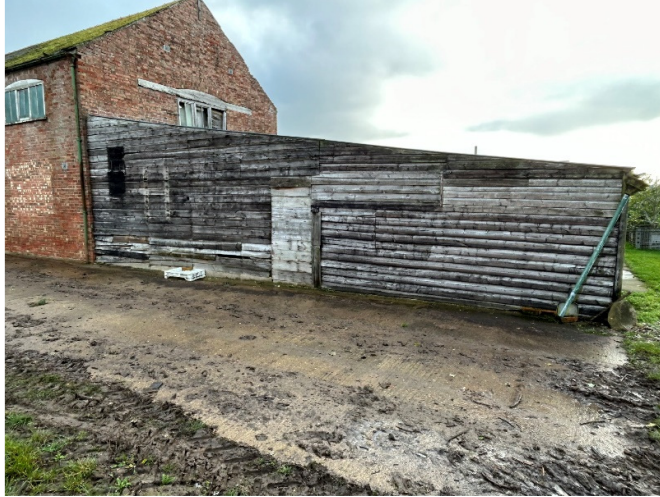
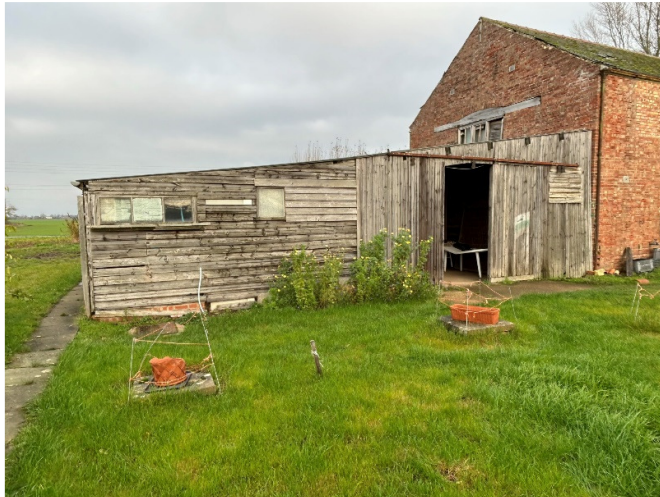
Pic 7 – North-west facing elevation of attached timber storage area

Pic 8 - South-east facing elevation of attached timber storage area

- The attached timber storage area is clad in horizontally laid boarding attached to a timber stud wall.
- The boarding is quite well weathered and there is some evidence of woodworm etc.
- Some decay was noted within structural studwork posts especially close to ground level.

The timber framed part of the building that is attached to the western gable end is, by contrast, not very structurally robust and in its current condition/form would be difficult to prove structurally without extensive repair/enhancement. New roof elements would be required, and the perimeter walls would need to be strengthened to ensure adequate load bearing strength and stability. The floor slab and foundations of this part of the building would also warrant further investigation/assessment.

The timber framed area attached to the western gable end will, as noted above, require extensive structural strengthening works and it may prove to be more cost effective to consider reconstruction of this area.

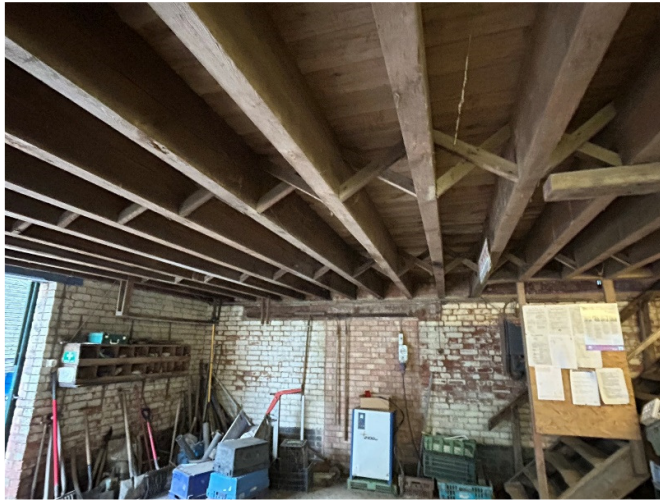
- The visible areas of the concrete floor slab appear to be relatively level and in good condition apart from a few isolated cracks.
- The underside of the first-floor structure can be seen from this level. The first-floor joists are fully exposed and were recorded as 275mm x 75mm timbers spaced at 360mm average c/c spanning the full width of the building (approx. 7.6m internally). Herringbone strutting was present between joists at  $\frac{1}{4}$  points along the joist span.

Pic 9 – Underside of first floor (showing herring bone strutting)

We understand the first-floor area was used for packing/storage and will have been subject to some reasonable loading over its lifetime. The introduction of plasterboard and sound insulation will warrant structural checks on the strength of the joists.

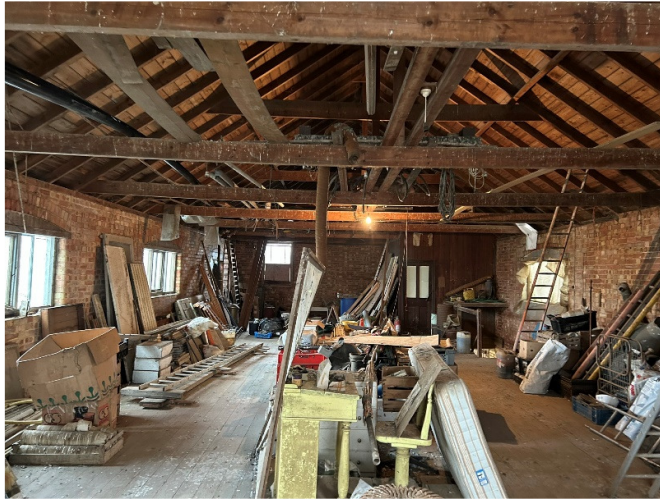
Pic 10 – Roof structure – General view

- The timber roof structure is visible from first floor level.
- This comprises T and G sarking boarding laid over 100 x 38 regularised softwood rafters spaced at approx. 600mm c/c.
- The roof system includes 75 x 75mm square canted timber purlins and 175mm deep collars set at mid span of rafter level.
- Further timber collars are present at wall-plate level spanning across between wall-plates (connected via twisted wrought iron straps)
- The roof appears to exhibit good alignment and is in good overall condition with the exception of some areas of damage towards the southern end of the building where there are holes in the roof.
- Some decay of timber elements was noted at this end of the building.

The roof is covered in a relatively lightweight tile/slate. The introduction of insulations and plasterboards etc will increase loadings and as such some nominal strengthening may be required. Some localised timber repairs will be required but this should be a relatively small percentage of the overall roof structure. Rainwater drainage provisions will need to be reviewed.
