## REPORT

Barns

Manor House Farm, Broadgate, Station Road, Gedney, PE12 0DE

**CCL Ref:** 201549/RP/pmb

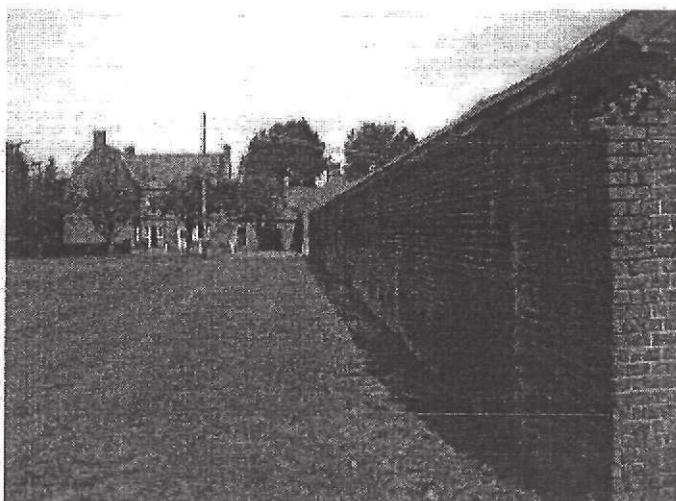
- 4.1.3 The west wall is a long elevation occasionally broken by an aperture. Refer to P2. Some evidence of historic movement to this elevation is present, both in terms of vertical movement and lateral distortion.

2. The West Barn. General view of courtyard area, looking north.

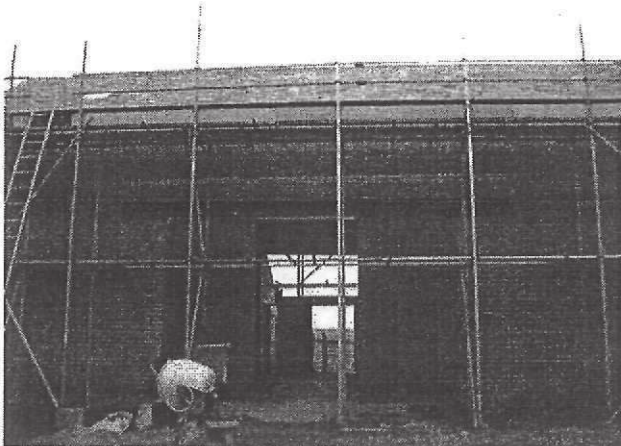
9. The front opening.

- 4.2.1 The barns comprise a two storey main barn to the centre, with two smaller single storey structures which are adjacent to the main building.
- 4.2.2 The central main barn is in very good order. Recent improvement works have substantially improved the condition of the barn. Refer to P9, 10 and 11. In general, the improvement works have included a complete re-roofing programme, together with roof timber repairs as necessary. Brickwork repairs have been undertaken in places.

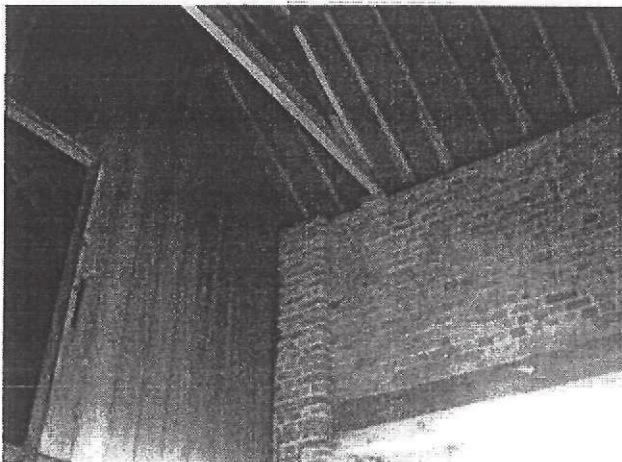
- 4.2.3 The roof structure has been enhanced with the addition of new tie beams, to connect the wall plates together. This is shown on P10. We have no knowledge as to the precise manner of fixity, however we are aware of the Contractor and have confidence that a robust construction method would have been utilised.

10. Roof construction to the North Barn. Note the remedial strengthening works undertaken, with the addition of a tie member.

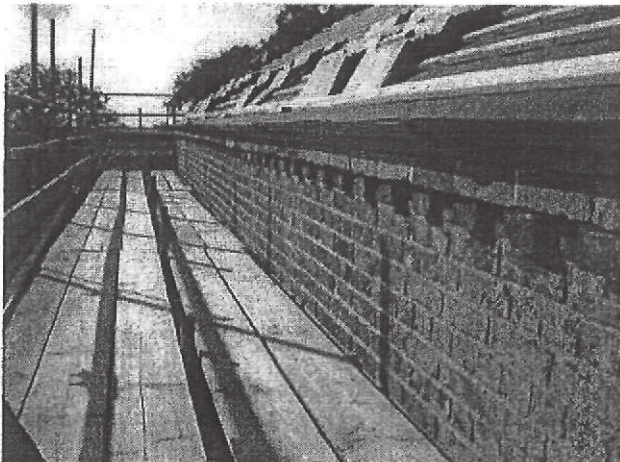
- 4.2.4 The brickwork at eaves level has been repaired and reconstructed in places. Refer to P11. We also understand that the eaves beam / wall plate has been strengthened and repaired in places.

11. The south wall of the main barn. Note the masonry repairs undertaken adjacent to eaves level.

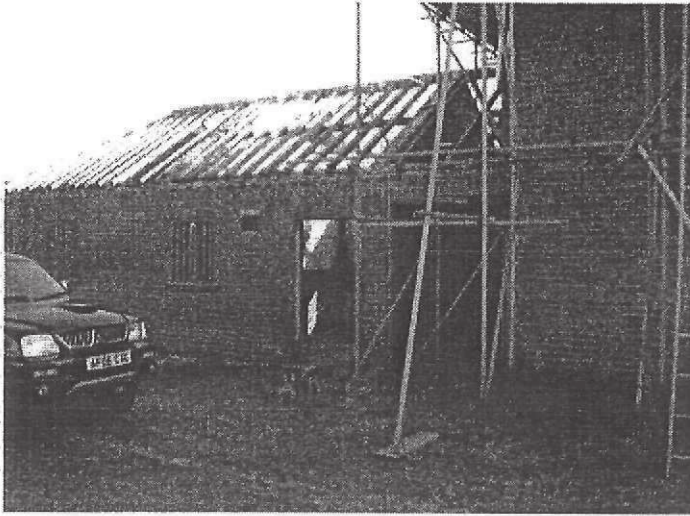
- 4.2.9 The east addition to the main barn is presently in poor condition. The roof timbers are exposed, with no slate covering to the roof. We suspect that the barn has been in this state for many years. The brickwork and structural elements have therefore been exposed to the elements which will only encourage their deterioration.

- 4.2.10 In the temporary condition, the roof structure to the east addition is helping to provide temporary support and stability to the remaining structure. We would therefore suggest that the roof skeleton is retained until such a point as the proposals can be implemented. It is likely that at some point in the near future, further temporary works will be required to ensure stability.

12. North wall of the main barn and North wing. Note the remaining rafters to the wing, which act as props to the remaining masonry.

- 4.2.11 In terms of permanent repair, we would suggest that the roof structure to the east addition will need to be entirely reconstructed. In addition to this, brickwork repairs and strengthening will inevitably be required.

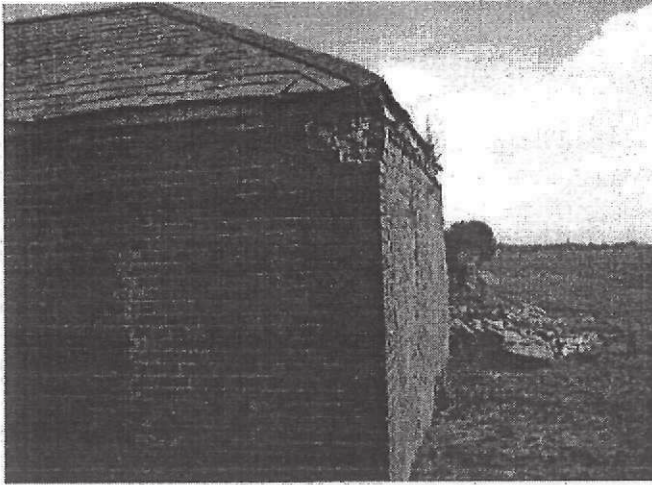
The corners represent foundation movement and an indication of the slight rotation to the west wall. This is evidenced on P15, with a severe vertical and diagonal crack. Some evidence of brickwork deterioration is present, for example this is shown on P14. We would suspect that the deterioration has been encouraged by the lack of rainwater goods.

14. The north corner of the west barns. Note the high level damage to the brickwork and the lack of appropriate rainwater pipes or gutters.

- 4.1.6 We would suggest that a degree of masonry repair / reconstruction will be required. This may also be supplemented and enhanced by the introduction of masonry reinforcement. It would be advisable to incorporate a degree of lateral robustness to the Architectural proposals, in terms of dividing walls and framing to stabilise the west wall.

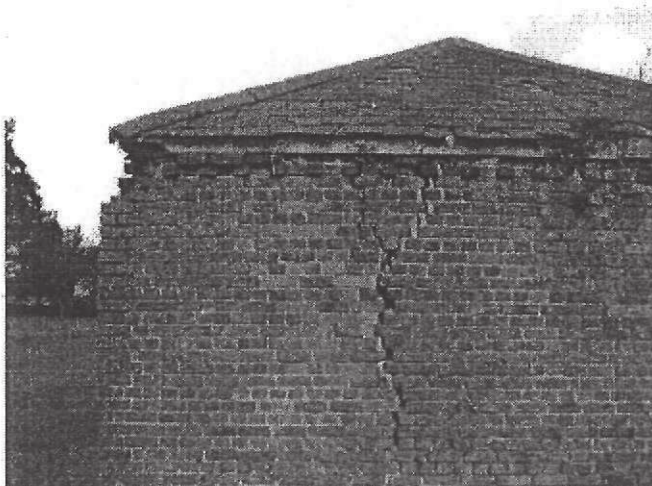
15. The south wall to the west barn. Note the vertical crack, indicating rotational movement to the west wall.

- 4.1.5 The brickwork condition to the West Barn is generally good, although there are areas of deterioration which one would expect for a structure of this type, age and previous usage. Refer to P21. We would suggest that a degree of foundation enhancement / possible underpinning will be required, particularly to the corners. Depending on the findings of future ground investigations some underpinning to the west and east walls may also be required.

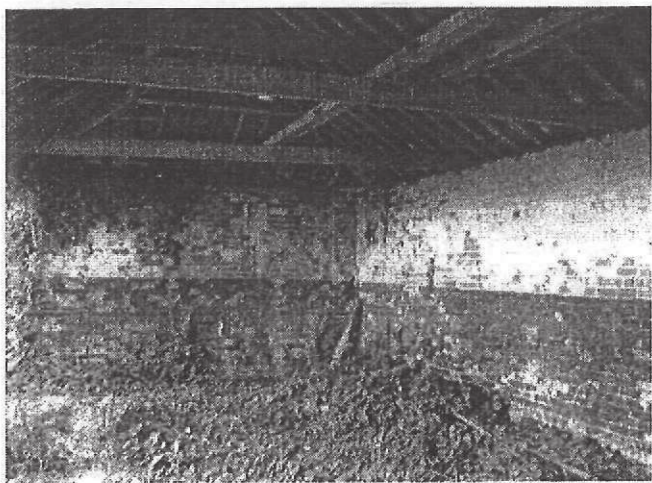
The roof structure is shown on P16 and 19.

16. Internal view of the south wall of the west barn. The aforementioned crack is also depicted internally.

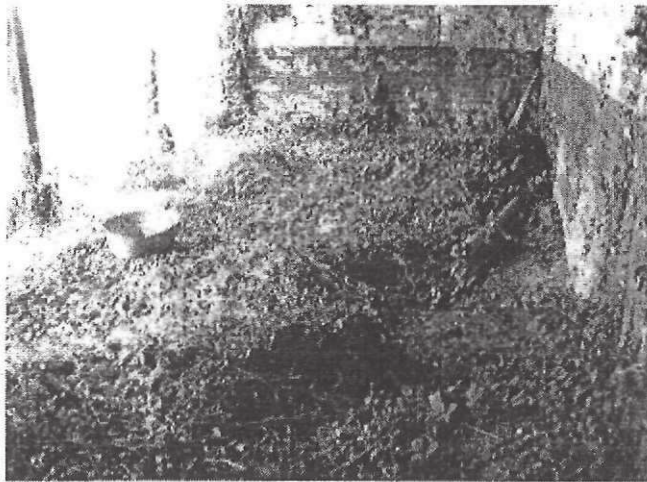
The ground floor varies to the west barns. In the southernmost bay, no obvious floor structure is present. A concrete slab is present in places, as is a brick tiled floor.

17. Note the ground / floor construction to the south bay of the west barn.

- 4.1.7 We would suggest that lintels should be replaced and strengthened where appropriate. The floor slab to the barns should be reconstructed throughout.

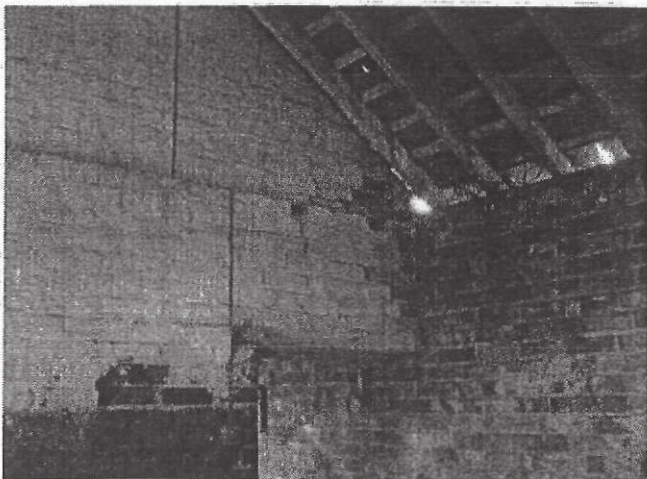
- 4.1.4 The West Barn is divided into a series of smaller units. The separating walls are constructed of solid brickwork which extends full height to the roof. Access between the rooms is provided by a door opening adjacent to the west wall. This opening position has encouraged the rotation and separation between the internal dividing walls and the west wall, resulting in movement to the brickwork above the doors, further compromised by what we foresee as inadequate lintels.

This is shown on P18.

18. Door opening between bays to the west barn. All door openings are positioned adjacent to the west wall; this has resulted in a removal of robustness which has encouraged the rotation. The result is the cracking and separation shown.

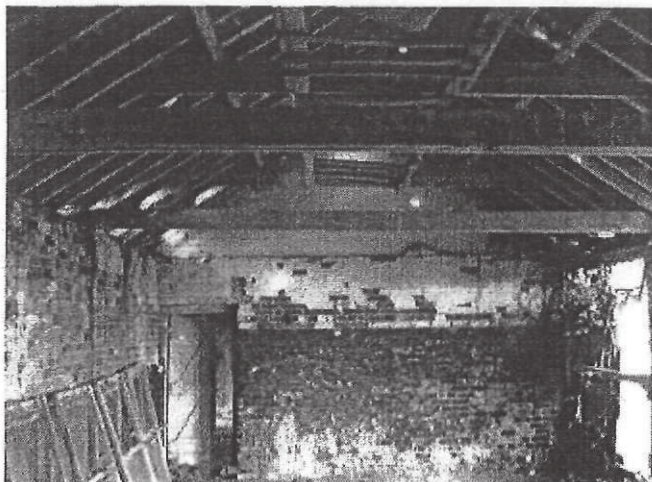
- 4.1.2 The roof structure is generally in a condition one would expect considering the age and lack of maintenance for many years. Inevitably there will be a requirement to replace and repair structural timbers.

The true condition of the roof structure can only be established once the roof is stripped and a full inspection is undertaken. We would expect the wall plate to require a degree of attention, and the eaves support to the open east elevation will require replacement, as will the posts. As a general assessment, we would suggest an allowance of 30% of the structural timbers will require replacement.

19. General view of the west barn, looking north. Note the tied roof construction, with tie members at regular centres.

Depending upon the final architectural proposals, some strengthening will be required to ensure that the roof structure accords with current requirements and the Building Regulations. This will be established following the detailed design stage and further to exhaustive elemental inspections.

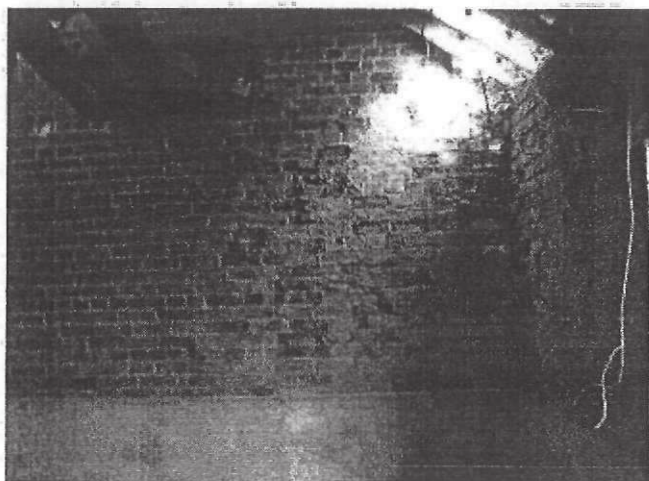
21. The northernmost bay of the west barn. Note the significant brickwork deterioration.

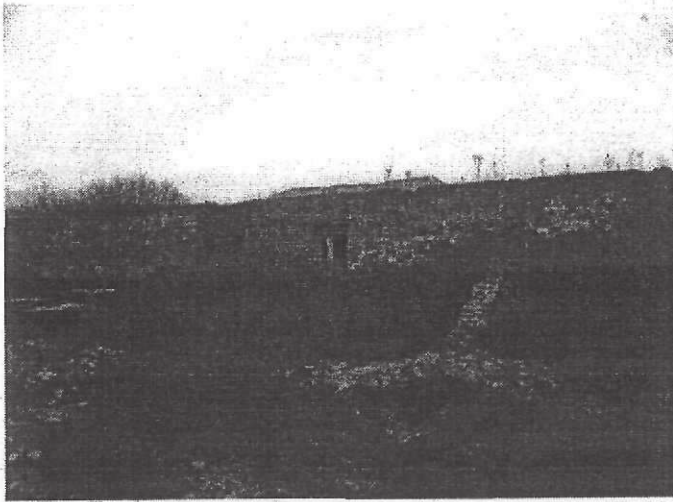
- 4.3.1 This range of barn structures is presently a series of remaining walls, as can be seen by photographs P22 to P24.
- 4.3.2 The condition of the remaining walls is reasonable given their exposed nature, however inevitably a significant degree of repair and reconstruction will be required to enable the existing walls to be incorporated into any proposals.
- 4.3.3 We would recommend that the original (mostly demolished) internal walls are slightly enhanced to provide an increased buttress. This will provide additional buttressing to the long east wall,

22. General view looking east.  
Note the remaining internal wall which is providing stability by virtue of acting as a buttress.

and prolong the walls in their current condition. Some temporary works will be required in time, depending upon the programme for repair.

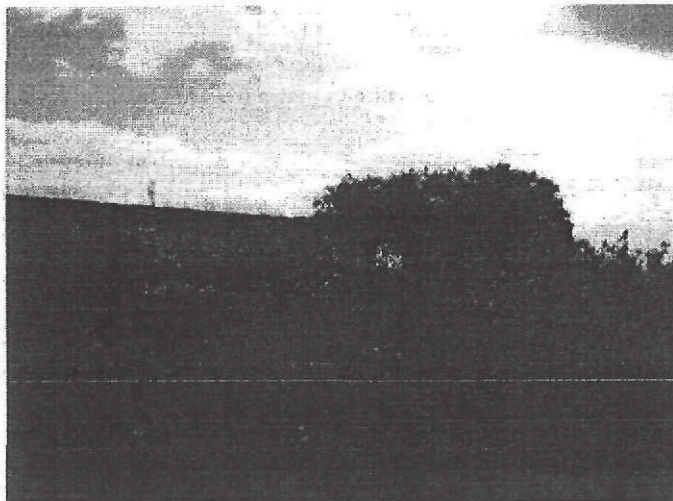
23. Continuation of P22.  
Remaining internal walls acting as buttresses.

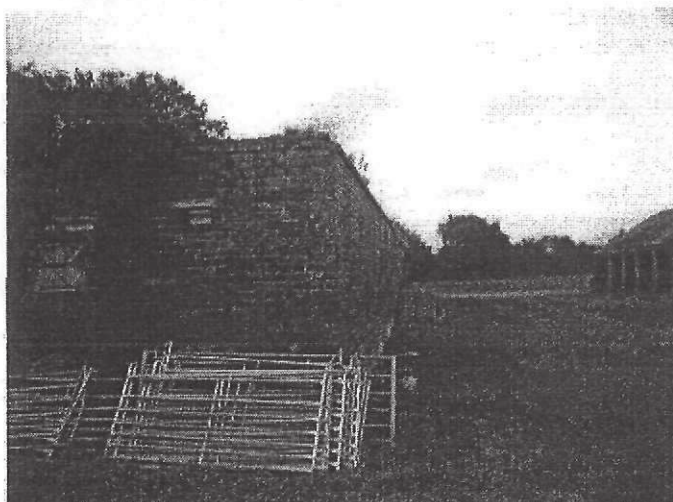
24. View of east wall looking north.  
Note minimal rotation.

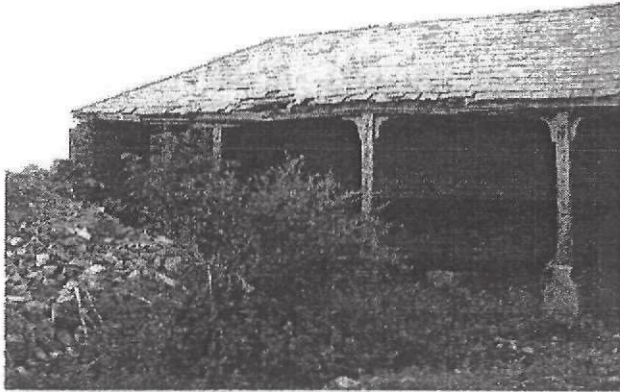
4.4.2 The roof structure is generally in reasonable condition. There are areas of deterioration, as one would expect. A degree of repair and strengthening will be required to the roof structure, particularly concerning the eaves member and posts (which will require replacement), together with we expect, the wall plates. We would also suggest that in the order of 20% of the common rafters will require replacement.

25. General view looking east.  
Note the obvious distortion at  
eaves level and the  
deterioration of the roof slates.

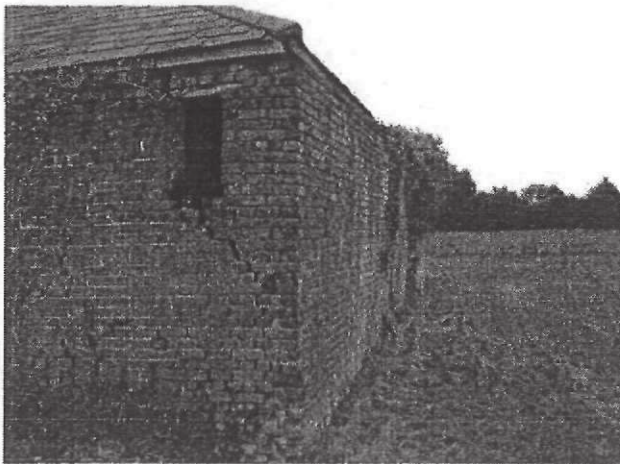
4.4.3 The rear (east) wall has significantly rotated. This is evidenced by the serious cracking which has occurred to the corners, and the lack of position and fit to the roof trusses internally. Refer to P26 and P27. The cause of this rotation is likely to be a combination of roof forces, wind pressure to a relatively exposed barn and foundation movement.

26. View looking north, of the  
south east corner. Note the  
diagonal cracking and rotation  
of the rear wall.

- a) Roof works, as mentioned above.
- b) Investigations to determine the foundation profiles and ground conditions.
- c) Underpinning of the existing walls as required by b).
- d) The construction of external buttresses, to stabilise the rear wall and provide enhanced robustness.
- e) The construction of an internal slab, tied to the base of the walls.

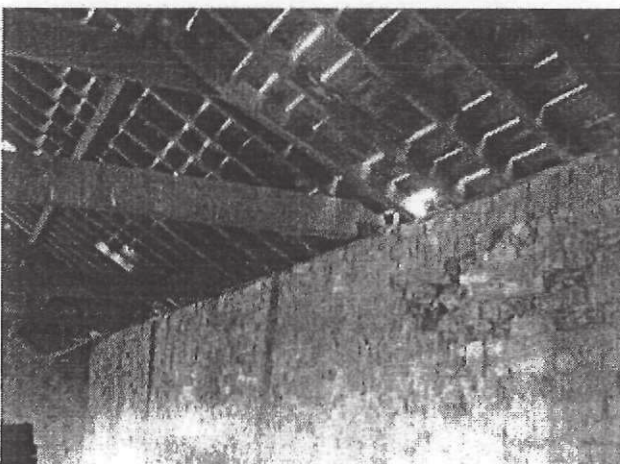
27. Internal view, of east wall.  
Note the rotation of the rear  
wall, evidenced by the position  
of the tie member in relation to  
the top of the wall.

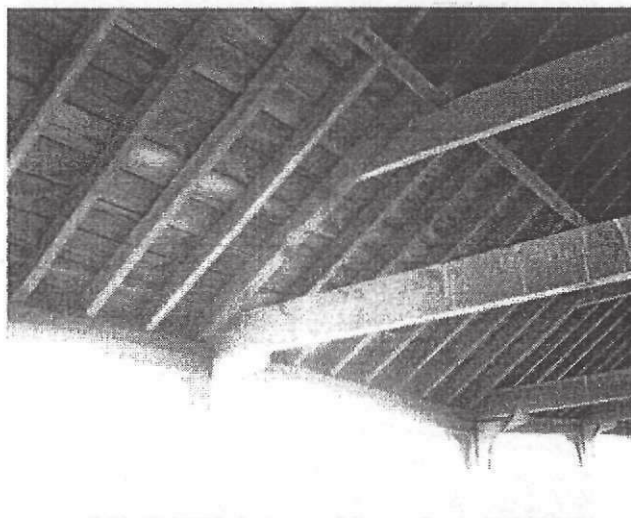
29. Roof construction, comprising common rafters, purlins and ties.

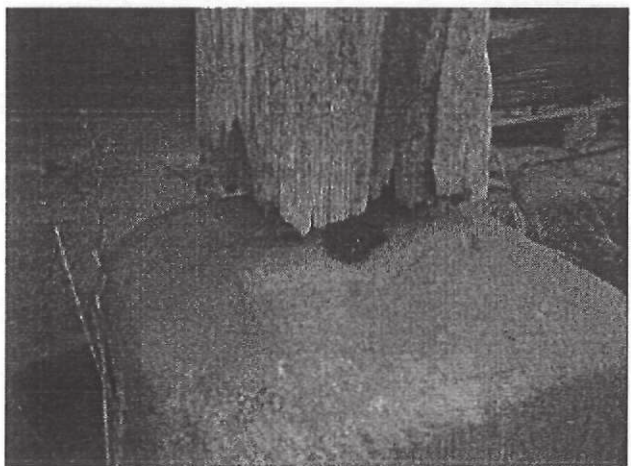
30. The base of the primary posts and the interface with the saddle stone. Note the severe deterioration of the base of the post.
