**Project No. 8467b – STEEL FRAMED BARN**

**Ref: Structural Inspection of Steel Framed Barn at Broadgate Nurseries, Gedney Broadgate, Spalding**

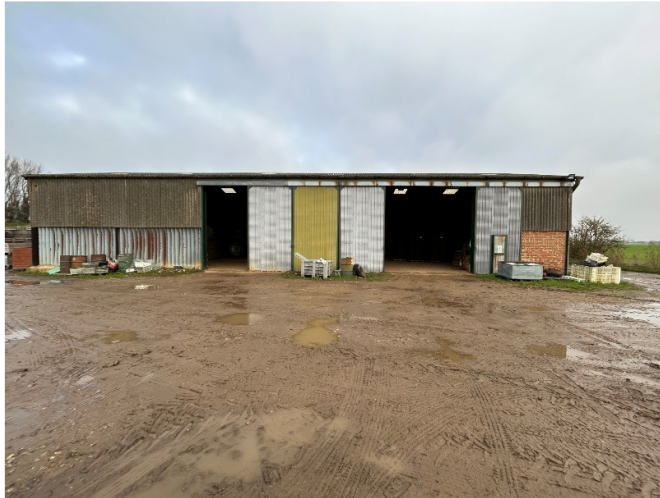
Pic 3 - South-west facing wall (side) Elevation

- The upper part of the south-west facing wall is clad in grey corrugated sheeting.
- At the left-hand end of the elevation, the first 2 bays of this elevation are formed from galvanised steel grain walling spanning vertically. This shows some signs of surface corrosion.
- Towards the right-hand end of the elevation, the lower part of the wall is formed from red common brickwork.
- This side of the building is also punctuated by 2 full height sliding steel doors.
- The steel stanchions are partly exposed and there is some mild corrosion especially close to ground level.

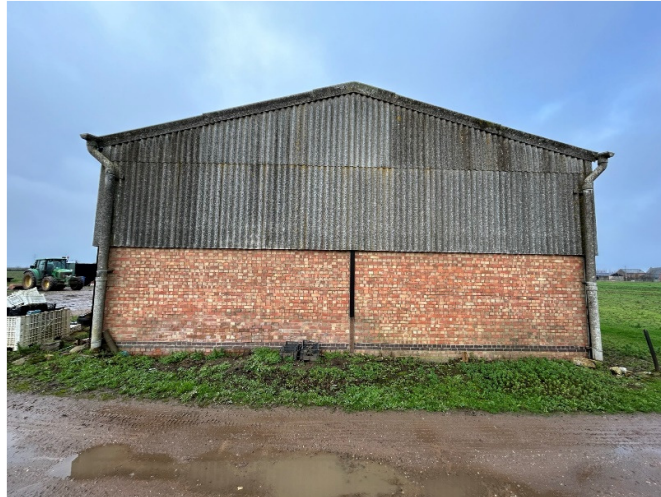
Pic 4 - South-east facing wall (gable) Elevation

- The upper part of this gable wall is clad with grey corrugated sheeting and the lower 2.4m in common brickwork masonry.
- The masonry is in good condition.
- The steel stanchions are also partly exposed and there is some mild corrosion especially close to ground level.
- There are two large downpipes attached to this elevation serving the eaves guttering.

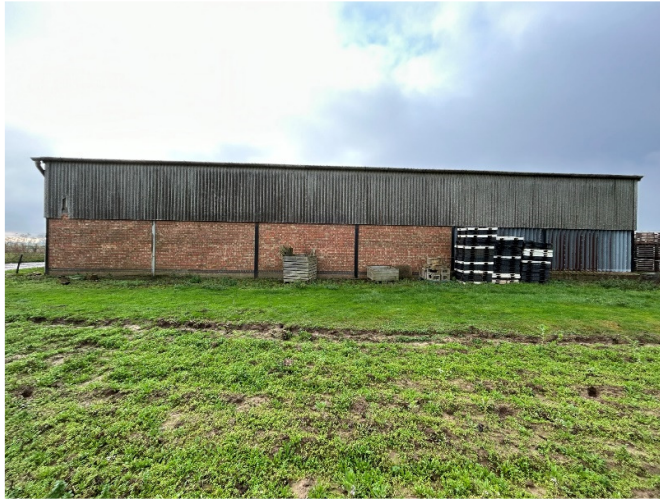
Pic 5 - North-east facing wall (side) Elevation

- The upper part of this wall is clad with grey corrugated sheeting, a small area of which is slightly damaged.
- The lower 2.4m is formed from a combination of common brickwork masonry (4 bays) with 2 bays of corroded galvanised steel grain walling at the right-hand end.
- The masonry is in good condition.
- The steel stanchions are partly exposed and there is some mild corrosion especially close to ground level.

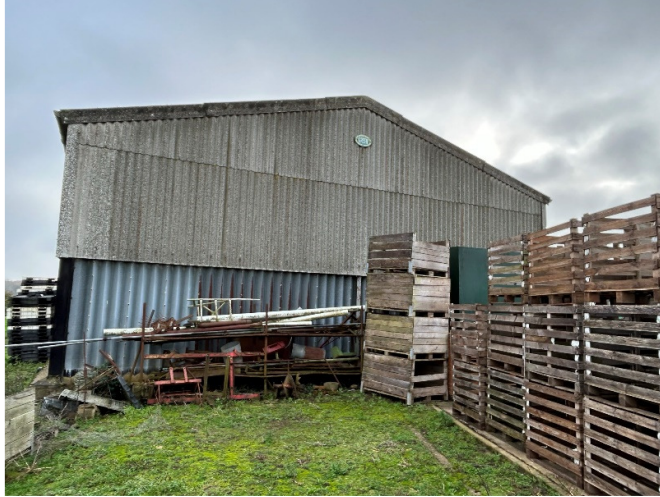
Pic 6 - North-west facing wall (gable) Elevation

- The upper part of this wall is clad with grey corrugated sheeting.
- The lower 2.4m is formed from galvanised steel grain-walling.
- Some corrosion was noted on the surface of the grain-walling.
- The steel stanchions are partly exposed with some mild corrosion, especially close to ground level.

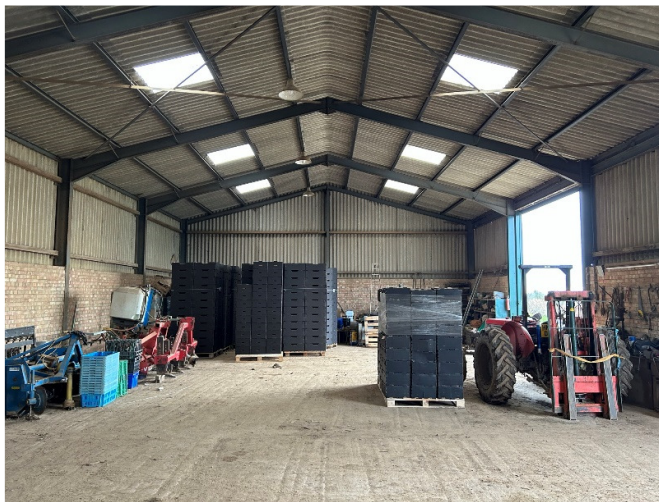
- The ground floor area is essentially one large open space.
- The steel framing is exposed and comprises a combination of 254 and 305 deep U.B. columns supporting 254mm deep U.B. rafters with eaves haunches.
- Some of the steelwork shows signs of mild surface corrosion.
- The roof sheeting is supported on a series of cold formed steel purlins (believed to be a “Wards” profile). No anti-sag rods are present.
- The roof contains some steel cross bracing.
- The sheeting to the upper part of the walls is fixed to timber side rails spanning between steel columns.
- The internal face of the masonry walls and the grain walling is also exposed.
- The concrete floor slab is flat and generally in good order

Pic 7 – General internal view of Steel Framed Barn
