TREE SURVEY AND RISK ASSESSMENT OF  
CEDAR TREE AT THE CHURCH OF THE HOLY  
TRINITY, GEDNEY HILL

# **Tree survey and risk assessment of Cedar Tree at the Church of the Holy Trinity, Gedney Hill**

**Site:** Churchyard at the Church of the Holy Trinity, 17, Hillgate, Gedney Hill,  
Spalding PE12 0NN

**Date:** June 2024

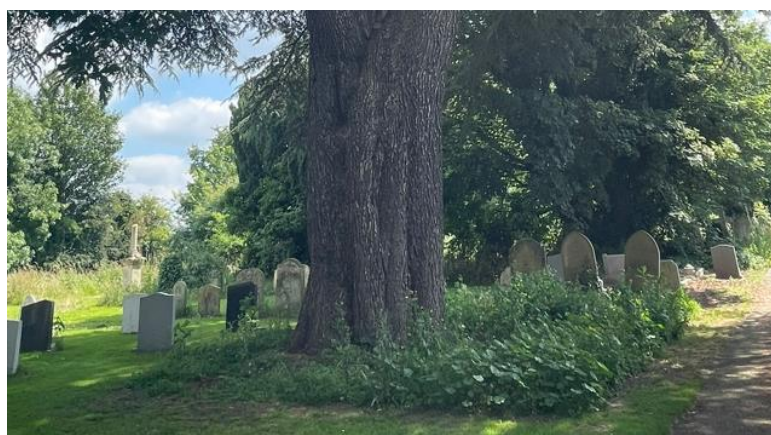
- 5.1 The tree stands approximately 18 metres tall and has reached full maturity. Although this species is non-native, originating from Morocco and Algeria, it is now commonly found in parks, gardens, and churchyards across the country. When not competing for shade or nutrients, the Atlas Cedar can live for around 150 years. In the UK, these trees are primarily threatened by fungal pests and diseases, such as Honey Fungus, which rots the roots, and a fungal needle blight, indicated by foliage discoloration and tip dieback. While the species is relatively well-adapted to the UK climate, it is occasionally susceptible to storm damage from high winds, rain, and snow. This particular tree is located within the memorial area near the site boundary, surrounded by grass and some deposited soil at its base.

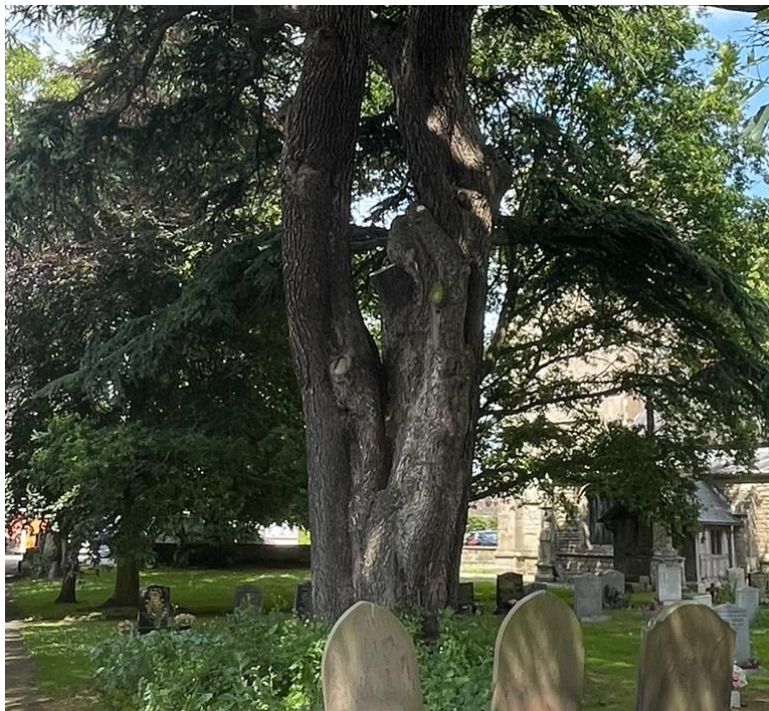
- 5.5 The stem of the tree has several historic pruning wounds and one tear-out wound, suggesting that the tree has been pruned for crown height clearance in the past or may have suffered from previous storm damage.

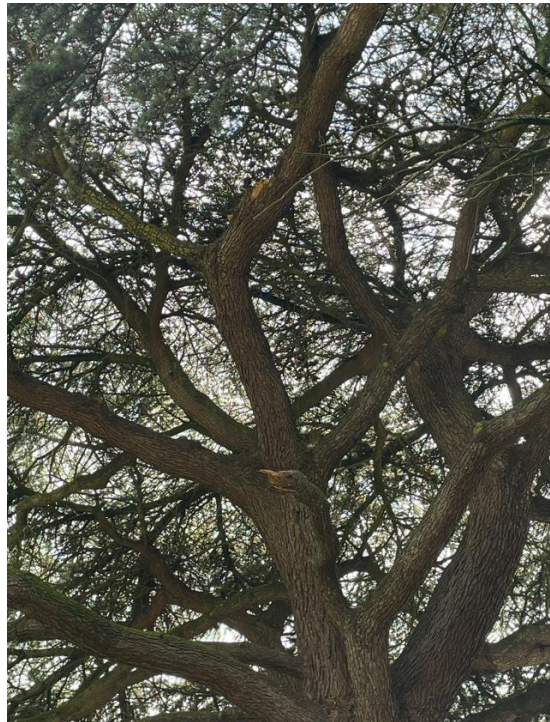
- 5.6 Dead wood is scattered throughout the tree's crown, particularly in the lower areas where access to light is limited. While dead wood is a natural by-product of a tree's life cycle and not necessarily a sign of ill health, it is prudent to remove it to prevent it from falling into the path of pedestrians or vehicles below. It is recommended to remove dead wood over 25mm in diameter.
- 5.7 During last winter, the tree lost a sizeable branch, which fell into the memorial area of the churchyard. Although the branch was not available for inspection, it is assumed that storm damage caused the branch to fail, rather than disease or decay. An open area in the crown indicates a small loss of canopy cover on the tree's north side where the branch was lost.

- 6.1 It is recommended to carry out a dead wood removal to the whole crown of the tree, to include all dead wood with a stem diameter of 25mm or more. This may be carried out any time of year within the recommended time frame of 6-12 months, however, an assessment should be made with regard to the presence of any nesting birds prior to works taking place.

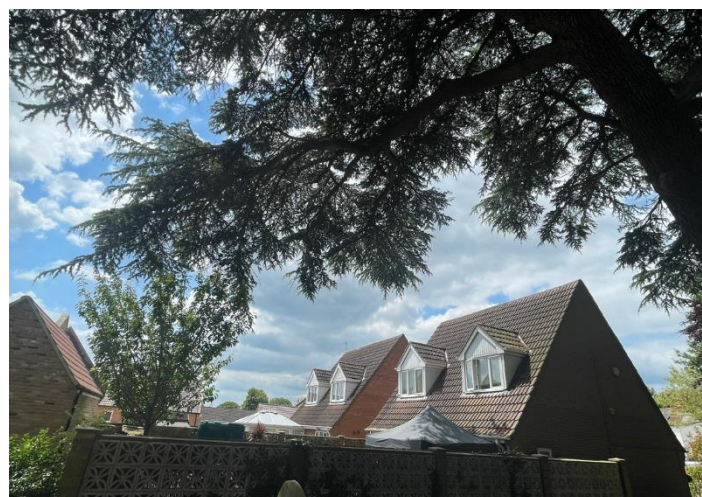
- 5.8 Following loss of this branch, concerns about the health and safety of the tree have arisen from neighbouring residential property. Branches from the tree overhang the property over the southerly boundary, though are not touching the property, and crown clearance is good. The branch nearest to the property is a secondary limb from one of the primary branches, and its angle appears to contribute to unnatural loading. While trees have evolved not to fail, the intuitive notion is that this branch may succumb to future storms and cause property damage. In order to discharge the tree owner's liabilities under Occupiers Liability, it is recommended to take some action upon the tree.

It is recommended to perform a clearance prune on the branches over this property by 2-3 metres, or nearest branching point, thus reducing branch loading, and reducing the chance of any potential failures landing upon the property.

An alternative, though more costly solution would be to secure this branch with a non-invasive flexible bracing system. It is possible to explore this option further on request.

- 6.2 It is recommended to prune branches back from the neighbouring property by 2-3 metres, or to the nearest branching point possible for executing the works.

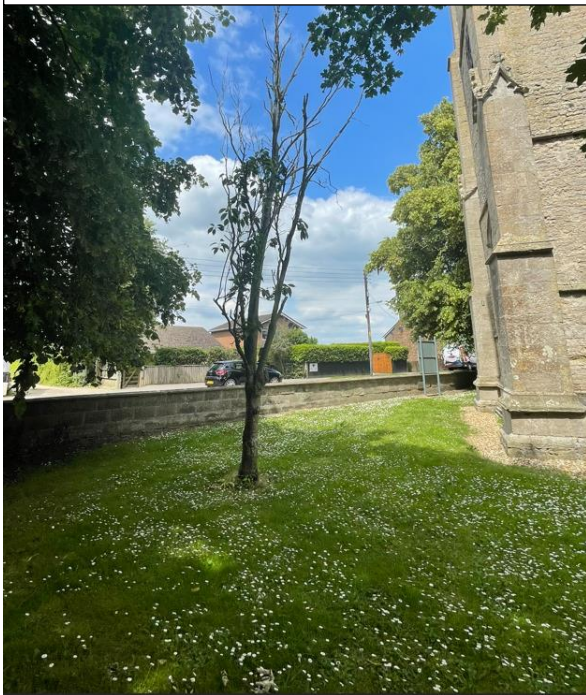
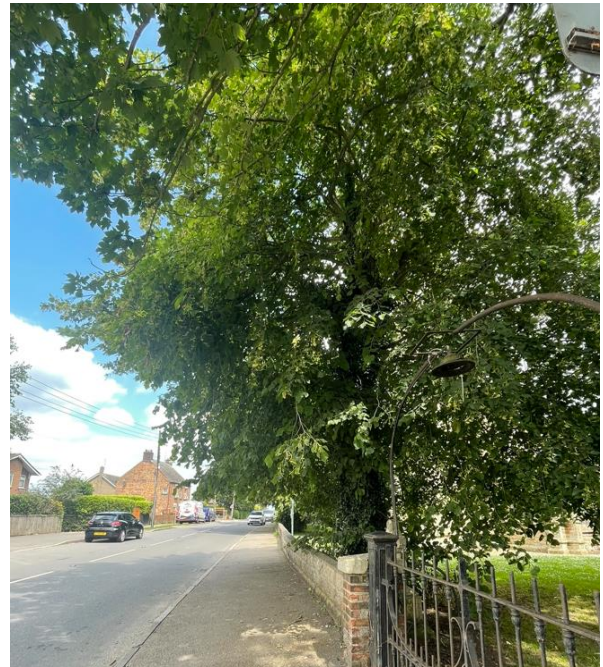
## FAILED TREE

REMOVE CHERRY TREE NEAR TO FRONT  
BOUNDARY AS IT IS IN SEVERE DECLINE
