**Phase 2 (ground investigation) assessment report**

**Land between 10 and 12 Risegate Road, Gosberton**

Produced for JC Architectural Consultant

December 2024

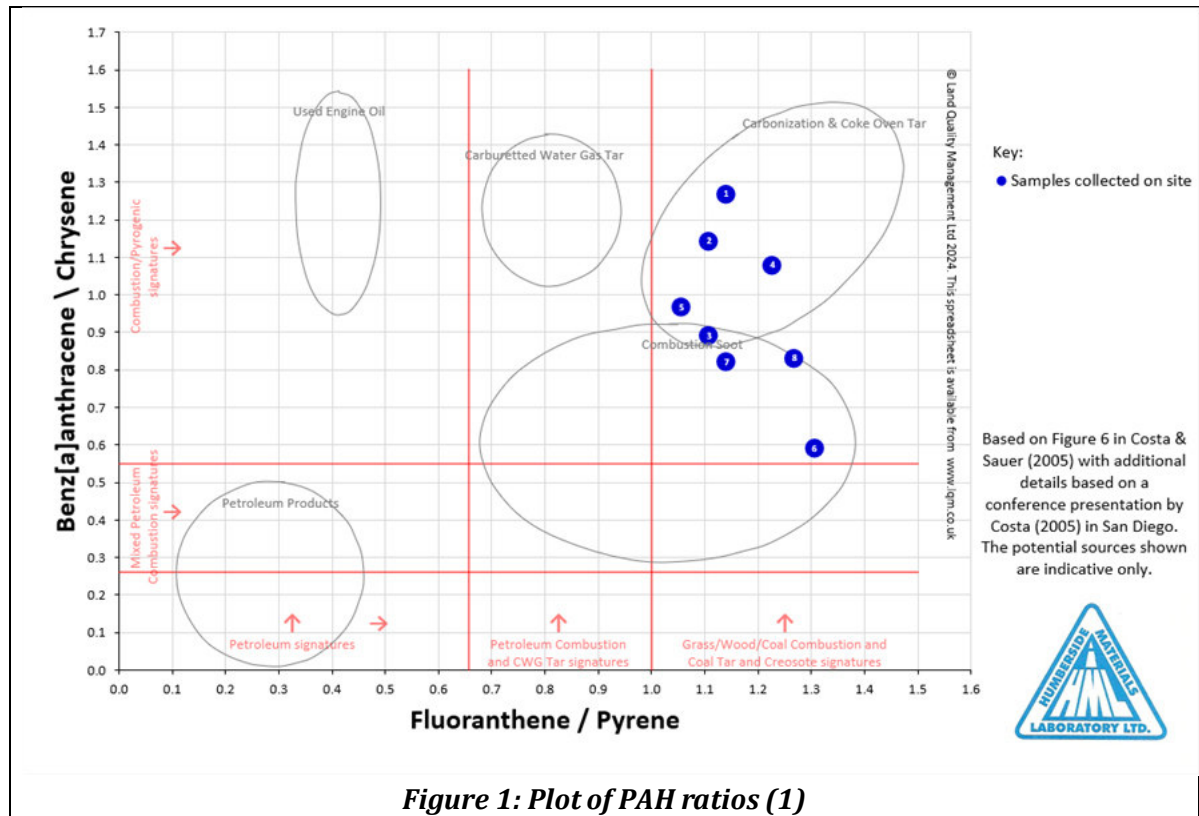
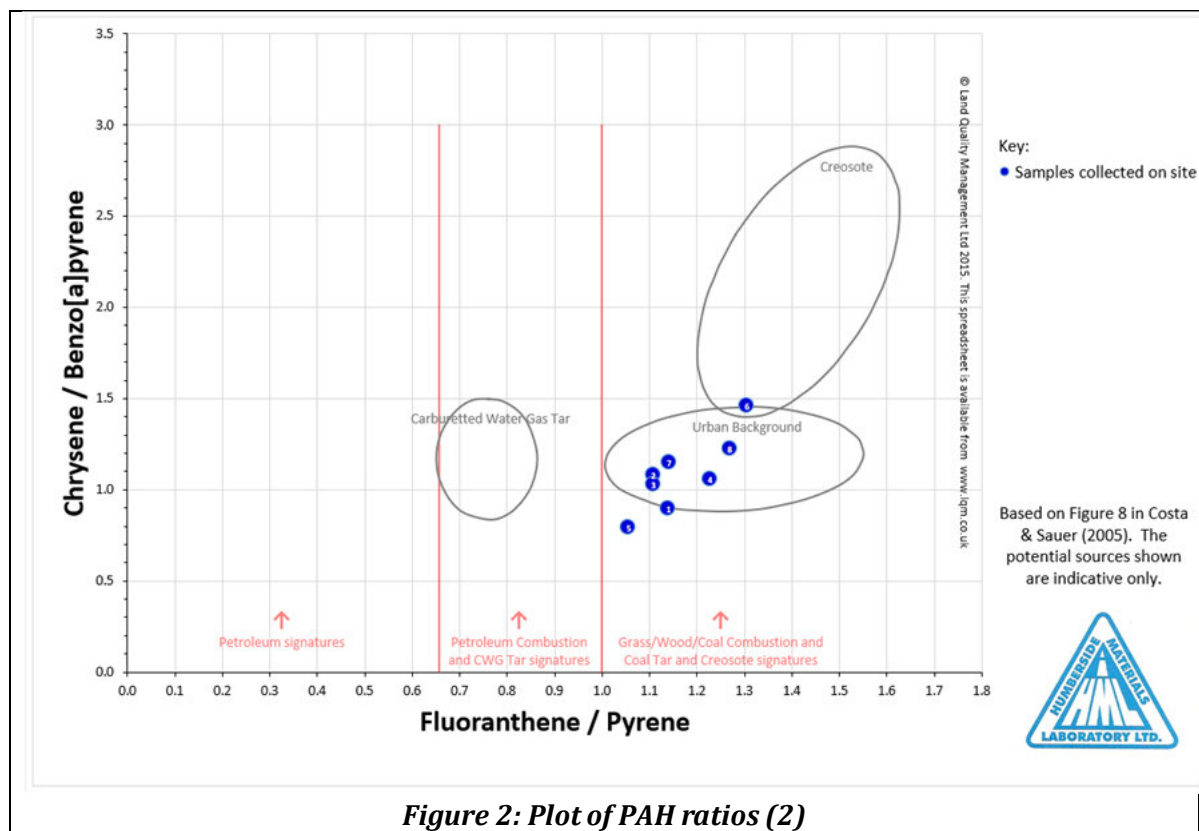
PAH profiling plots, for example, as shown below (in Figures 1 and 2) confirm the source of the detected, mostly relatively low levels of PAH contamination to be pyrogenic rather than petrogenic and the likely source of the detected PAHs is expected to be ash or clinker (in burnt grass/wood/coal) or traces of coal tar (from asphalt) within the revealed made ground. No petroleum signatures have been identified.

*Accordingly, there is a localised potential hazard to human health from low volatility genotoxic PAHs (such as benzopyrene) within shallow soily rubbly/stony made ground. However, there is no identified hazard from volatile PAHs (such as naphthalene) and no indication of petroleum contamination has been identified.*

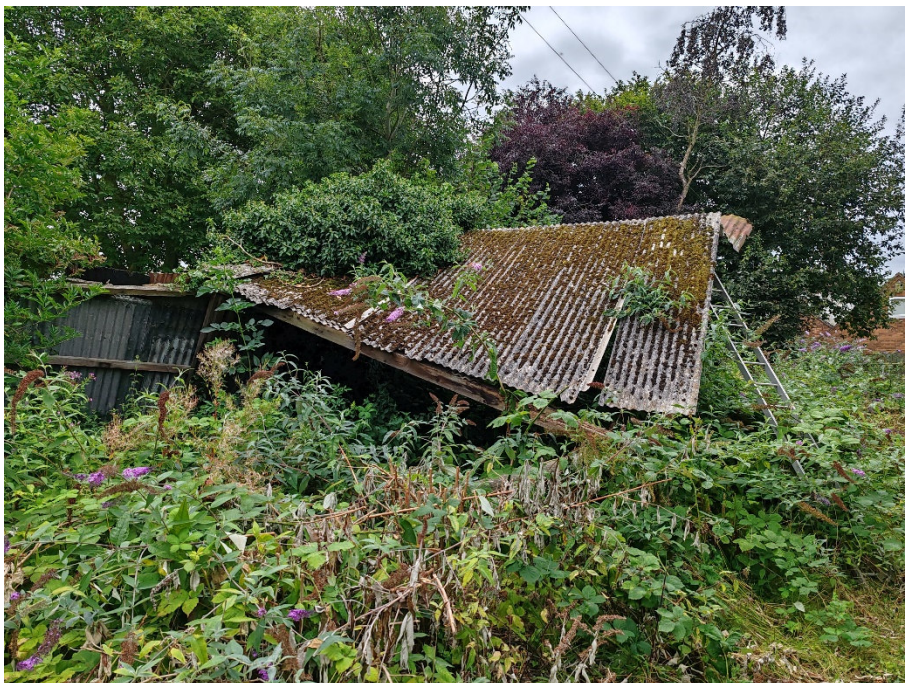
*Site walkover photo: 3*    *Date: 05 Aug 2024*  
*Photo direction: South*  
*Description: View of dilapidated farm building (cattle shelter) and overgrown vegetation*

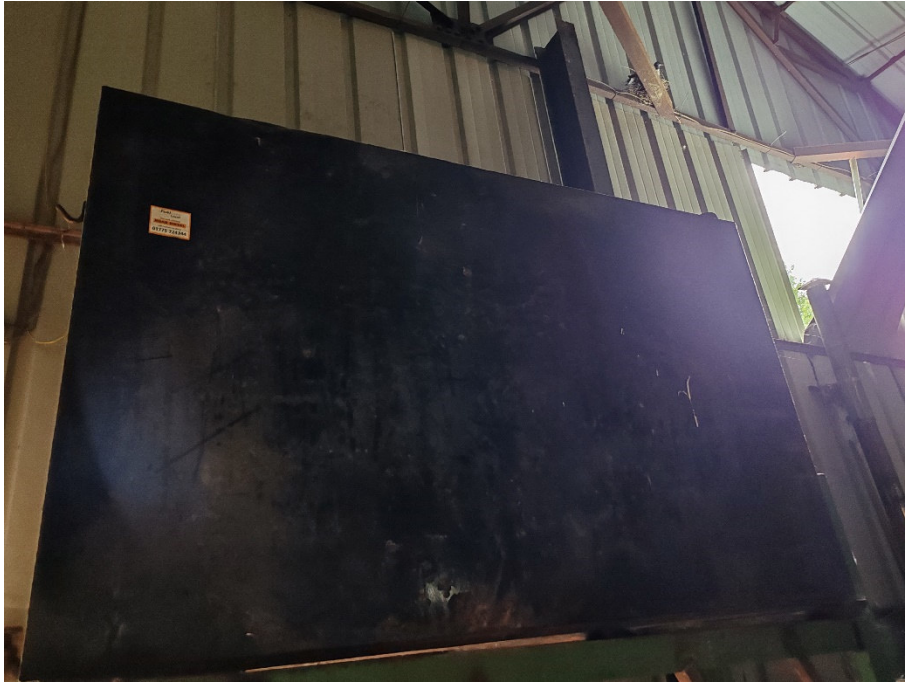
*Site walkover photo: 6*    *Date: 05 Aug 2024*  
*Photo direction: South*  
*Description: View of red diesel tank in southwestern corner of barn with external pump*

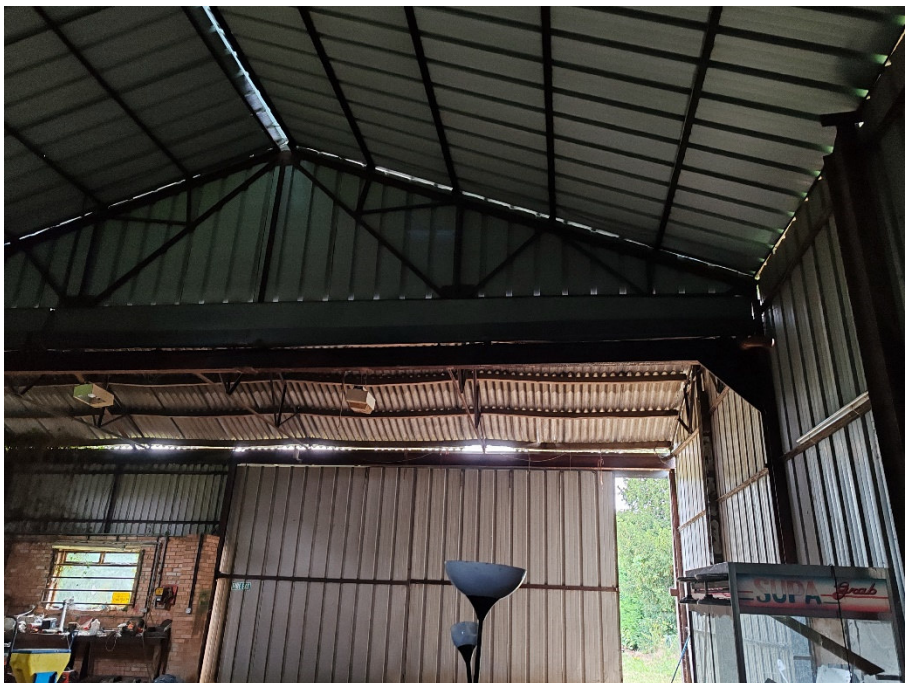
The **existing building fabric** has been identified to potentially include much asbestos within the existing corrugated cement wall and roof panels. The removal of these panels, if carried out carelessly, could introduce asbestos into the ground and pose a significant hazard to human health.

*Site walkover photo: 7*    *Date: 05 Aug 2024*  
*Photo direction: North*  
*Description: View of existing barn with localised possible asbestos containing roof panels*

Suitable dismantling and  
off-site removal of existing  
building fabric, especially  
possible asbestos sheeting,  
by competent workers

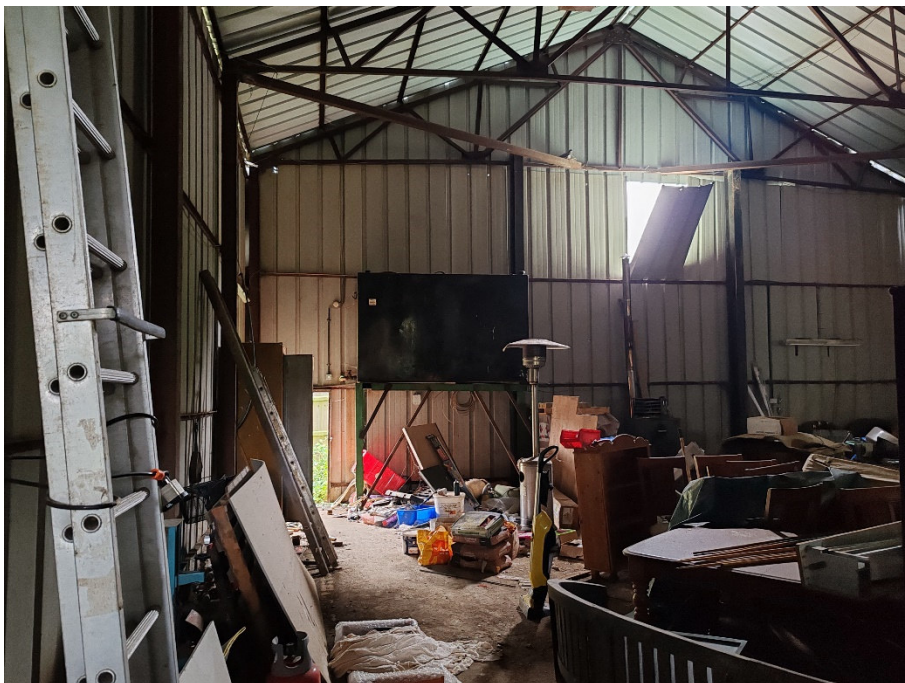
*Site walkover photo: 9*    *Date: 05 Aug 2024*  
*Photo direction: South*  
*Description: View of inside of barn with assorted wares, red diesel tank and possible asbestos roof*
