**PRELIMINARY STRUCTURAL REPORT  
UPON  
EXISTING BARN  
AT  
BALL HALL FARM  
WARGATE WAY  
GOSBERTON  
LINCOLNSHIRE  
PE11 4HE**

**PRELIMINARY STRUCTURAL REPORT**  
**UPON**  
**EXISTING BARNs**  
**WARGATE WAY**  
**GOSBERTON**  
**LINCOLNSHIRE**  
**PE11 4HE**

**Ref: 15520**

**MARCH 2020**

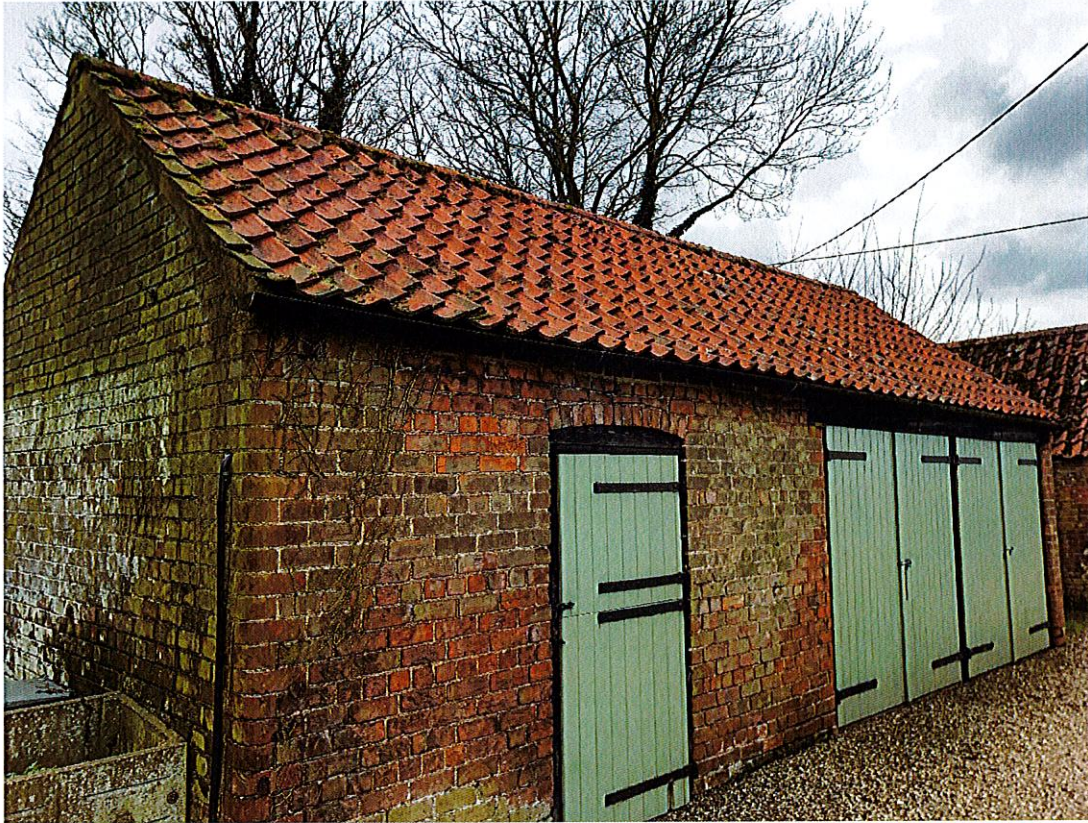
PHOTOGRAPH 1

Barn 1 is a well maintained building, with both garage and stable doors to the frontage – see Photograph 1.

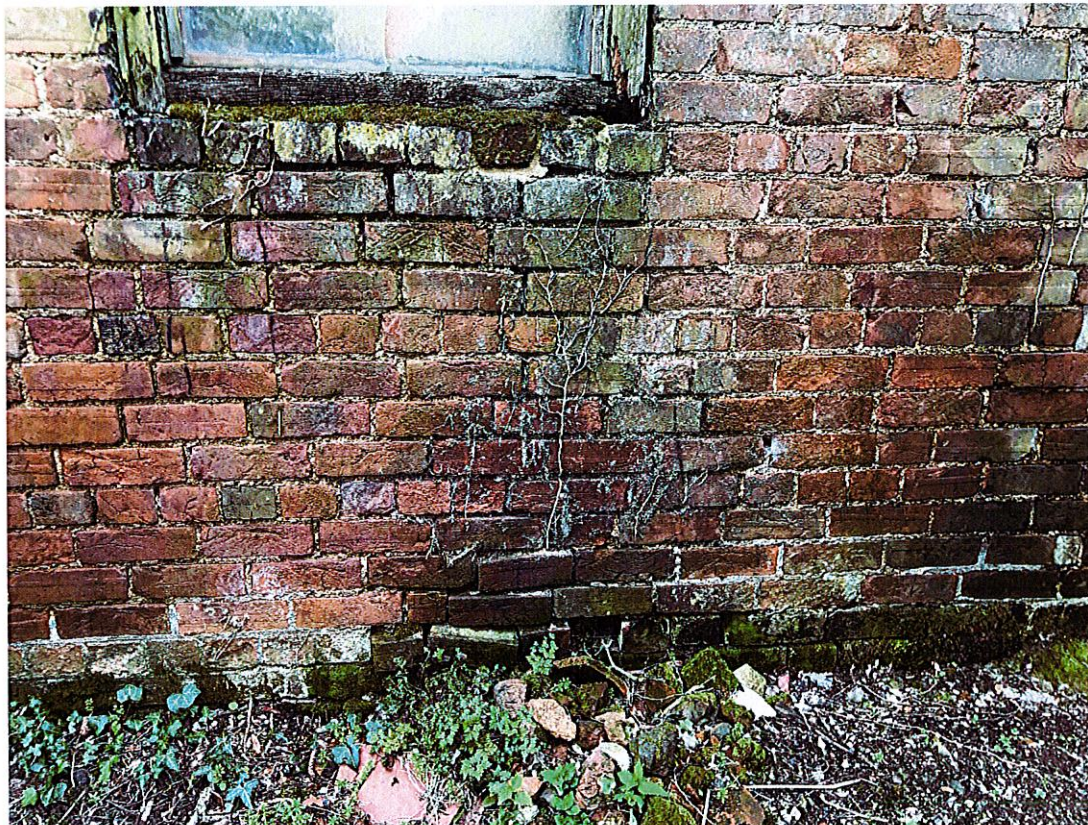
PHOTOGRAPH 2

However, some loose brickwork was noted below the rear window – see Photograph 2.

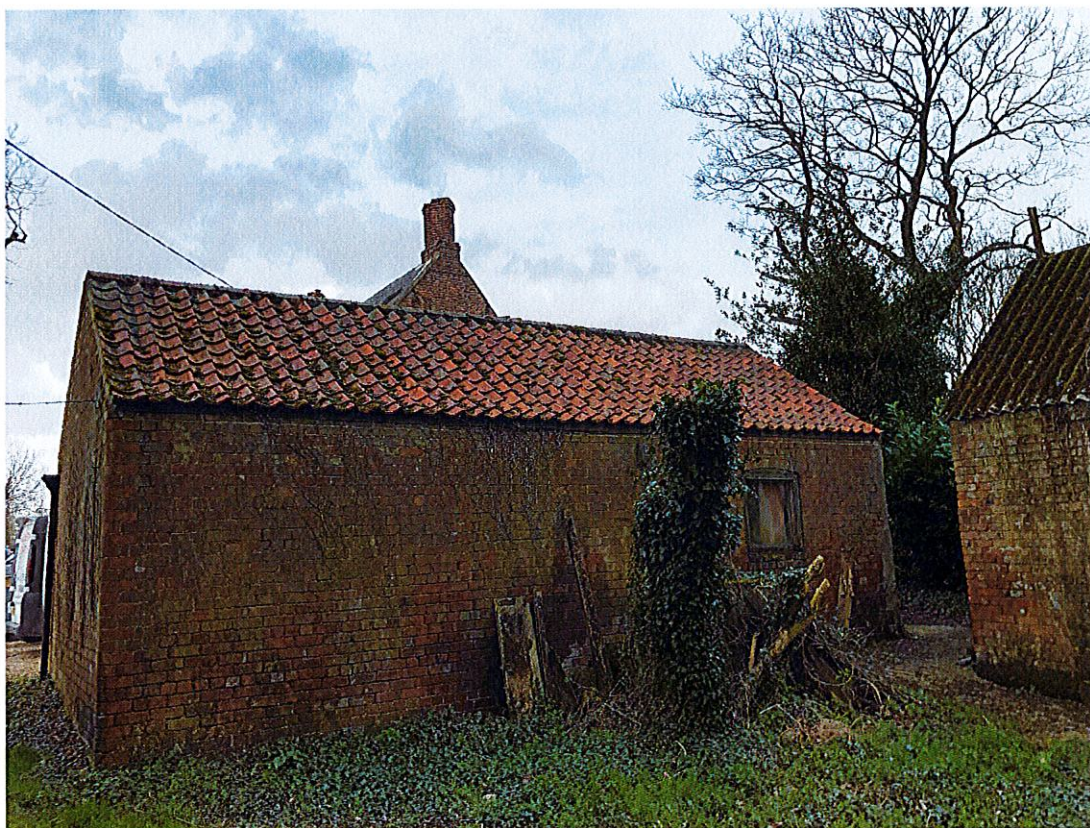
PHOTOGRAPH 3

The roof covering of clay pantiles is intact with a relatively straight ridge line – see Photograph 3.

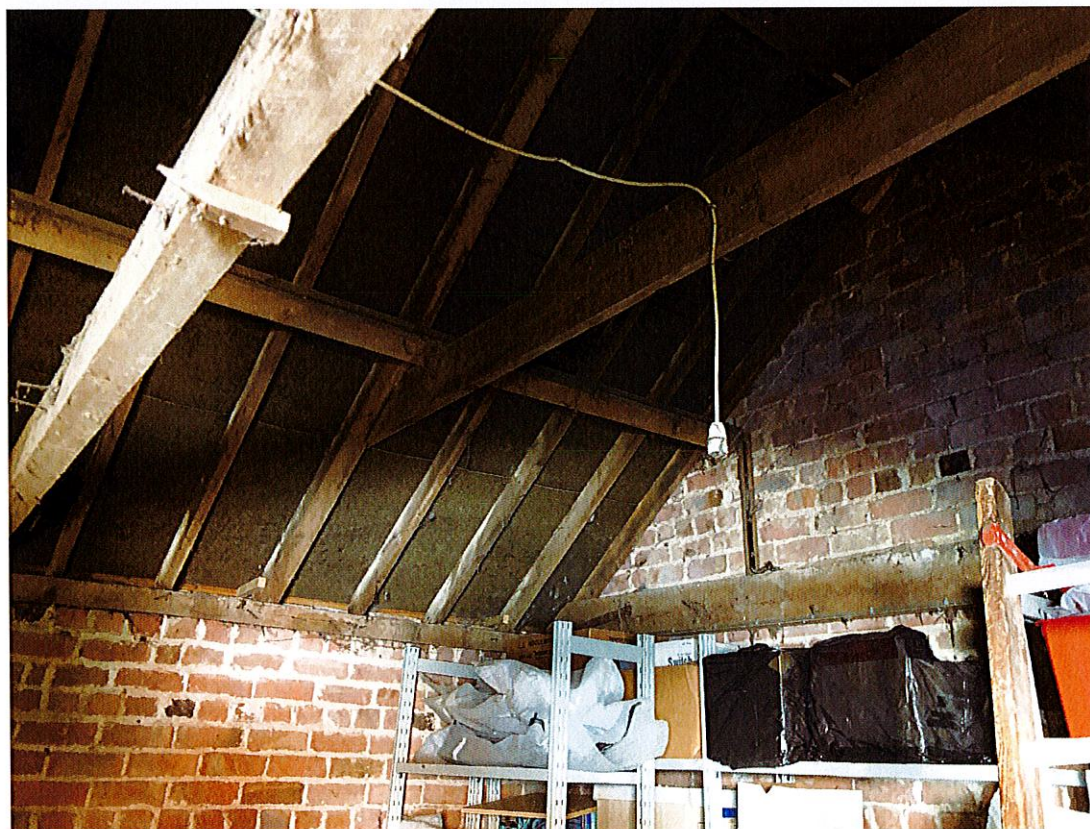
PHOTOGRAPH 4

Within the barn, a typical timber framed roof structure is in place, with newly placed bituminous felt noted – see Photograph 4.

Since Barn 1 is in active use at this time, for document and general storage, no significant works are anticipated, other than ensuring the waterproof membrane is maintained and damp prevention is provided.

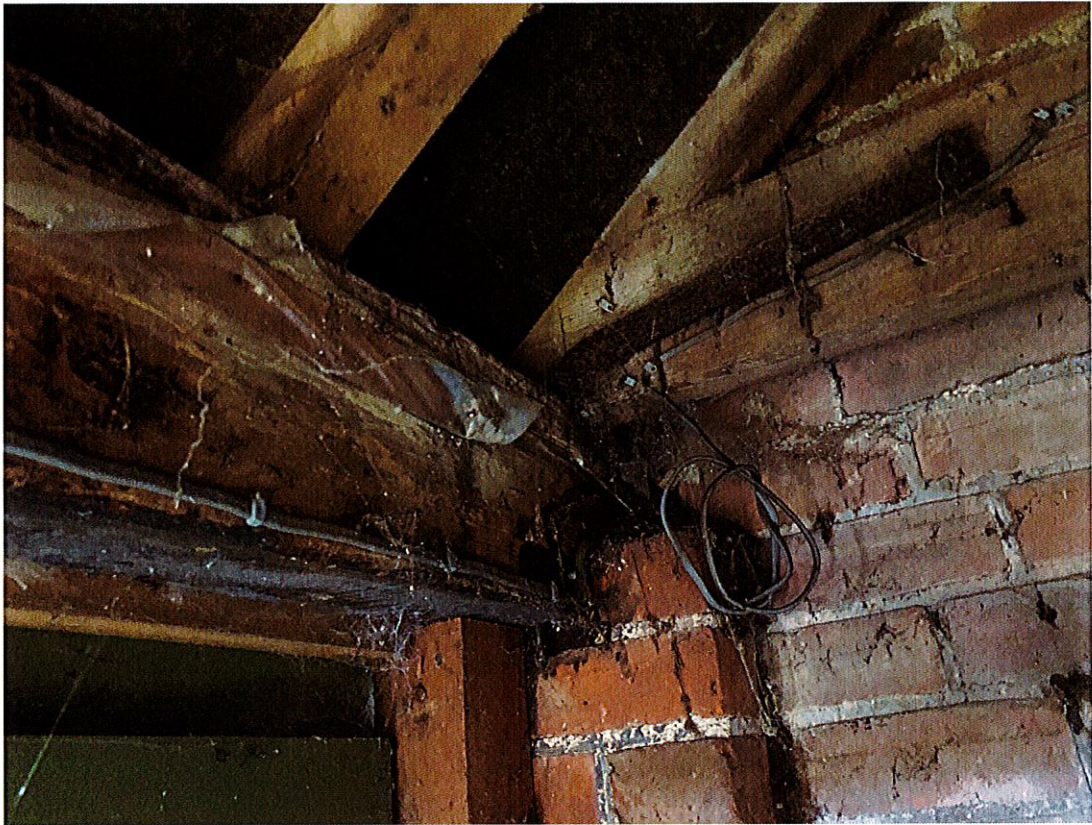
PHOTOGRAPH 5

Some minor decay was noted to the timber lintel over the front doors – see Photograph 5.

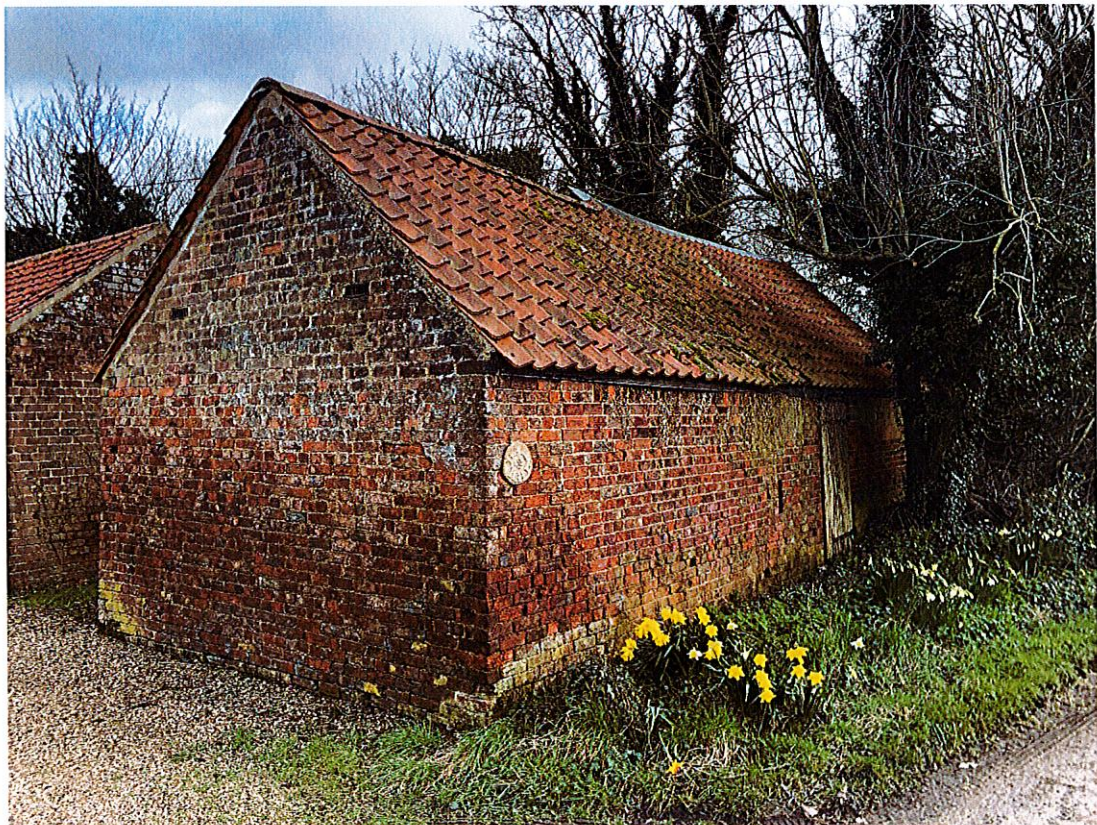
PHOTOGRAPH 6

Situated close to the road, there is a mature ivy covered tree adjacent to the front wall – see Photograph 6.

Furthermore, the close proximity of mature trees and ivy growth has been a detrimental effect upon the present condition.

To Barns 2 and 3 ground investigations should take place to confirm the type of soil strata, prior to the removal of trees to the close proximity.

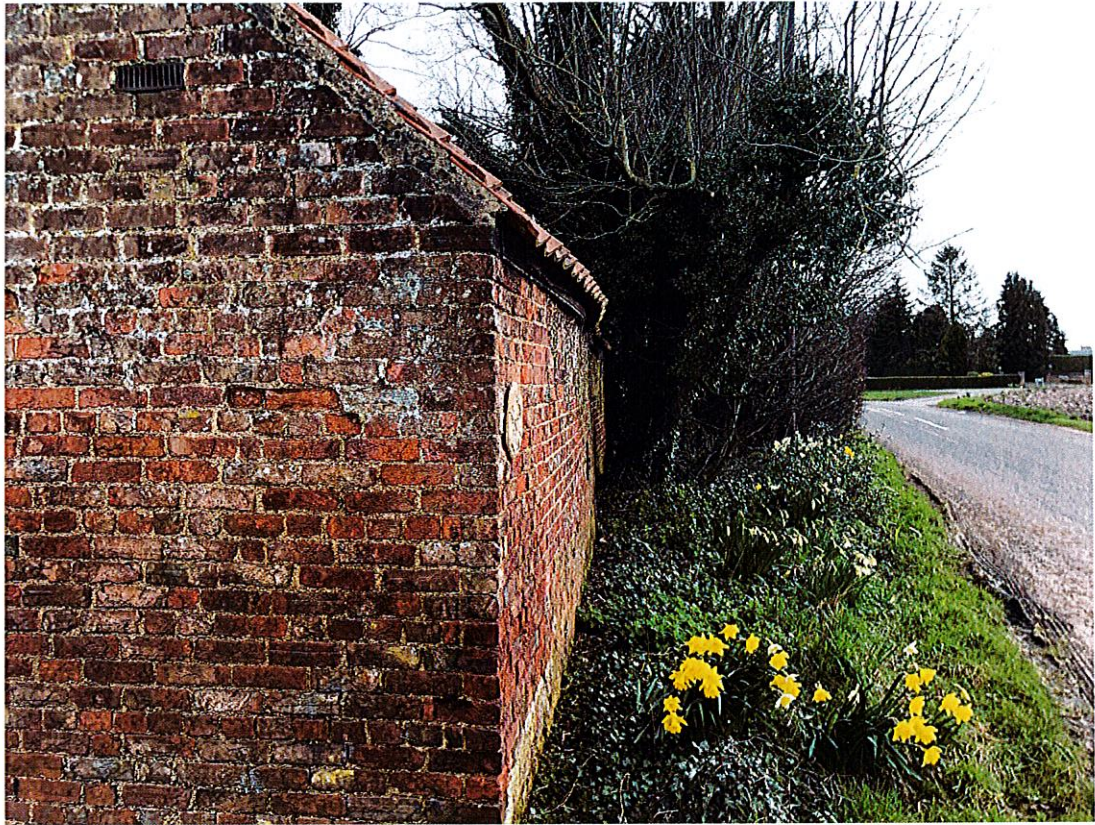
PHOTOGRAPH 7

The front wall bows outwards and a tie bar is present at mid height – see Photograph 7, with vertical cracking also visible – see Photograph 8.

Nevertheless, whilst internal decay of roof timbers is present throughout, the main cause of wall movements is due to the roof spread at eaves level, with no effective tie being present.

This has resulted in the outward movement of the brickwork, which has also contributed to cracking within gable walls.

To suit the internal wall arrangement horizontal ties would be provided to enhance the support to existing external walls, via the roof structure.

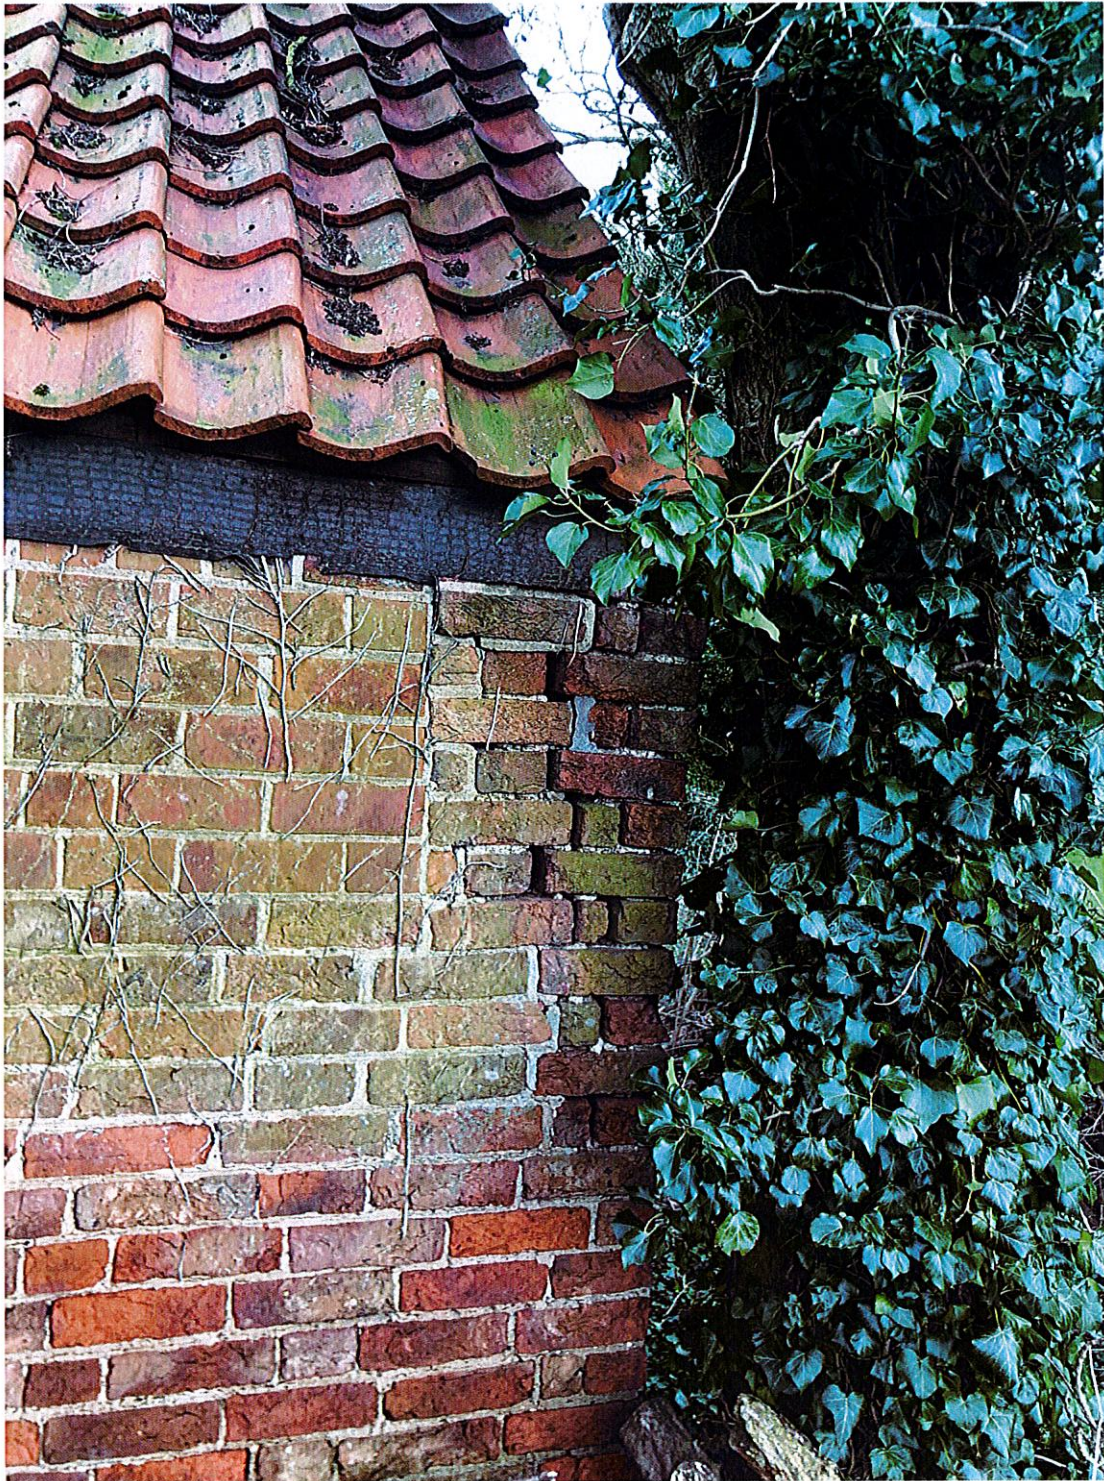
PHOTOGRAPH 9

To the rear corner, wall movement and loose brickwork is visible – see Photograph 9.

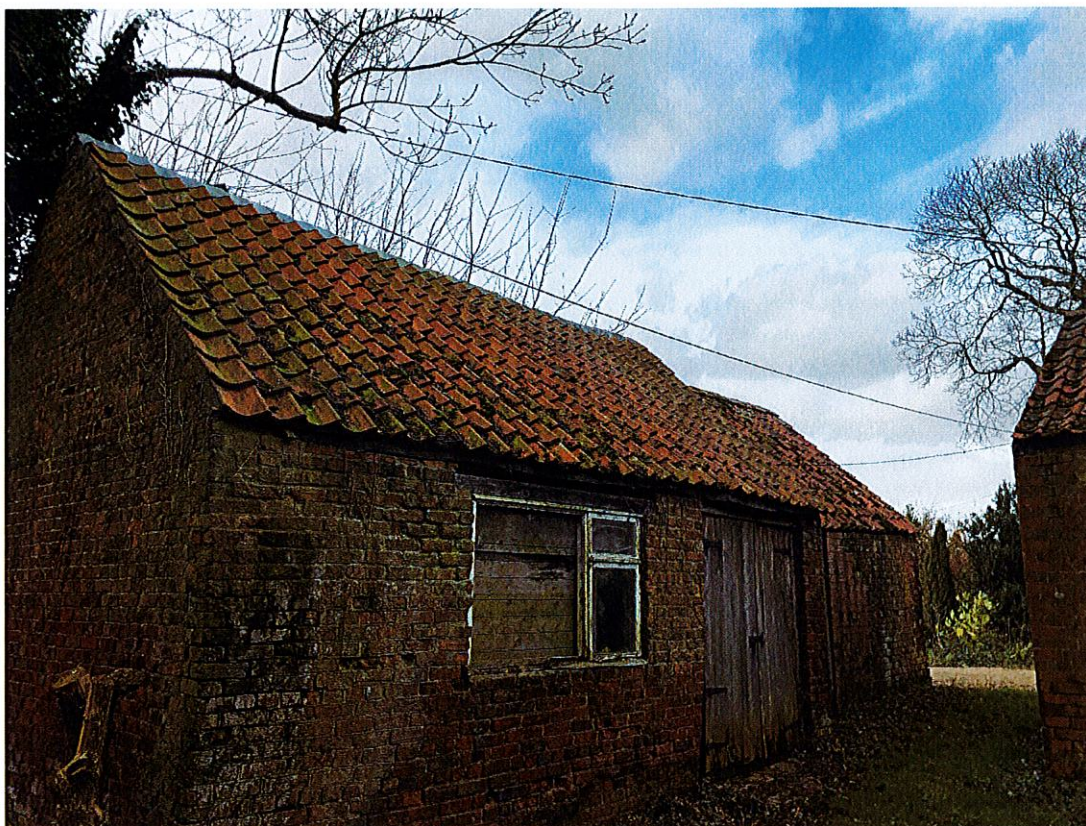
PHOTOGRAPH 10

Along the rear elevation – see Photograph 10, the brickwork remains intact, however undulation and slopes along mortar joints were noted, with mortar joints being washed away to the rear corner – see Photograph 11.

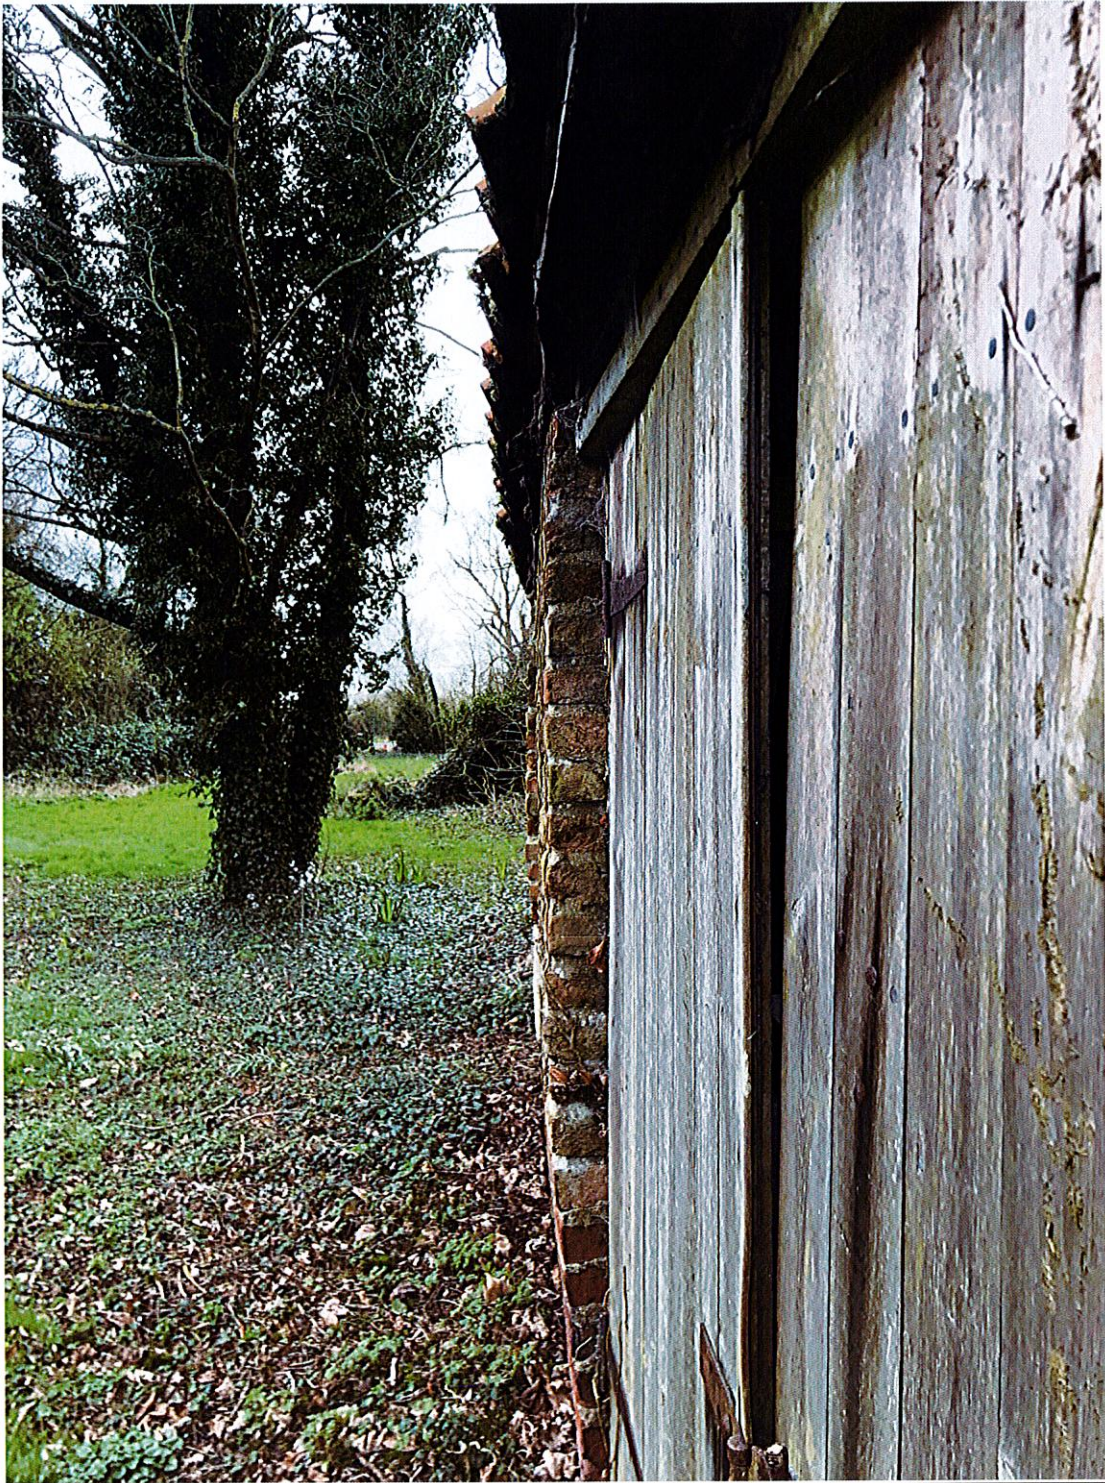
PHOTOGRAPH 12

The rear wall also bows outwards – see Photograph 12. Internally, the roof has been renewed in the past, with new timbers and bituminous felt present, however no effective tie or purlin to assist the span of the rafters was noted – see Photograph 13.

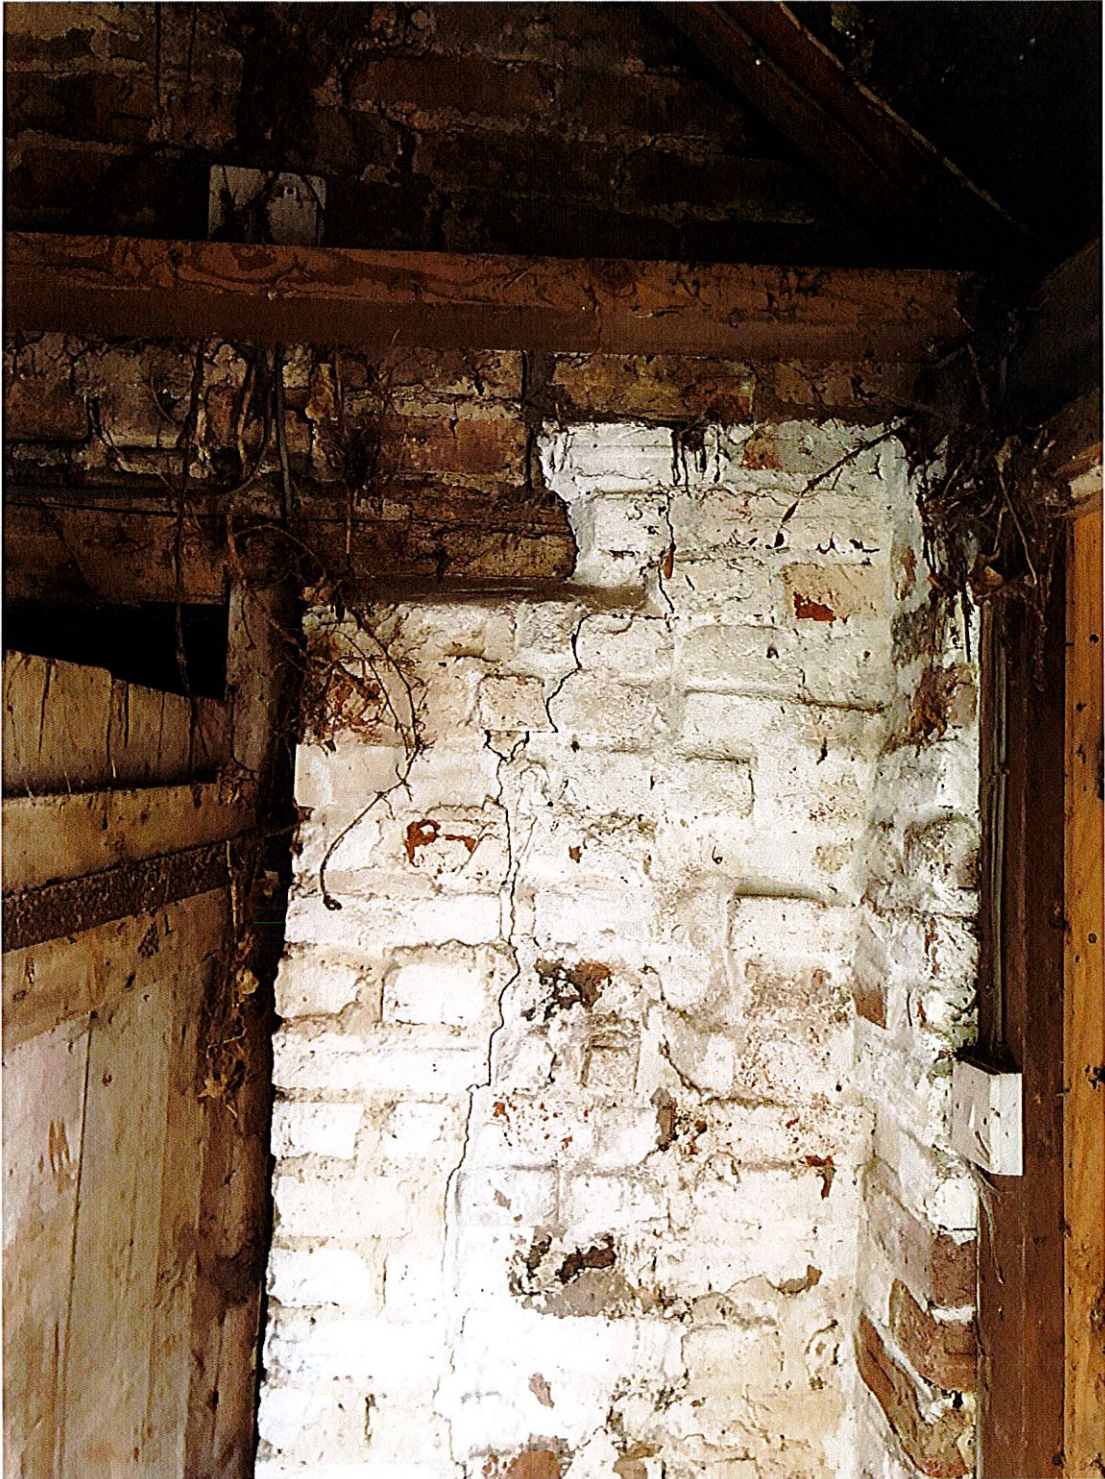
PHOTOGRAPH 14

Minor cracking was visible within the rear gable and internal walls – see Photograph 14.

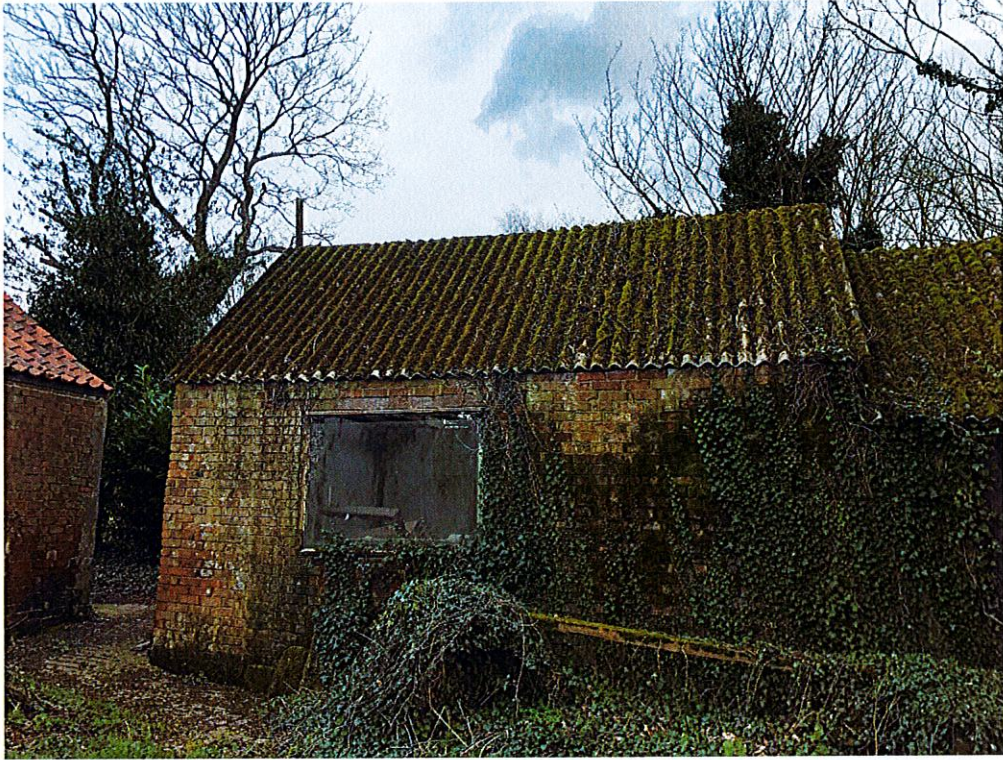
PHOTOGRAPH 15

This barn has a pitched roof with two eaves heights and is covered by corrugated asbestos sheeting – see Photograph 15.

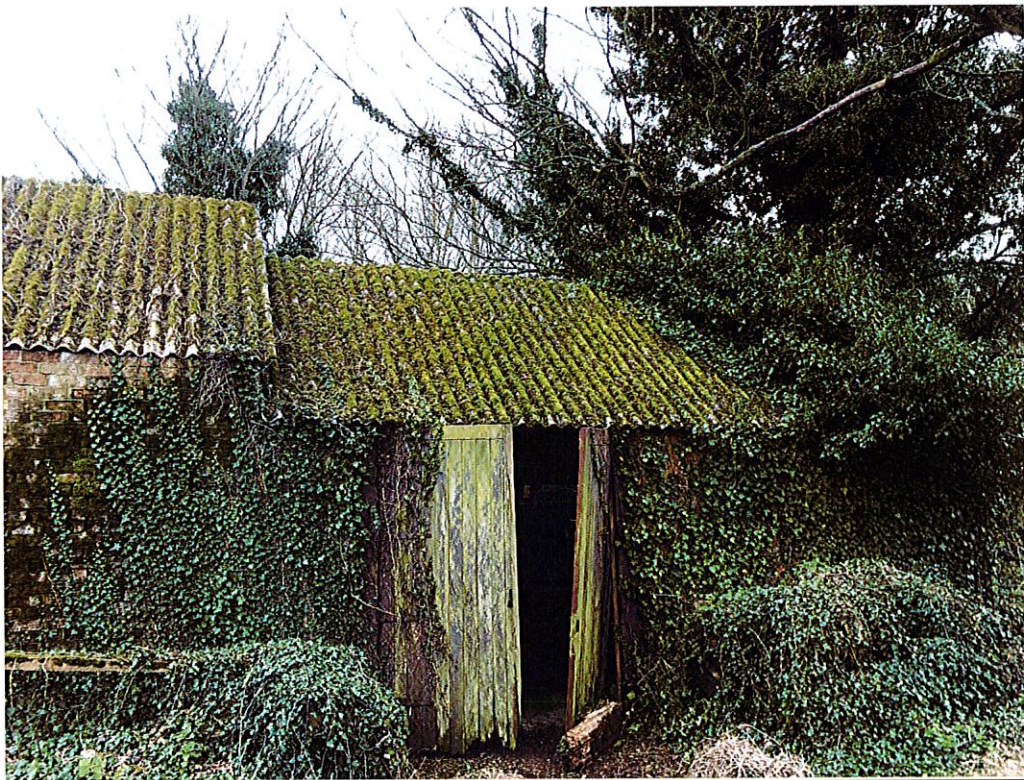
PHOTOGRAPH 16

The majority of the front elevation and rear gable is covered by vegetative growth – see Photograph 16, which makes it impossible to comment upon the masonry. Nevertheless, significant cracking was noted in the rear gable wall.

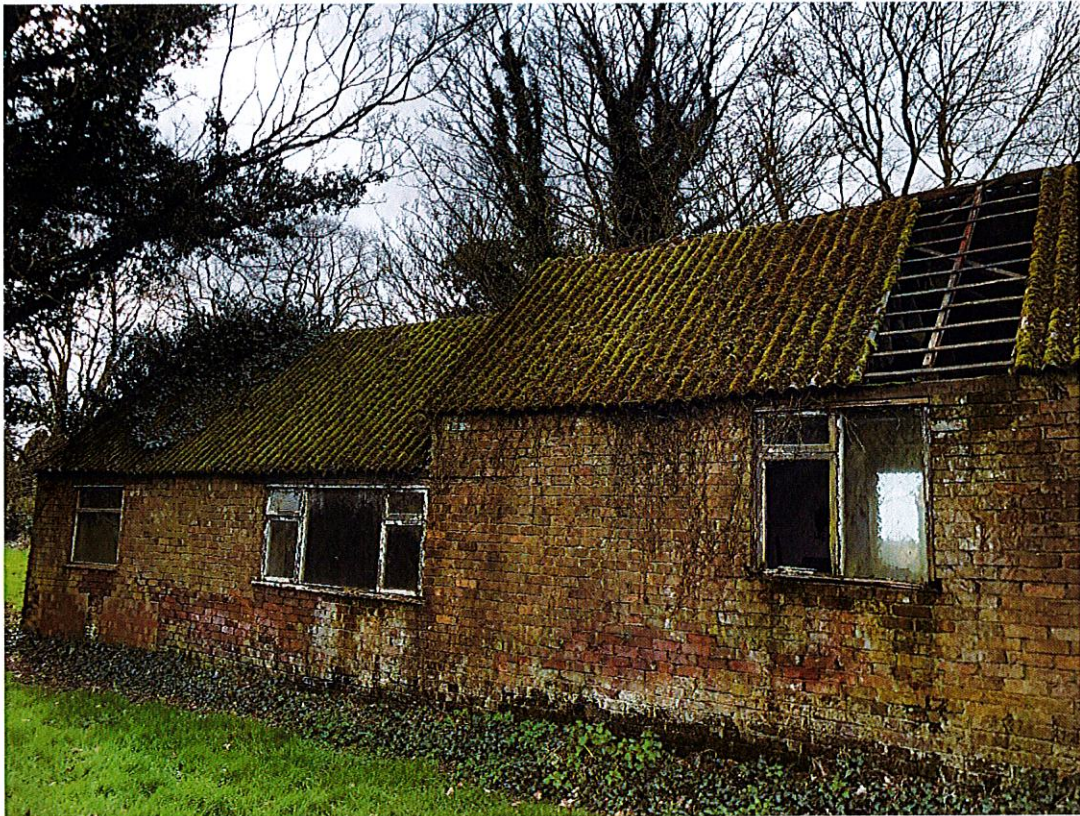
PHOTOGRAPH 17

However, the rear elevation is free of vegetation – see Photograph 17.

Areas of new brickwork were visible at low level, with dampness present in the brickwork throughout.

The rear wall also leans outwards at eaves level, and a large hole is present in the roof covering.

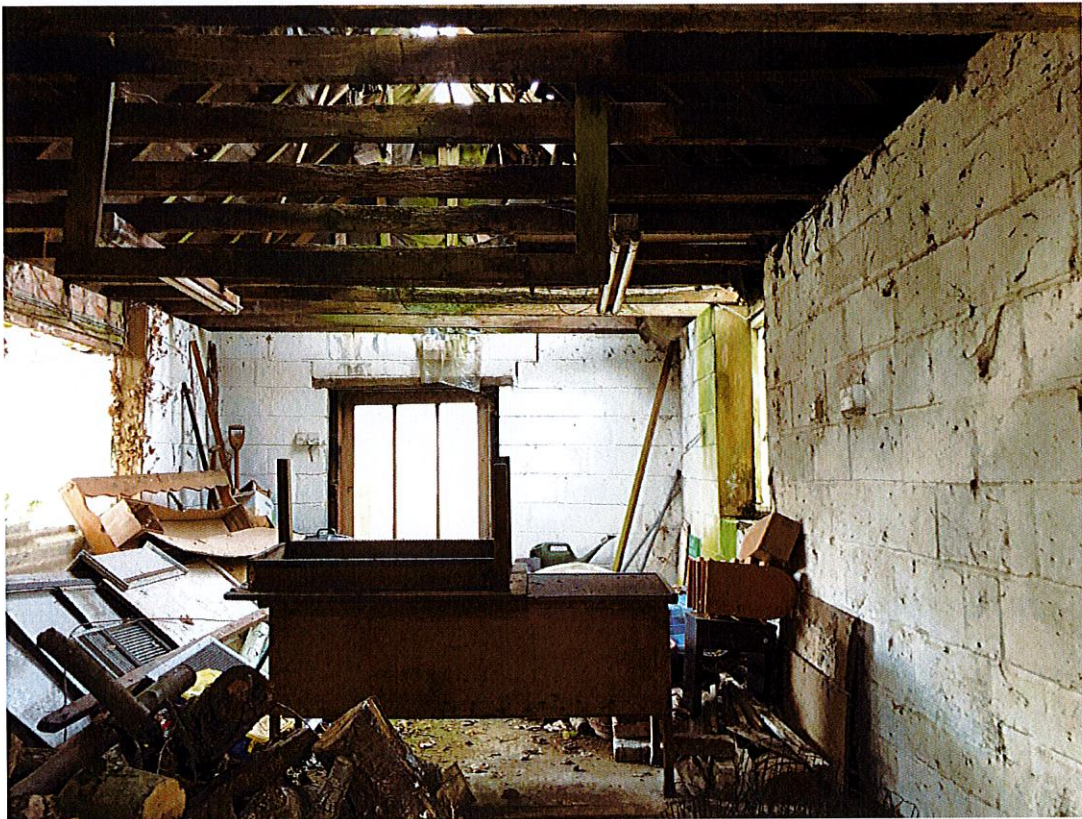
PHOTOGRAPH 18

Internally, blockwork has been introduced to the higher eaves portion of the barn to form an inner leaf. A large stepped crack was noted in the gable wall – see Photograph 18.

The internal blockwork to Barn 3 should be removed and a new reinforced concrete floor provided with needle beams taken below the existing brickwork, to provide a raft type foundation to support the structure to Barn 2 and 3 as a whole.

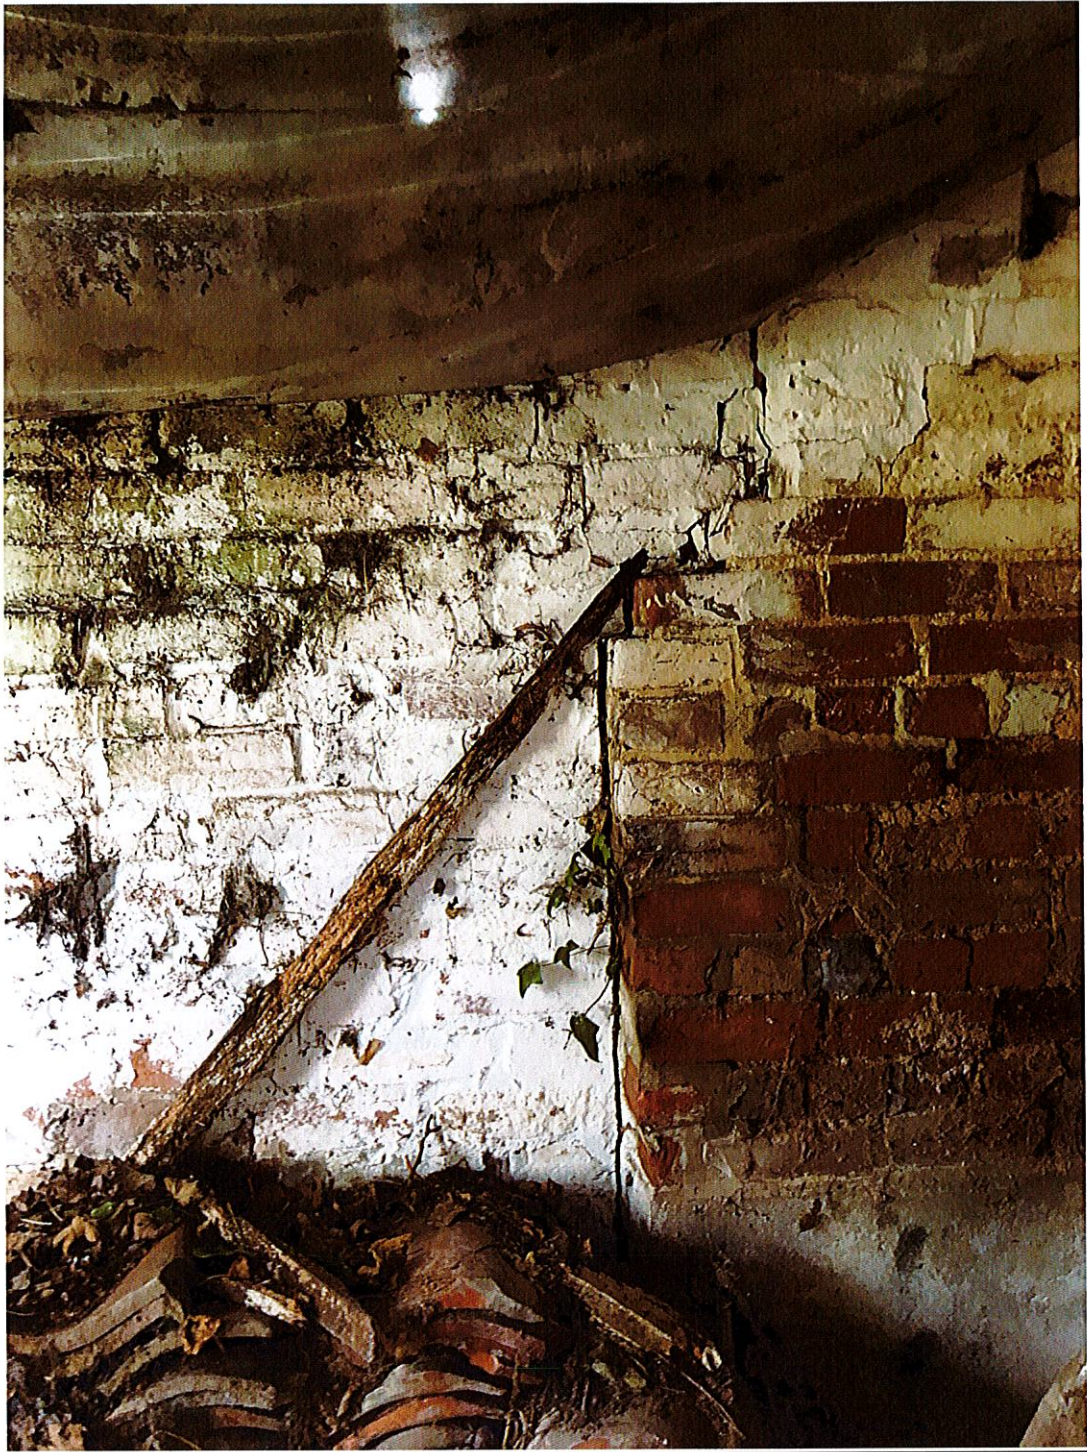
PHOTOGRAPH 19

A further large crack was noted in the rear gable wall – see Photograph 19.
