**HISTORIC BUILDING RECORDING  
PANTON HOUSE BARNs  
HEDGEFIELD HURN  
RISEGATE  
GOSBERTON  
LINCOLNSHIRE**

Prepared For  
TAC Architects  
By  
Neil Parker MA

October 2019

APS Report No: 70/19

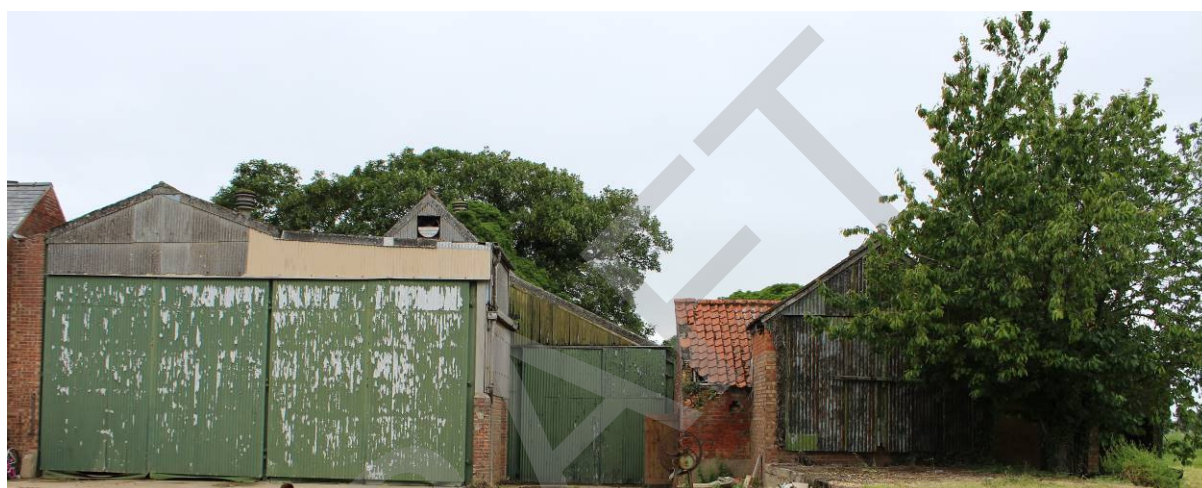
**Plate 1.** Panton House Barns, enclosed by modern additions

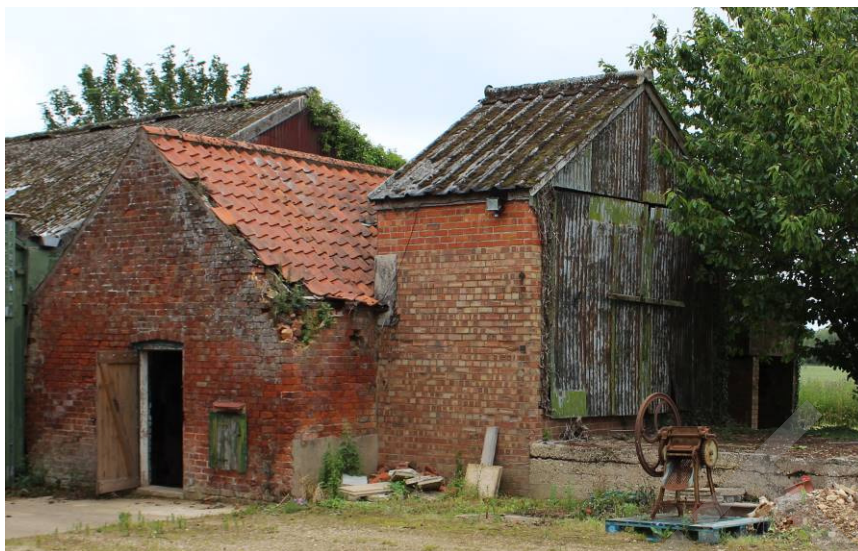
Much of the external southeast elevation of the stable is covered by a 20<sup>th</sup> century brick structure designed for the unloading of grain into the sheds. The front and roof are corrugated metal and it is accessed by a concrete ramp and platform.

**Plate 2.**  
The southwest elevation of the stable

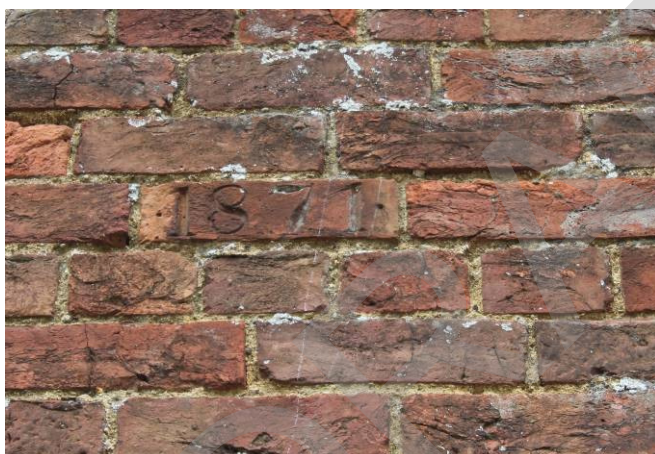
The southwest elevation of the stable has a central door with segmental arch,<sup>3</sup> next to which is a small recess in the wall, a later addition. This is covered with a small wooden door.

Above the door is a brick carved with the date 1871.

**Plate 3.** Detail of the dated brick above the door in the southwest elevation of the stable

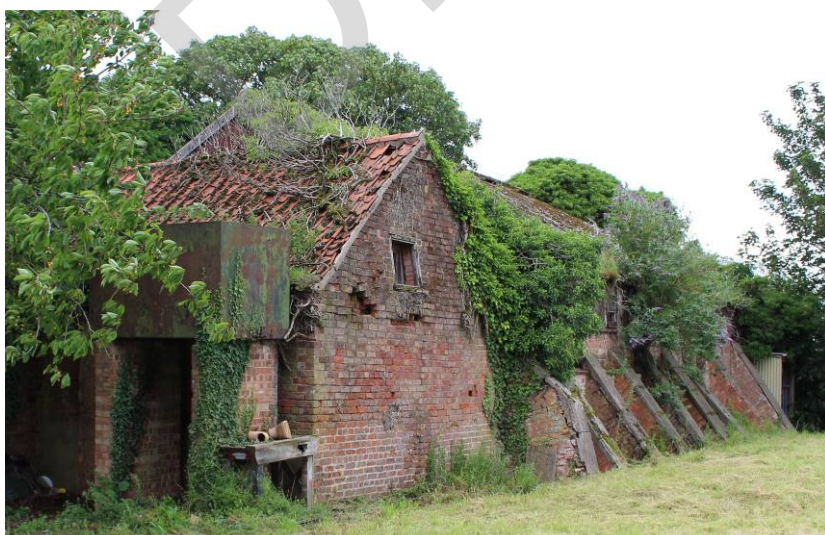
The remainder of the southeast elevation of the stable is overgrown and also covered by two brick pillars supporting a water tank. Between this and the grain door is an aperture for a later door. The northeast elevation is plain, aside from an aperture knocked through in the 20<sup>th</sup> century.

**Plate 4.** Oblique view, northeast elevation of the stable

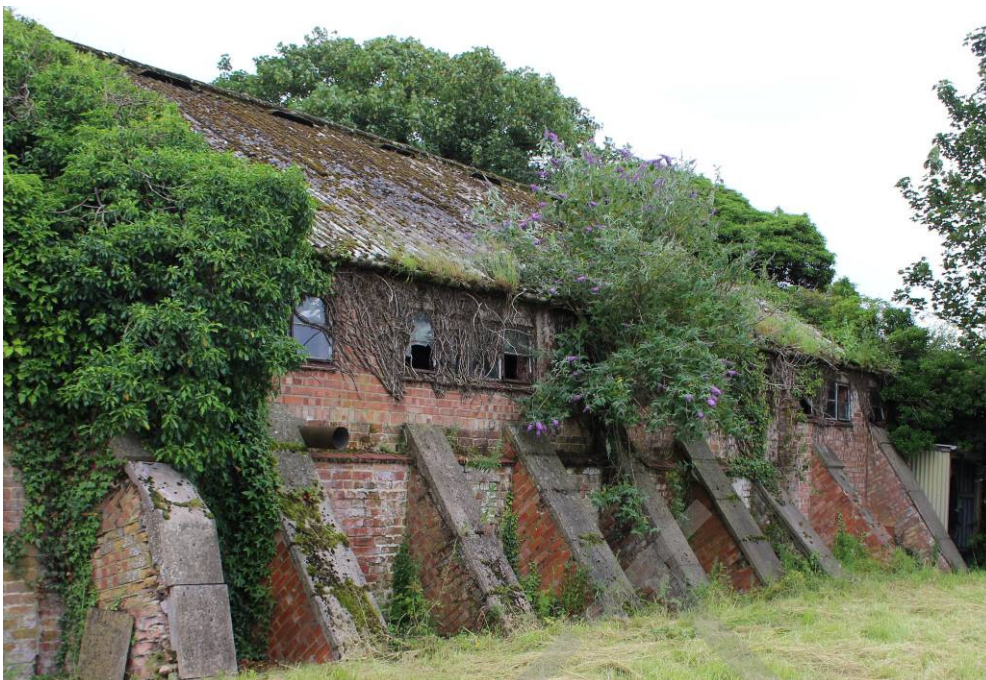
**Plate 5**

Abutting the stable wall, to the northwest is a low wall capped with tiles. Later than the stable it forms the earlier of two additional phases. The second phase saw the wall buttressed with 20<sup>th</sup> century brick and then further raised with modern brick to form the northeast wall of the modern grain storage shed.

Two phases of later addition to the northwest of the historic stable

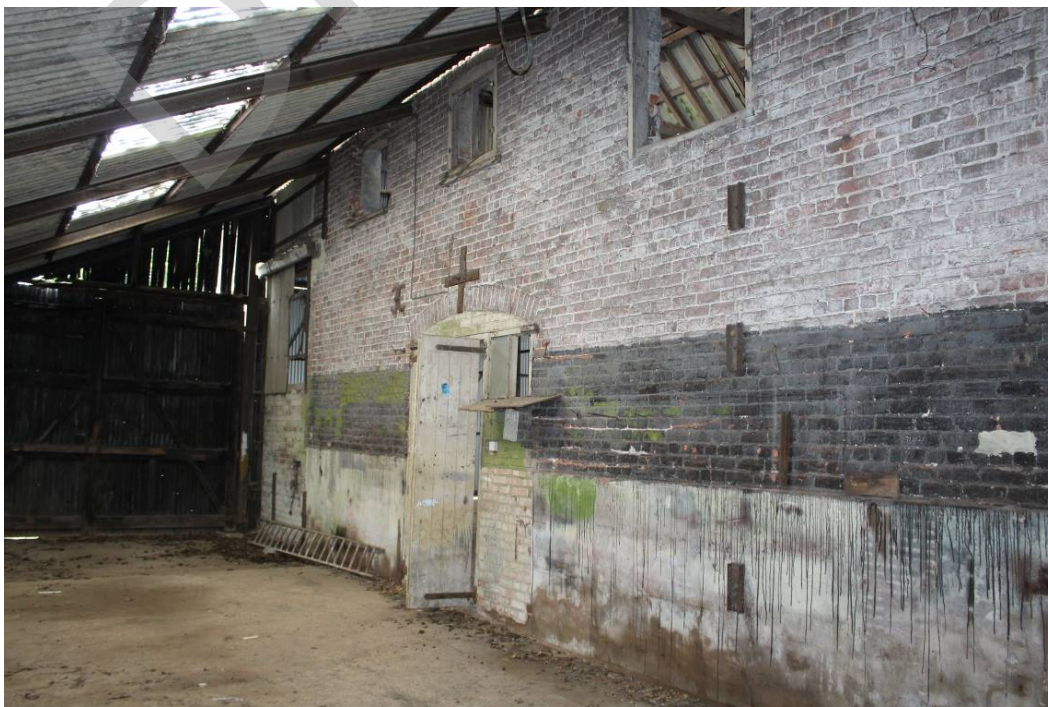
**Plate 6**

The northeast elevation of the threshing barn, looking south

On the northeast elevation, the lower third of the threshing barn wall has been painted, at the bottom with limewash and above with bitumen indicating the presence of livestock.

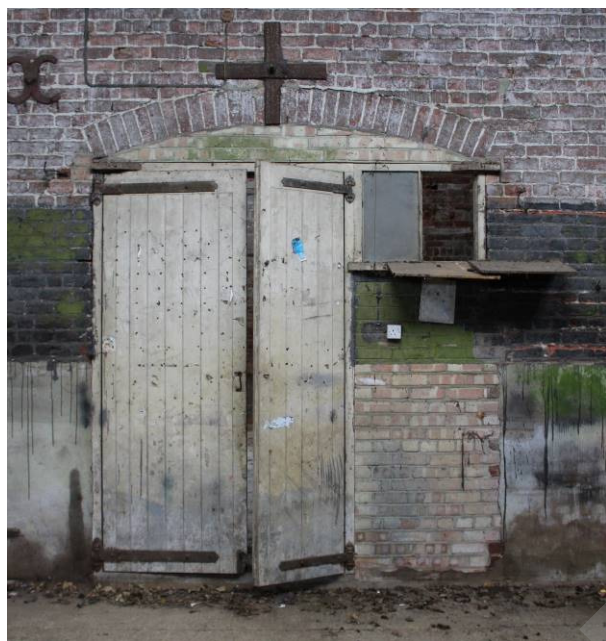
The threshing door in this elevation is topped with a segmental arch of bricks laid as soldiers.<sup>4</sup> At some stage the door has been infilled using 20<sup>th</sup> century bricks to create a smaller door aperture and a window, probably before the building was encapsulated.

Above the door is an iron cross tie plate with another smaller one to the southeast. There is a similar tie on the northwest corner.

**Plate 7.** The wide door to the northeast elevation of the threshing barn, infilled in the 20<sup>th</sup> century

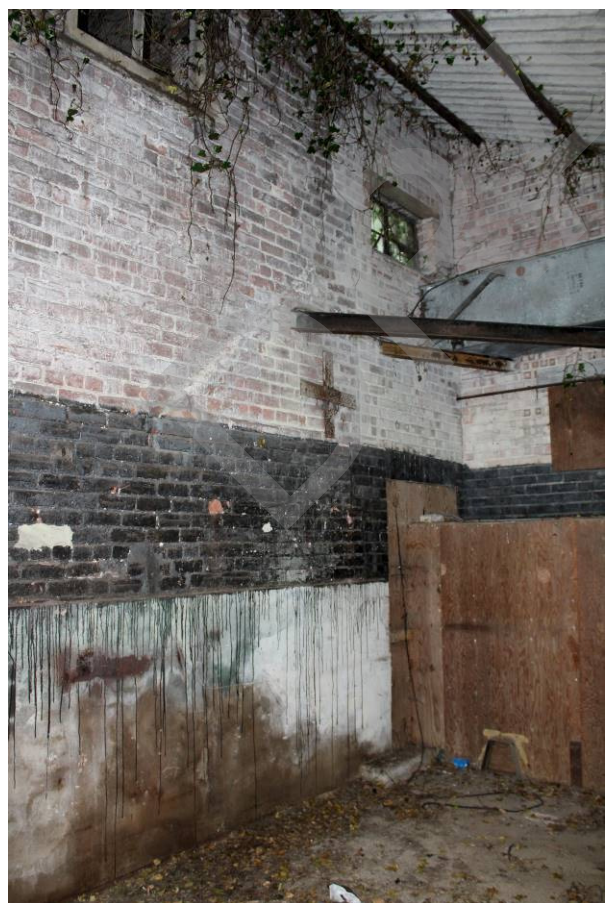
The windows to the upper floor of the threshing barn are original, each topped with a segmental arch, although the frames are later replacements.

At the northwest end, below the window level, there is evidence of the roof of the now demolished shelter shed roof which has left a scar on the brickwork of the bar.

The northwest end has also been extended with a wall enclosing the area behind the barn.

A door has been added allowing access between the two areas.

Spanning the corner is a metal girder which suggests a removed floor. The window in the extension is plain with a straight lintel of bricks laid as a rowlock course.<sup>5</sup>

**Plate 8.** The northwest corner of the northeast elevation of the threshing barn

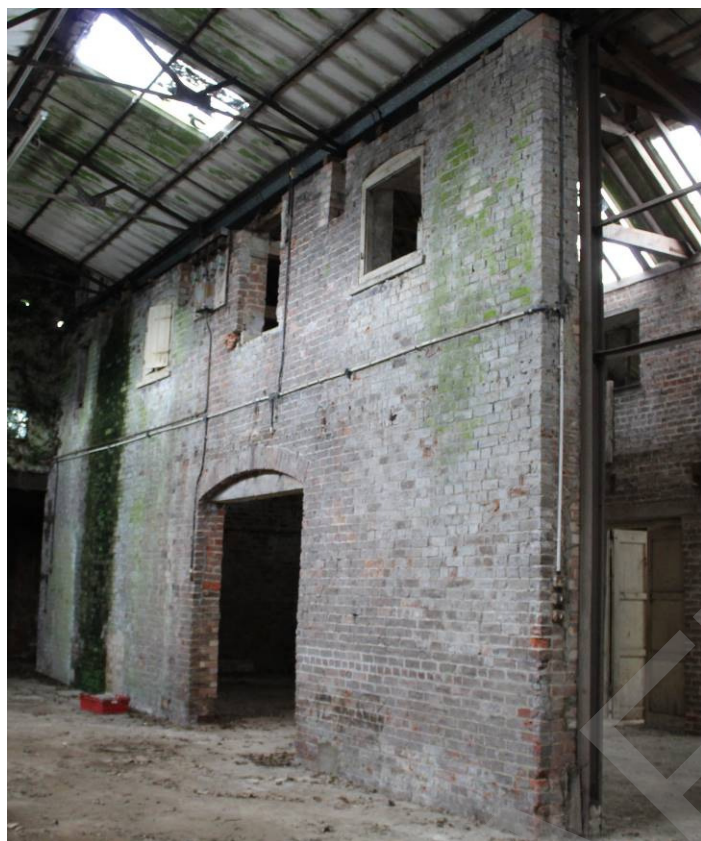
**Plate 9** (above). Blocked door, northeast end of the southwest elevation of the threshing barn

At the southwest end, a door aperture has been blocked with 20<sup>th</sup> century brick. It appears to have had an arched top and was probably an original feature of the barn. Slightly to the southeast of this is a low, blocked aperture corresponding with an internal recess.

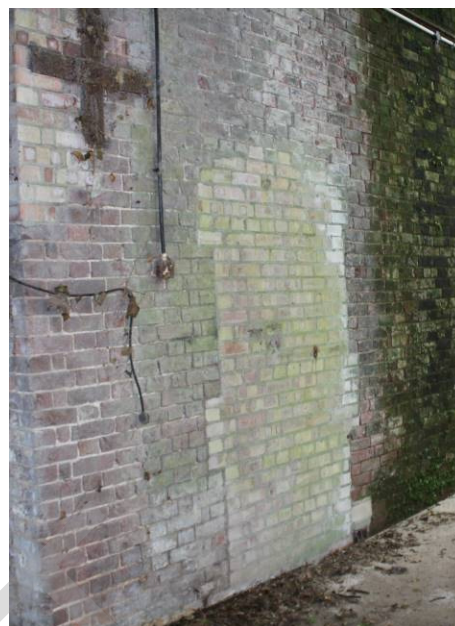
The southwest elevation of the barn is dominated by the opposing threshing door to that on the northeast elevation. This door has not been blocked and retains its original aperture.

**Plate 10** (left). The southwest elevation of the threshing barn

Each of the window apertures are original and mirror those in the northeast elevation. The window immediately above the threshing door has been extended upwards, probably to accommodate modern machinery.

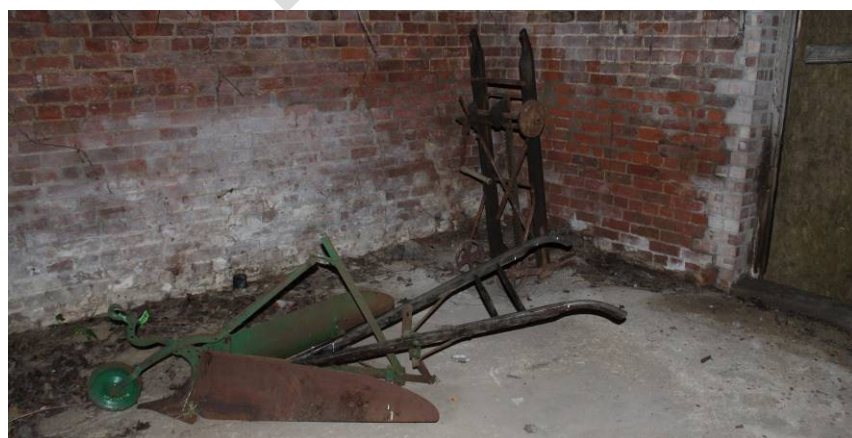
The larger of the two rooms has had the entirety of the northwest elevation demolished and then partially rebuilt with 20<sup>th</sup> century bricks. The later door added to the southeast elevation is also surrounded by bricks of this date.

**Plate 11.** Antique farm machinery in the stable

Any fixtures in the room have been removed, all that remains on the concrete floor are two pieces of antique farm machinery, a small plough and a sack lifter.

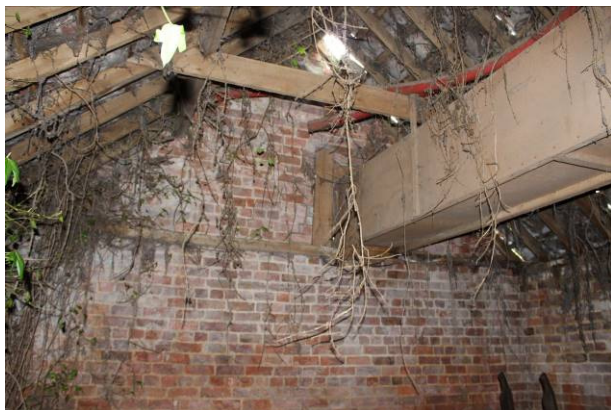
The roof timbers throughout the stable appear to be replacements and may have been added when the additional frontage for the grain loading machinery was added.

**Plate 12** (above). Roof timbers and a probable air duct for the modern grain machinery in the stable, looking northeast.

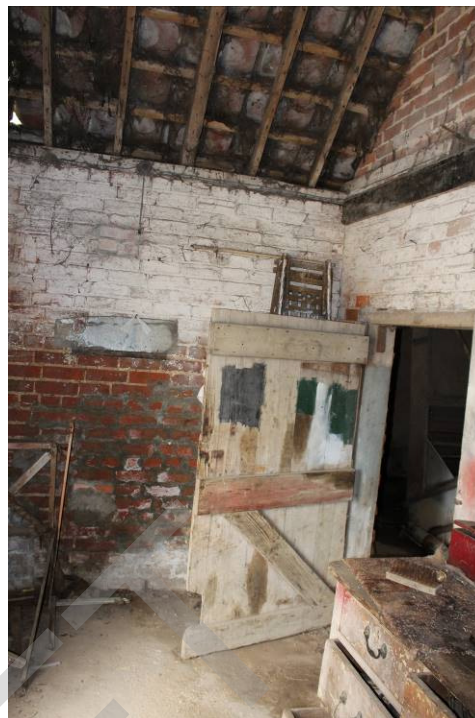
**Plate 13** (right). View from the entrance to the tack room, looking north towards the internal door to the stable.

The smaller of the two rooms would have served as a tack room. The floor of the room has been lowered from the original and a concrete floor has been poured in its place. In the northeast corner is the door giving access from the tack room into the stable. All fixtures and fittings have been removed from this room also.

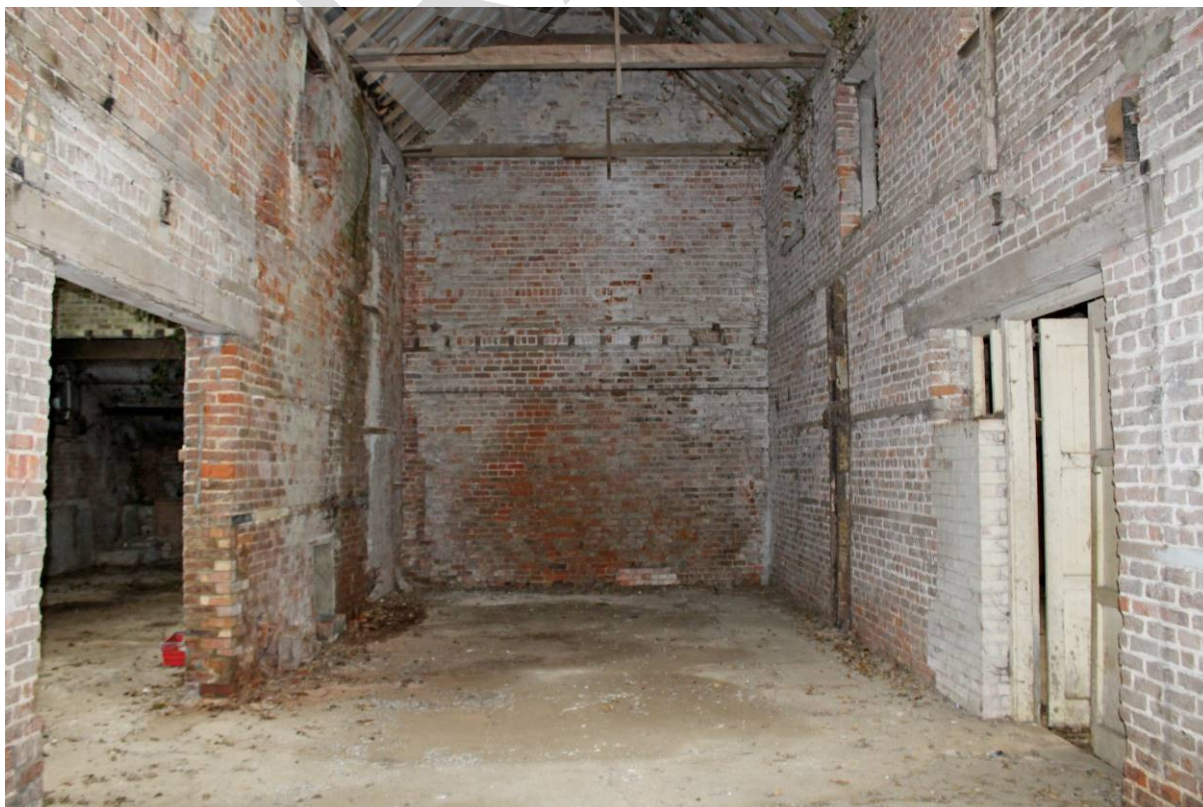
**Plate 14**  
The internal view of the threshing barn, looking northwest

There are few notable features on the internal elevations of the threshing barn. Of note are bands of bricks laid as a rowlock<sup>6</sup> course at regular spaced heights along the internal walls (Fig. 6). These courses are more prevalent on the internal northeast elevation.

On the internal southeast elevation (Plate 14), wooden beams that would have supported the upper floor can be seen.

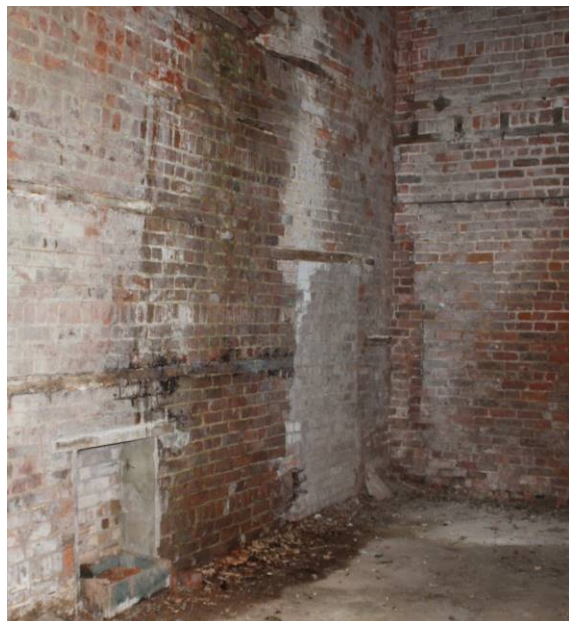
**Plate 15**

Recess next to the blocked door in the internal northeast elevation of the threshing barn

Slightly to the southeast of the blocked door, as seen externally, there is, on the internal northeast elevation, a small recess at ground level (seen externally as a blocked aperture). This probably served as an aperture for historic threshing machinery. On the internal southwest elevation is a small blocked ventilation slit.

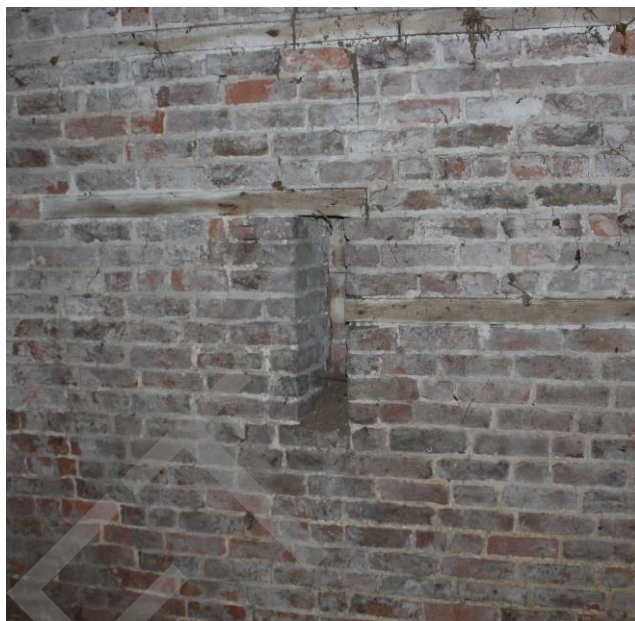
**Plate 16**

Blocked ventilation slit in the internal southwest elevation of the threshing barn

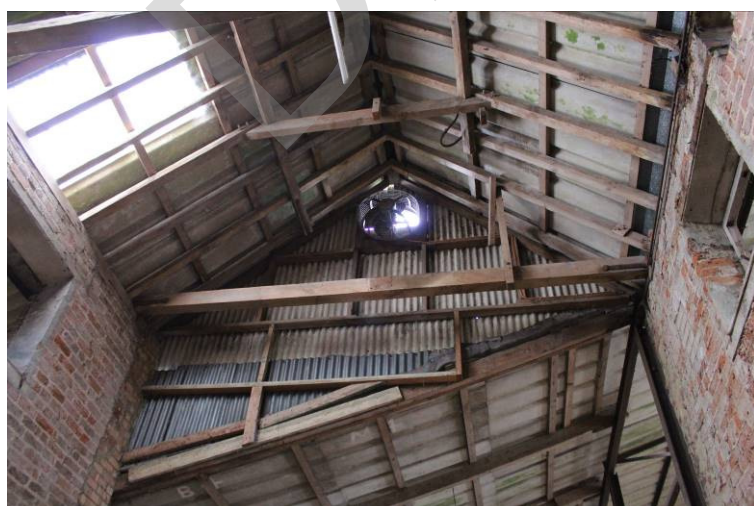
The southeast gable end of the barn (internal northwest elevation) has been removed entirely, as has the roof, although much of the original timber is still extant. The original tiles have been removed and replaced with corrugated metal. A new metal gable with an integral air vent has also been added at the southeast end.

**Plate 17.** Detail of the roof timbers over the removed southeast gable end of the threshing barn

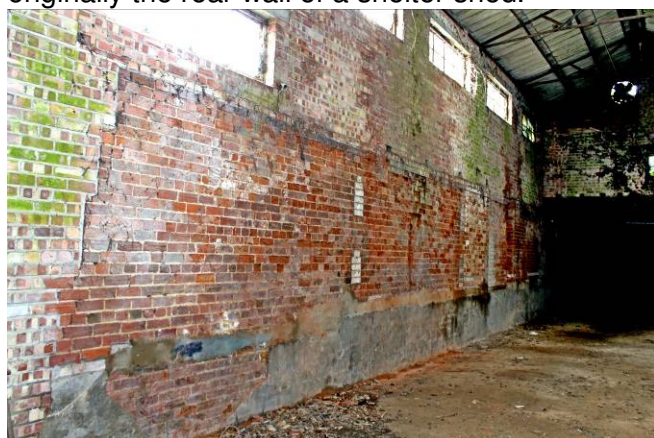
**Plate 18**

To the southwest of the threshing barn, the lower part of the wall that forms the southwest external wall of the encapsulated area dates from a similar period to the threshing barn. This wall was the southwest external wall of the separate structure that may have been a piggery. The wall was heightened in the 20<sup>th</sup> century and extended south-eastwards to form the

Internal view of the southwest wall of the grain processing shed; an extended wall of a former building, possibly a piggery

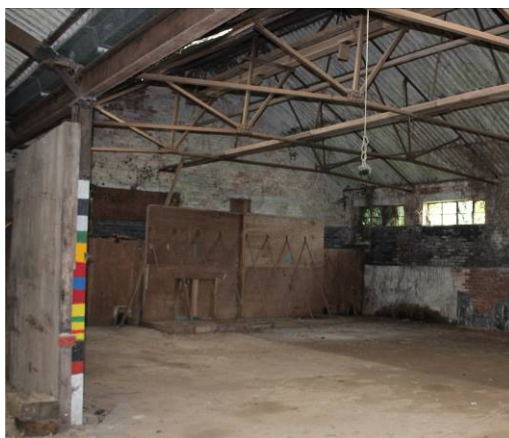
**Plate 19**

current grain processing sheds. The north-western wall of the modern grain sheds (Plate 19), although mostly covered in wooden board, was altered in the same manner and was originally the rear wall of a shelter shed.

View to the northwest wall of the grain shed, the lower part of which dates to the 19<sup>th</sup> century and was part of a probable shelter shed
