**HISTORIC BUILDING RECORDING  
PANTON HOUSE BARN  
HEDGEFIELD HURN  
RISEGATE  
GOSBERTON  
LINCOLNSHIRE**

Prepared For  
TAC Architects  
By  
Neil Parker MA

October 2019

APS Report No: 70/19

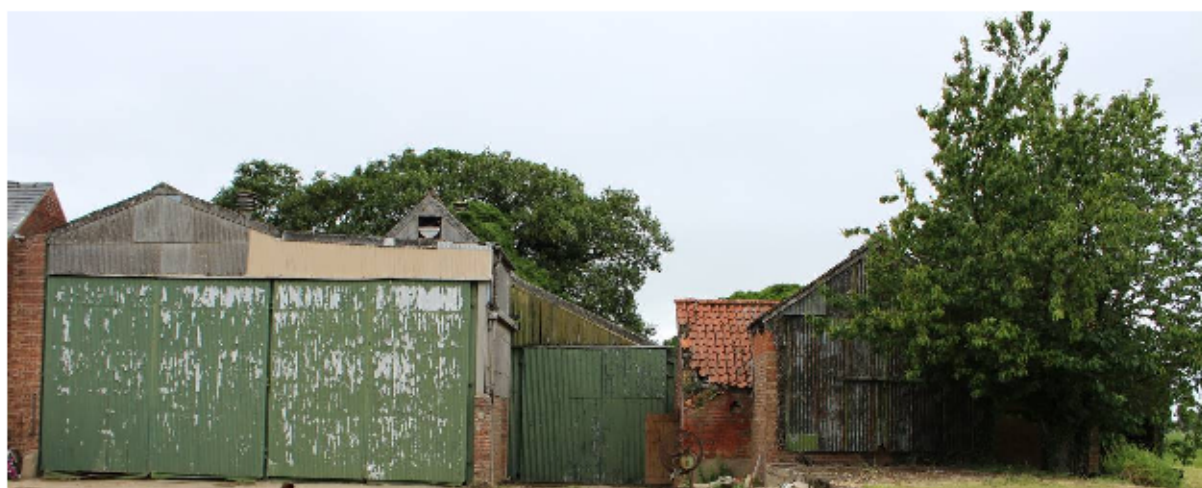
**Plate 1.** Panton House Barns, enclosed by modern additions

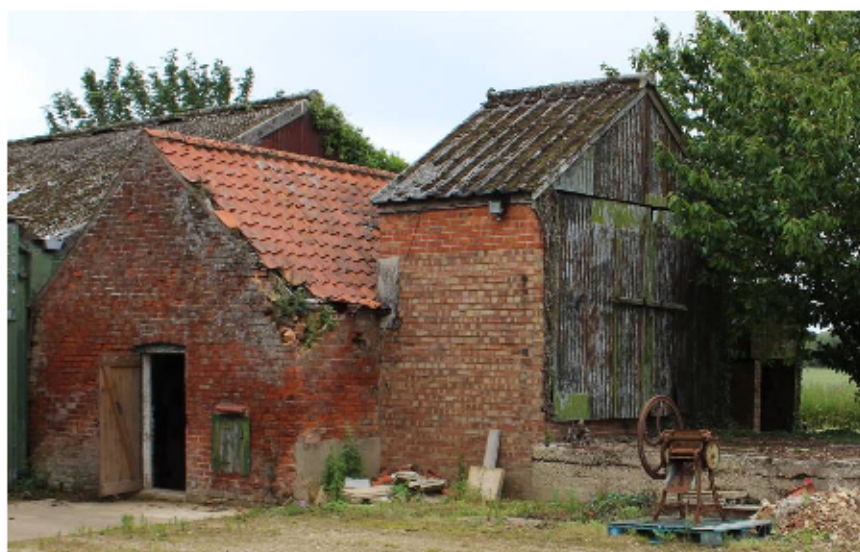
**Plate 2.**  
The southwest elevation of the stable

Much of the external southeast elevation of the stable is covered by a 20<sup>th</sup> century brick structure designed for the unloading of grain into the sheds. The front and roof are corrugated metal and it is accessed by a concrete ramp and platform.

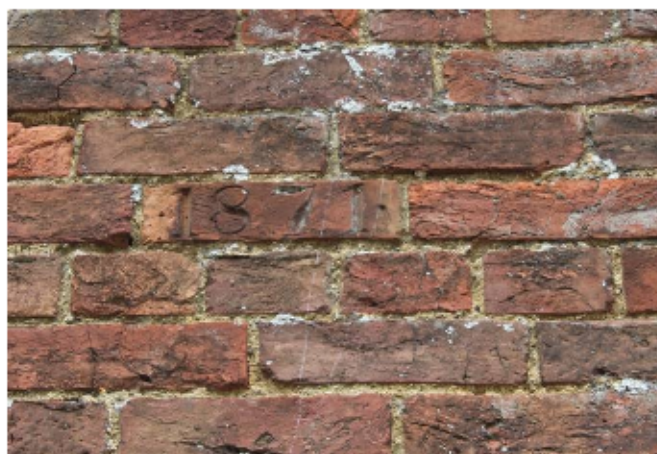
The southwest elevation of the stable has a central door with segmental arch,<sup>3</sup> next to which is a small recess in the wall, a later addition. This is covered with a small wooden door.

Above the door is a brick carved with the date 1871.

**Plate 3.** Detail of the dated brick above the door in the southwest elevation of the stable

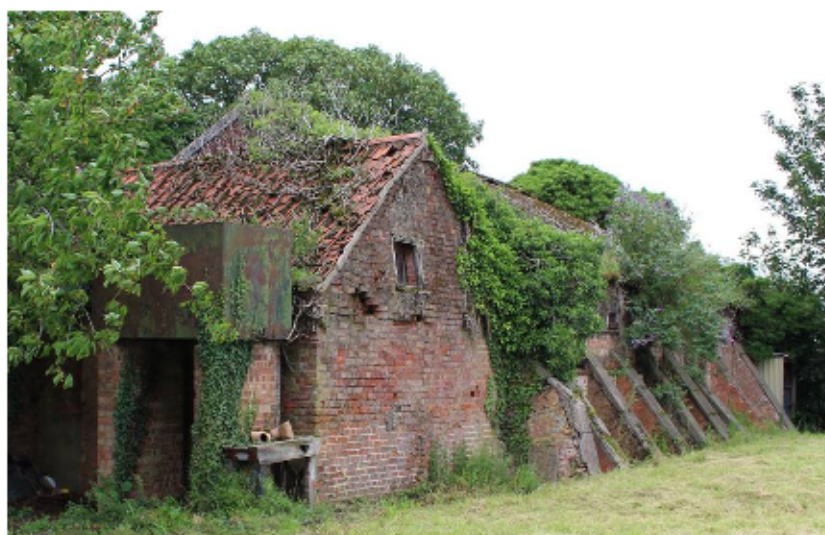
The remainder of the southeast elevation of the stable is overgrown and also covered by two brick pillars supporting a water tank. Between this and the grain door is an aperture for a later door. The northeast elevation is plain, aside from an aperture knocked through in the 20<sup>th</sup> century.

**Plate 4.** Oblique view, northeast elevation of the stable

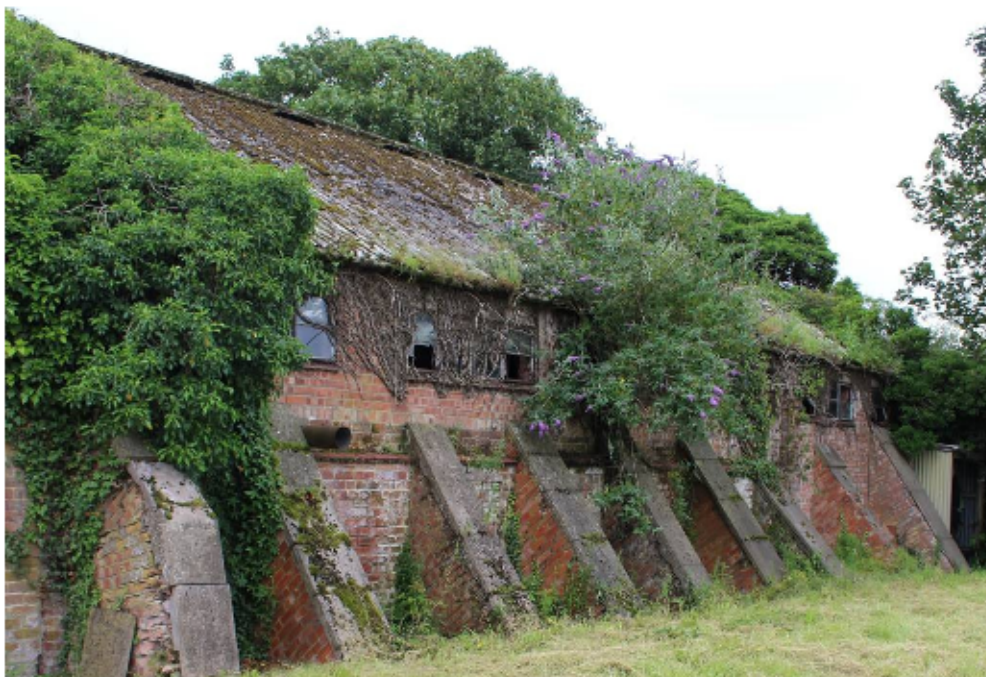
**Plate 5**

Abutting the stable wall, to the northwest is a low wall capped with tiles. Later than the stable it forms the earlier of two additional phases. The second phase saw the wall buttressed with 20<sup>th</sup> century brick and then further raised with modern brick to form the northeast wall of the modern grain storage shed.

Two phases of later addition to the northwest of the historic stable

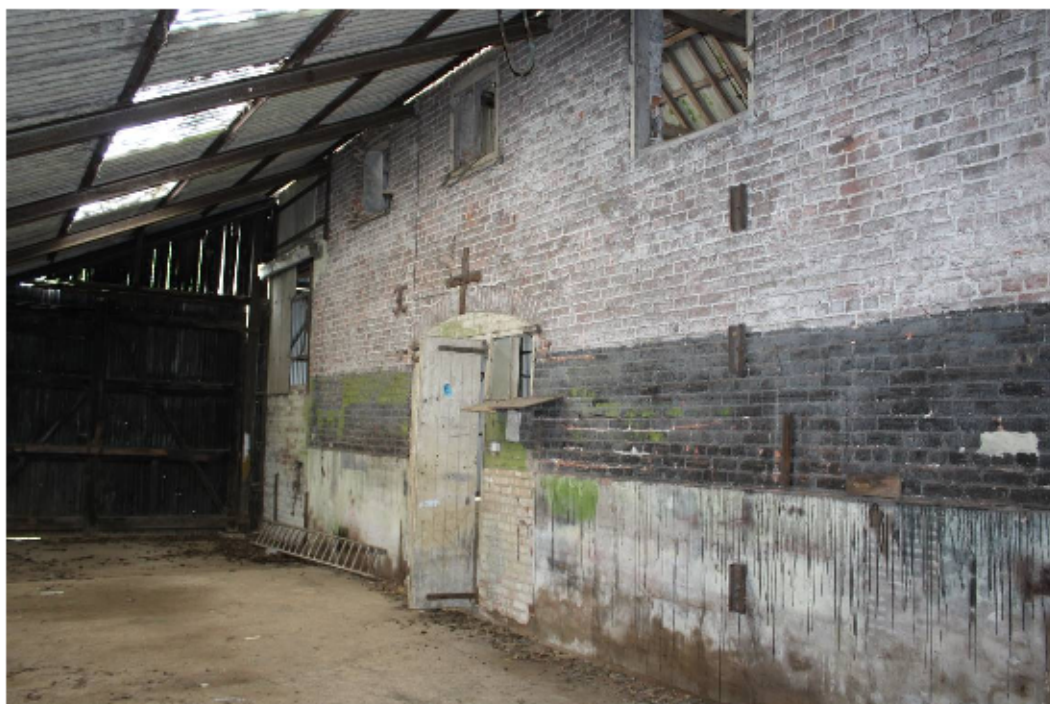
**Plate 6**

The northeast elevation of the threshing barn, looking south

On the northeast elevation, the lower third of the threshing barn wall has been painted, at the bottom with limewash and above with bitumen indicating the presence of livestock.

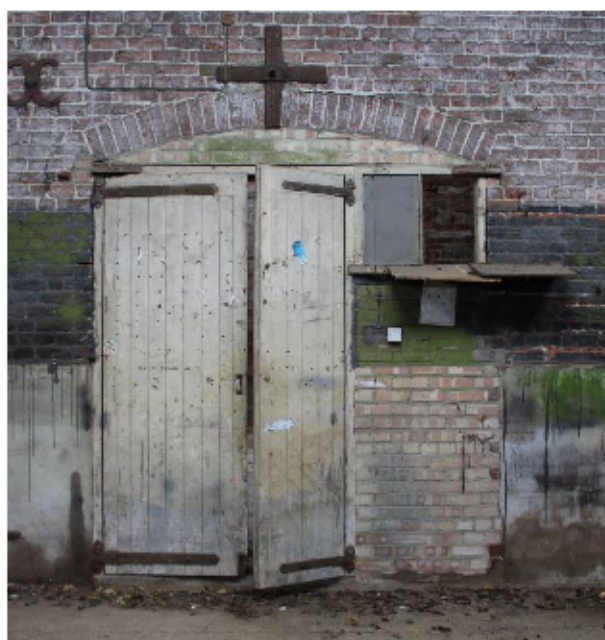
The threshing door in this elevation is topped with a segmental arch of bricks laid as soldiers.<sup>4</sup> At some stage the door has been infilled using 20<sup>th</sup> century bricks to create a smaller door aperture and a window, probably before the building was encapsulated.

Above the door is an iron cross tie plate with another smaller one to the southeast. There is a similar tie on the northwest corner.

**Plate 7.** The wide door to the northeast elevation of the threshing barn, infilled in the 20<sup>th</sup> century

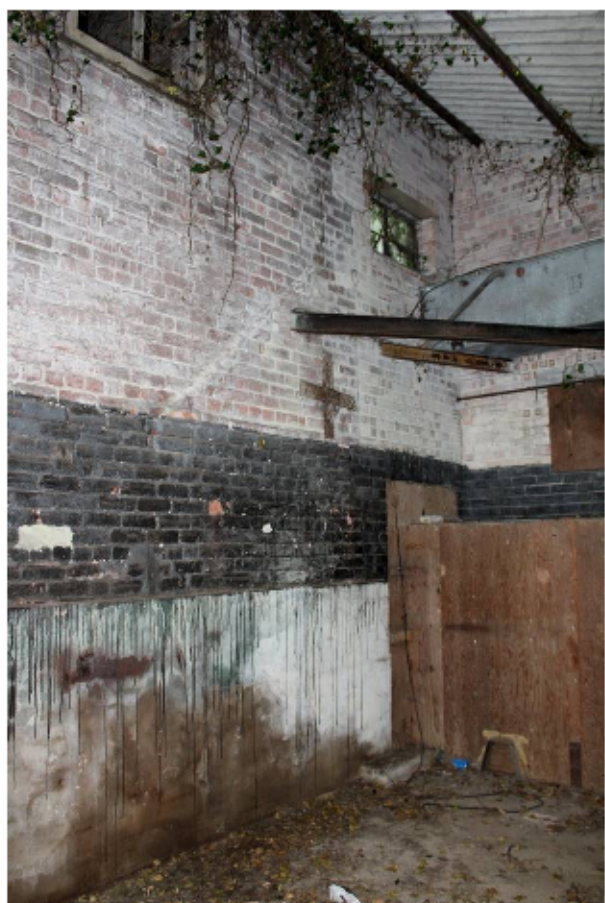
The windows to the upper floor of the threshing barn are original, each topped with a segmental arch, although the frames are later replacements.

At the northwest end, below the window level, there is evidence of the roof of the now demolished shelter shed roof which has left a scar on the brickwork of the bar.

The northwest end has also been extended with a wall enclosing the area behind the barn.

A door has been added allowing access between the two areas.

Spanning the corner is a metal girder which suggests a removed floor. The window in the extension is plain with a straight lintel of bricks laid as a rowlock course.<sup>5</sup>

**Plate 8.** The northwest corner of the northeast elevation of the threshing barn

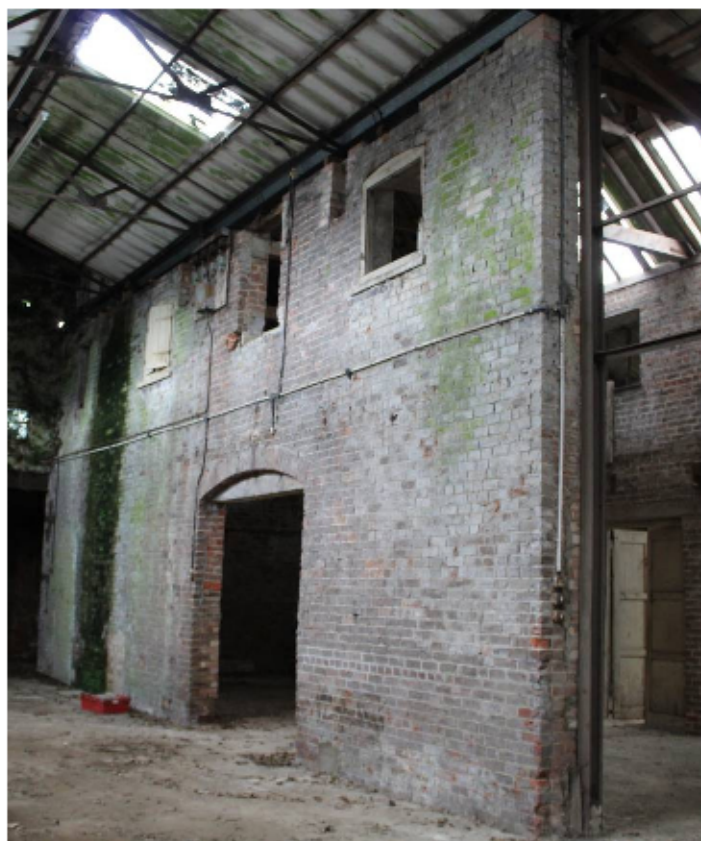
**Plate 9** (above). Blocked door, northeast end of the southwest elevation of the threshing barn

At the southwest end, a door aperture has been blocked with 20<sup>th</sup> century brick. It appears to have had an arched top and was probably an original feature of the barn. Slightly to the southeast of this is a low, blocked aperture corresponding with an internal recess.

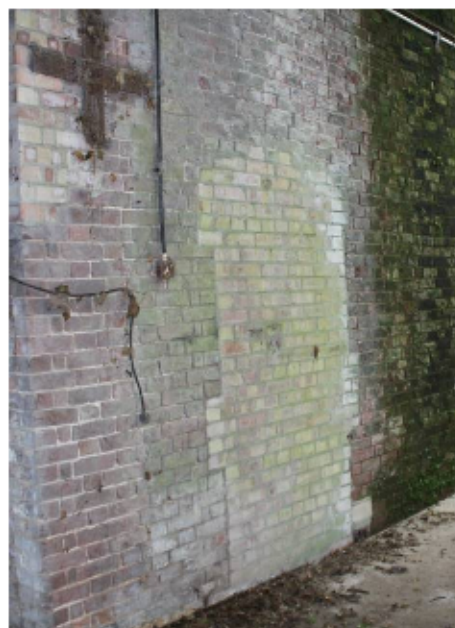
The southwest elevation of the barn is dominated by the opposing threshing door to that on the northeast elevation. This door has not been blocked and retains its original aperture.

**Plate 10** (left). The southwest elevation of the threshing barn

Each of the window apertures are original and mirror those in the northeast elevation. The window immediately above the threshing door has been extended upwards, probably to accommodate modern machinery.

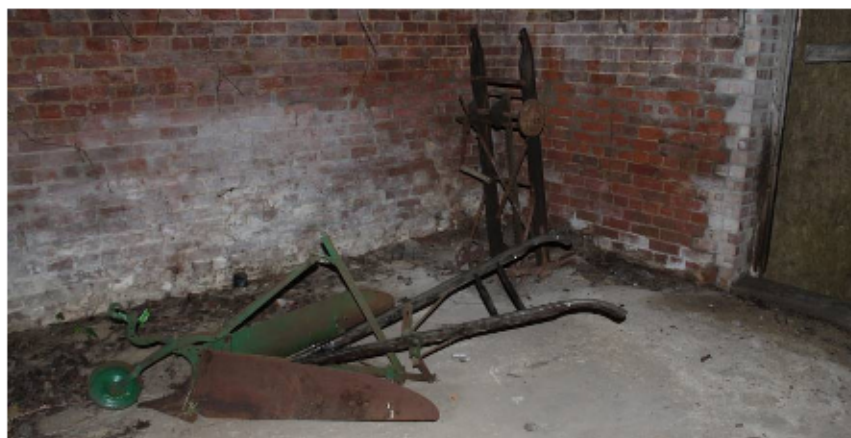
The larger of the two rooms has had the entirety of the northwest elevation demolished and then partially rebuilt with 20<sup>th</sup> century bricks. The later door added to the southeast elevation is also surrounded by bricks of this date.

**Plate 11.** Antique farm machinery in the stable

Any fixtures in the room have been removed, all that remains on the concrete floor are two pieces of antique farm machinery, a small plough and a sack lifter.

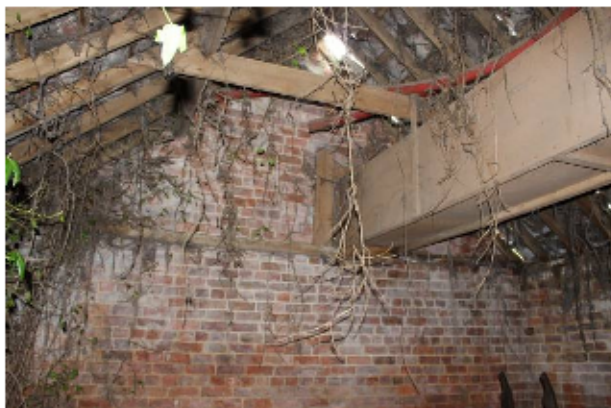
The roof timbers throughout the stable appear to be replacements and may have been added when the additional frontage for the grain loading machinery was added.

**Plate 12** (above). Roof timbers and a probable air duct for the modern grain machinery in the stable, looking northeast.

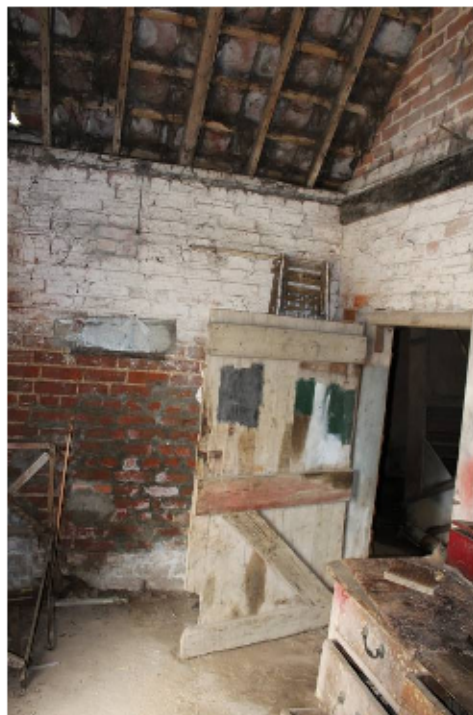
**Plate 13** (right). View from the entrance to the tack room, looking north towards the internal door to the stable.

The smaller of the two rooms would have served as a tack room. The floor of the room has been lowered from the original and a concrete floor has been poured in its place. In the northeast corner is the door giving access from the tack room into the stable. All fixtures and fittings have been removed from this room also.

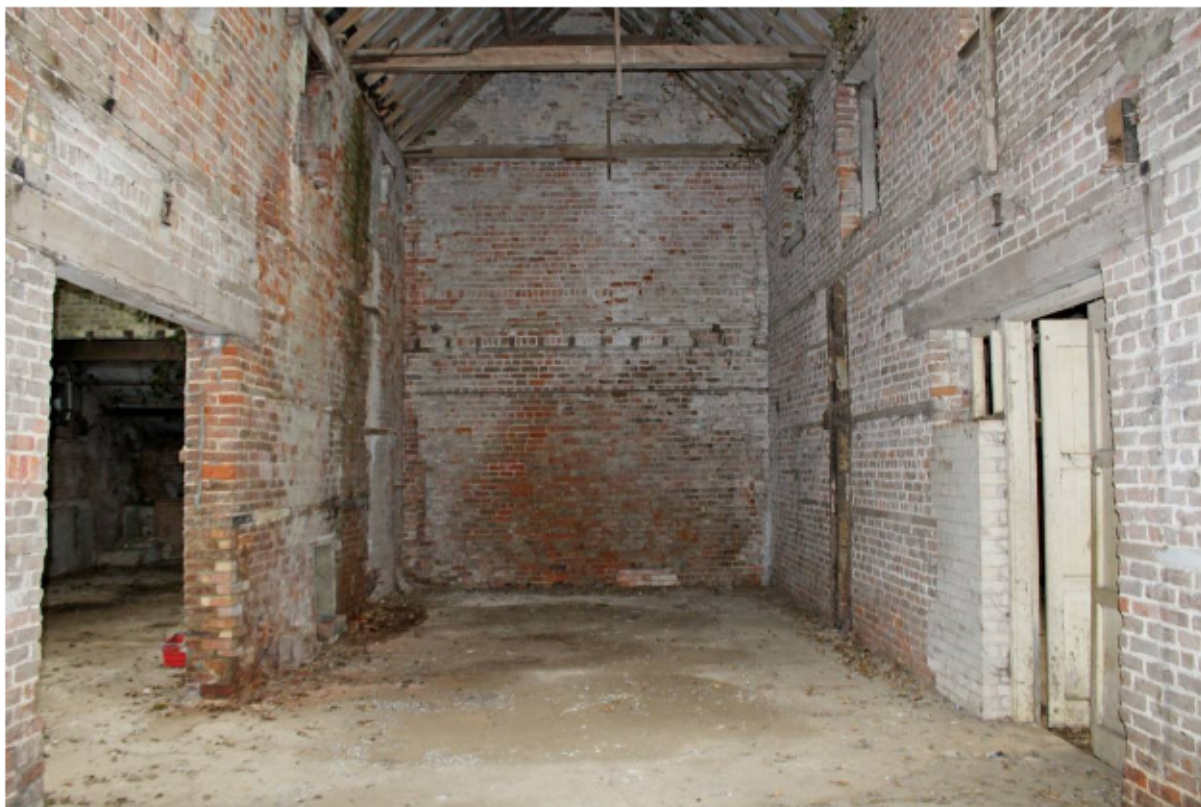
**Plate 14**  
The internal view of the threshing barn, looking northwest

There are few notable features on the internal elevations of the threshing barn. Of note are bands of bricks laid as a rowlock<sup>6</sup> course at regular spaced heights along the internal walls (Fig. 6). These courses are more prevalent on the internal northeast elevation.

On the internal southeast elevation (Plate 14), wooden beams that would have supported the upper floor can be seen.

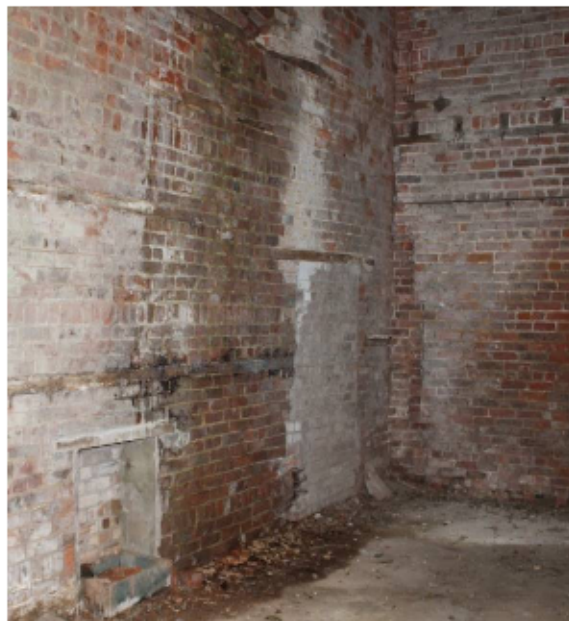
**Plate 15**

Recess next to the blocked door in the internal northeast elevation of the threshing barn

Slightly to the southeast of the blocked door, as seen externally, there is, on the internal northeast elevation, a small recess at ground level (seen externally as a blocked aperture). This probably served as an aperture for historic threshing machinery. On the internal southwest elevation is a small blocked ventilation slit.

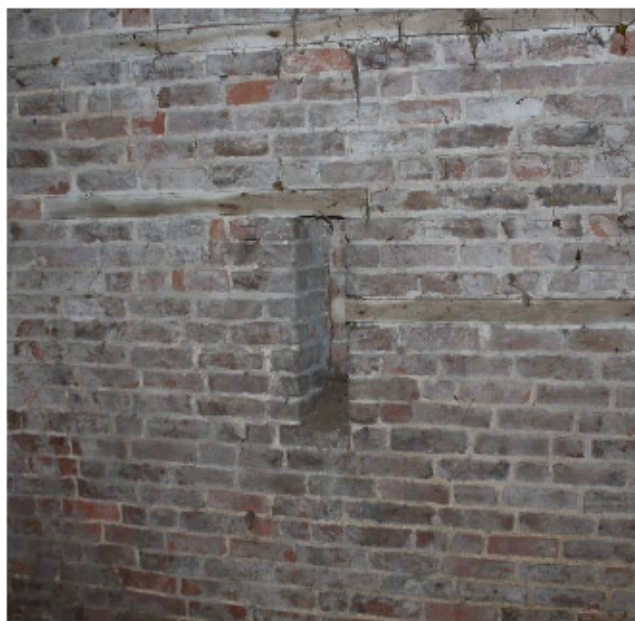
**Plate 16**

Blocked ventilation slit in the internal southwest elevation of the threshing barn

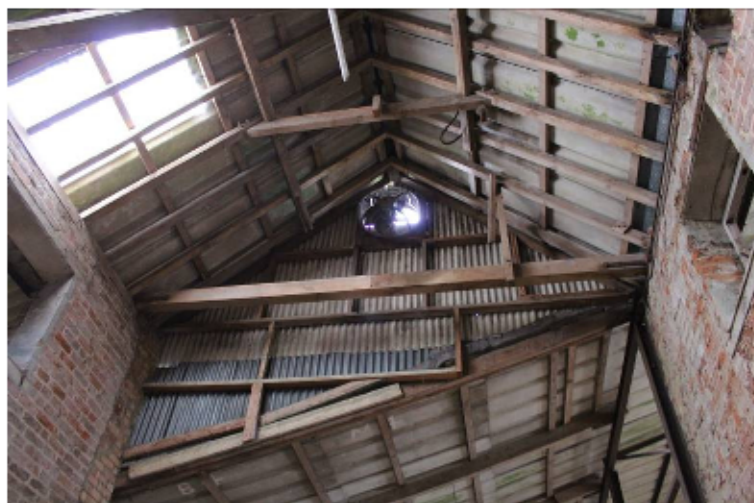
The southeast gable end of the barn (internal northwest elevation) has been removed entirely, as has the roof, although much of the original timber is still extant. The original tiles have been removed and replaced with corrugated metal. A new metal gable with an integral air vent has also been added at the southeast end.

**Plate 17.** Detail of the roof timbers over the removed southeast gable end of the threshing barn

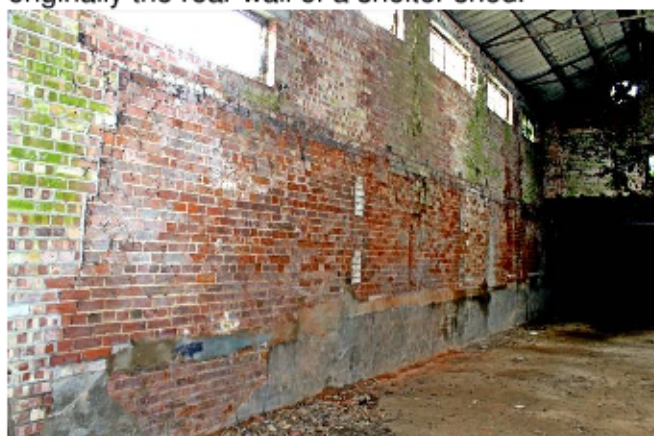
**Plate 18**

To the southwest of the threshing barn, the lower part of the wall that forms the southwest external wall of the encapsulated area dates from a similar period to the threshing barn. This wall was the southwest external wall of the separate structure that may have been a piggery. The wall was heightened in the 20<sup>th</sup> century and extended south-eastwards to form the

Internal view of the southwest wall of the grain processing shed; an extended wall of a former building, possibly a piggery

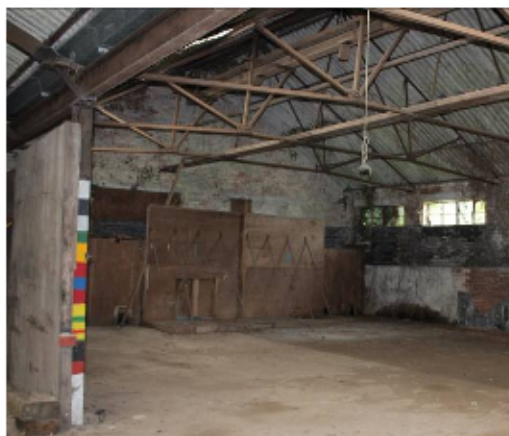
**Plate 19**

current grain processing sheds. The north-western wall of the modern grain sheds (Plate 19), although mostly covered in wooden board, was altered in the same manner and was originally the rear wall of a shelter shed.

View to the northwest wall of the grain shed, the lower part of which dates to the 19<sup>th</sup> century and was part of a probable shelter shed
