Our ref: CE24/4214/RAC/REB

**Farm Building Cheal Road, Gosberton, Spalding, Lincolnshire, PE11 4JG**

Thank you for your instructions to undertake a structural assessment of the outbuilding at the property and to report on the necessary structural works to carry out conversions to domestic accommodation.

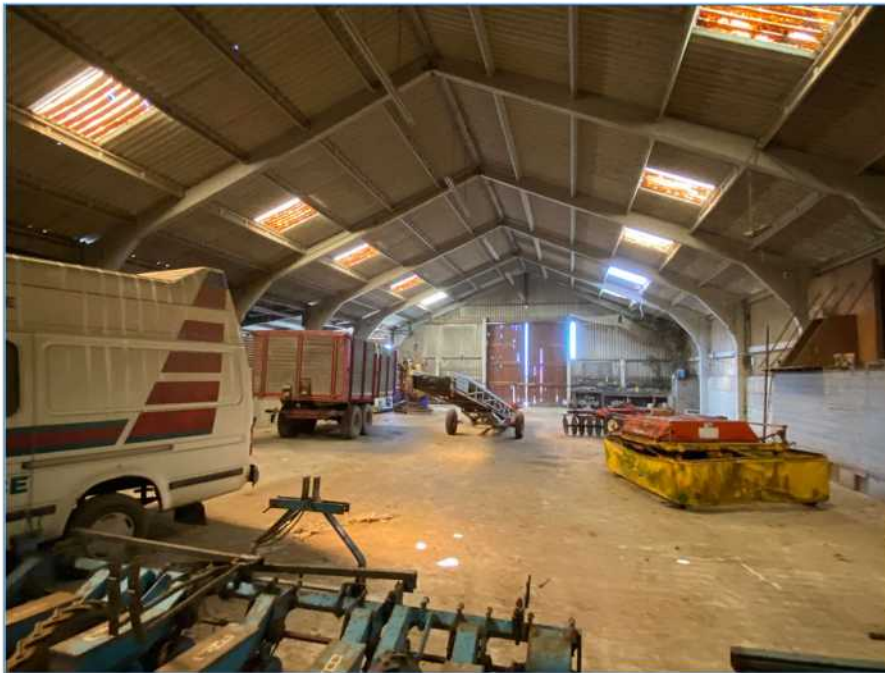
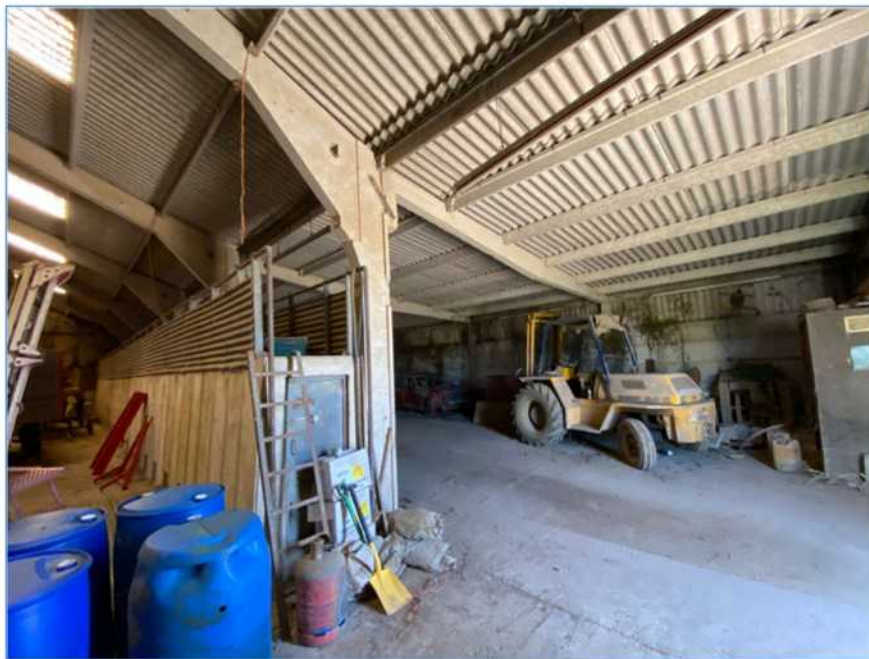
There is a ground slab throughout which measures approximately 100mm thick where visible. The slab has been cast in approximately 4m wide strips the full length of the building, and as such shrinkage cracks are evident at approximately 15m c/c along the strips.

The precast frame appears to be in reasonable condition with no significant defects noted. However, there is evidence of vehicle impact to the front and rear precast panels adjacent to the door openings. Precast panels vary in height around the perimeter; above the panels and over the roof is clad in a fibre reinforced cementitious corrugated sheets

which are supported by a mixture of precast and steel purlins. The roof cladding has some localised damaged and daylight can be seen coming through.

Some localised replacement or strengthening of secondary members will likely be required where these have been damaged in the past by the agricultural usage.

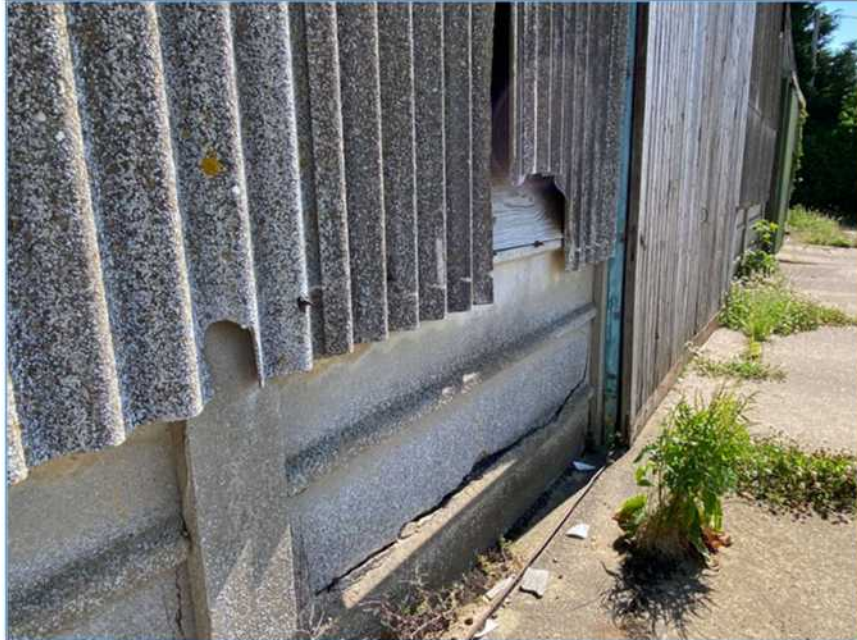
The outside of the building as significant vegetation growth on the east and north elevations; there is another building partly obscuring the west elevation. The vegetation has started to protrude to the inside.

The gable ends have precast columns cantilevering out the ground to support the gable end cladding; the top of the gable end columns are not fixed back to the end frame. This suggests that the foundations are substantial to provide a robust cantilever base. No settlement of the frame was noted which suggests the foundations are similar to the main frames.
