# **N J PACEY LANDSCAPING**

## **Tree Safety Survey Report**

**21 Westhorpe Road  
Gosberton**

**3<sup>rd</sup> June 2024**

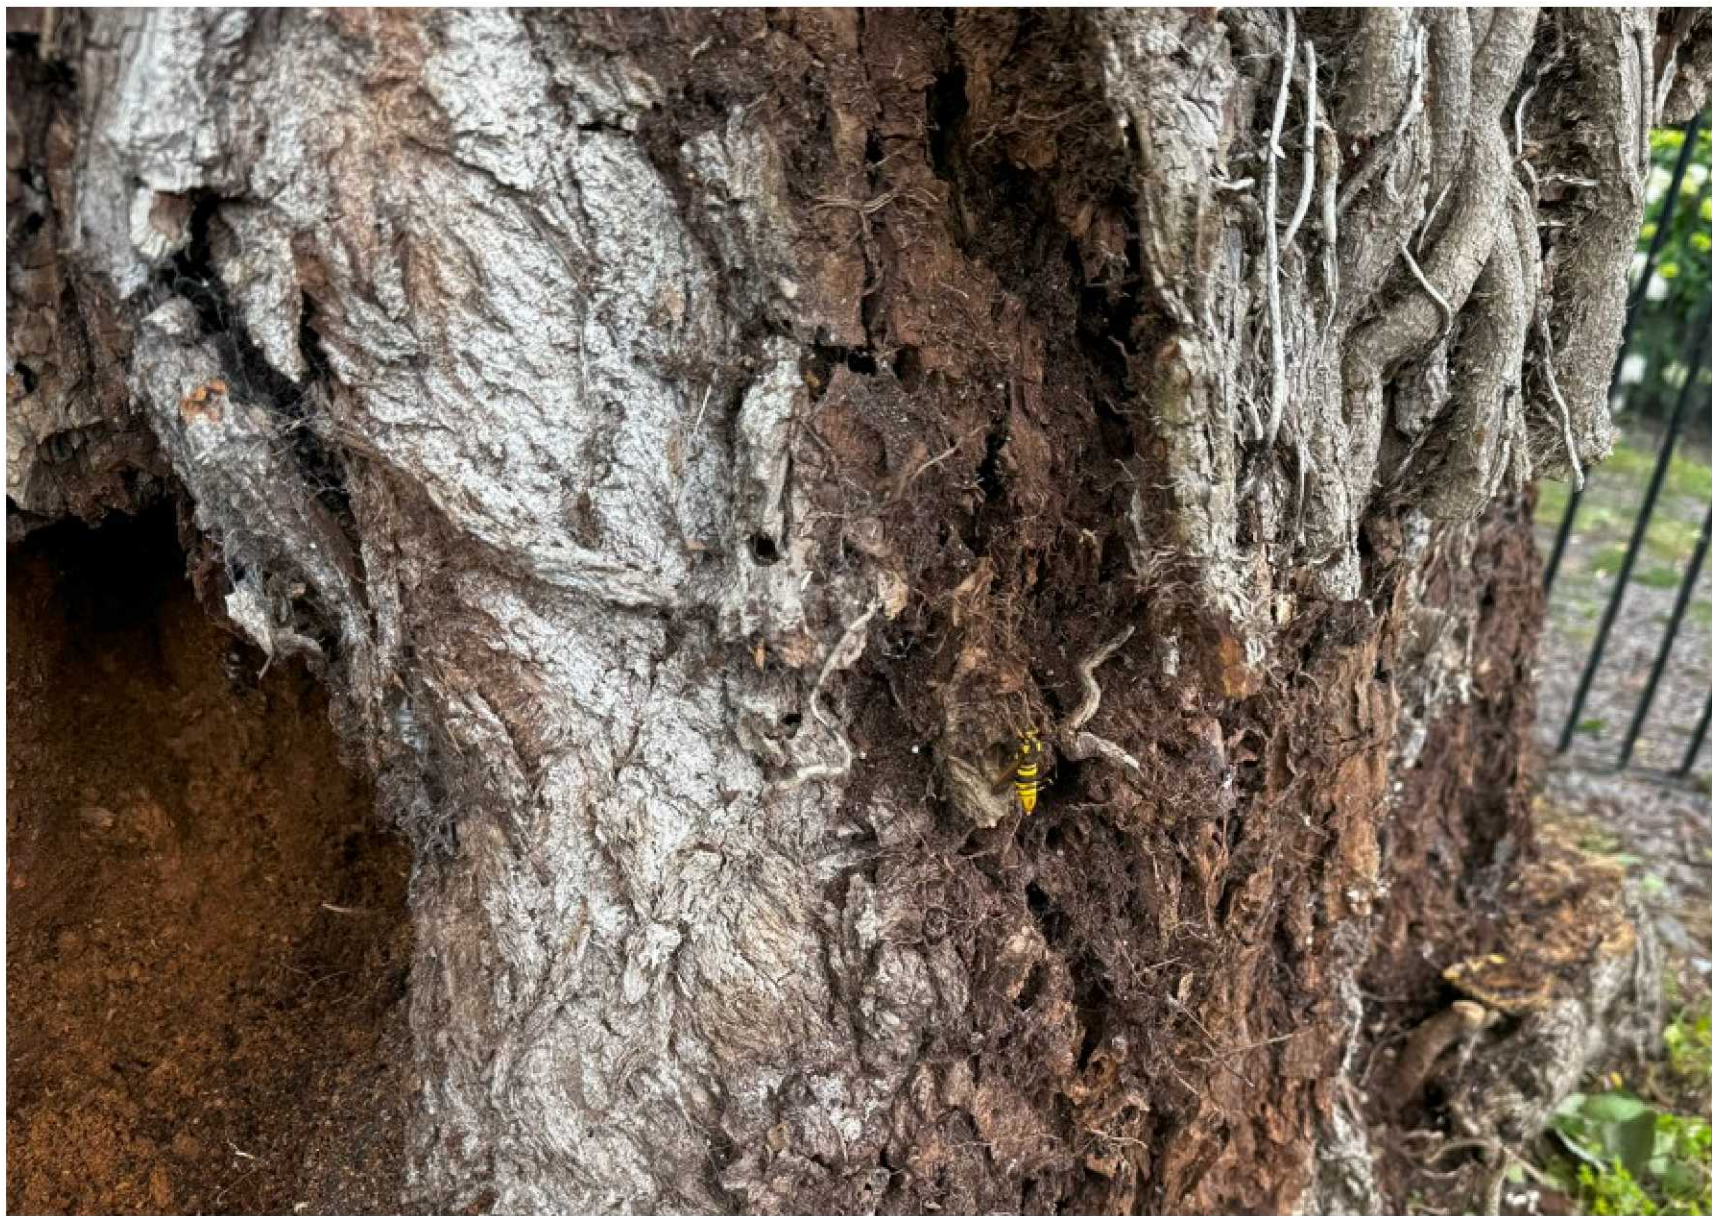
Multiple holes of the Hornet Moth *Sesia apiformis* at base. (They are not listed UK BAP and are nationally scarce classification B)

Figure 1 - Hornet Moth *Sesia apiformis*

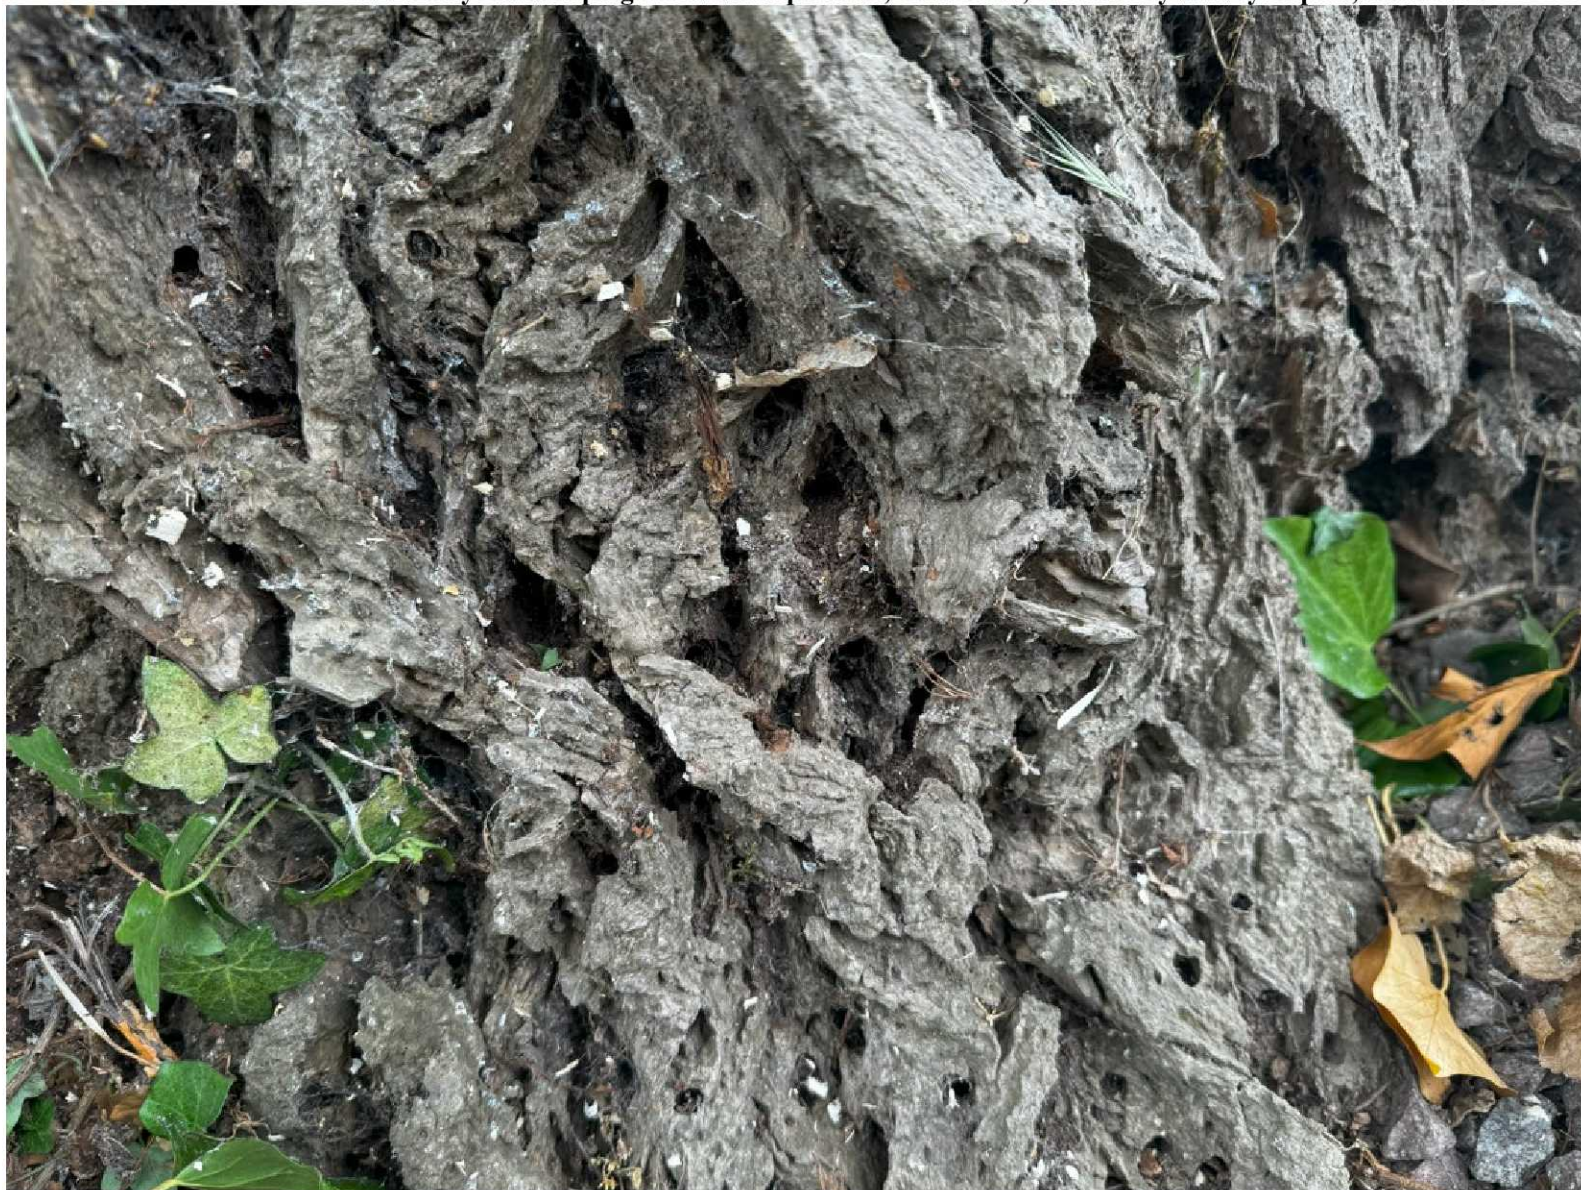
Concerns over secondary infection at base caused by the infestation of Hornet Moth.

Figure 2 -Hornet Moth Holes

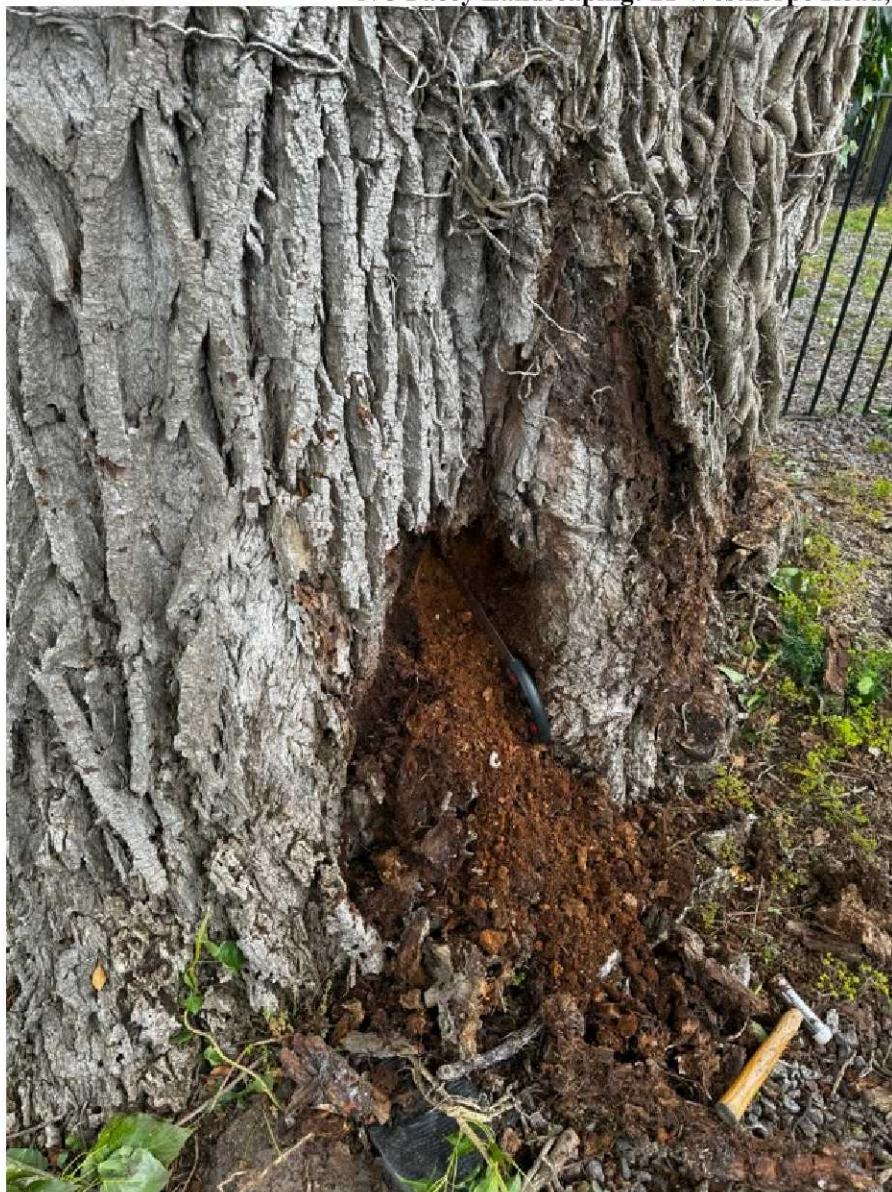
Open cavity at base south west side with a brown rot decay, opening 30cm wide with a hollow cavity of at least 40cm when probed.

Figure 3 - open cavity at base

We also recommend that a Picus tomogram is undertaken at the base of the tree to see the extent of the decay and see if even further reduction or removal is required.

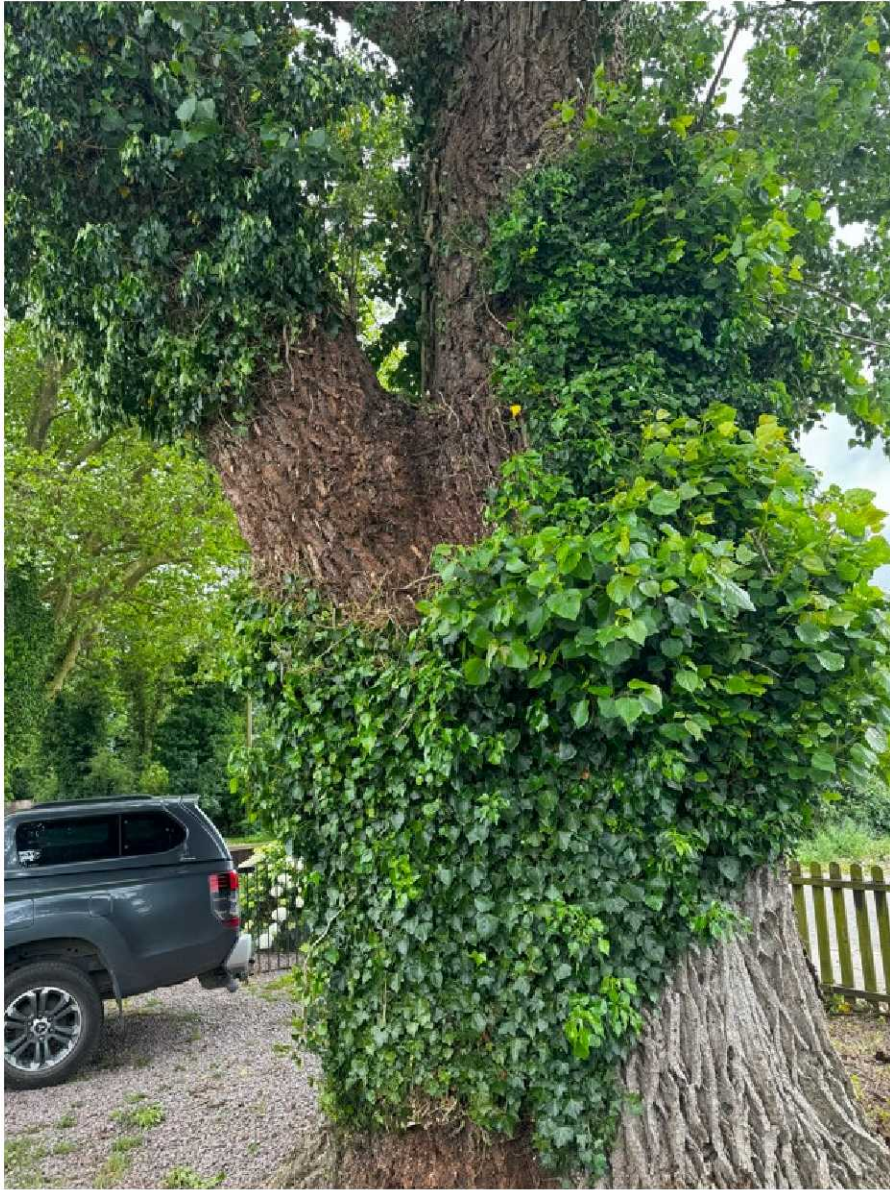
There is ivy still on main stem obscuring visibility however this is removed from major structural unions.

First and major notable fork bifurcates at 3m with a 1m diameter estimated branch heading north towards property 21 and 19 Westhorpe Road.

**Figure 4 - Ivy covering stem and first main fork viewed from west**

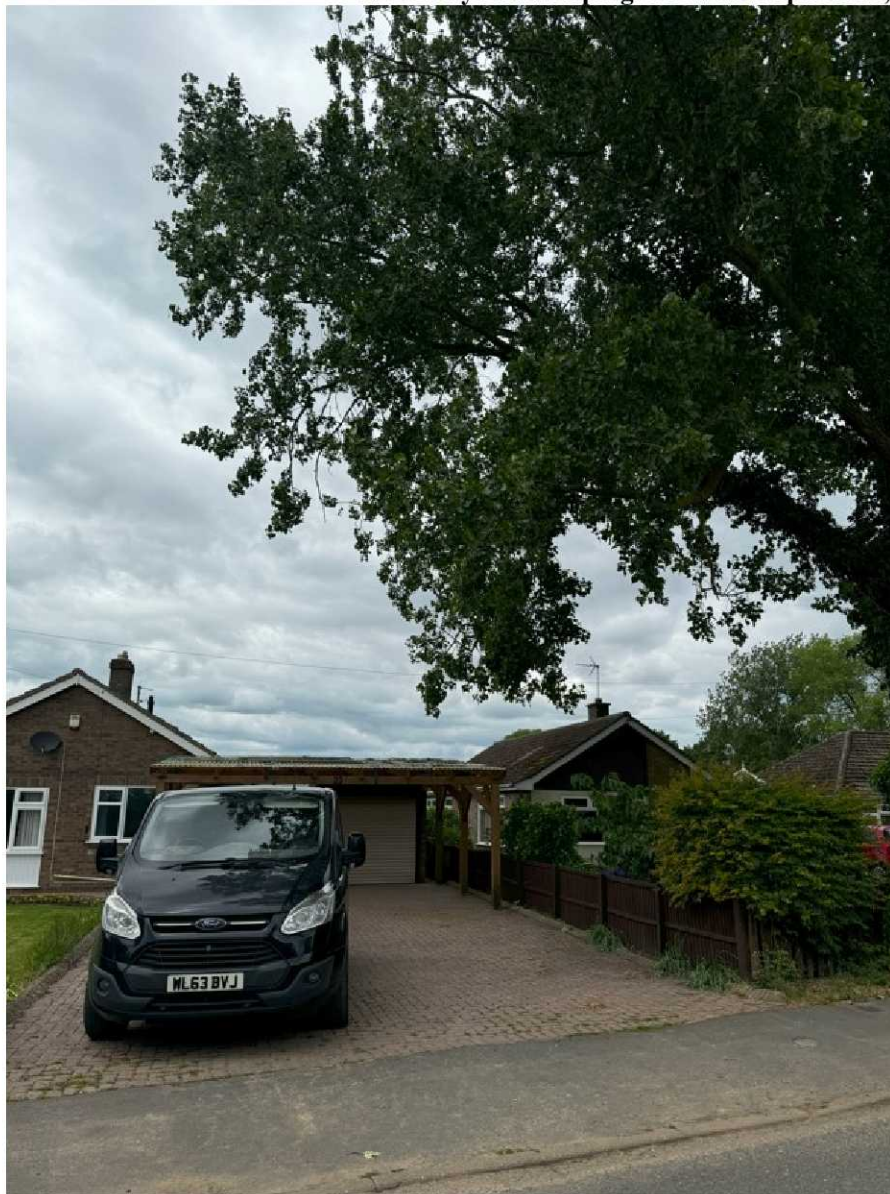
Heavy limbs heading over the roofline of no 21 and over the telecoms cables beneath.

**Figure 5 - Heavy limbs over neighbours carport and house**

Crown Reduce by an estimated 70% with the aim of leaving the following 8m tall reduced tree.

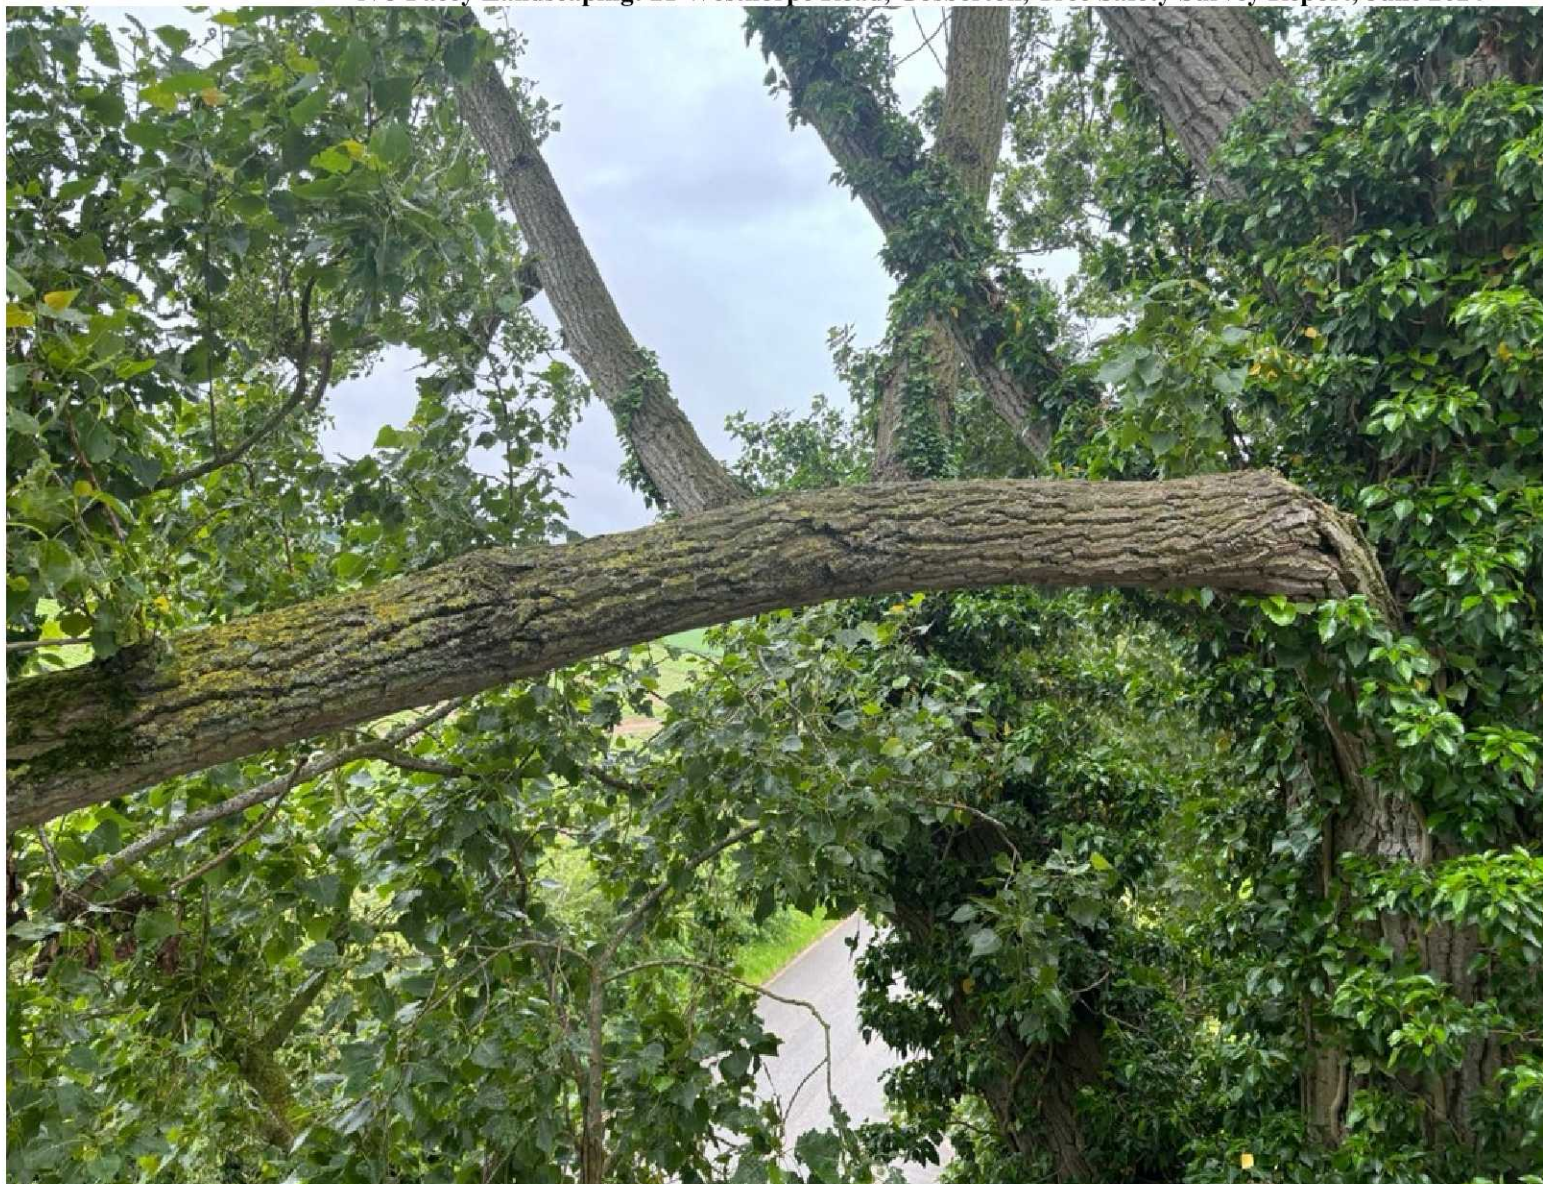
Recent Failure over road was removed by the team on 30<sup>th</sup> of May which had failed and was hung up over the footpath and highway. This was dangerous over the highway so was removed as a priority.

**Figure 6 - failed limb over highway now removed**
