STRUCTURAL APPRAISAL REPORT

Existing Barn;-
Belnie House Farm Buildings,
Belnie Lane,
Gosberton, Spalding,
Lincolnshire.
PE11 4HN

Property;-	Existing Barn;- Belnie House Farm Buildings, Belnie Lane, Gosberton, Spalding, Lincolnshire. PE11 4HN.	Instructed;- Jan 2026 Survey & Report by;- JC Consultancy Limited
Client:-	Mrs K M Baxter c/o G R Merchant Ltd, 4 Wrights Mews, Holbeach Spalding Lincolnshire. PE12 7EE	Checked by;- J. Ellington BSc. CEng MStructE, FRSA, MIO D Authorised By;- J. Hicks BEng(Hons) MSc. PgDipCHE., MIO D
Reference:-	JC/25/12/8393	Issued:- Jan 2026

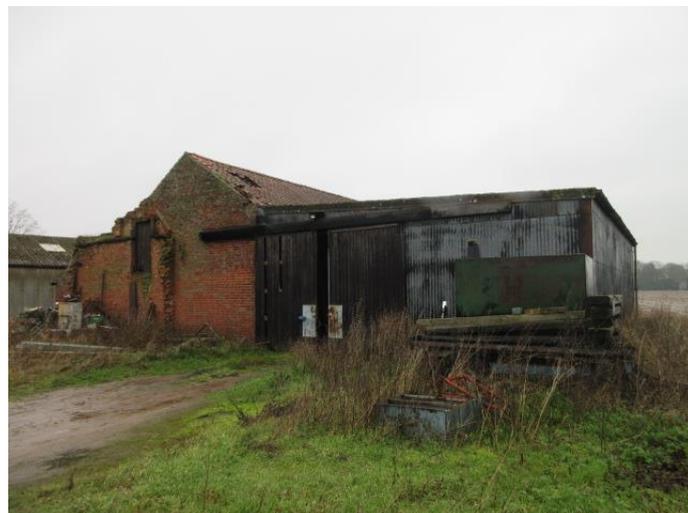
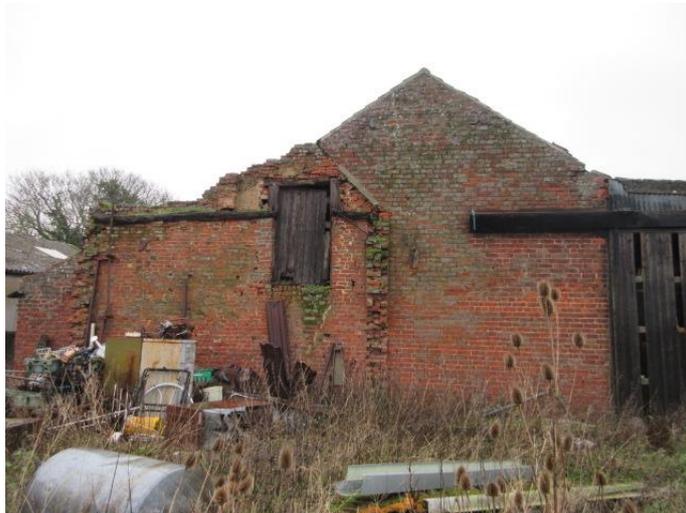
The South- East and North-West facing gable walls of the main two storey element are in a reasonable condition, however both upper apex gables have suffered lateral movement, a defect commonly associated with the previously mentioned 'racking' of the defective roof structure. Allowance should be made for the careful demolition and reinstatement of the upper apex gable masonry. The South-East facing gable displays the remnants of some former structures that were assumed to be adjoined to this elevation but have been since lost. Generally low key masonry repair and localised areas of reinstatement should be allowed for following the removal / tidy of the remaining masonry remnants.

Similarly to the two-storey element, the South-East facing gable of the lean-to structure displays a continuation of the remnants of some former structures that have been since lost. Generally low-key masonry repair and reinstatement should be allowed for following the removal / tidy of the remaining masonry remnants on this elevation.

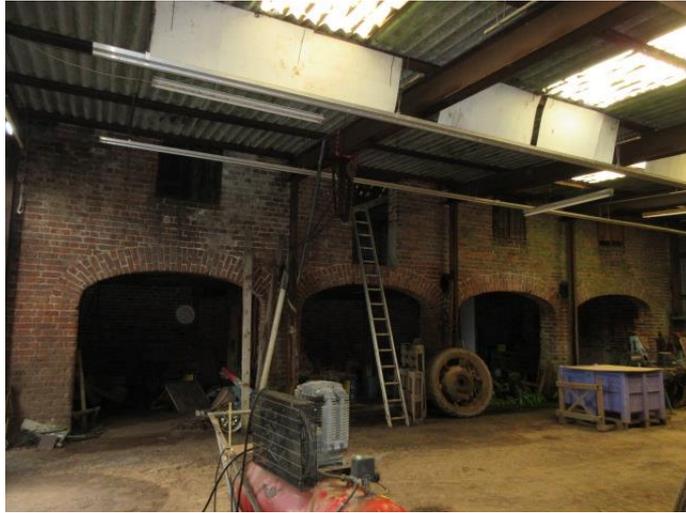
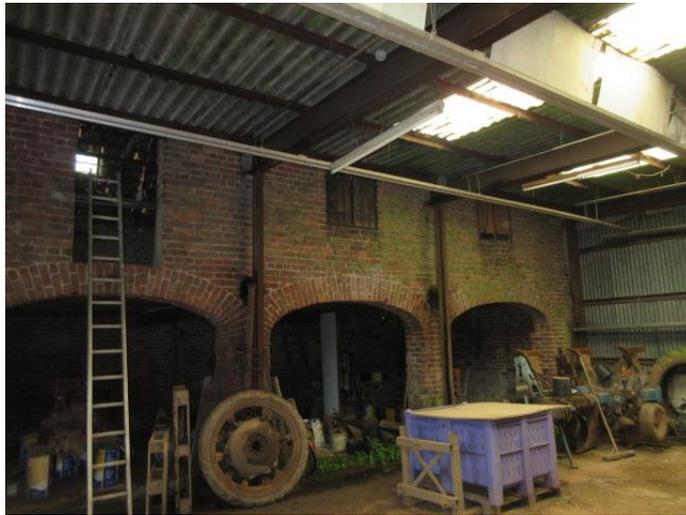
The North-East facing flank elevation contains 4No large 'Cart' style openings at ground floor level, each formed with masonry arches between supporting pillars. The arches and associated masonry forming the pillars appear structurally stable with little in the form of deflection or movement noted. The South-West facing elevation, observed from within the adjacent lean to appears plumb with no significant fractures noted. At first floor level the upper sections of the flanking walls do display a slight outward lean, which is likely to have been contributed by stress from a failing roof structure.

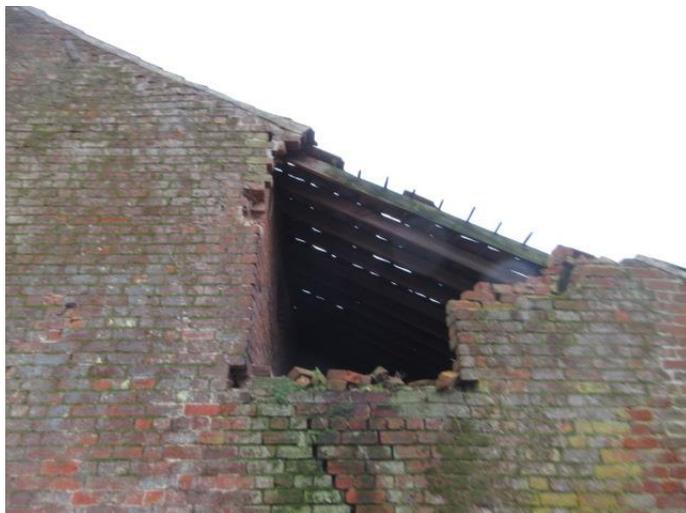
Photograph # 9 (North-West Facing Gable Elevation – Lean-to element)

The North-West facing gable has suffered from some partial collapse at high level, with a large panel of masonry now missing, and further evidence of movement / former replaced masonry present at the corner junction of the adjoining flank wall. A reasonable amount of intervention and rebuild should be allowed for on this gable wall.

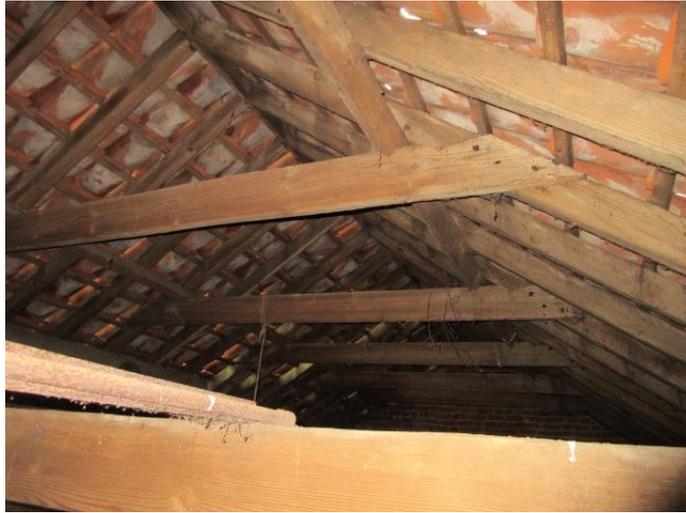
Photograph # 13 (2 Storey Element - Roof)

4.4 The existing duo pitched roof structure is slender in parts but typical in construction of a building of this age. The mono-pitched lean-to is similarly slender in parts but does include substantial timber purlins. There has been a degree of movement to the duo-pitched roof structure, and it is displaying longitudinal 'racking' movement in the North-West to South-East direction.

4.5 A new roof structure will be required throughout, which should not only provide a durable and watertight structure but will also help to eliminate the principal catalysts of stress within the original wall fabric.

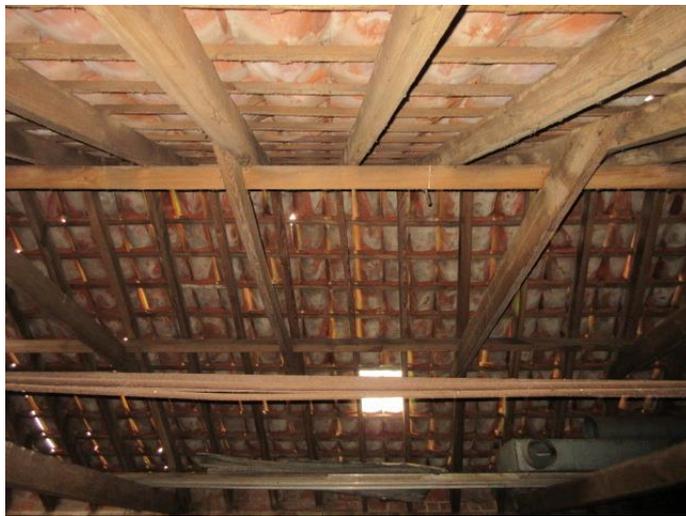
Photograph # 14 (2 Storey Element - Roof)
(Note – Roof 'racking' right to left)

The predominant cause of any movement within the building fabric and any subsequent fractures present within the masonry is likely to be partly due to the general relaxation, deflection and racking of the hand cut, collared purlin duo pitched roof structure, which is a common defect in traditional, agricultural style barns, together with general wetting and deterioration of fabric from defective rainwater discharge from the roof structures.

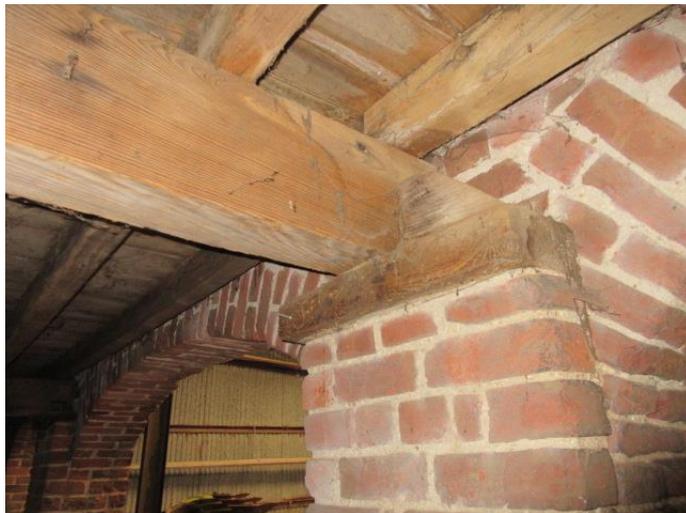
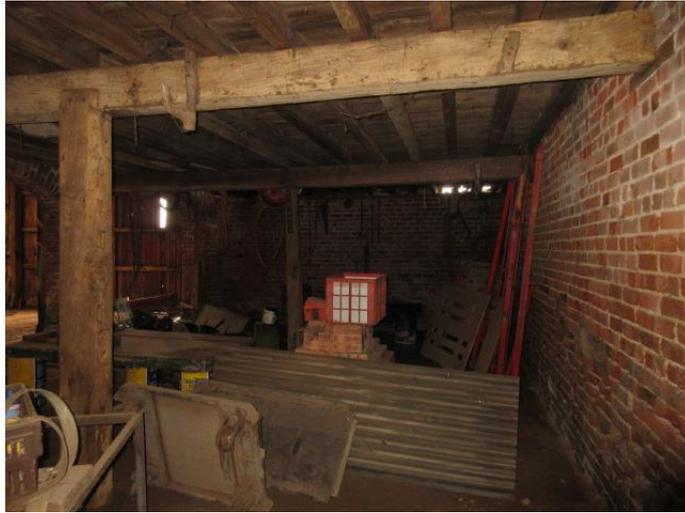
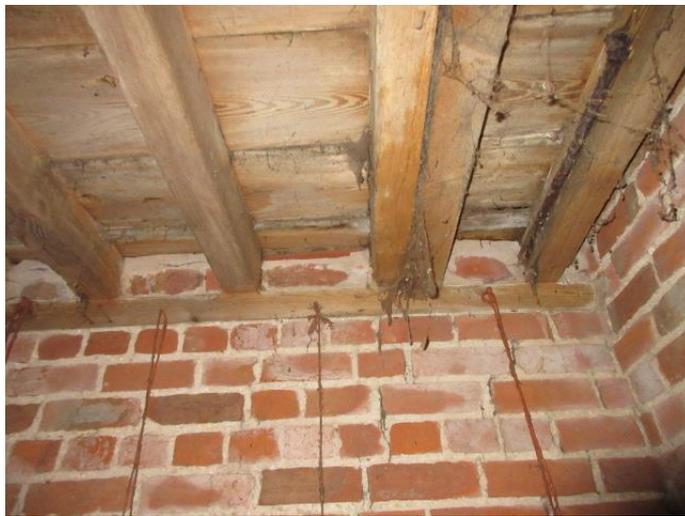
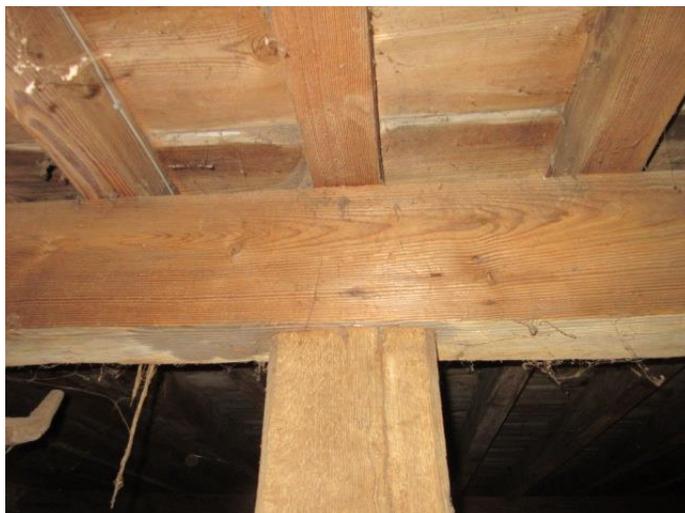
4.6 The area of existing first floor structure is in a reasonably sound condition. The primary timber beams and supported timber joists appear to be free from significant defects. Depending on finalised conversion schemes, the existing timber floor elements could be utilised in parts, however repair to localised areas of decayed timber should be allowed for. The primary timber support beams are substantial and also act as ties between flanking walls, via the presence of tie bars and pattress plates at each of their locations. We therefore recommend that the primary support beams and associated support posts are retained in any conversion scheme where possible in order that they continue to assist the flanking walls with stability.
