ALDI HOLBEACH

REMEDIATION VALIDATION REPORT

ALDI STORES LIMITED

DECEMBER 2024

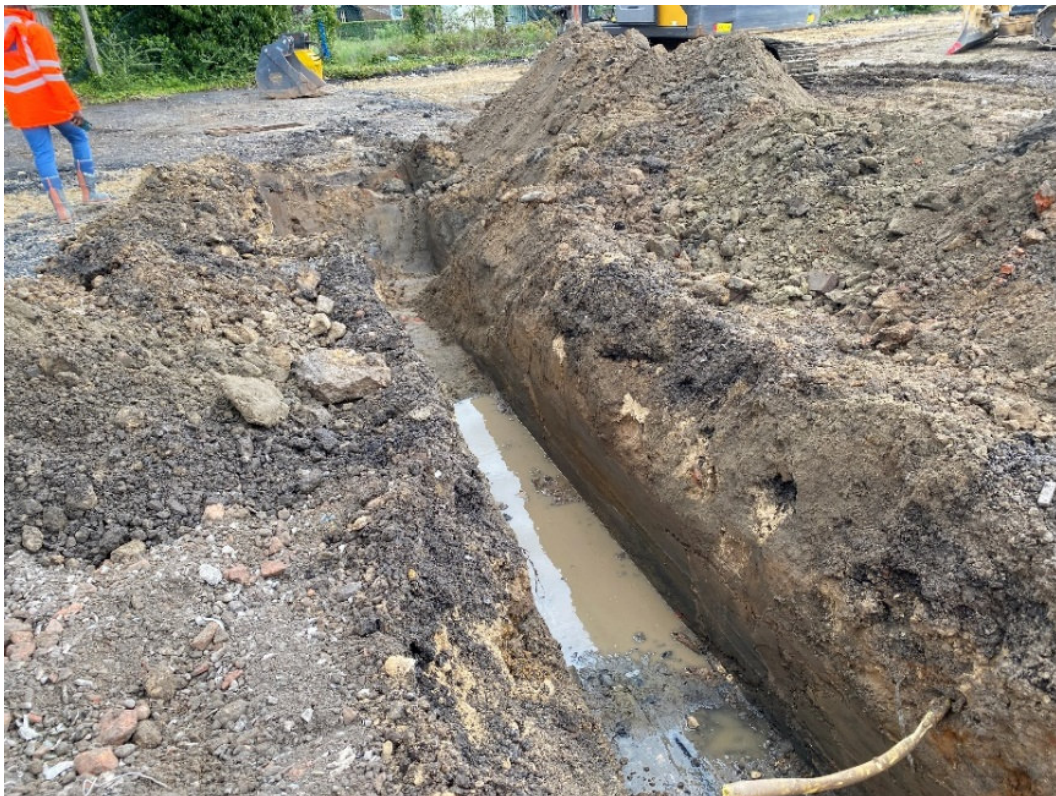
The result of this testing determined that the impacted waters in the former pond area required removal from site due to elevated concentrations above the commercial screening values recorded by the laboratory testing results, the Groundwater Testing Results are presented in *Appendix 7*. Ref 24-043849.

*Trial Pit excavation to obtain groundwater sample (Former Pond Area)*

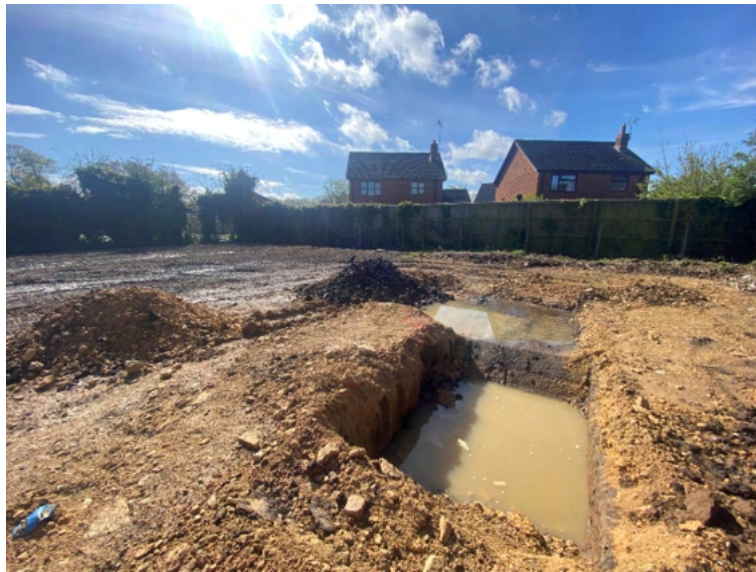
The groundwaters in the remainder of the site had not been impacted by the hydrocarbon and free phase contamination. The Groundwater Testing Results are presented in *Appendix 7* Ref 24-017835 and 24-017833.

*Trial Pit excavation to obtain groundwater sample (Wider Site)*

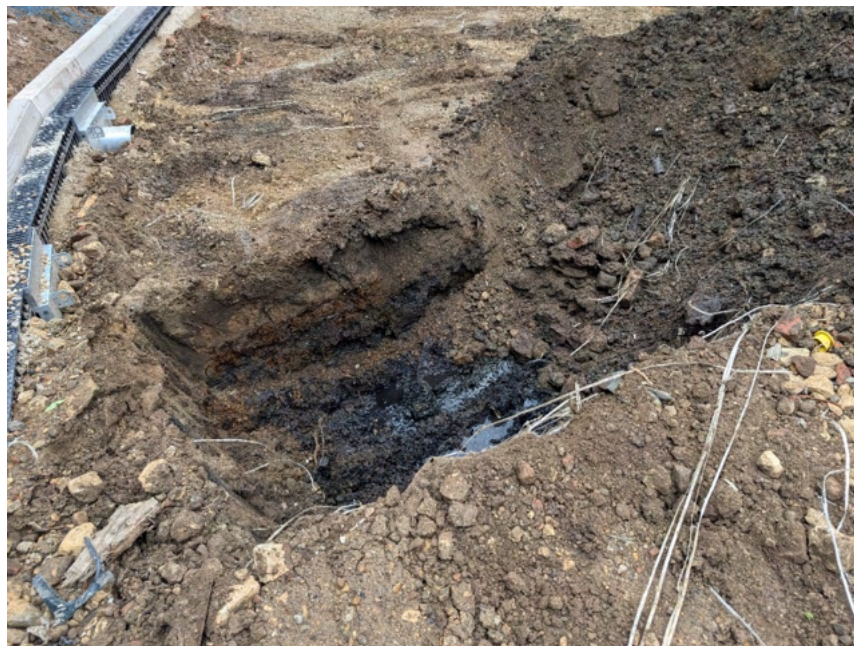
Groundtech Consulting then visit the site on the 8<sup>th</sup> August 2024 to delineate the contaminated materials associated with the former Pond area, during this time sheet piling had been installed at the site to accommodate an attenuation tank. The sheet piling encroached on the extents of the former pond and contaminated materials were visible along the north western extent of this area. Due to the sheet piling the extents of the former pond had already been delineated along the north western extent and so Groundtech Consulting conducted trial pits to determine the extent of this area in the remaining directions. The contaminated material that was encountered during the sheet piling for the attenuation tank was removed from site as hazardous waste, waste transfer notes are presented in *Appendix 4*.

*Delineation of former pond material*

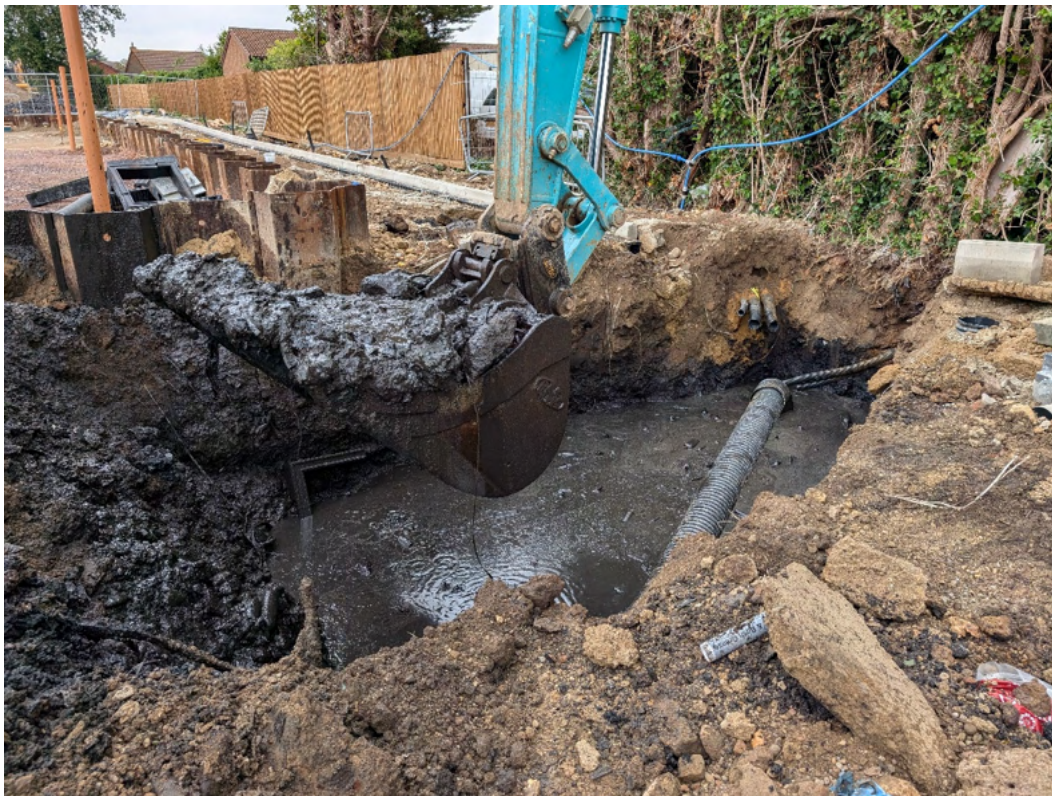
Groundtech Consulting visit site on the 2<sup>nd</sup> of September 2024 to supervise the excavation of the former pond. Excavation was started in the previously delineated area however a large ingress of water was encountered associated with the previously identified free phase and hydrocarbon impacted soils in the original Groundtech Consulting Investigation.

No provision was made on site to accommodate the large ingress of water and so the exercise was postponed until a tanker could be mobilised to site. The impacted waters were encountered in the excavation however are also migrating from offsite, this is because the former pond is present offsite to the east. A ground barrier is to be installed around the perimeter of the excavation to prevent the ingress of these impacted water.

*Delineation of former pond material (Water Ingress)*

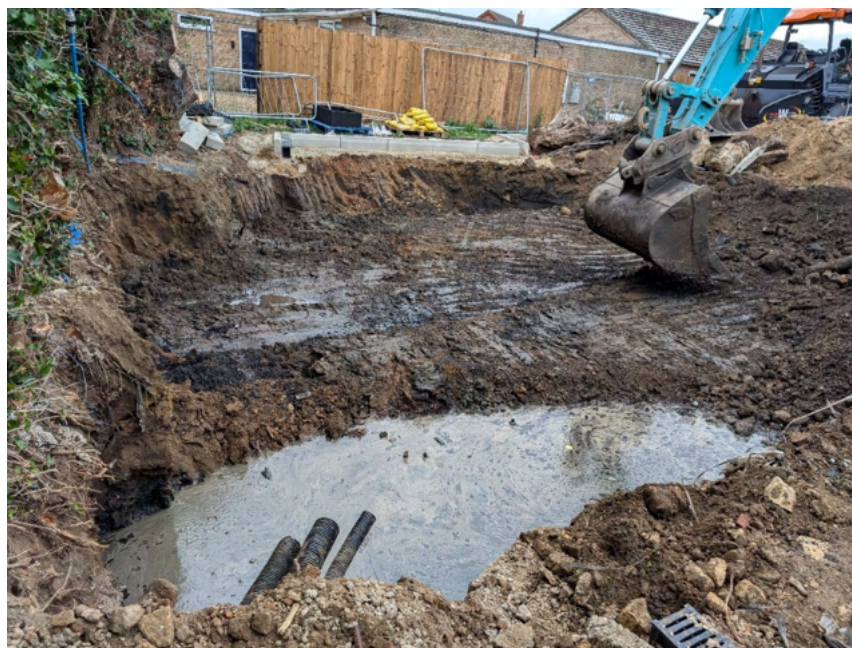
*Delineation of former pond material (Initial Excavation)*

During the excavation, an imported cohesive material was used to create a barrier along the site boundary where the former pond extended offsite to prevent further water ingress and to also act as an impermeable barrier for mobile contaminants present offsite.

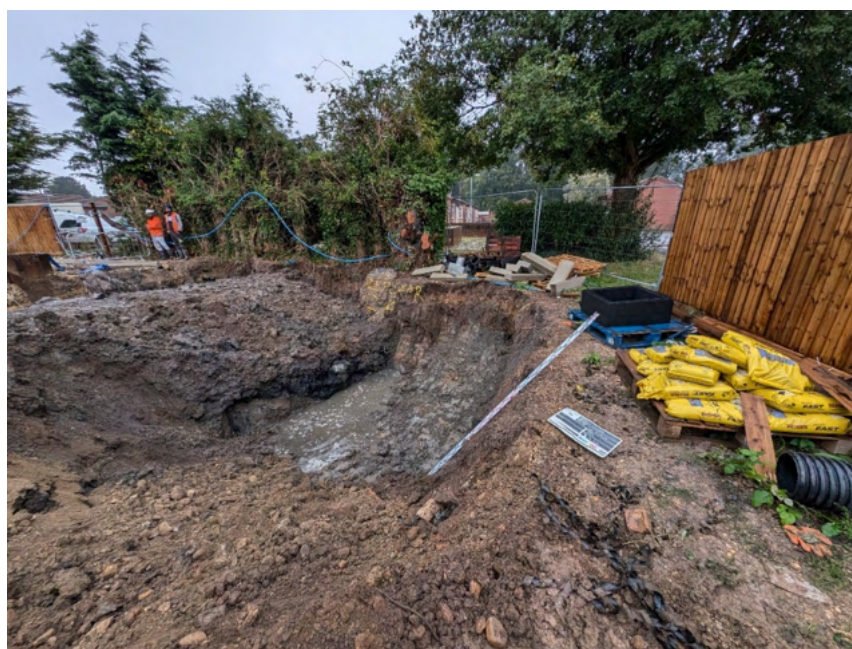
Validation samples were obtained on the base and sides of all excavations and geo-environmental testing scheduled to determine if sufficient excavation had been undertaken to validate the source of the contamination had been removed. The laboratory testing confirmed that no elevated concentrations of contamination were present in the surrounding in-situ soils and no further visual or olfactory evidence of contamination was present. The validation testing results are presented in *Appendix 8*.

*Delineation of former pond material (Staged Excavation)*

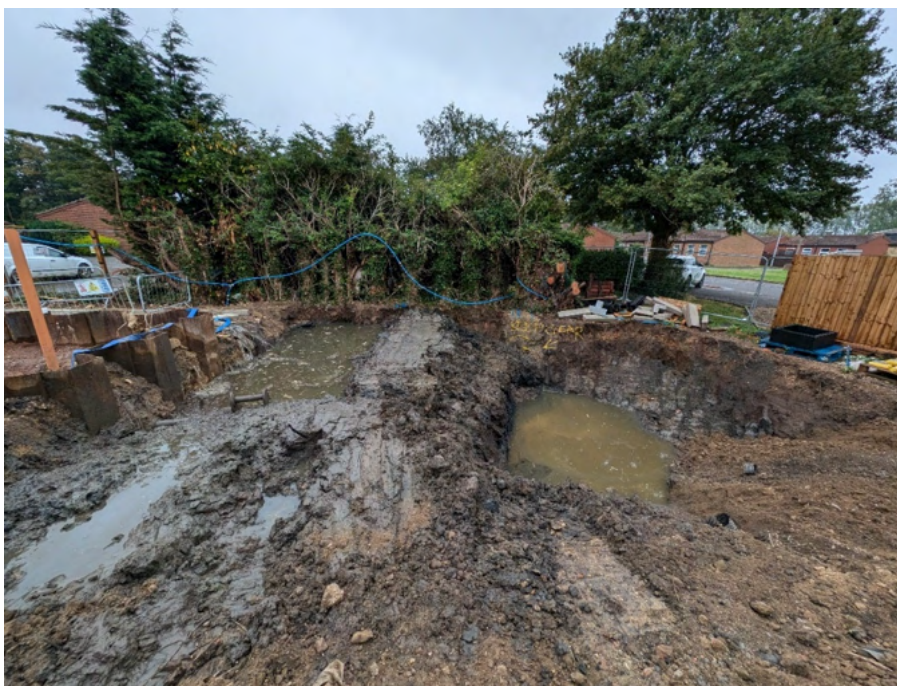
*Delineation of former pond material (Staged Excavation)*

The contaminated soils were stockpiled in a bunded visqueen area to prevent cross contamination and then removed from site. Waste transfer notes for the exported contaminated material are provided in *Appendix 4*.

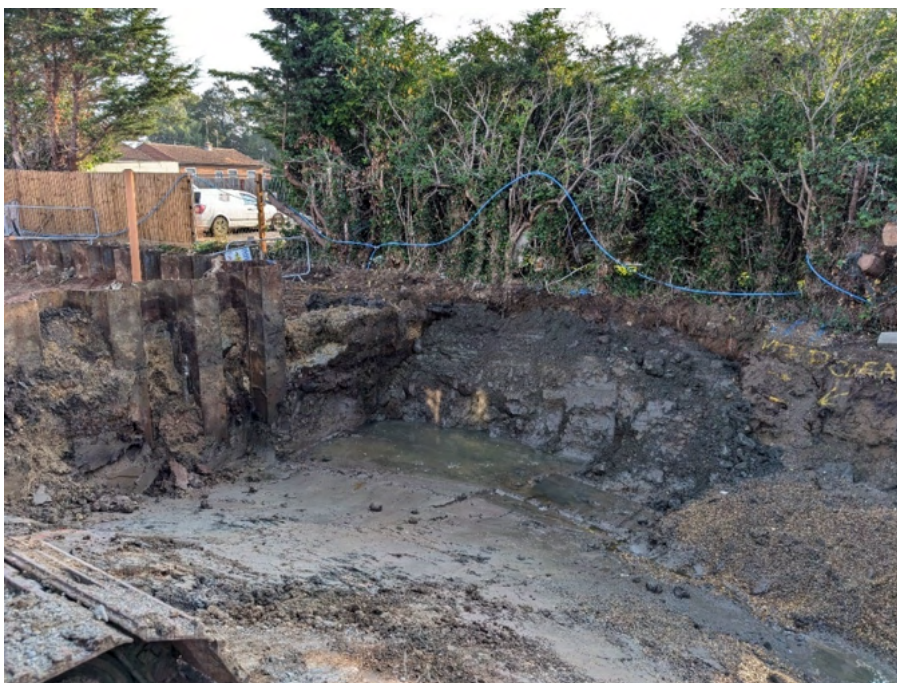
*Delineation of former pond material (Final Excavation)*

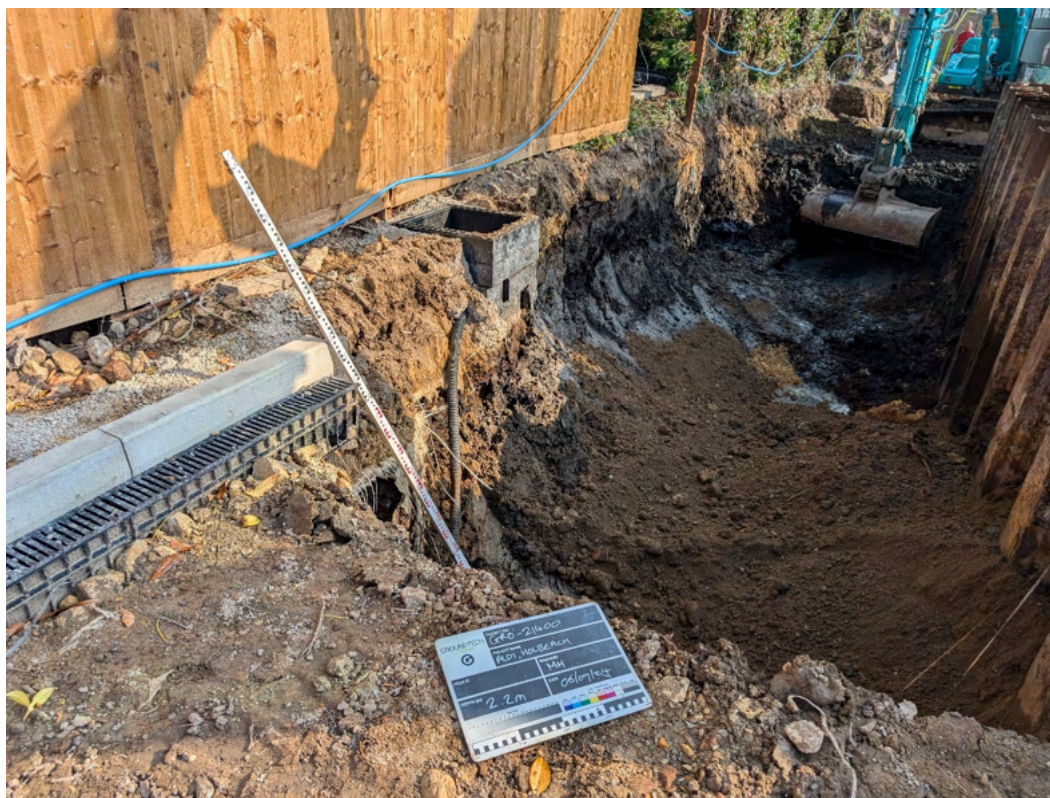
*Delineation of former pond material (Final Excavation)*

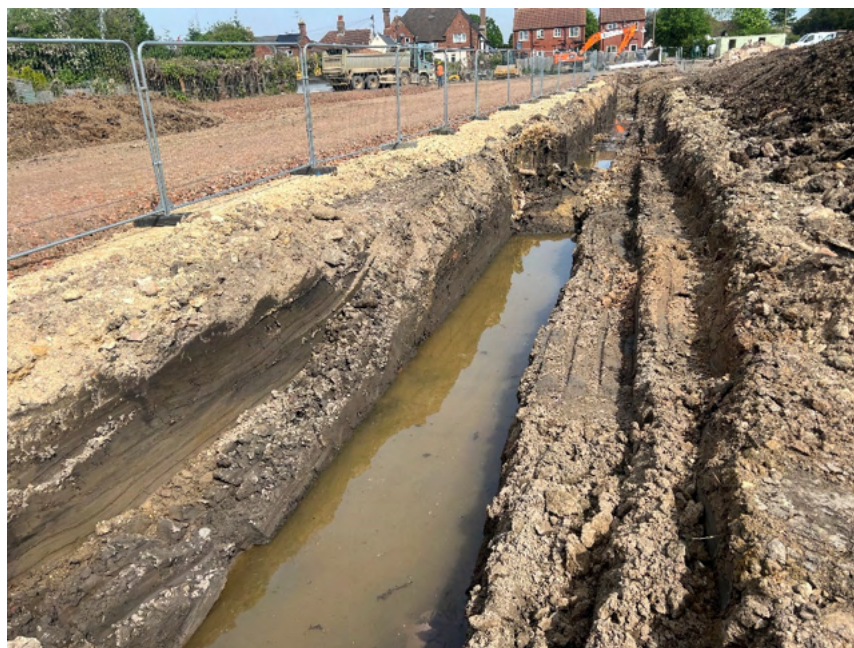
Groundtech Consulting visit the site on the 10<sup>th</sup> May 2024 to supervise the delineation and excavation of the former drain encountered during the Groundtech Consulting Investigation.

*Former Drain Excavation*

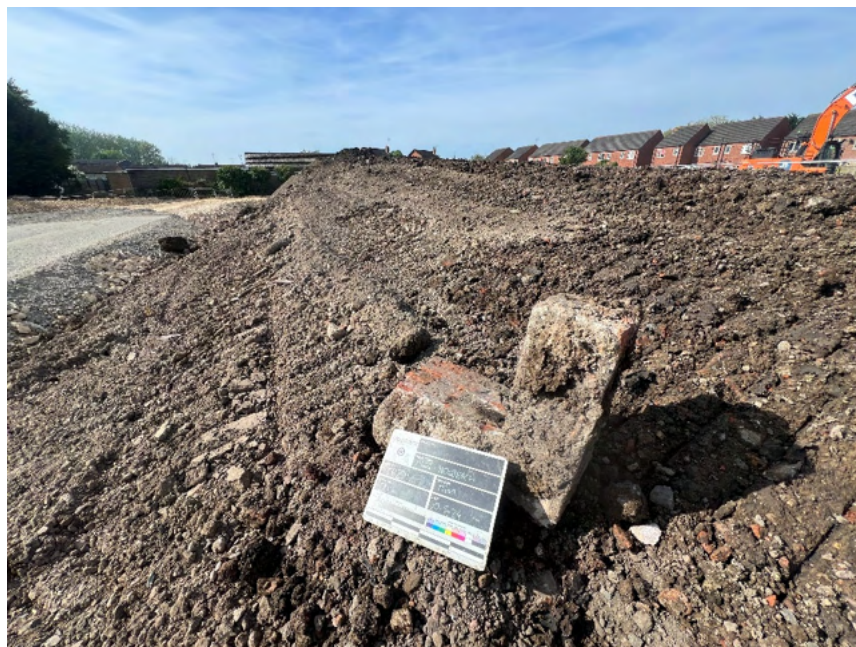
The drain had previously been encountered by the groundworks during foundation excavations and so this was traced out by a trial trench exercise. The trench was conducted along the length of the drain and associated drain segments and surrounding materials were removed.

Former Drain Excavation (Relic chamber segments)

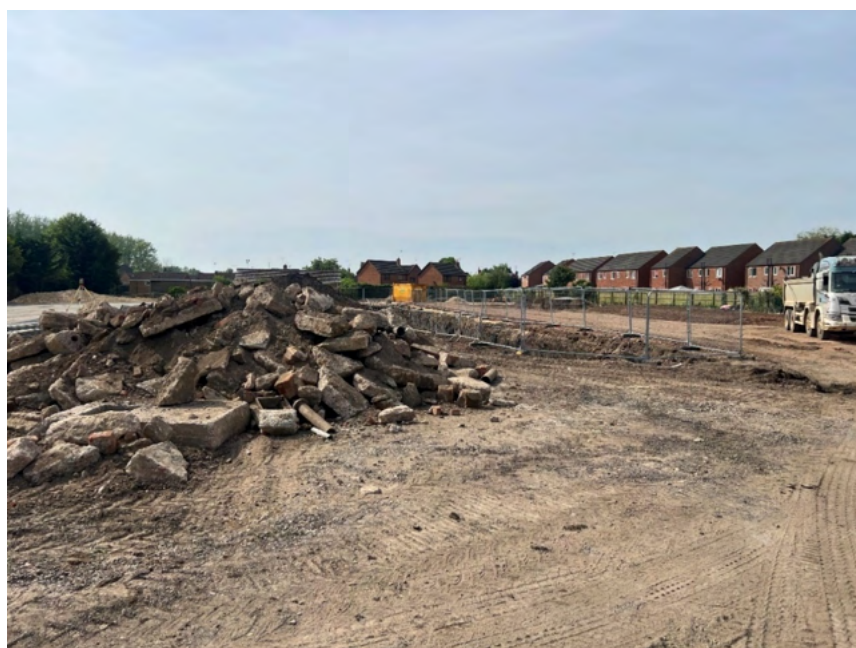
Former Drain Excavation (Relic chamber segments)

The extent of the former drain excavation is presented on Groundtech Plan *GRO-21400-P10*. Waste transfer notes for the exported material is presented in *Appendix 4*. The former drain excavation was validated visually only and all associated material and relic construction material was removed from site as hazardous waste.

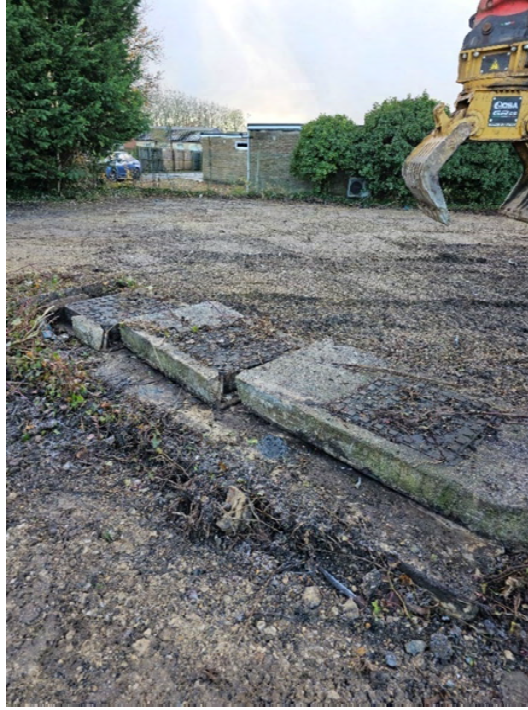
During the enabling works, an additional drainage chamber was encountered in the vicinity of the former sewage works at the site, this chamber along with associated drains was excavated and removed from the site.

*Drainage Chamber (Former Sewage Works)*

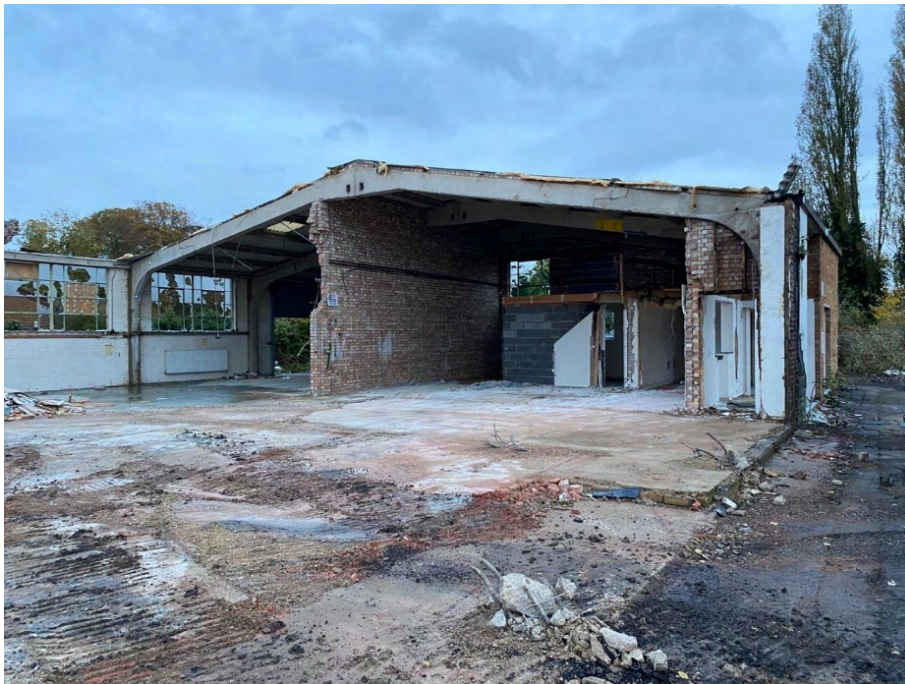
PBM Contractors Ltd undertook the demolition works at the site which comprised the demolition of the former gym in the east and the depot buildings along the western area of the site. During these demolition works the tank that was identified during the initial Ground Investigation by Groundtech Consulting in the central southern area of the site required decommissioning in accordance with the remedial specification.

*Demolition of Existing Structures (Former Gym)*

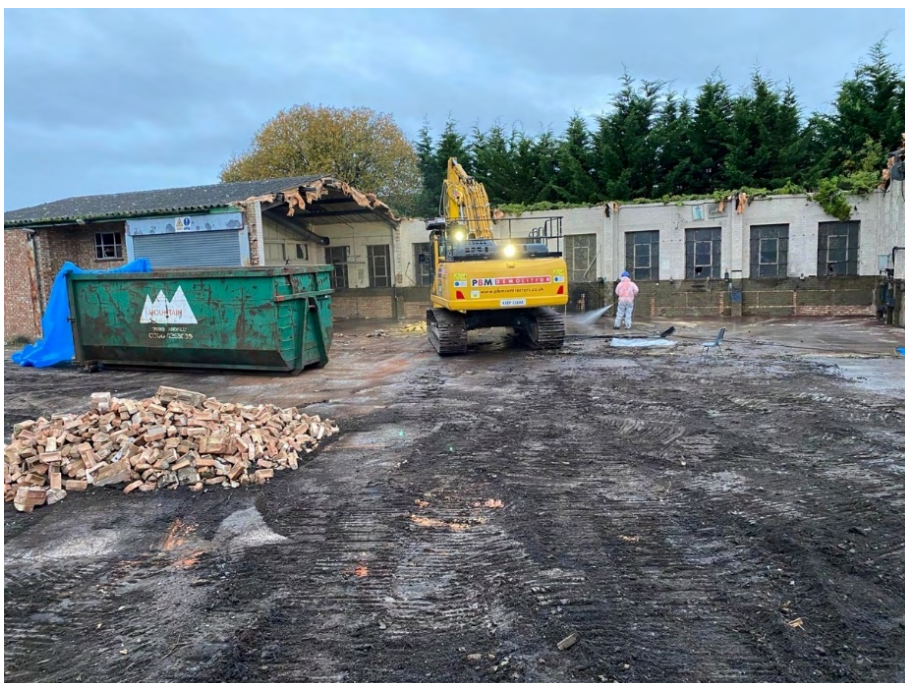
During the demolition works it was identified that this AST was empty and clean and did not require decommissioning and was disposed from site to a registered waste receiver as scrap metal. Waste transfer notes for the demolition material, stockpiled materials and scrapped metal are presented in *Appendix 4*.

*Demolition of Existing Structures (Former Depot)*

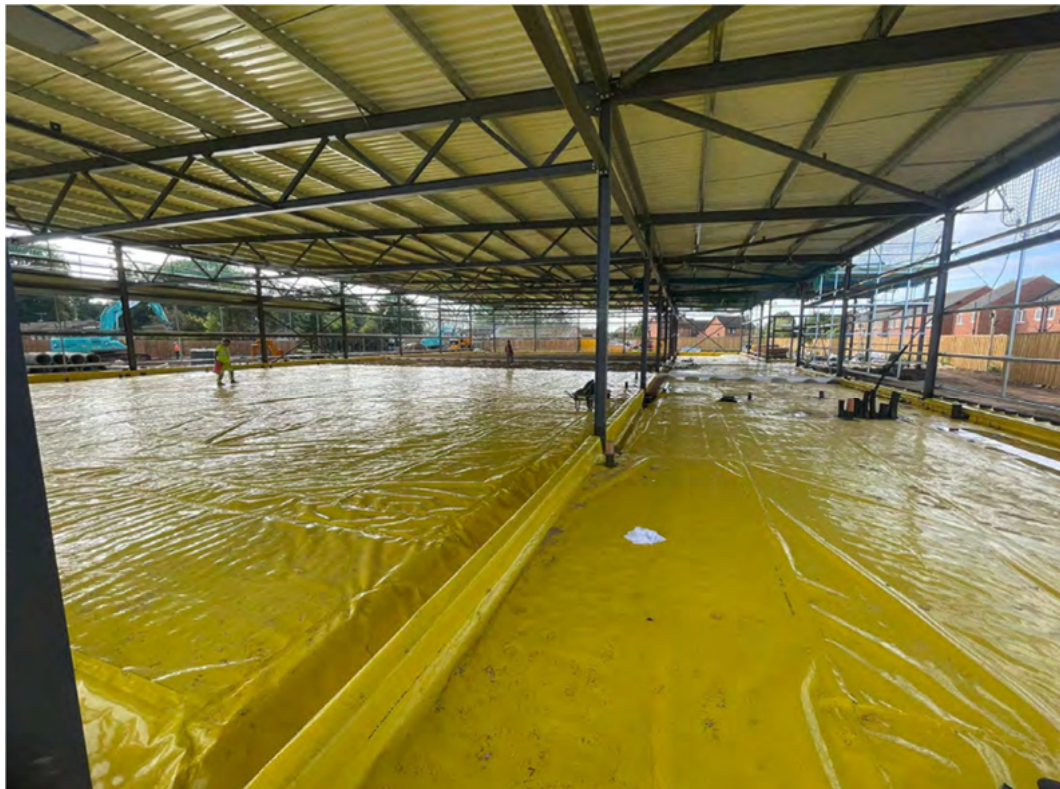
CS3 Gas Membrane

A Juta GP 5+ gas membrane was installed at the site which comprises a multi-layer composite polyethylene membrane suitable for resisting Carbon dioxide and Methane affected sites. The ground gas membrane is presented in *Appendix 6*.

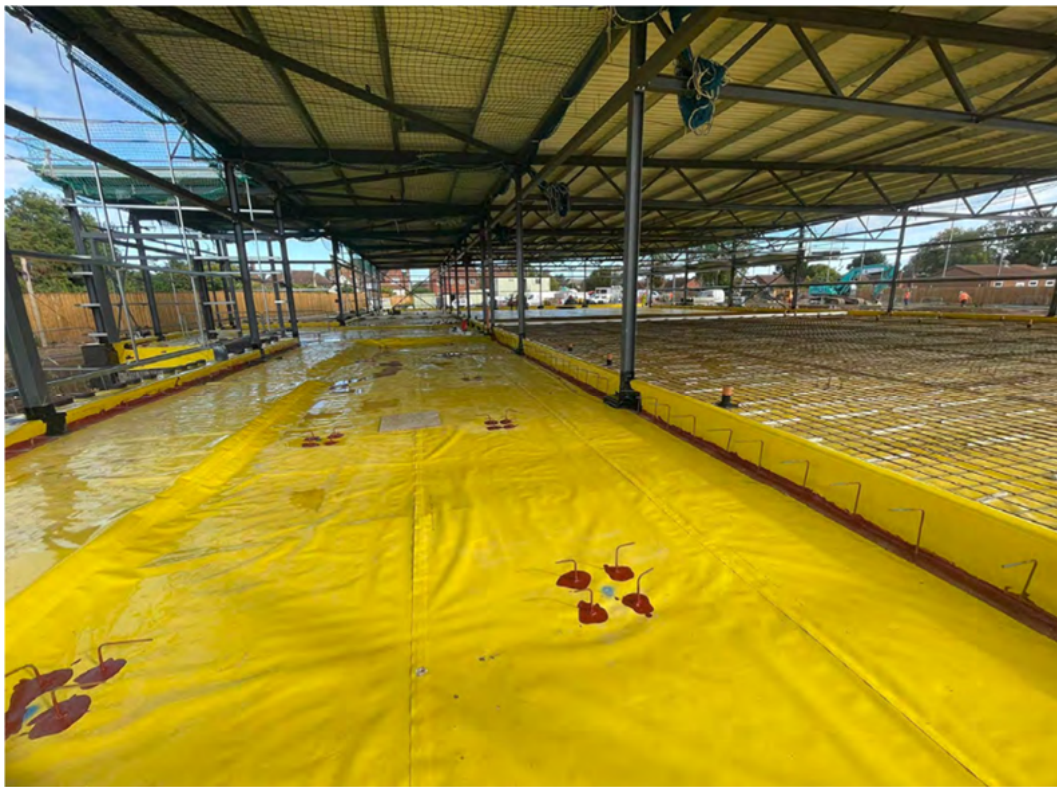
CS3 Gas Membrane

The installation of the Gas membrane was undertaken by Geoshield between the 6<sup>th</sup> September and 17<sup>th</sup> September 2024 and the relevant information is presented in the Geoshield verification reports (*GEO104785*).

The Gas Membrane was then verified by Paul Colbeck of Geoshield under a separate heading on the 25<sup>th</sup> of September 2024.

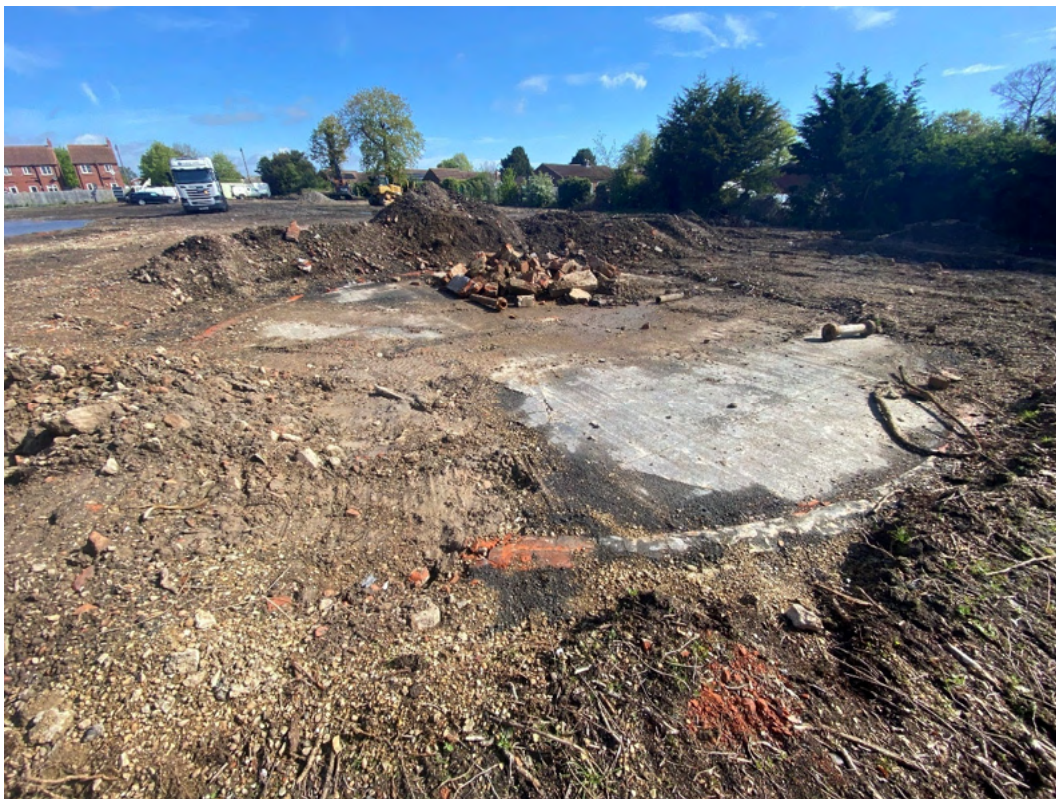
All concrete pads and ramps associated with the former sewage works were grubbed up, crushed, segregated and stockpiled for removal off site. A watching brief was in place during the enabling works by the enabling works contractor and no evidence of contamination was encountered at the site in relation to the former sewage works.

Former Sewage Works Concrete Pad
