**Barns at Leadenhall Farm, HOLBEACH St. MARKS**

***Condition & Structural Report:***

***Date of Inspection: 14<sup>th</sup> April 2020***

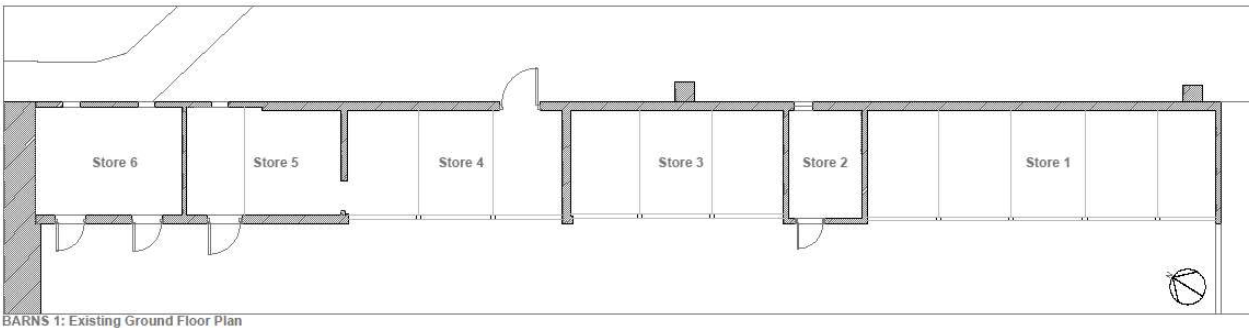
#### **BARNs 1: Existing Ground Plan**

- 2.2.2 The long rear wall (north-east elevation) to 'Barns 1' is generally true, with just the slight outwards lean out to the rear wall of 'Store 1'. With the installation of a new roof structure, which will help provide further restraint to this wall, this lean will not warrant re-building.

- 2.2.6 To 'Store 5', a section of the front (south-west) wall has in more recent times been re-built in common bricks. This wall also has a significant outwards lean, suspected to be largely due to the lack of lateral restraint; there is no masonry buttressing wall. This section of wall should be re-built in matching handmade bricks, and an internal buttressing wall provided as part of the conversion works.

- 2.2.7 To 'Store 6', the centre section of the front (south-west) wall has received impact damage in the past. A small section of the centre section of this wall will in turn requires chopping out and re-placing in handmade bricks.

- Minor Crack to north-east corner of 'Store 1'.
  - Minor Cracks to north-west corner of 'Store 1'.
  - Raking Crack to the Partition Wall between 'Store 5' and 'Store 6'

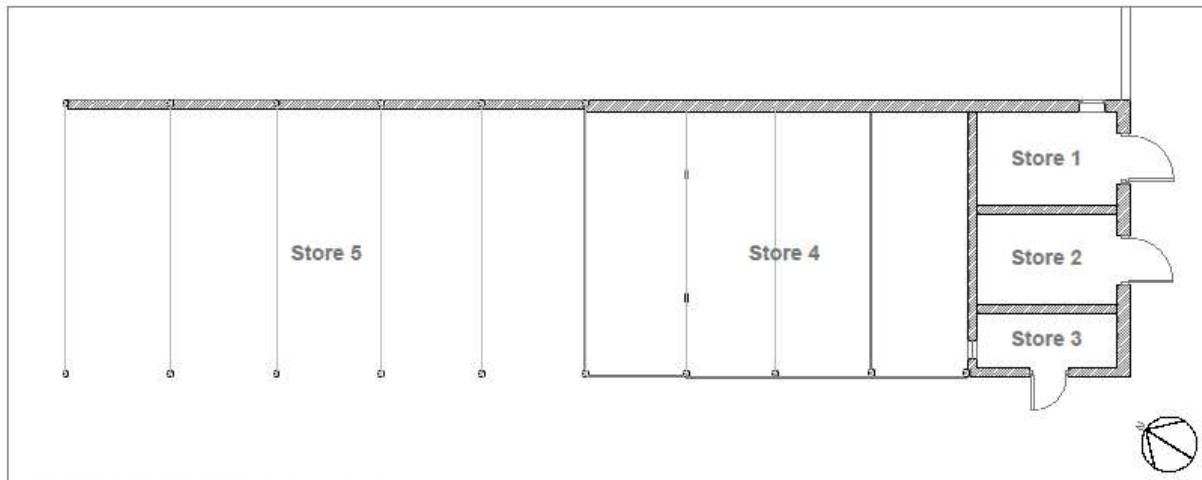
**BARNs 2: Existing Ground Floor Plan**

- 2.5.1 To 'Stores 1 to 4' The solid brick walls, formed by locally handmade bricks, are constructed in English Garden Wall bond with every fourth course a header course.
- 2.5.2 The long rear wall (north-east elevation) to 'Store 1' and 'Store 4' is all true and in good condition. A young self-set tree is in need of removing to this elevation.
- 2.5.3 Similarly the masonry walls to the south-east and south-west elevations to 'Stores 1 to 4' are all true and in good condition.
- 2.5.4 To 'Store 5', the rear 700mm high concrete blockwork dwarf wall with re-inforced concrete columns (185mm square) display no signs of cracking or deterioration.
- 2.5.5 Similarly, to 'Store 5' the front timber columns (bitumen painted and 155mm square) set in concrete display no signs of deterioration. It is understood though that a new masonry wall will be built to the south-west elevation of this barn.

- 2.6.1 There are no signs of structural cracking/ structural defects to the interior of 'Stores 1 to 5'.
- 2.6.2 The roof is of traditional timber construction with rafters supported by purlins with collars. There are no signs of roof-sag to 'Barns 2'.
- 2.6.3 It is understood the whole of the roof is to be replaced to 'Barns 2', with 'Stores 1 to 4' recovered in clay pantiles and 'Store 5' recovered in a lightweight corrugated sheeting to retain the existing agricultural aesthetic of these barns.

- 2.7.1 The structural condition of the barns is very good with no major remedial repairs or major re-building being necessary.
- 2.7.2 Our inspection did not include any investigation of the existing foundations.
- 2.7.3 It is understood the roof as a whole is to be replaced as part of the conversion works.
