David Aldridge Architecture Limited  
 Leadenhall House, Holbeach St. Marks  
 'As existing' photographs  
 Sheet No. 1

Ref: 0219-10

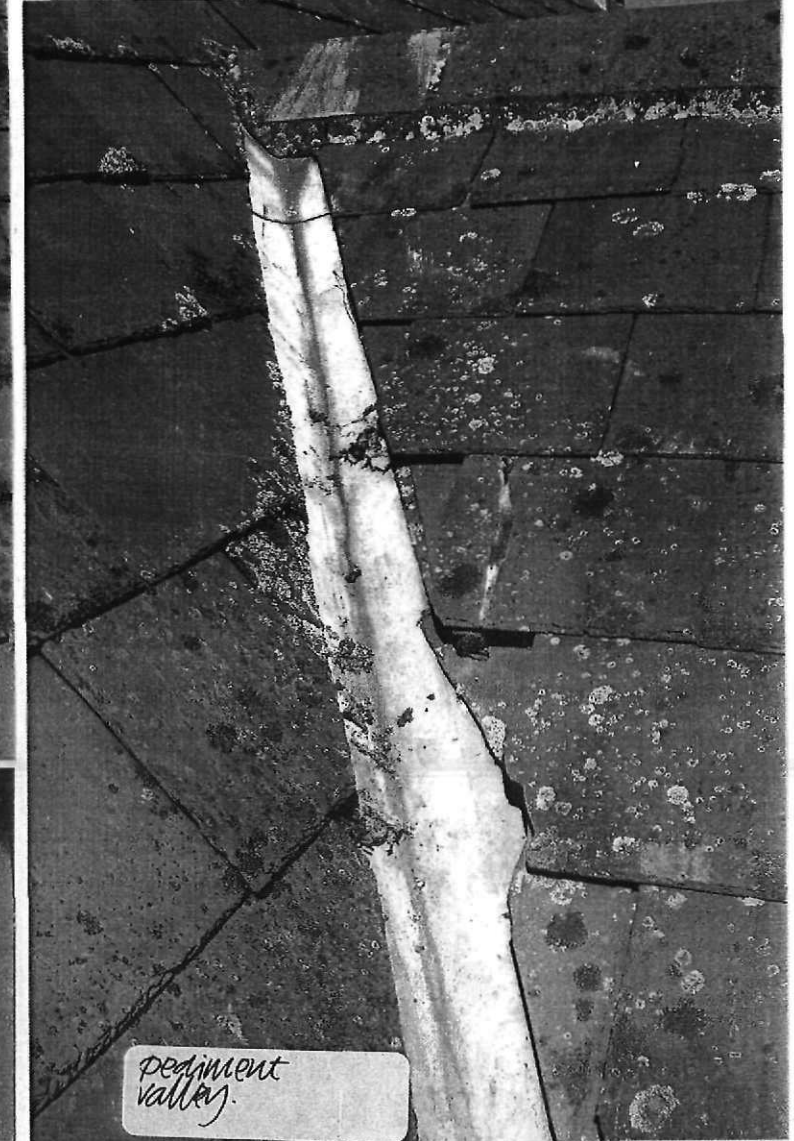
Pediment  
valley.

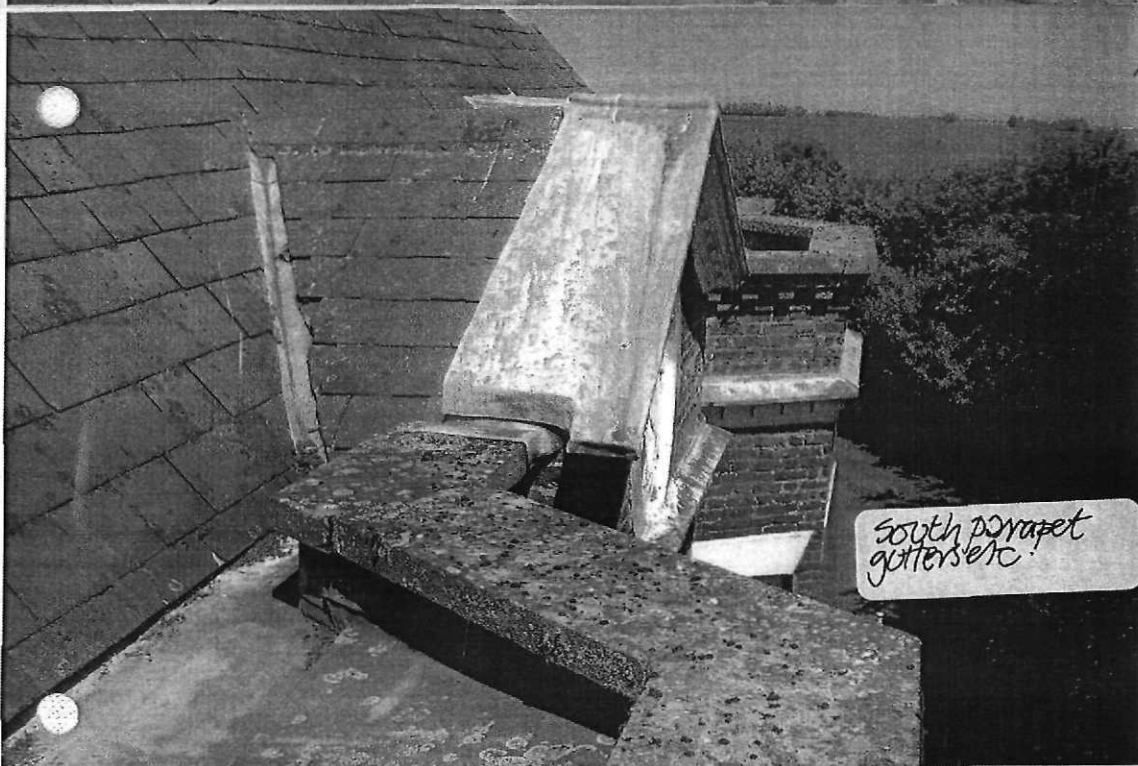
South parapet  
gutters etc.

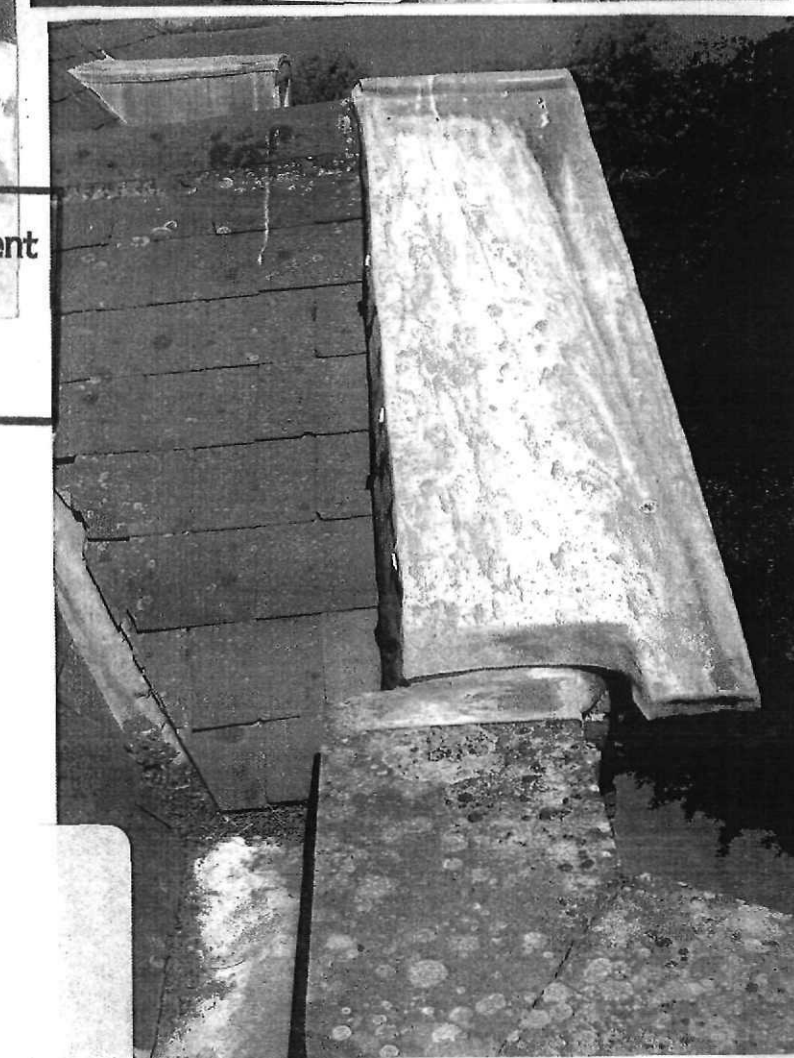
South parapet  
gutter/bay roofs.

Inverted dpc  
2008

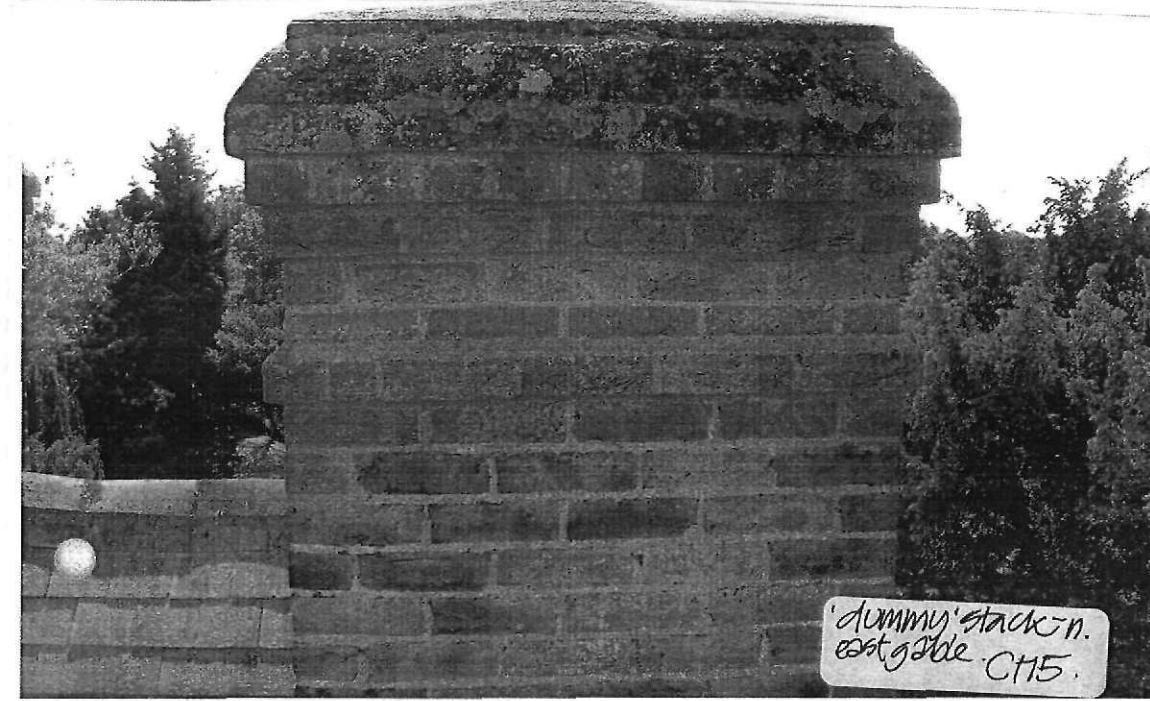
'dummy' stack on east gable CH15.

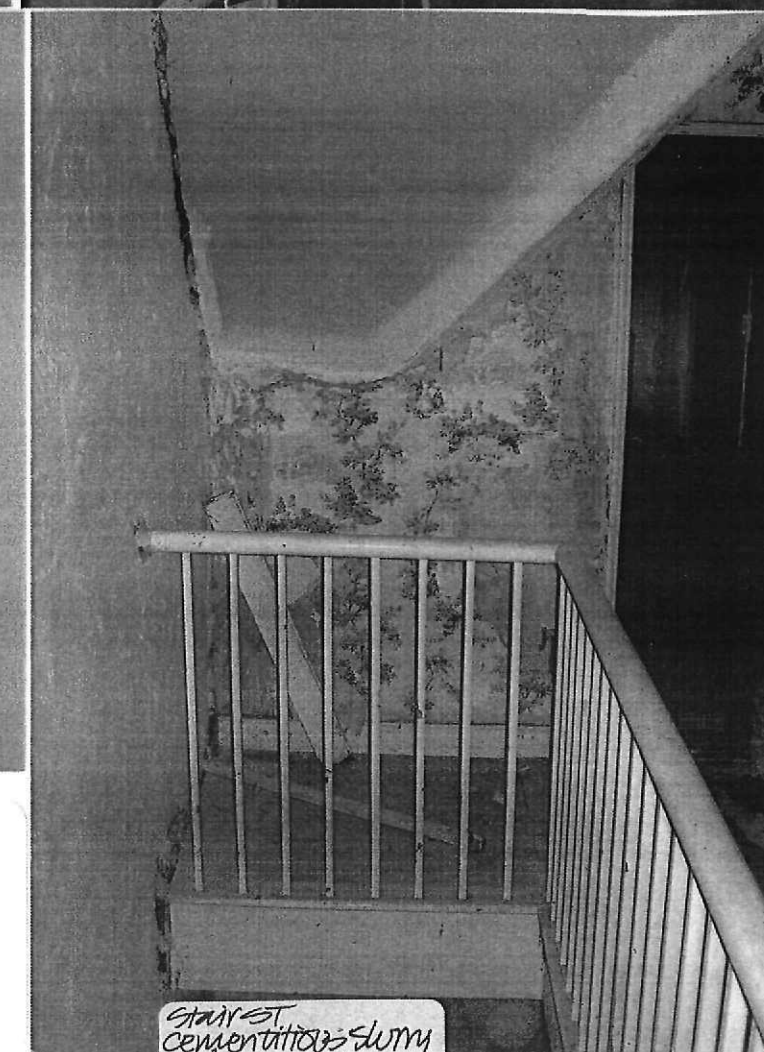
Staircase  
cementitious slurry  
applied 2008.

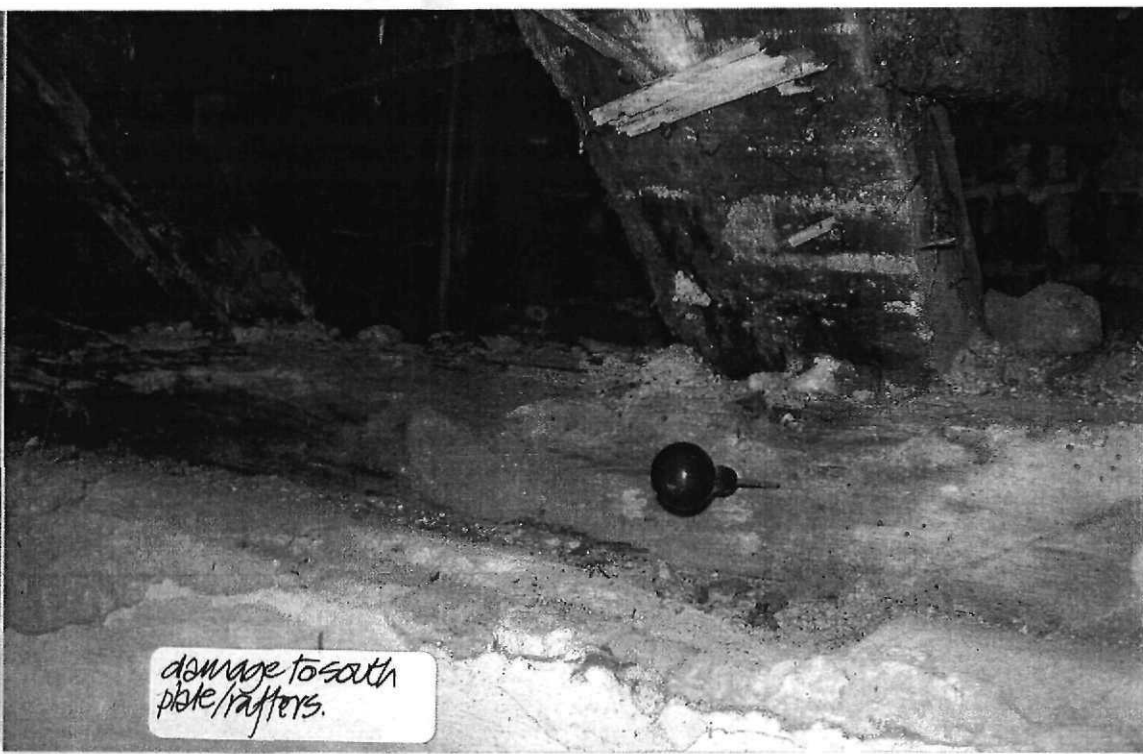
damage to south plate/rafters.

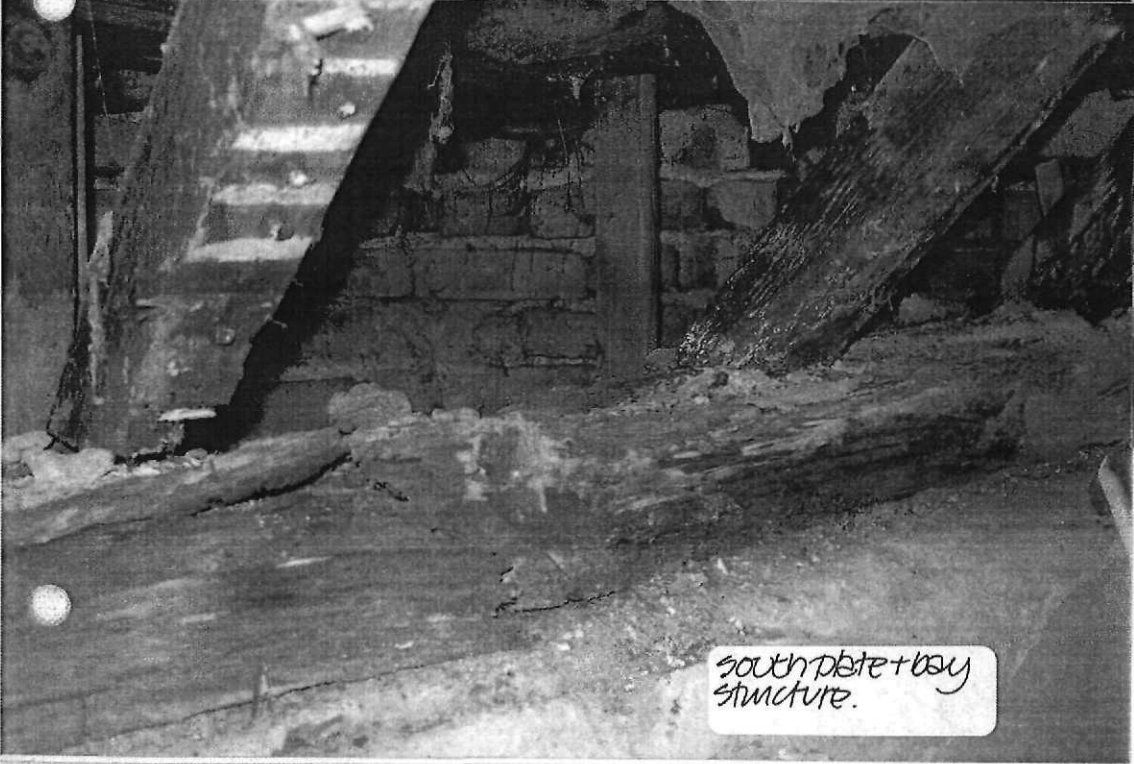
South plate + bay structure.
