## Verification Report

GEO101947

002

SLFEZ Zone

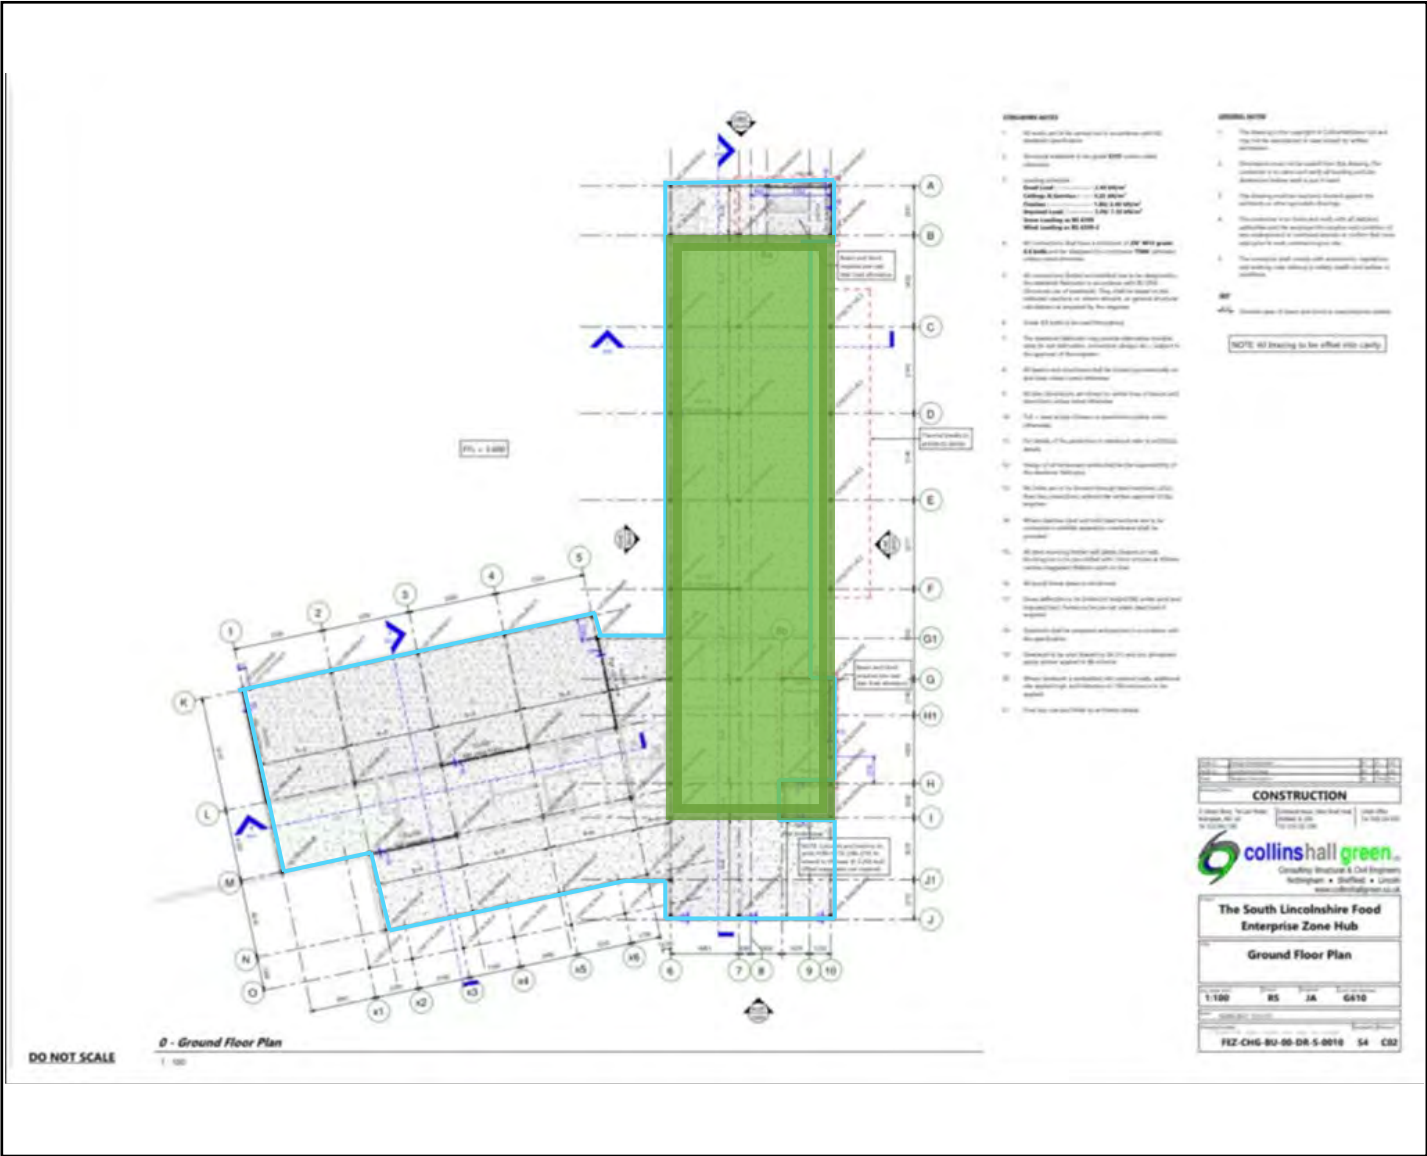
The area above highlighted in green shows where the installers have completed the installation of PAG Monarflex Reflex Super to the infills and where verification took place during this visit.

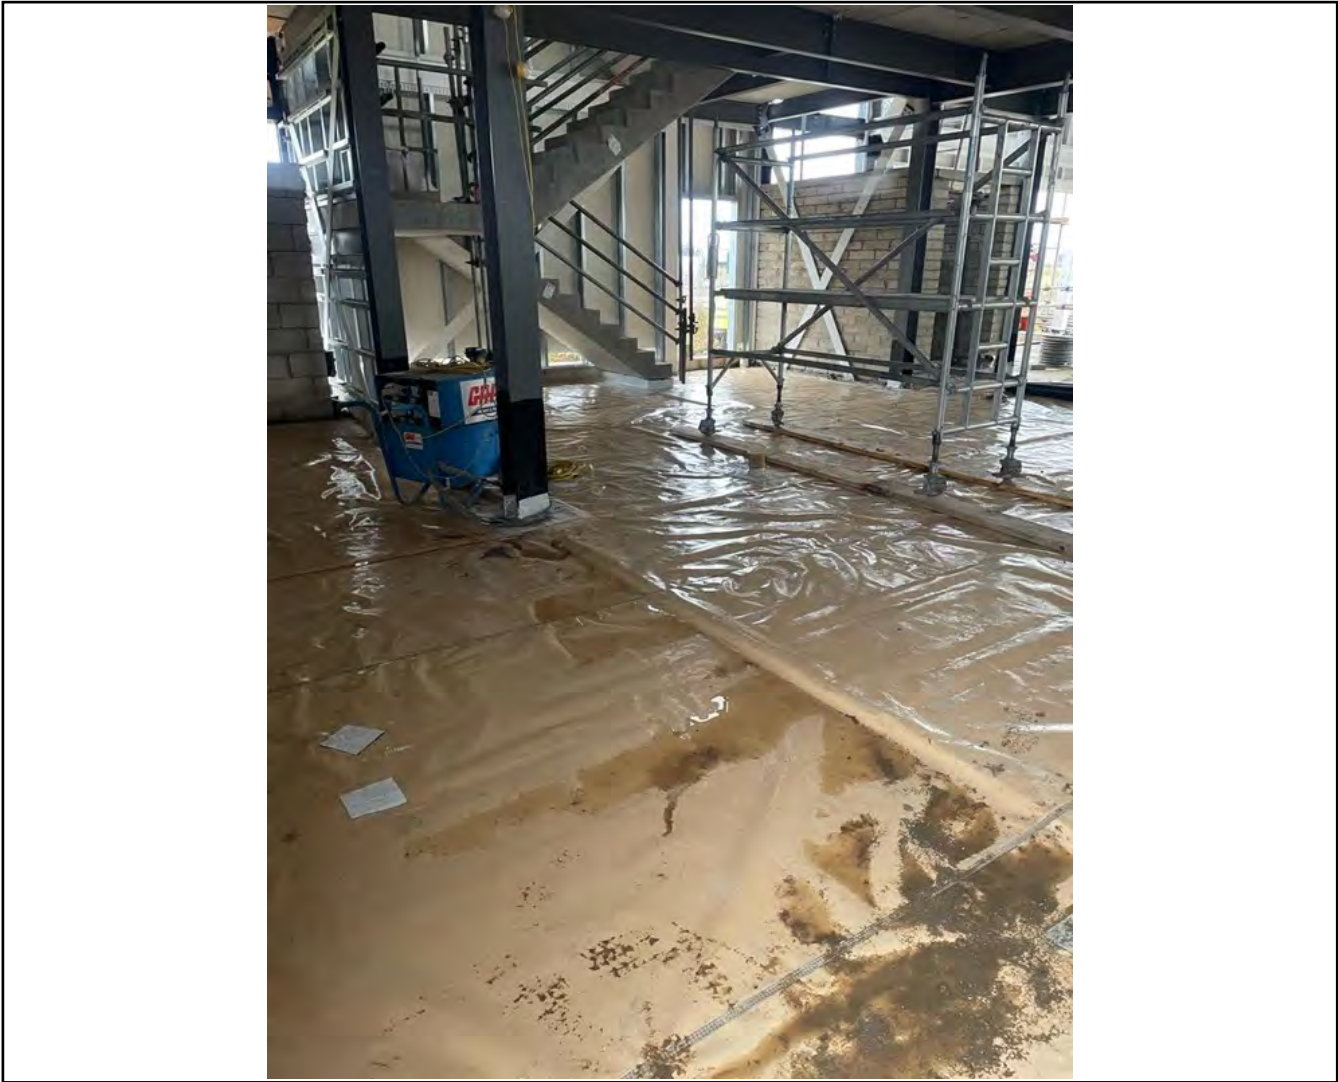
The photograph above shows an overview of a room verified during this

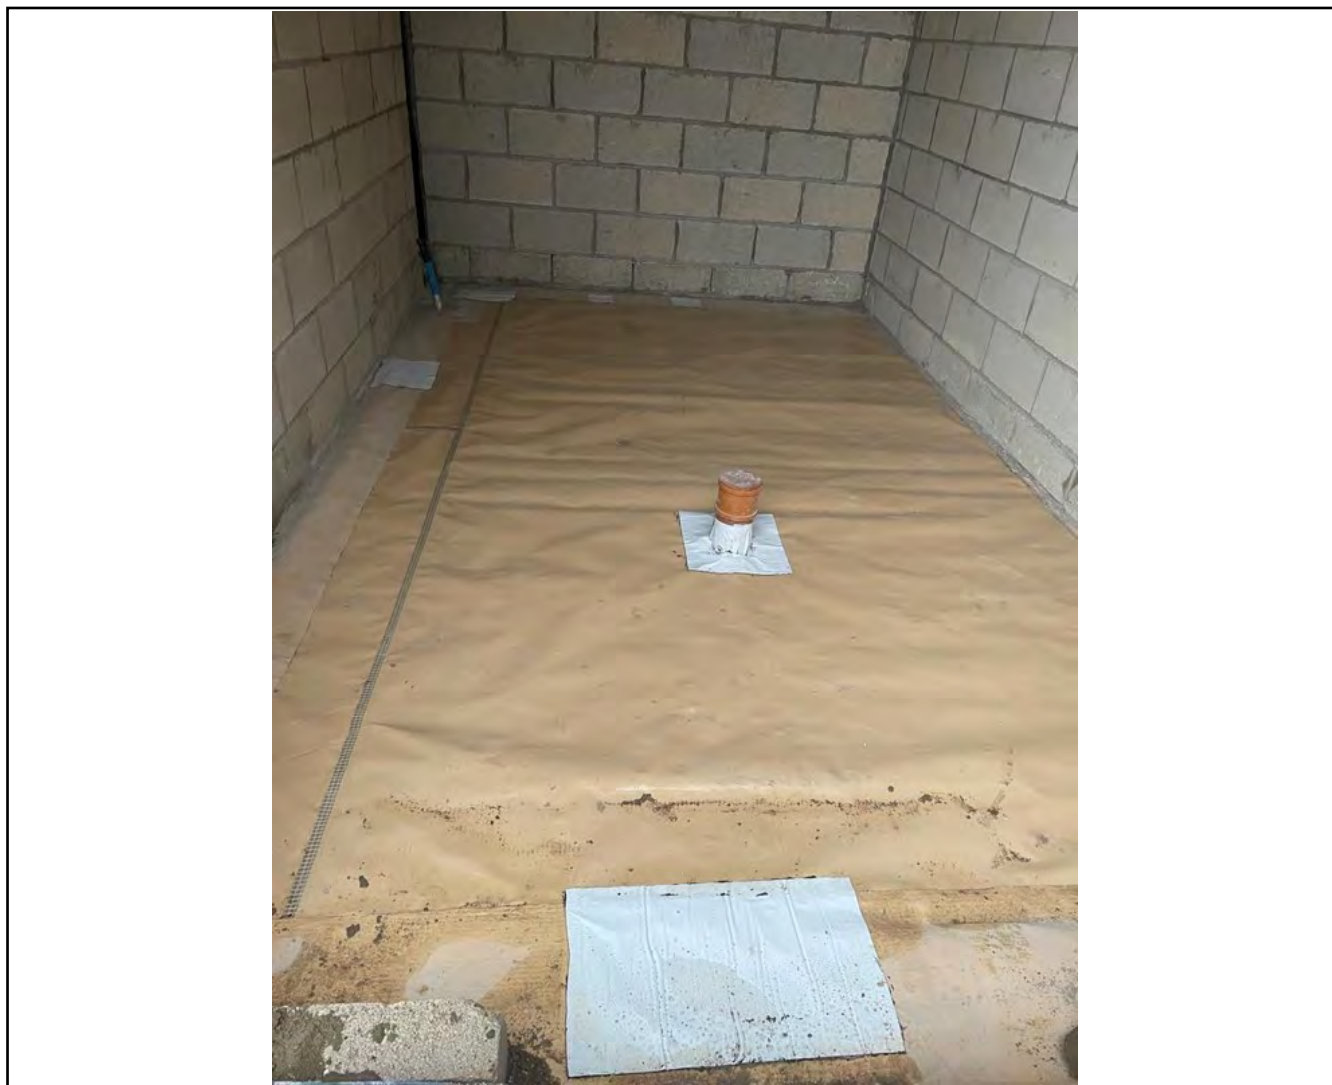
The photograph above shows an additional room where the PAG Monarflex

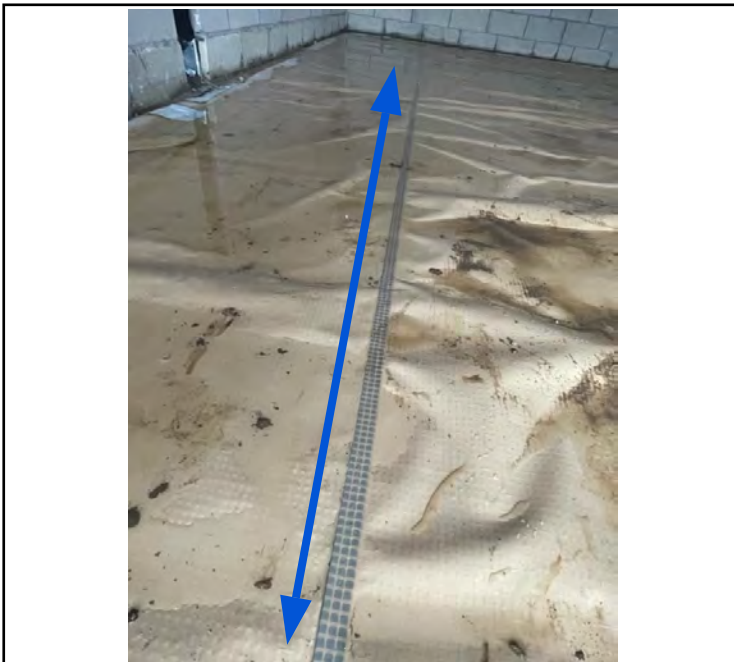
The first photograph below shows an overview of a welded lap which has been welded using an extrusion welder. The installer have achieved a sufficient lap and a strong weld is present.

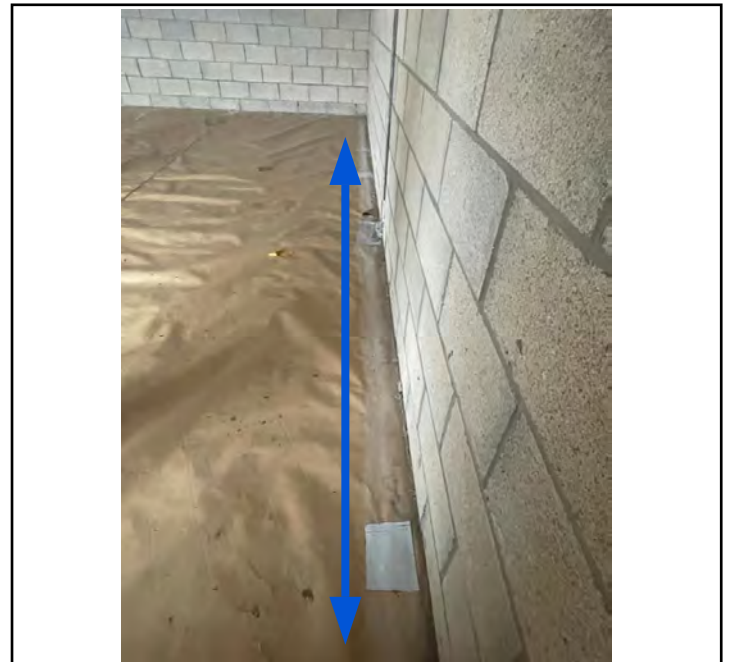
The second photograph above shows an overview of a welded lap using the hot air leister and roller to weld the newly installed membrane to the previously installed membrane.

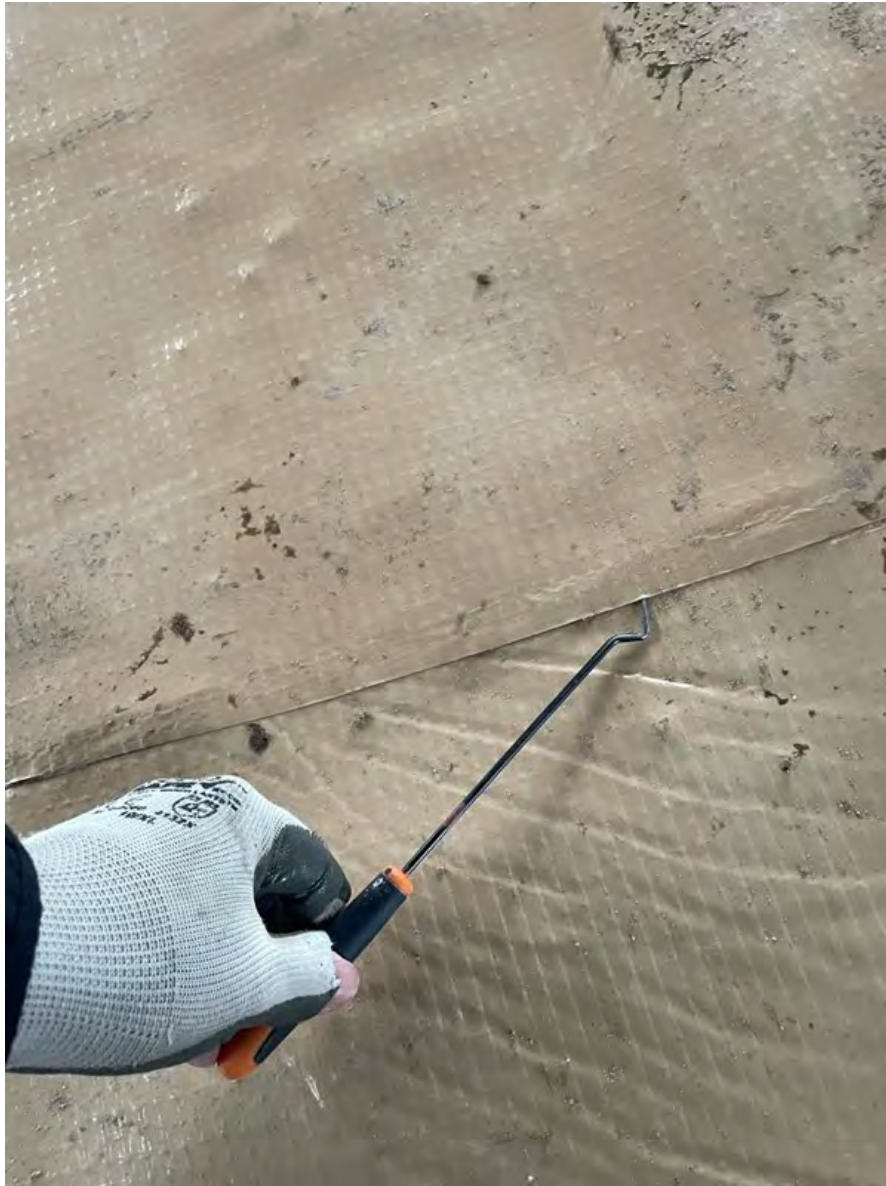
The photograph above shows a pick and probe test carried out to a welded lap of the PAG Monarflex Reflex Super installed to the infills. The installers have achieved a strong weld and any faults were rectified during this visit.

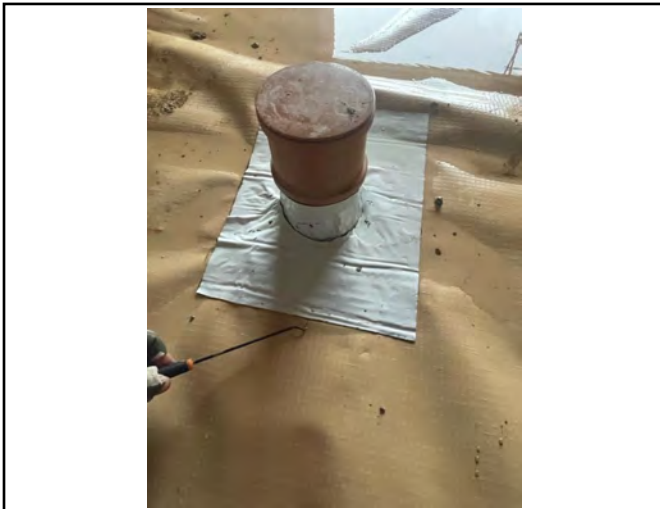
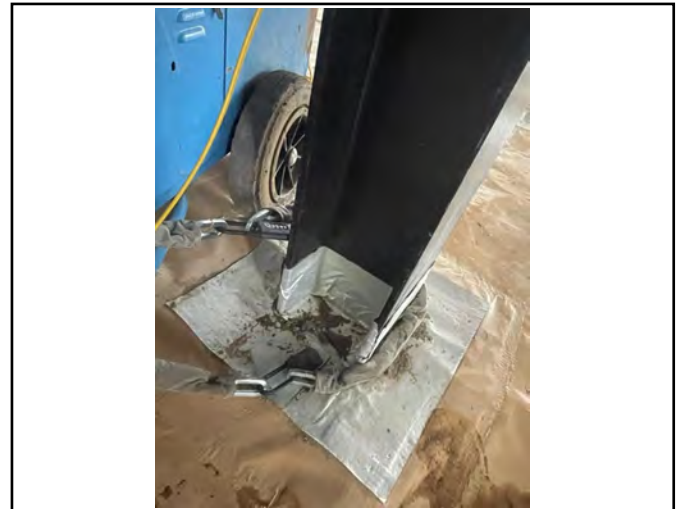
The photographs below shows examples of sealed pipe penetrations and steel columns. The installers have first cut the membrane tight around all details to minimise any gaps which need to be sealed using the PAG SAGR.

The installers have then used a gas blow torch to aid in the adherence of the PAG SAGR to ensure there are no gaps or air bubbles and a strong seal has been achieved.

No faults or defects were identified.

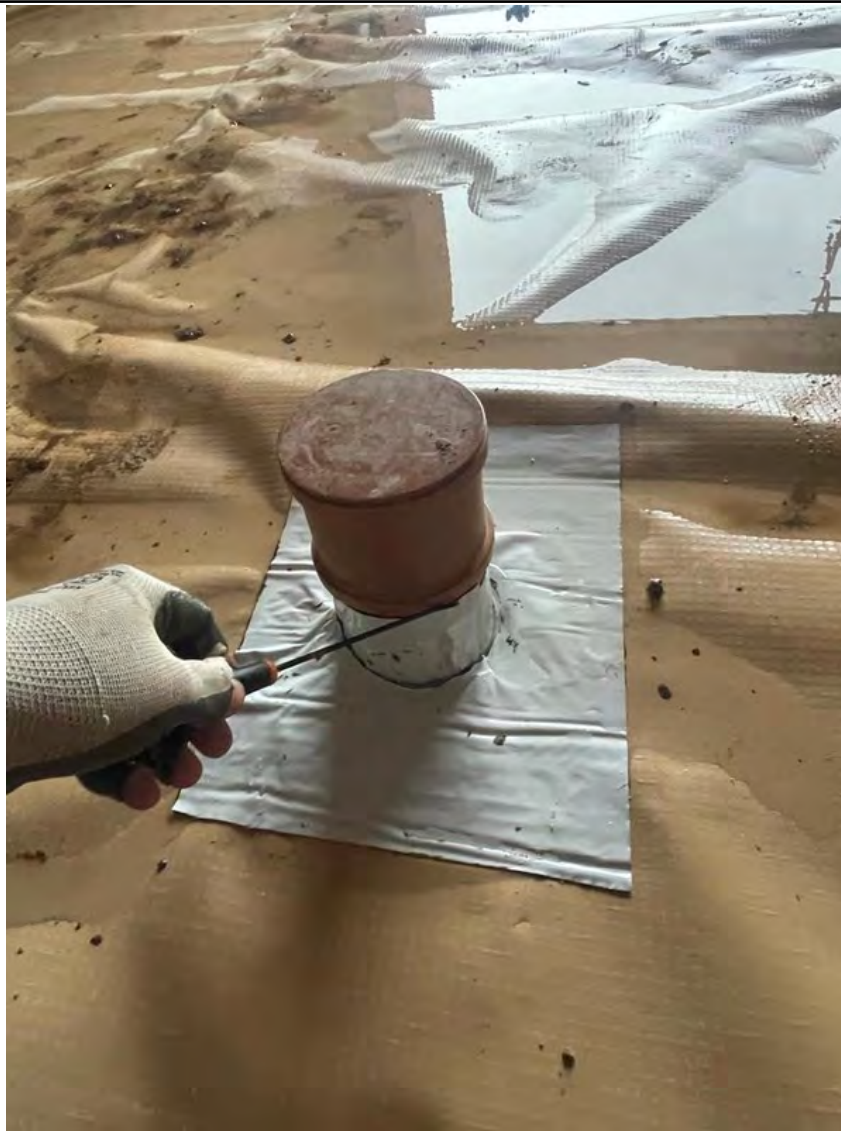
The photograph above shows a pick and probe test carried out to a sealed pipe penetration which has been sealed using PAG SAGR. A strong seal has been achieved using a gas blow torch to aid in adherence.

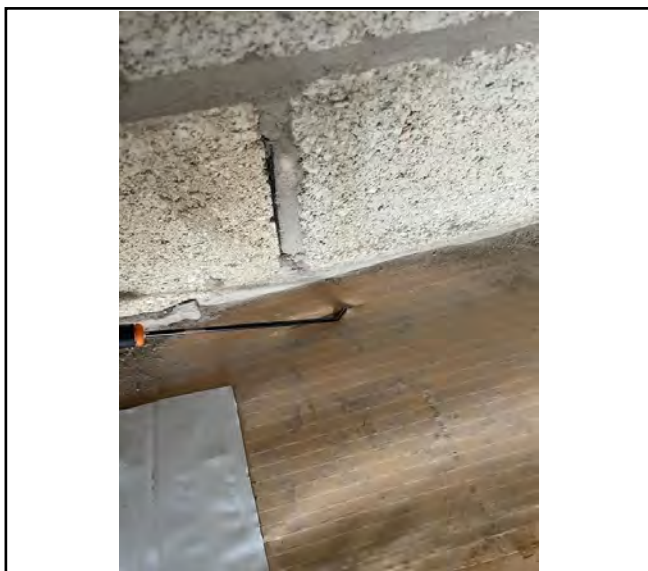
The first photograph below shows a fault identified during this site visit. The previously installed PAG Monarflex Reflex Super to the perimeters has been left exposed for a while and damage has been caused to the membrane.

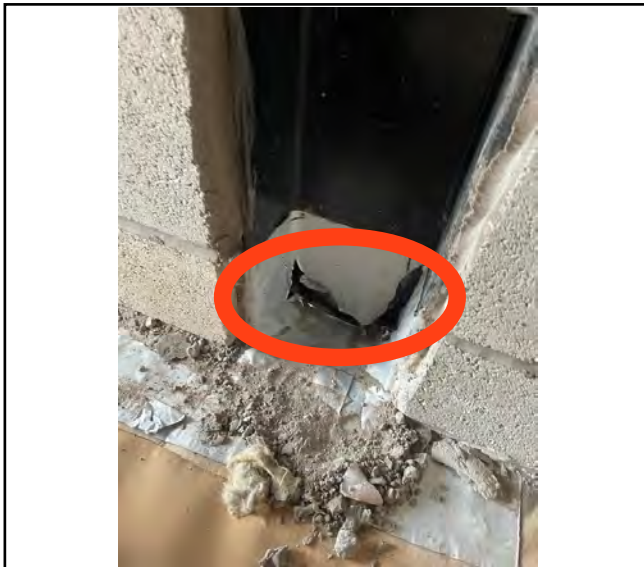
The first photograph below shows a previously sealed and verified steel column. Since the perimeters were signed off damage has occurred to this particular steel column as annotated below.

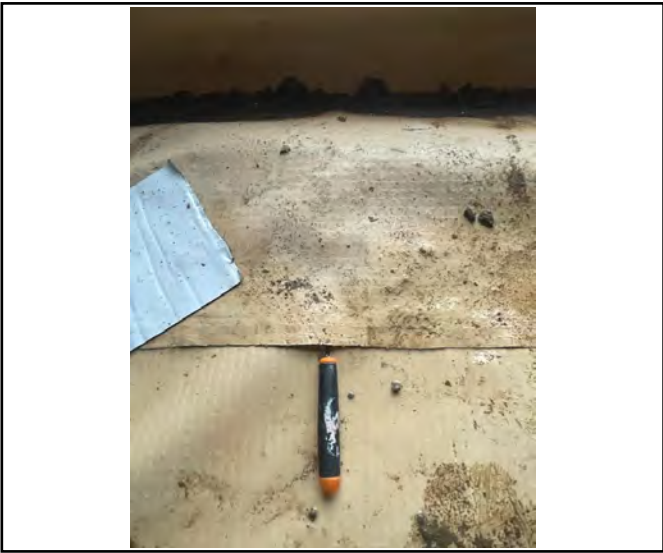
Miss weld identified using pick and probe method.

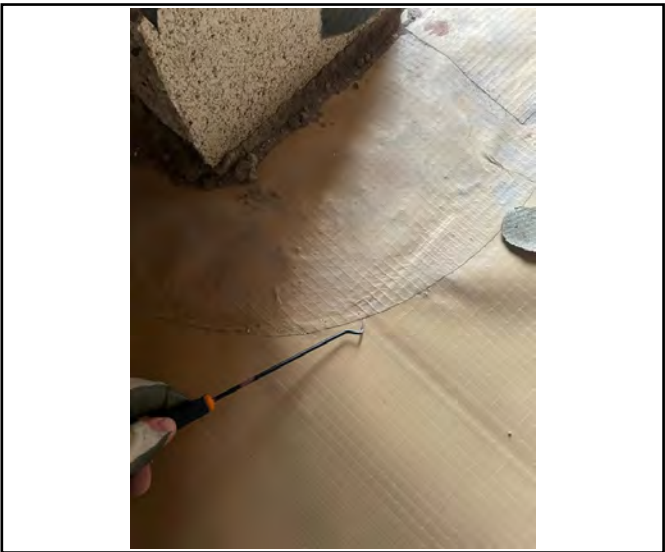
Additional pick and probe test carried

out to welded lap.

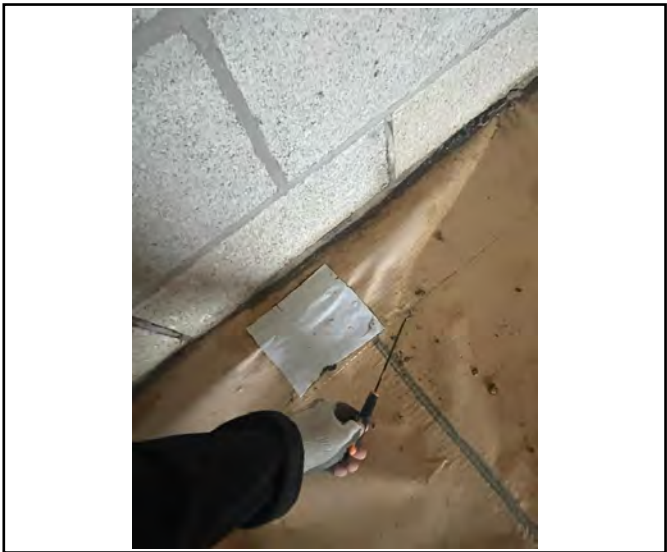
Pick and probe test carried out to hot

air leister and roller welded lap.
