## Verification Report

GEO101947

SLFEZ Zone

Gas membrane to specification BS8485 2015

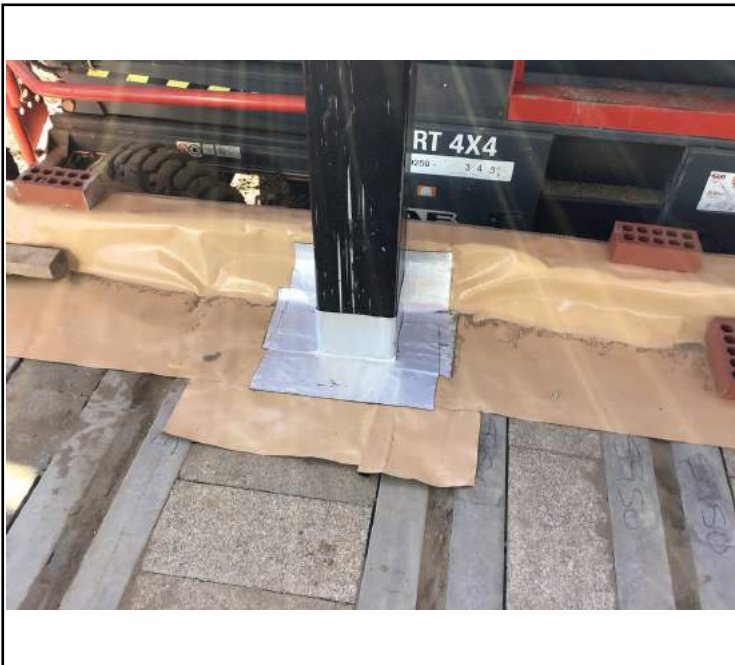
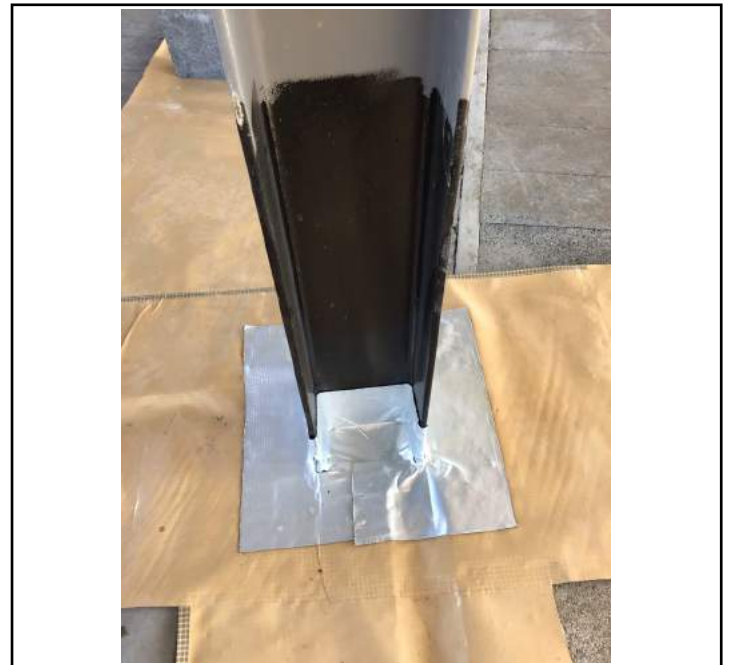
NOTES: Sealed Steel Columns

All steel columns across the verified area have been primed and left to dry. Sections of PAG SAGR have then been cut and a hot air leister has been used to activate the black bitumen side. The sections have then been applied to the steel column and overlapped

before being returned onto the membrane.

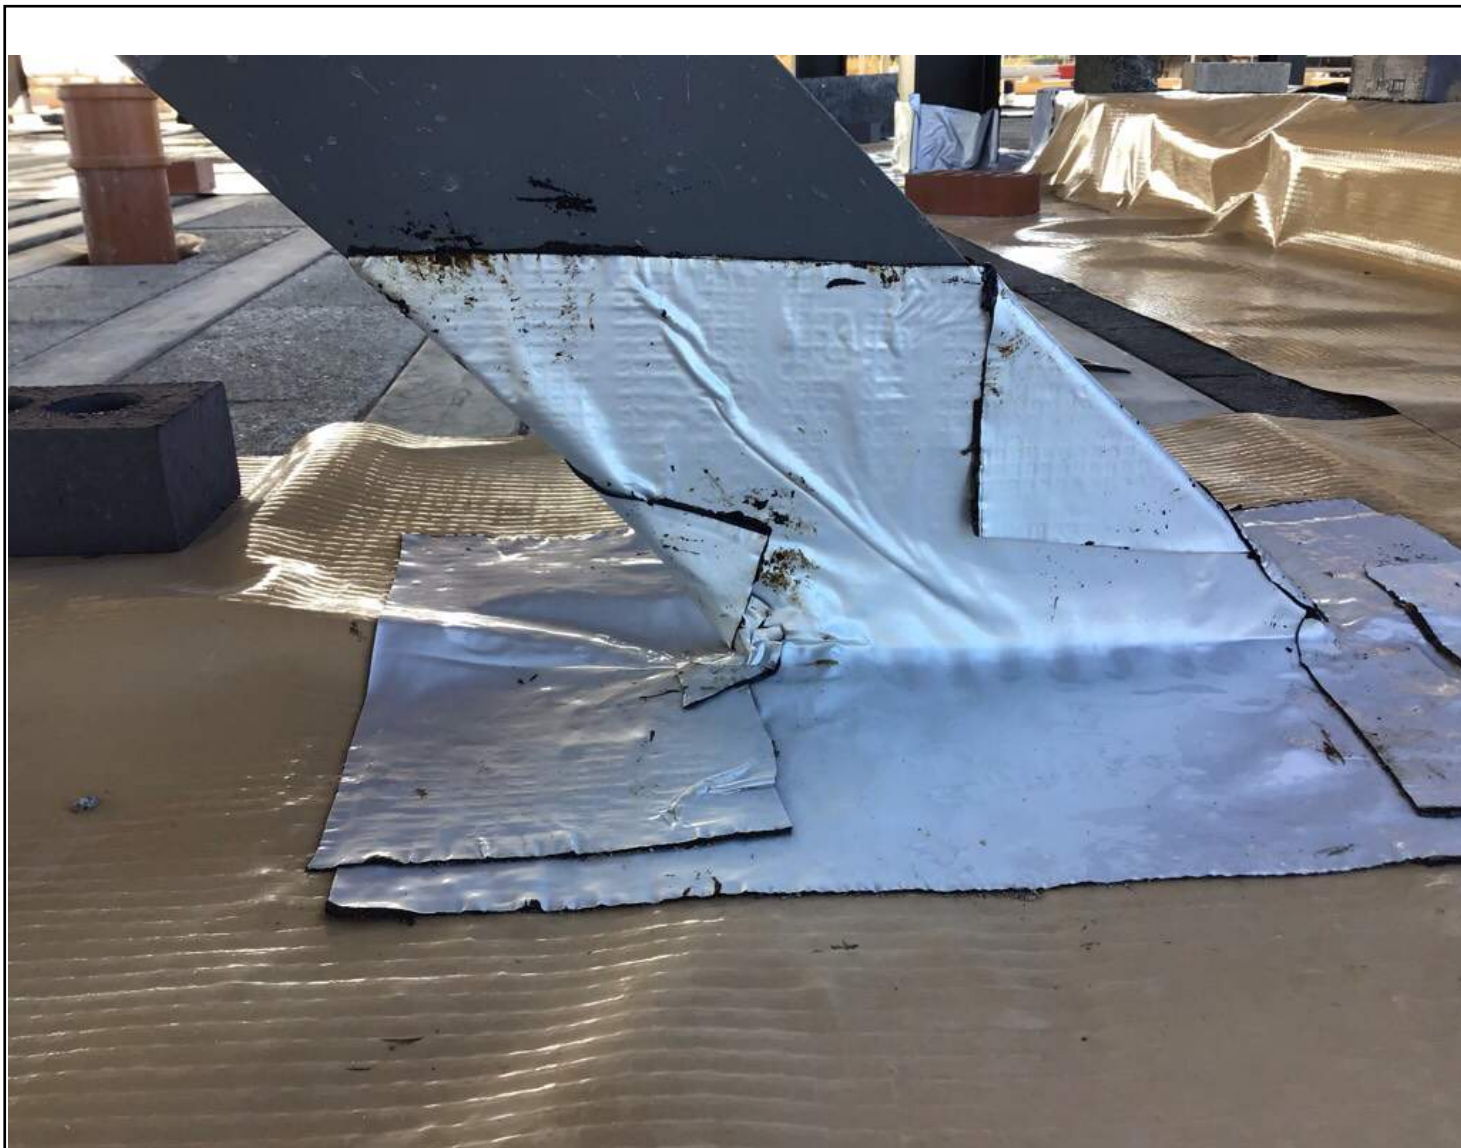
A thorough pick and probe test was carried out on all steel columns in the verified area to ensure that a continuous barrier had been achieved. All materials were installed to manufacturers specification and no faults were detected.

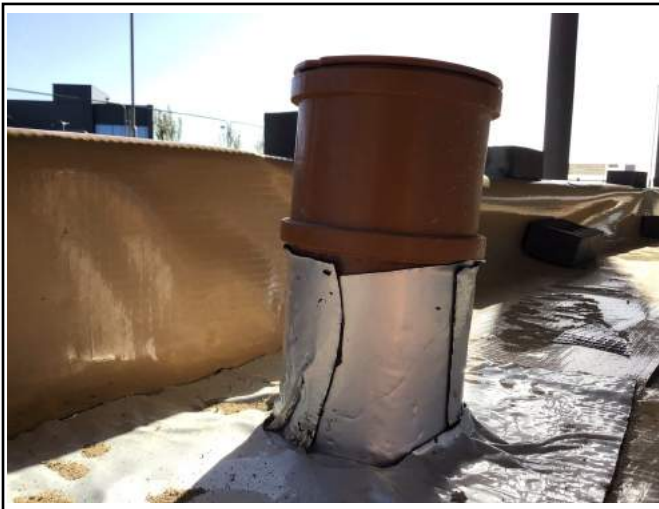
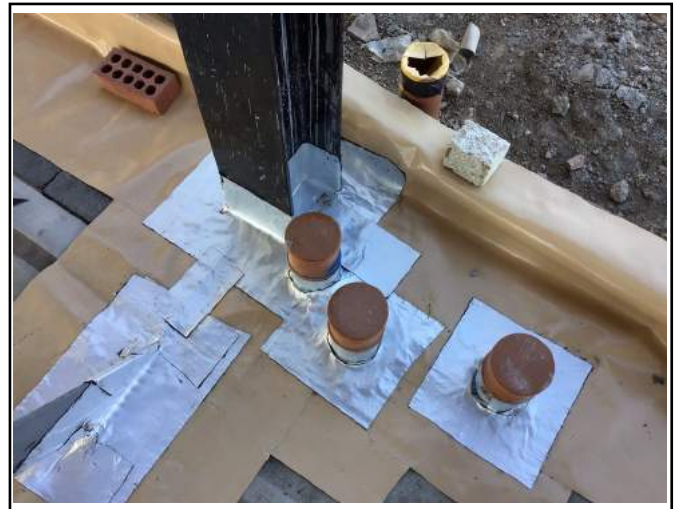
NOTES: Sealed Pipe Penetrations

All pipe penetrations in the verified area have been sealed using sections of PAG

SAGR. Sections have been cut and applied to the pipe penetrations in a petal

formation as shown on the left photo. A top hat has then been applied to the

pipe penetration to complete the detail and seal the pipe to the membrane.

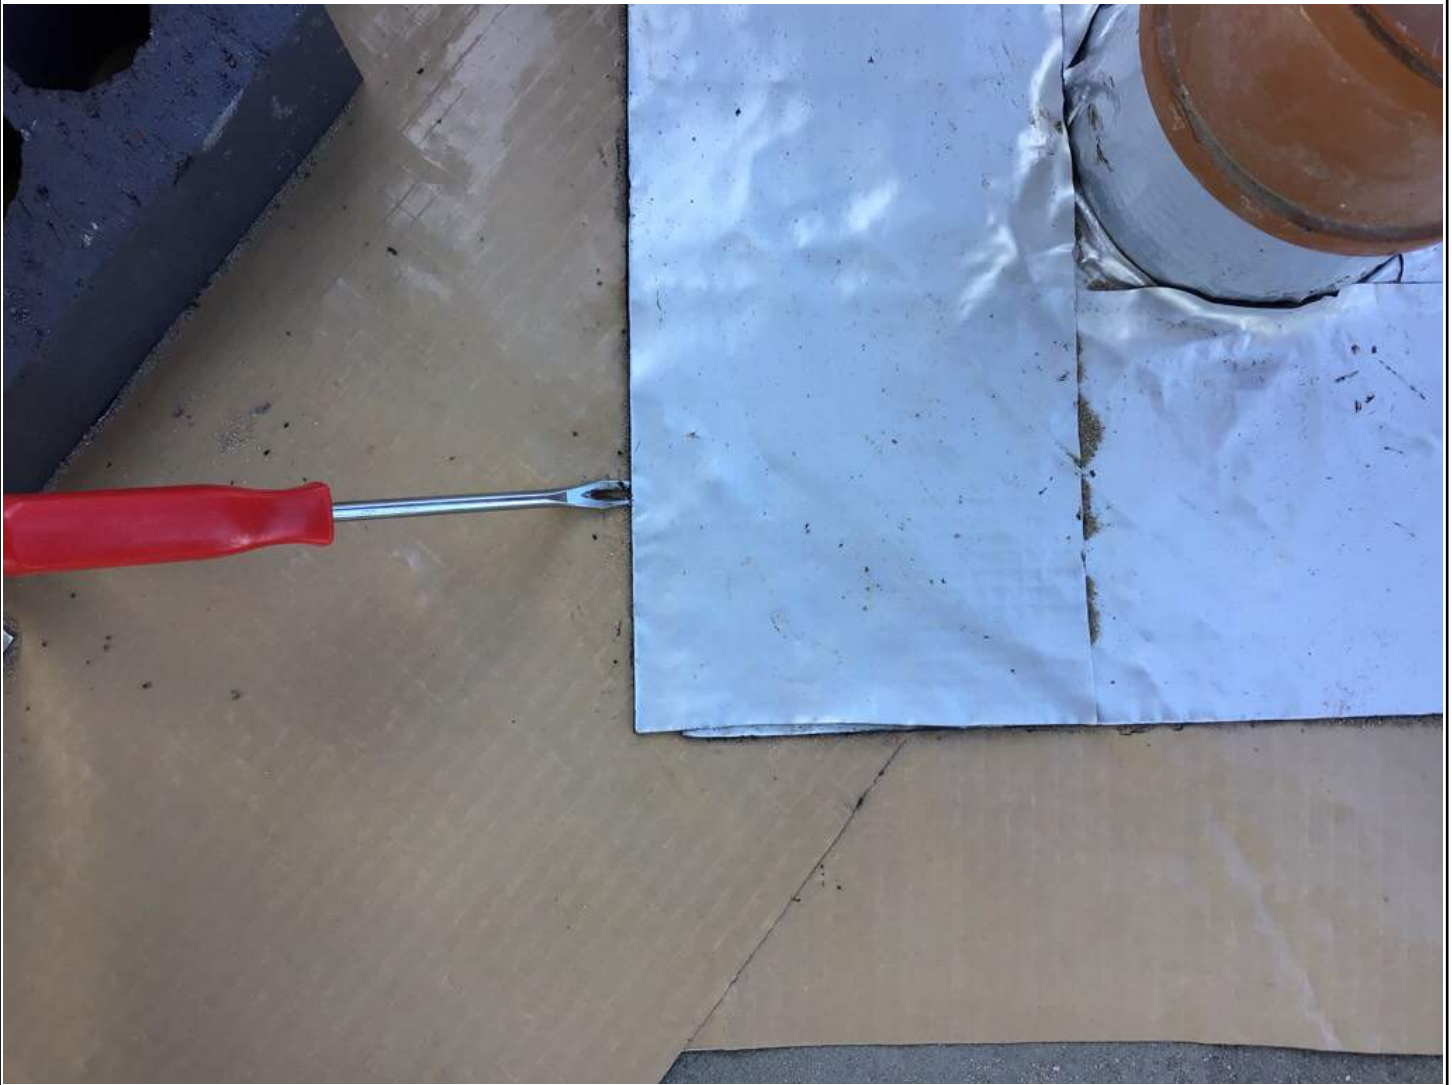
A thorough pick and probe test was carried out on all pipe penetrations across the  
verified area. No faults detected.

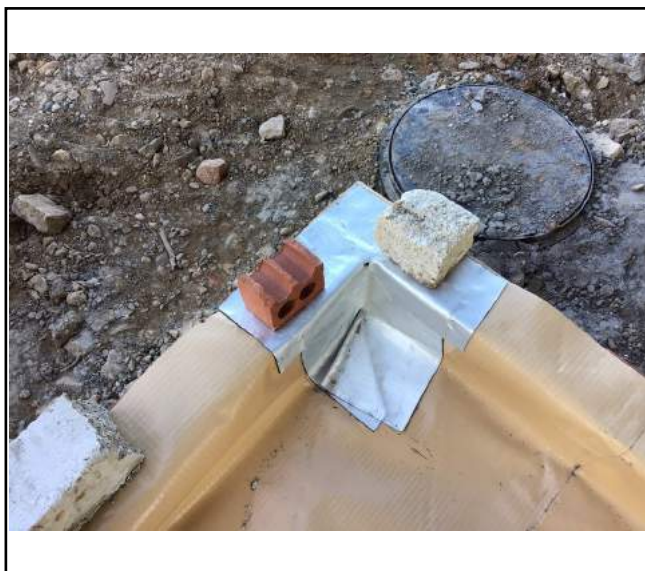
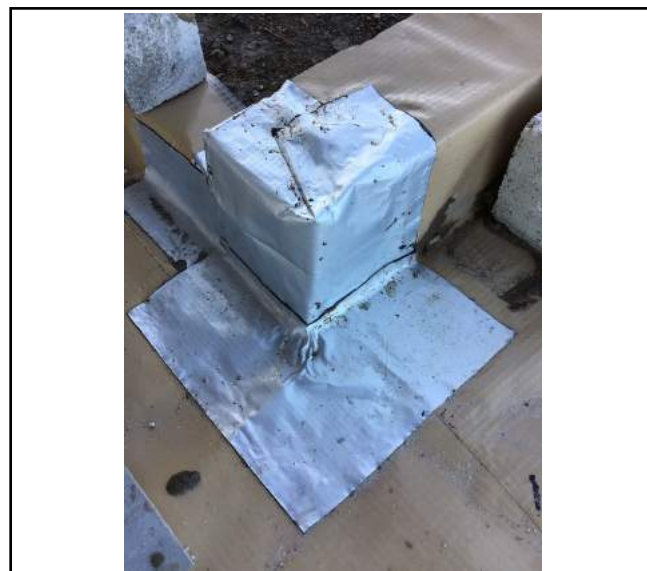
NOTES: Sealed Corner Details

All corner details across the verified area have been sealed using PAG SAGR. The

PAG Monarflex Reflex Super has been cut to accommodate the corner detail and

sections of PAG SAGR has been folded and applied to the corner. Another section

has been cut and applied to the base of the corner to seal and complete the corner

detail.

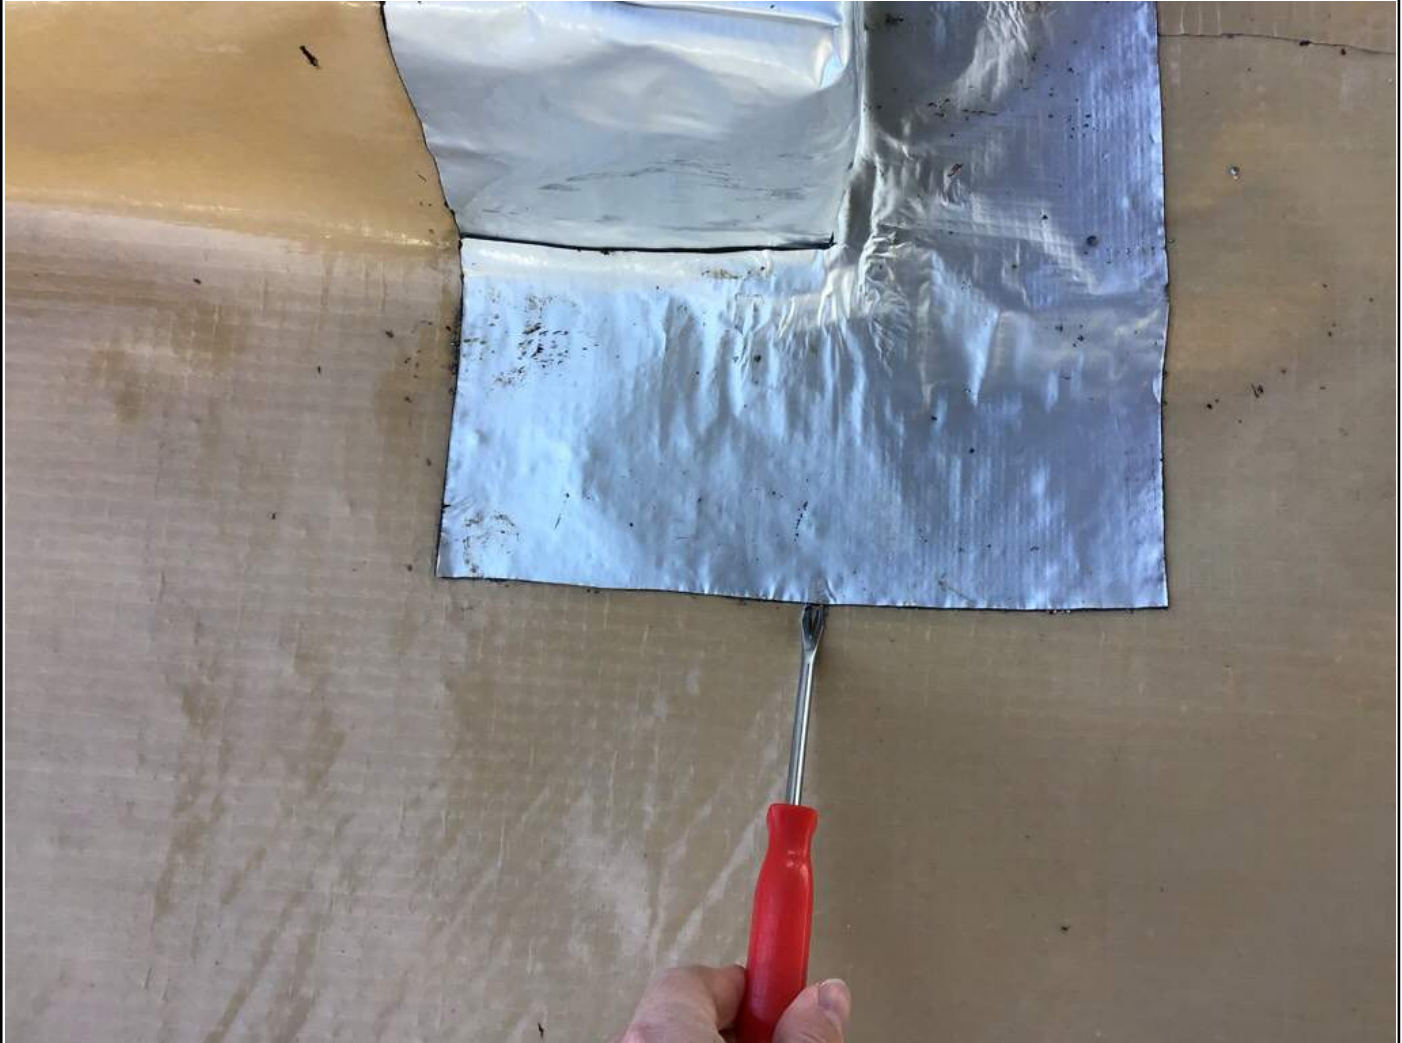
Pick and probe tests were again carried out, returning no faults. All corners were sealed to design and manufacturers specification.

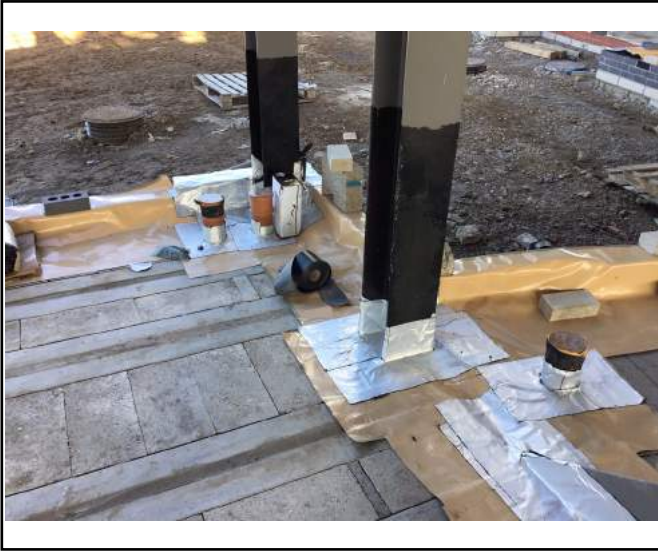
Overview of sealed pipes and steel

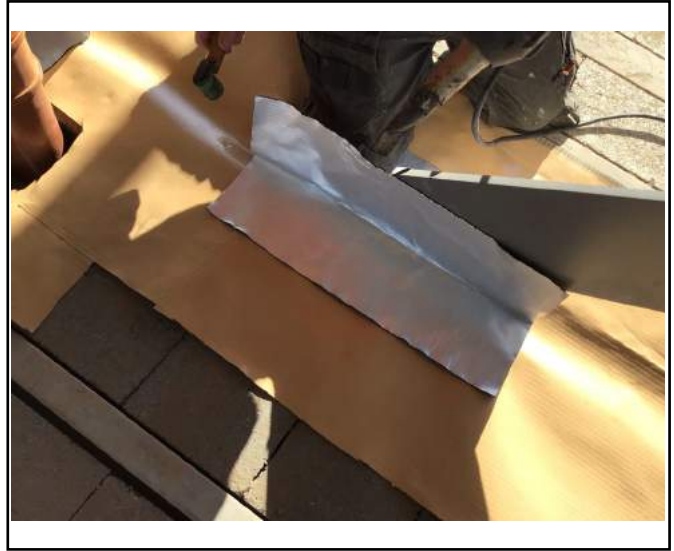
Installer applied PAG SAGR to a  
steel

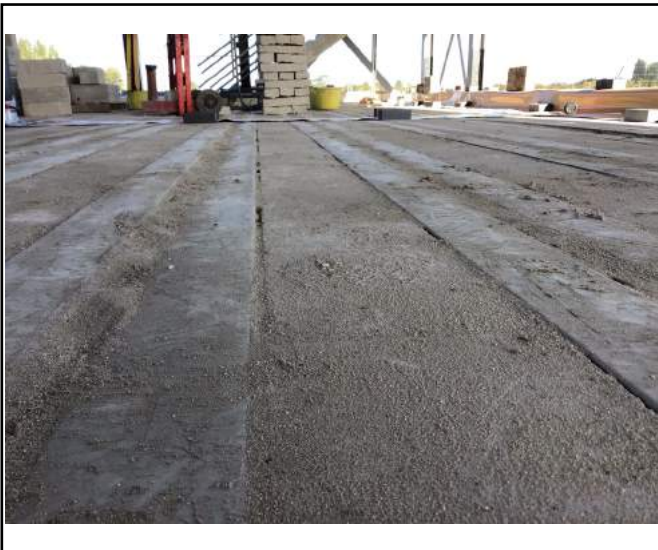
Smooth block and beam floor

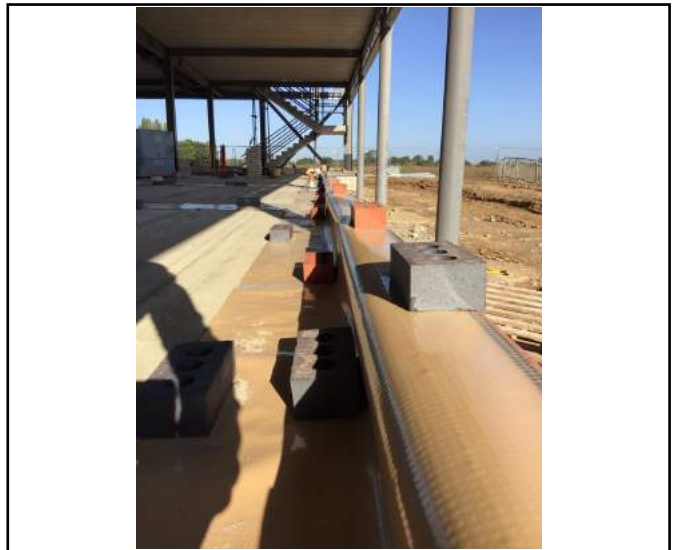
Membrane installed across proposed  
cavity.

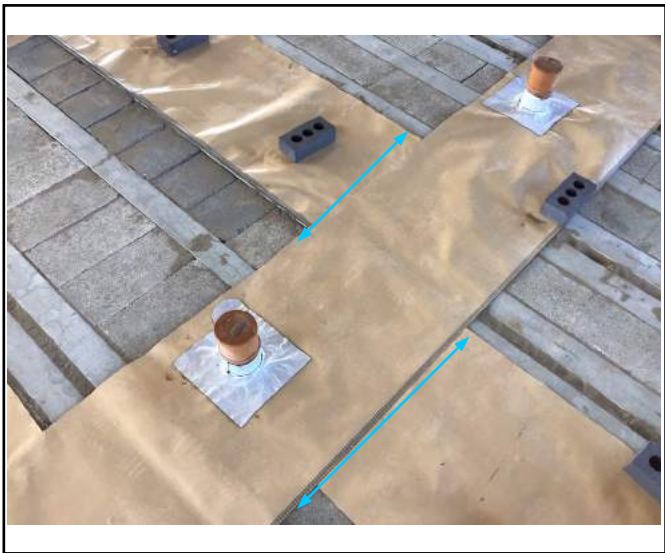
Overview of welded internal wall

membrane

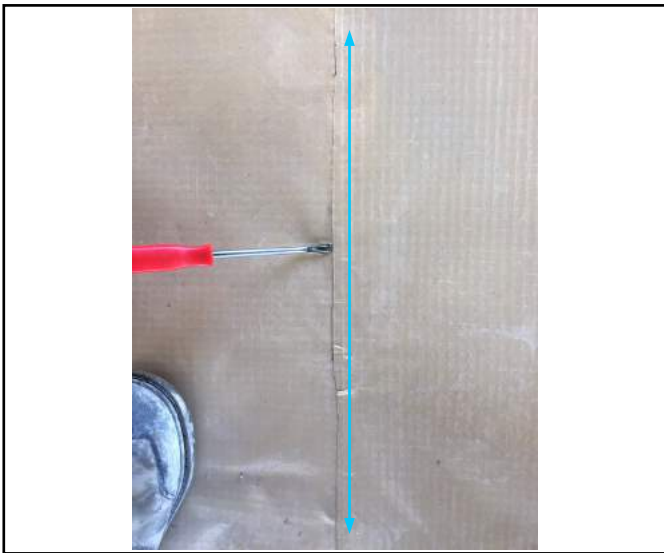
Pick and probe on welded lap

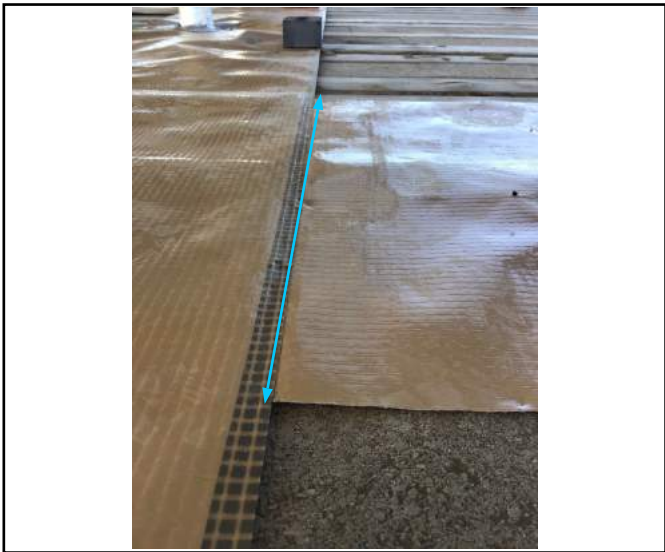
Overview of welded lap
