# GEOSHIELD Verification Report

GEO101947

SLFEZ Zone

Gas membrane to specification BS8485 2015

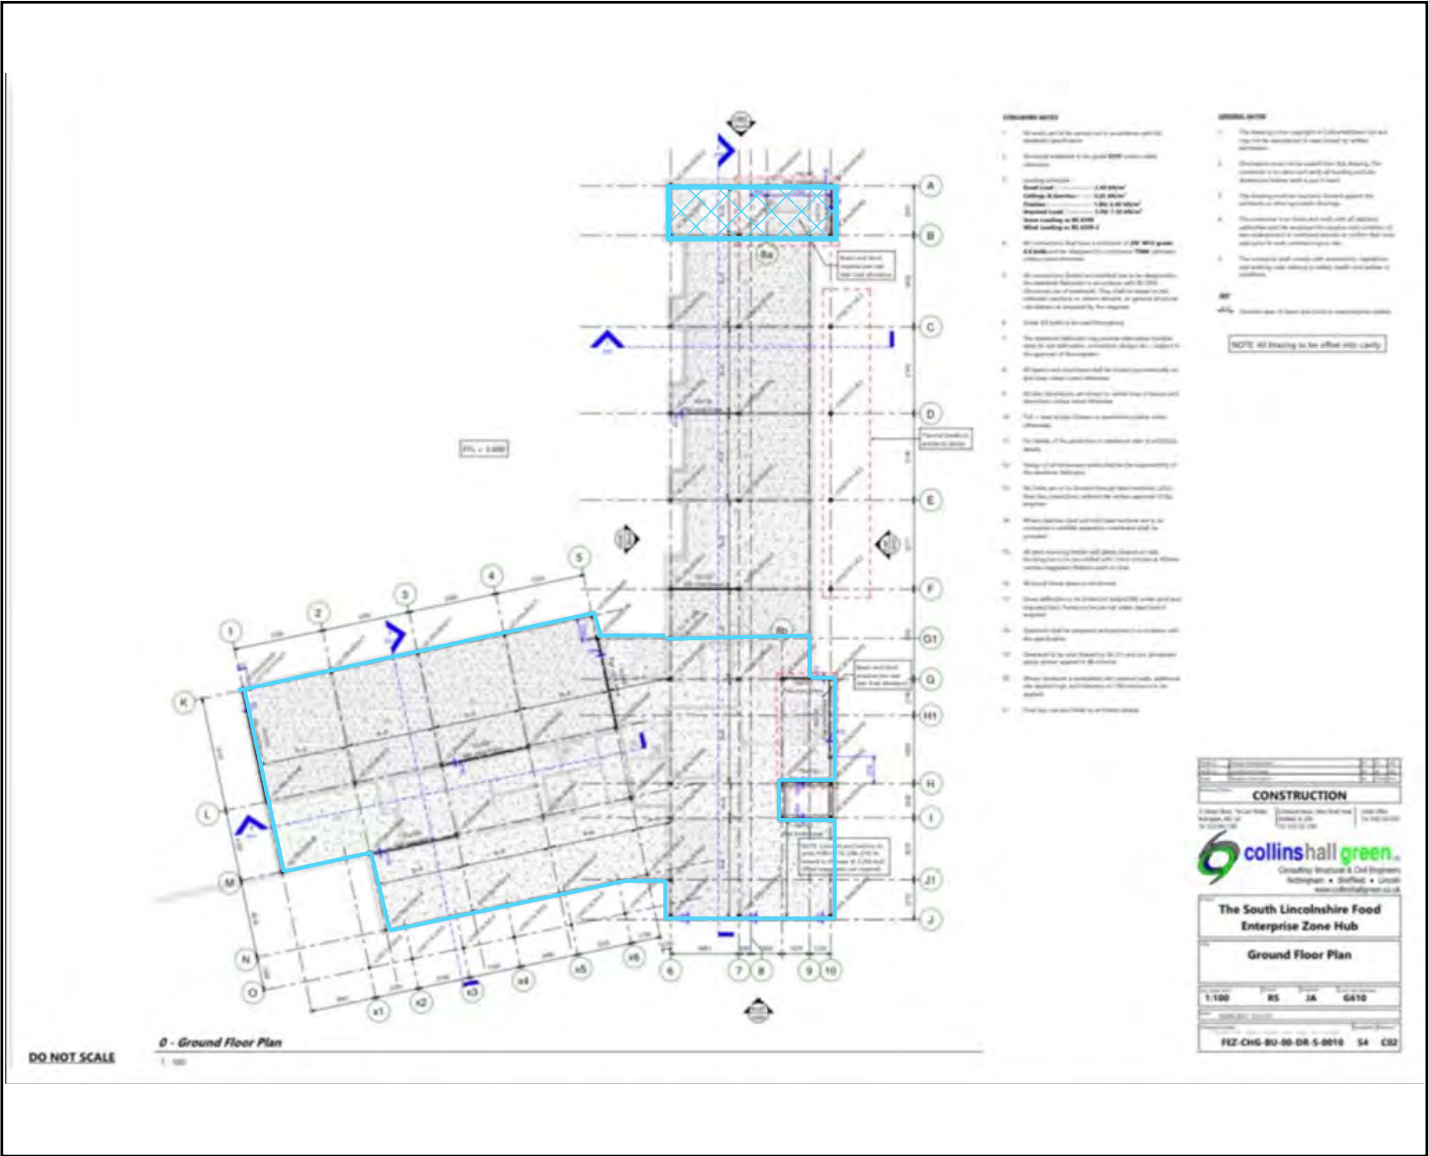
Overview of verified infills highlighted in Blue

Infills - Gridlines K-G1 & K-O & Stair well

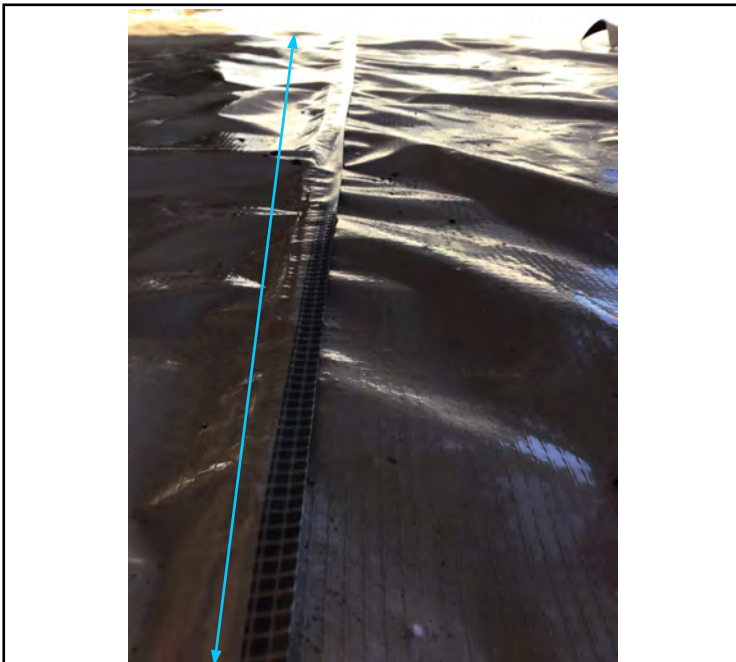
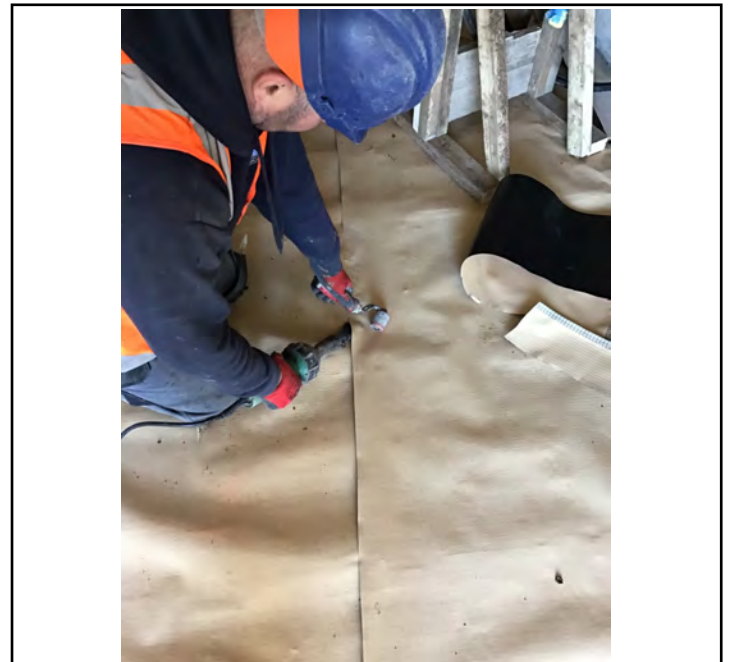
NOTES: Welded Lap Joints

The first photograph below shows an overview of a welded lap which has been welded using an extrusion welder. Overlaps have been created a minimum of 100mm and a hot air leister and roller have been used to weld the overlaps and form a continuous

barrier. The second photo shows a PAG installer forming a welded lap joint.

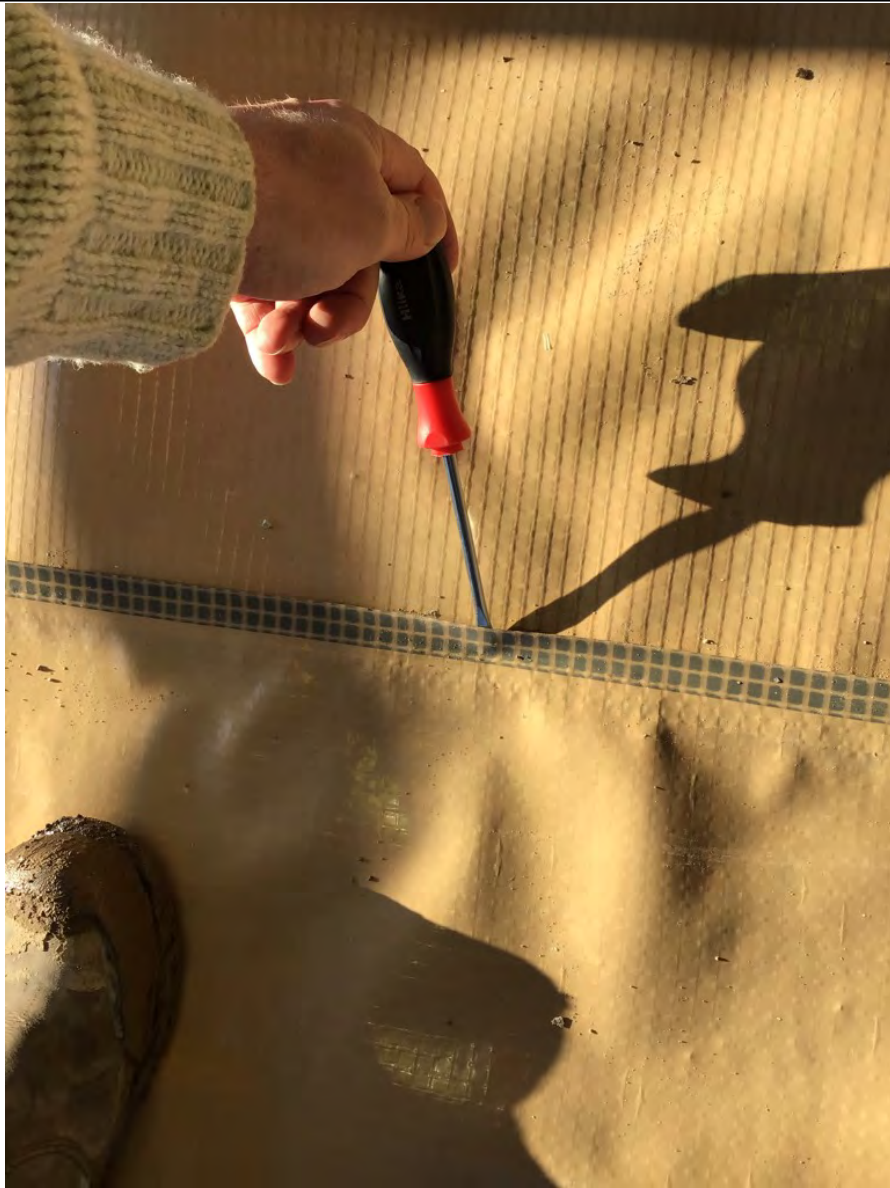
The photograph above shows a pick and probe test carried out to a welded lap of the PAG Monarflex Reflex Super installed to the infills. A complete barrier has been achieved with only one fault found. This was remediated on site.

Verified in accordance with CIRIA 735.

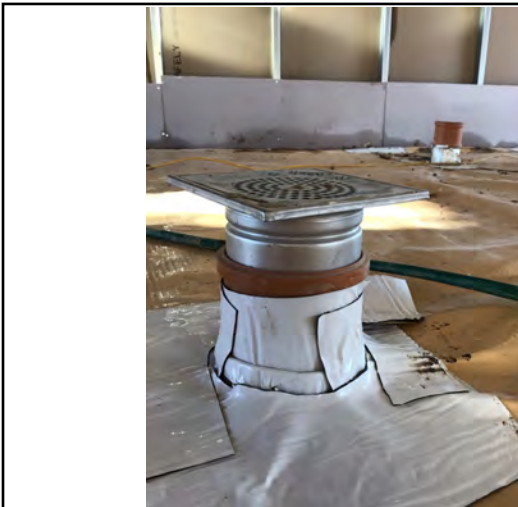
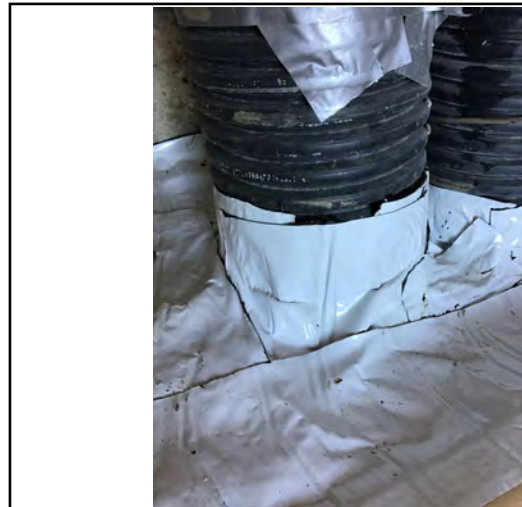
NOTES: Sealed Pipe Penetrations

All pipe penetrations across the verified area have been sealed using PAG SAGM.

Sections of self adhesive have been cut and a hot air leister has been used to activate the black bitumen side. The sections have then been applied 150mm vertically to the

pipe and then returned 150mm to the membrane, overlaps have been created using this method with a top hat cut from self adhesive (acceptable alternative to a preformed top hat) to complete the detail.

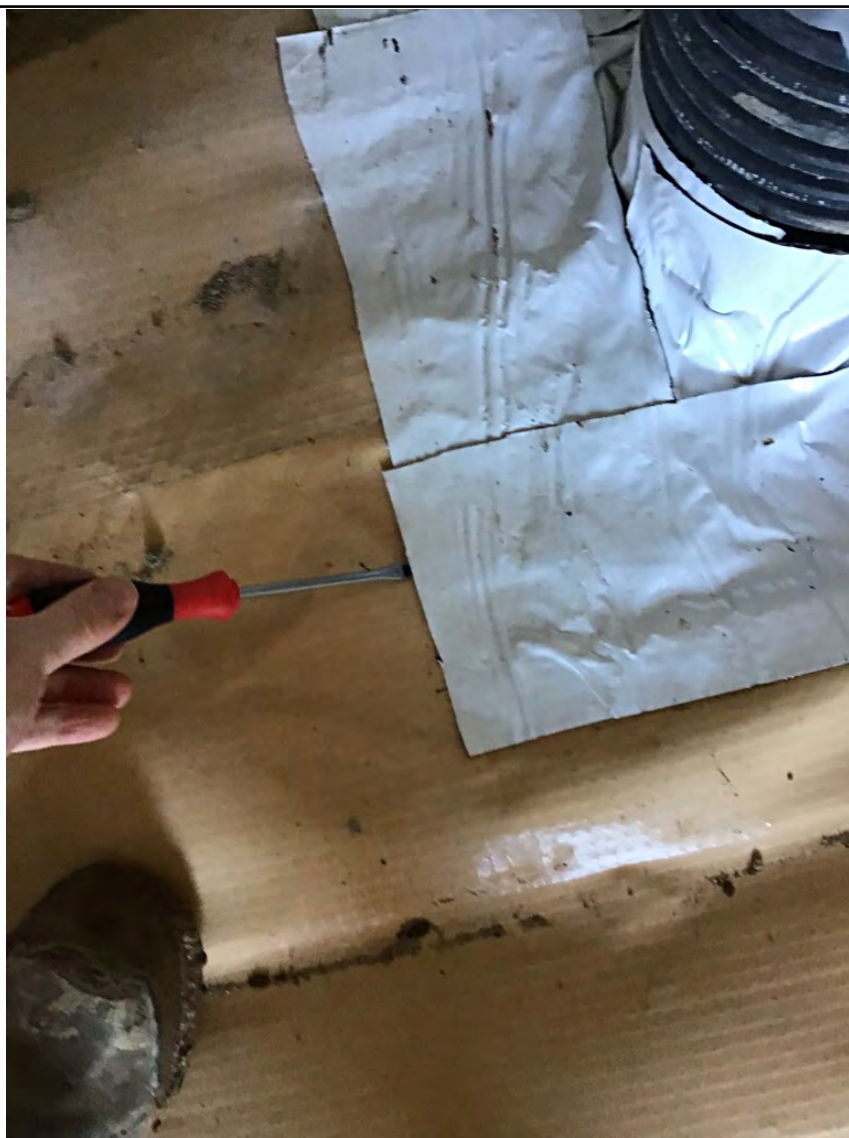
A thorough pick and probe test on all pipe penetrations returned no faults with the materials installed to manufacturers specification.

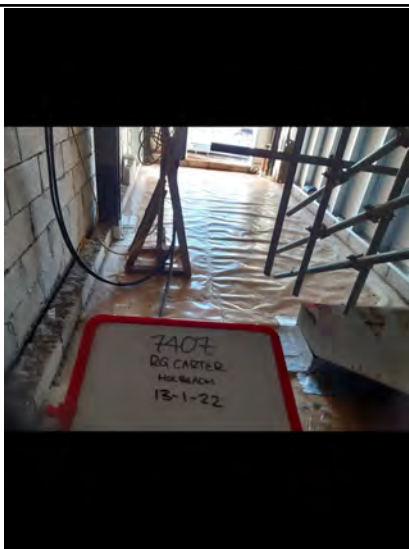
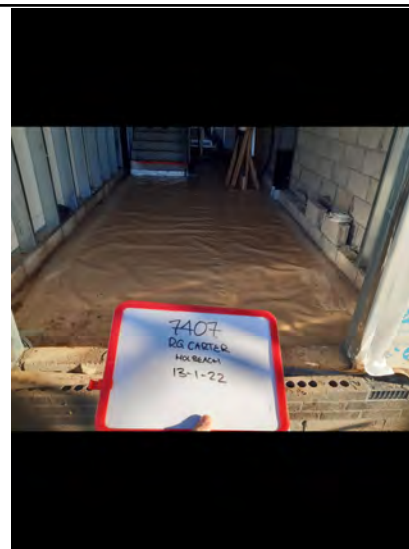
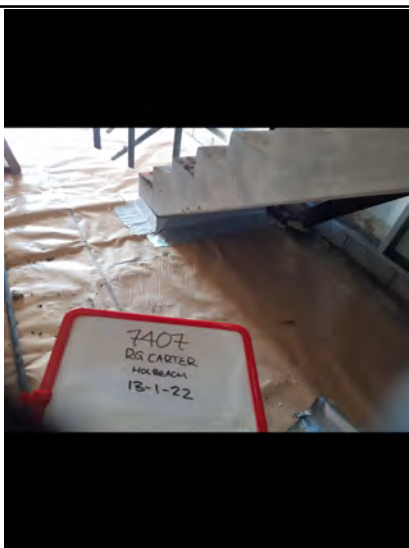
Sealed stair well

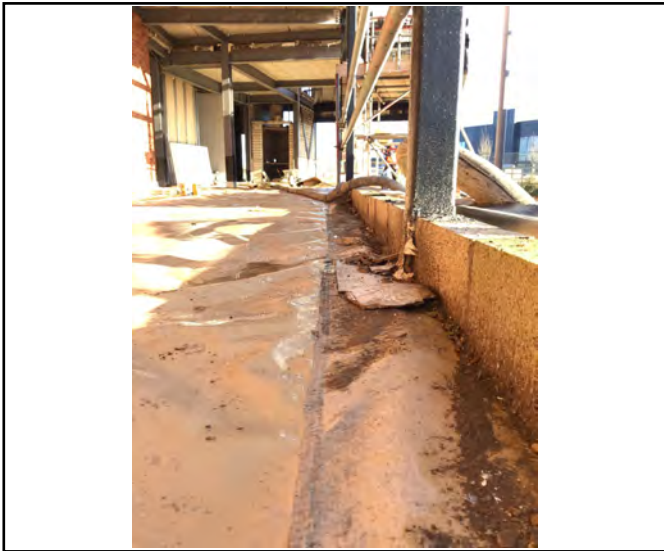
Infill terminated to perimeter membrane

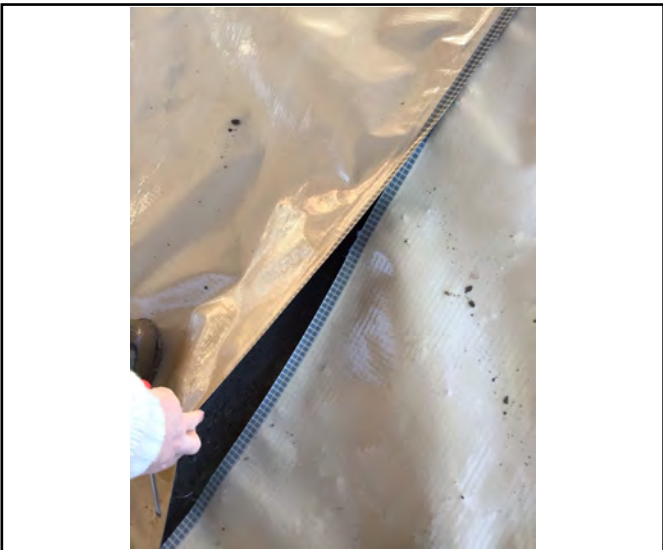
Fault found on welded lap

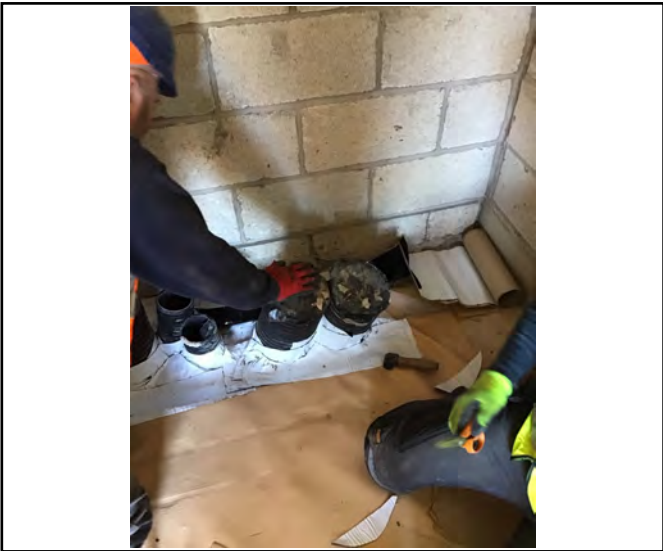
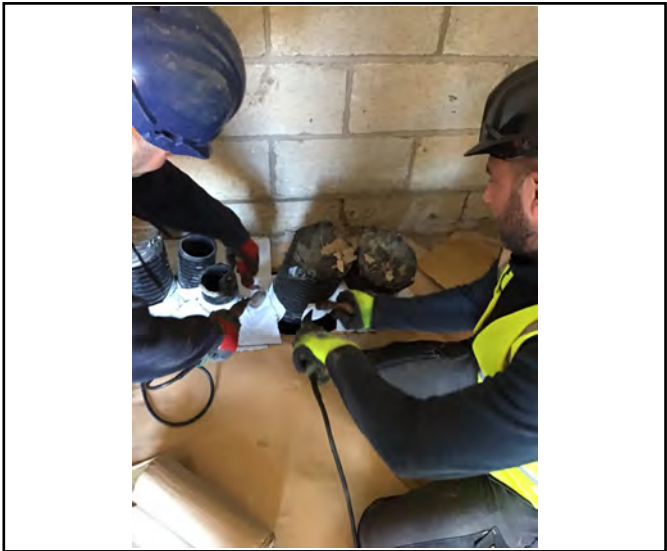
Installers sealing pipe cluster

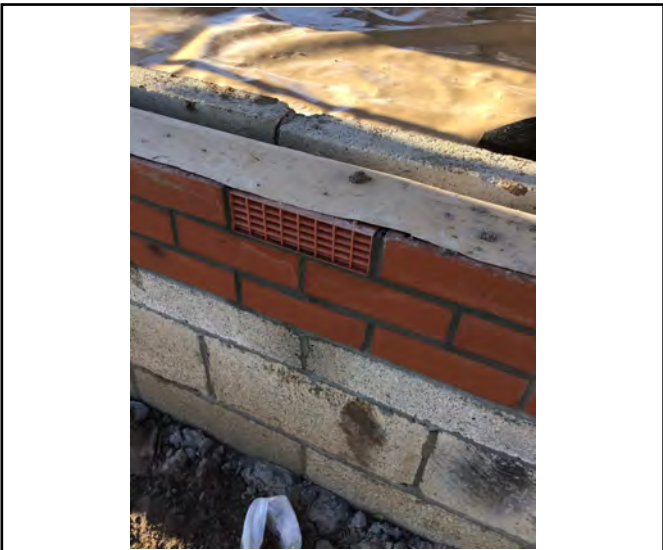
Air brick in perimeter
