**St John's Care Homes**  
**Patchett Lodge.**  
**Stukeley Rd,**  
**Holbeach,**  
**Spalding**  
**PE12 7LJ**

*James Rose, UK Landscapes*

*05/12/2023*

*Site visit 01/12/2023*

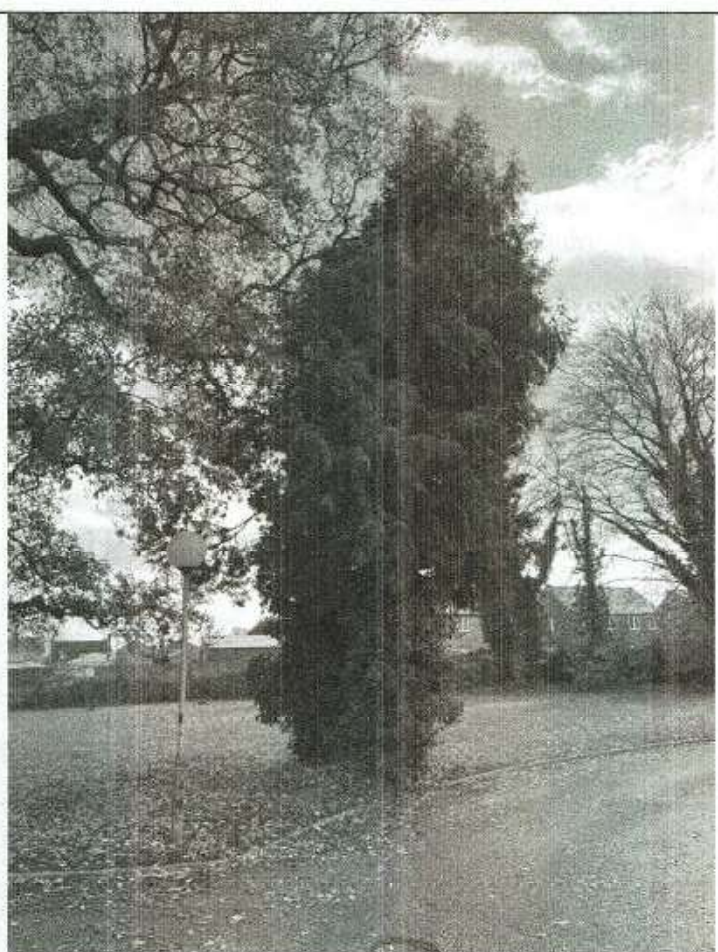
| <p>T3</p> | <p>Lawson Cypress</p> <p>Heavily clad in Ivy,<br/>Poor specimen</p> <p>Recommendations</p> <ul style="list-style-type: none"> <li>• Sever ivy.</li> <li>• Or consider felling</li> </ul> <p>Priority Low</p> | |

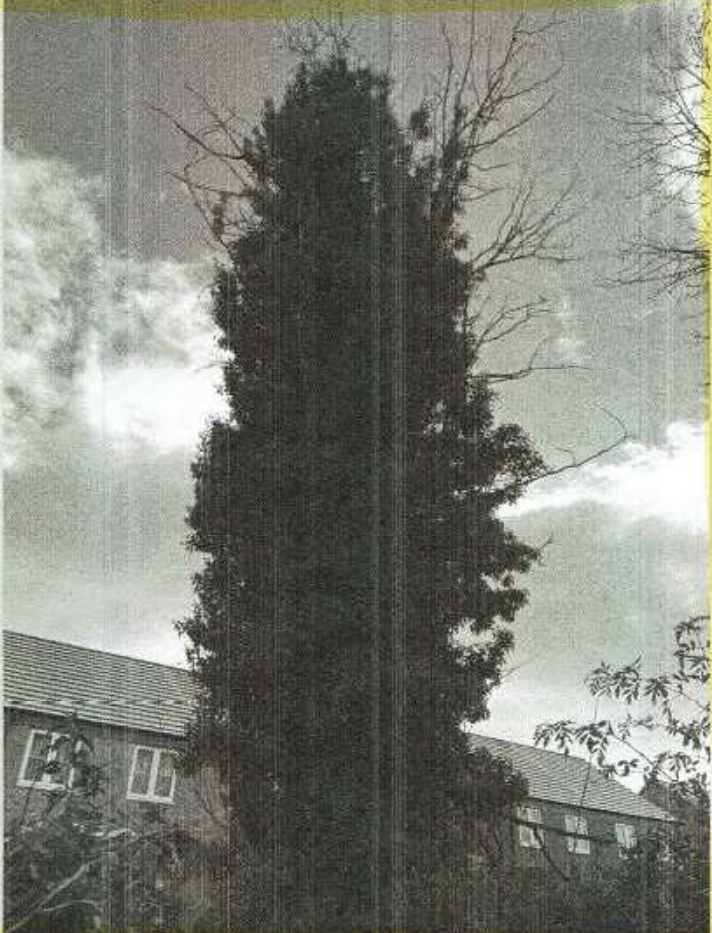
| <p>T4</p> | <p>Sycamore<br/>Densely clad in Ivy, situated on boundary near residential boundary,<br/>Extensive deadwood and little evidence of live growth</p> <p>Recommendations</p> <ul style="list-style-type: none"> <li>• Fell to ground level</li> </ul> <p>Priority High</p> | |

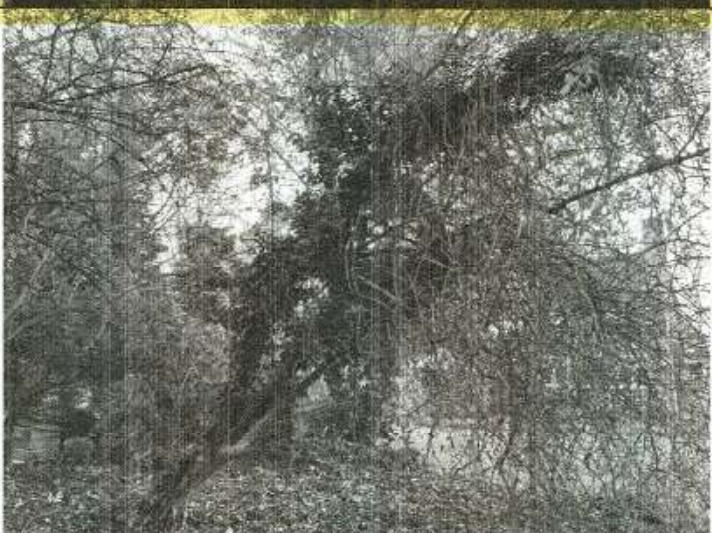
| <p>T5</p> | <p>Elder<br/>Failed root plate</p> <p>Recommendations</p> <ul style="list-style-type: none"> <li>• Fell to ground level</li> </ul> <p>Priority Medium</p> | |

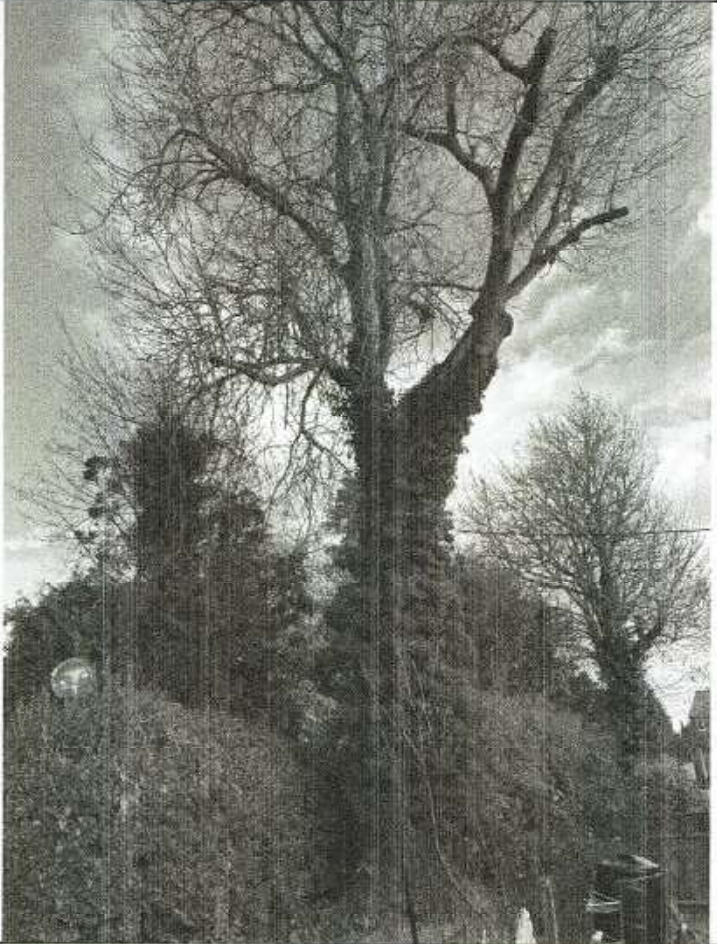
| <p>T6</p> | <p>Ash</p> <p>Ownership to be confirmed</p> <p>Previously heavily pruned</p> <p>Stem clad in ivy</p> <p>Ivy obscures inspection, suspect previous heavy pruning due to decay</p> <p>Recommendations</p> <ul style="list-style-type: none"> <li>• Sever ivy and reinspect,</li> <li>• Fell to ground level</li> <li>• Confirm ownership</li> </ul> <p>Priority Medium</p> | |

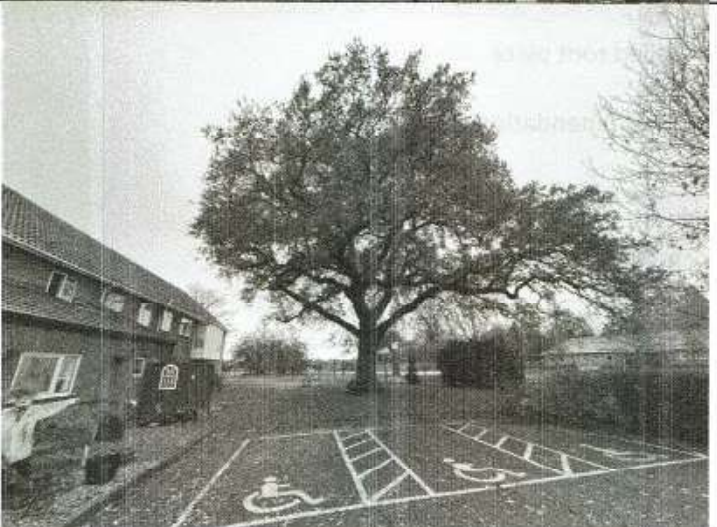
| <p>T7</p> | <p>Oak tree</p> <p>Situated close to building</p> <p>Previously reduced on building side</p> <p>Large lateral limb on North side</p> <p>Recommendations</p> <ul style="list-style-type: none"> <li>• Remove deadwood</li> <li>• Prune back from building .5m</li> <li>• Reduce over crown reduction of 1m reducing north limb by 2m</li> </ul> <p>Priority Low</p> | |

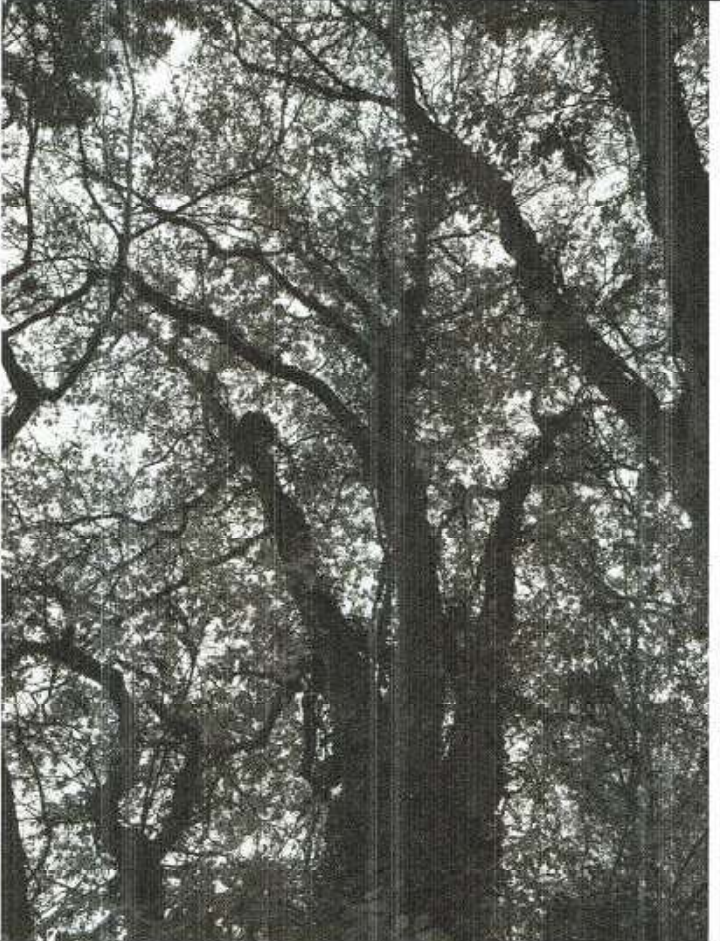
| G2 | <p>Oak and Ash tree<br/>Growing on edge of site<br/>Heavy crown bias to neighbour,<br/>Clad in ivy</p> <p>Recommendations</p> <ul style="list-style-type: none"> <li>• Clear ivy and vegetation from base and reinspect.</li> </ul> <p>Priority Low</p> | |
