# ANTHONY-JOHNSON

98 Dog Drove North,  
Holbeach Drove,  
Sapling.  
PE12 0SA.

## Overview:

It is proposed that an existing timber framed structure be converted to residential use.

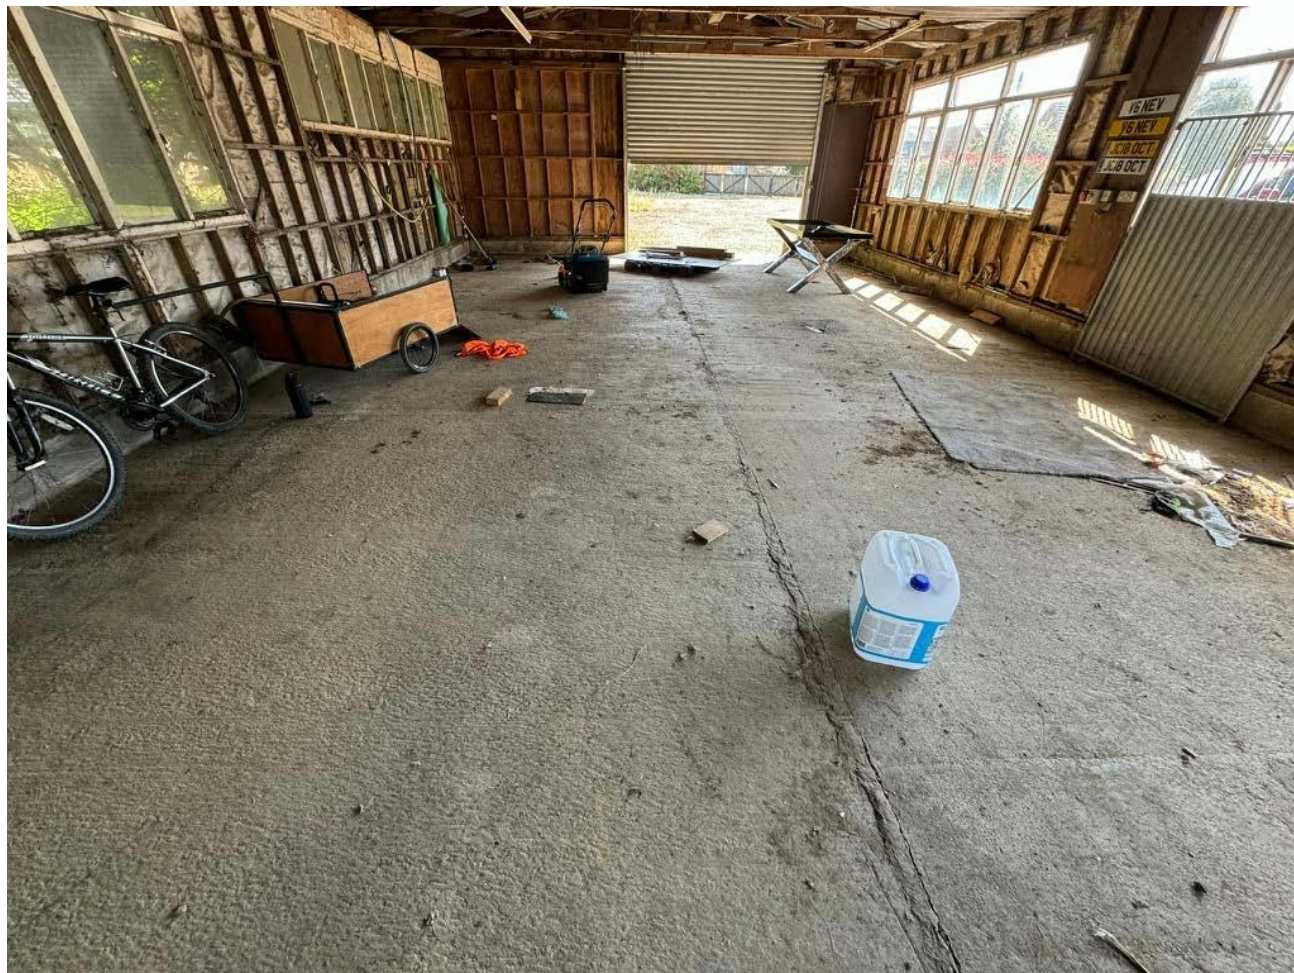
The structure is formed with a concrete slab to the base, internal to the building and the concrete slab appears in good overall condition with a single expansion joint set to the central line of the slab, running front to back. The concrete appears intact with no visible movement, distortion or cracking. The slab is cast level with the external ground to the front elevation, allowing for vehicle access.

Image 1.0: View of concrete floor slab

Given the above observations, the structure is suitable for conversion to residential use, particularly given the presence of a block-work plinth set to the head of the existing concrete floor slab which allows for the inclusion of DPM, insulation and screed. The floor slab lacks deviation/ movement indicative of poor or shrinkable ground conditions and has not deteriorated to the head, indicating a suitable grade concrete was employed, capable of resisting ice, snow and salts.

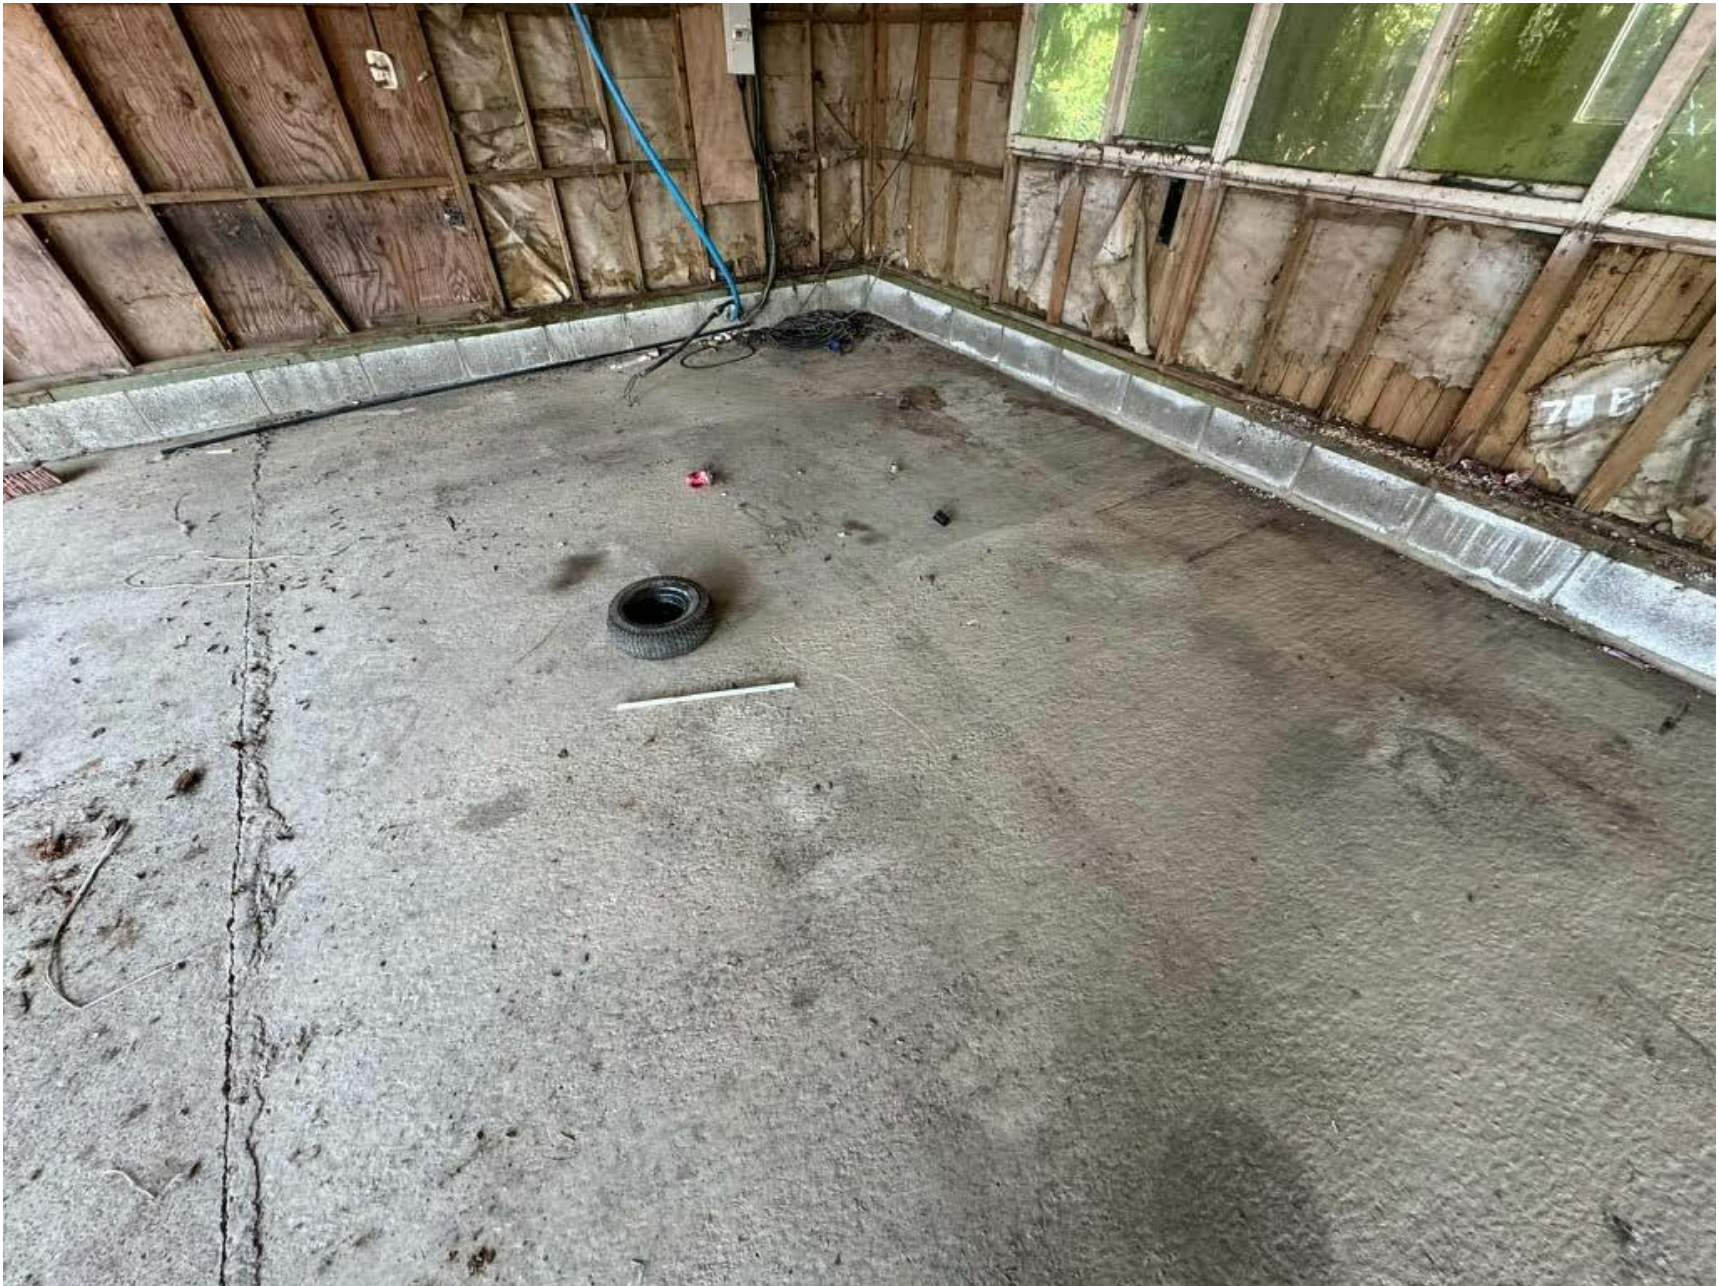
A Plinth course of block-work runs the full perimeter of the structure, setting the sole plate of timber studs above finished floor level, thus protecting them from moisture ingress. Drain holes set to the bottom mortar joint of the block-work allow for the discharge of any water within the structure.

Image 2.0: drain holes to base of structure.

The block Work plinth was found to be visually intact, level and free of distortion. Visual inspection failed to show any movement and lacked any cracks to bed joint, perpend and blocks themselves. The blocks appear to be dense concrete and are likely of a high compressive strength, suitable for use at ground level where freeze-thaw action would otherwise result in long term spalling and failure.

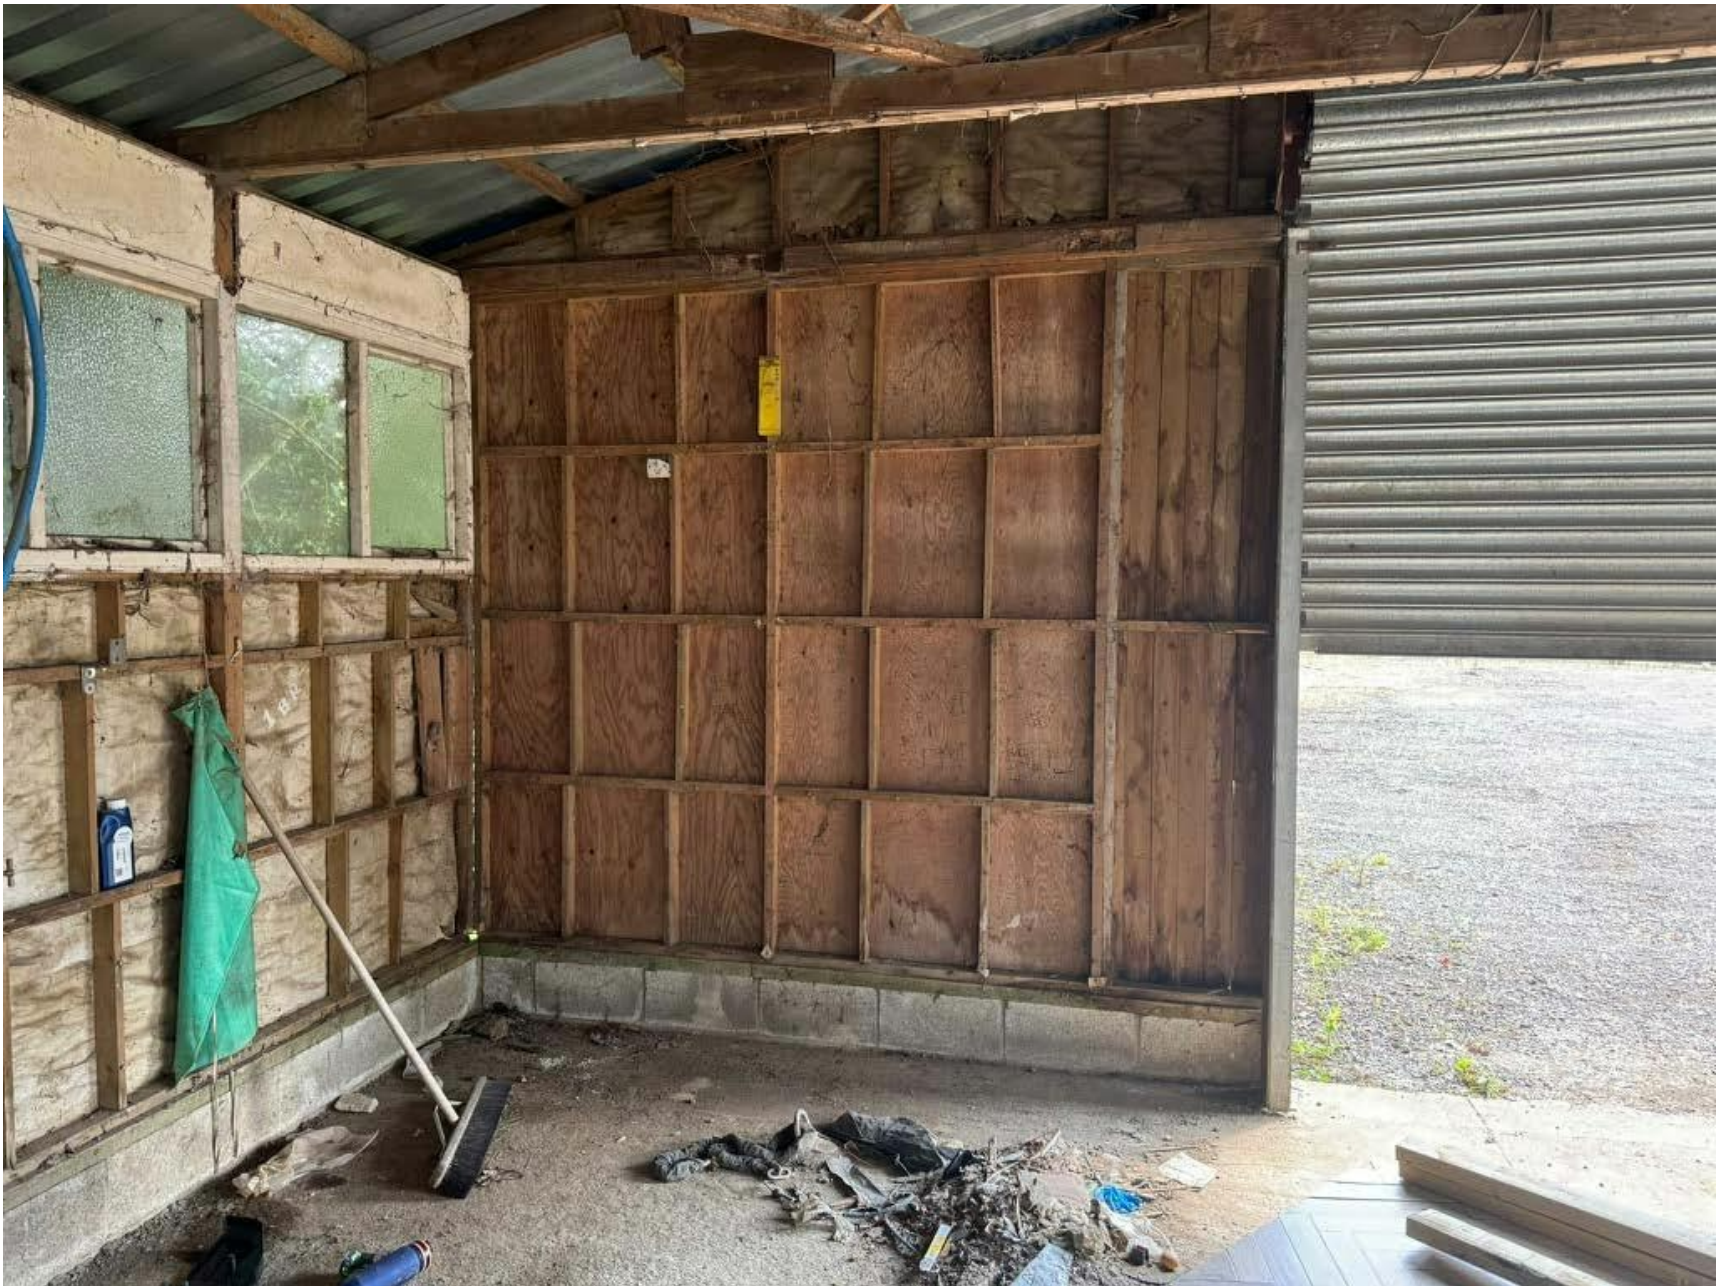
Timber studs are set at suitable centres with framing having been formed as panel sections, lifted into place and fixed together forming double studs. Infill timbers set to each panel appear to be formed predominantly of primary horizontal members with vertical members running between the horizontals.

Image 3.0: Typical timber stud wall panel.

Timber wall panels to external elevations should be retained and subsumed into the proposed conversion.

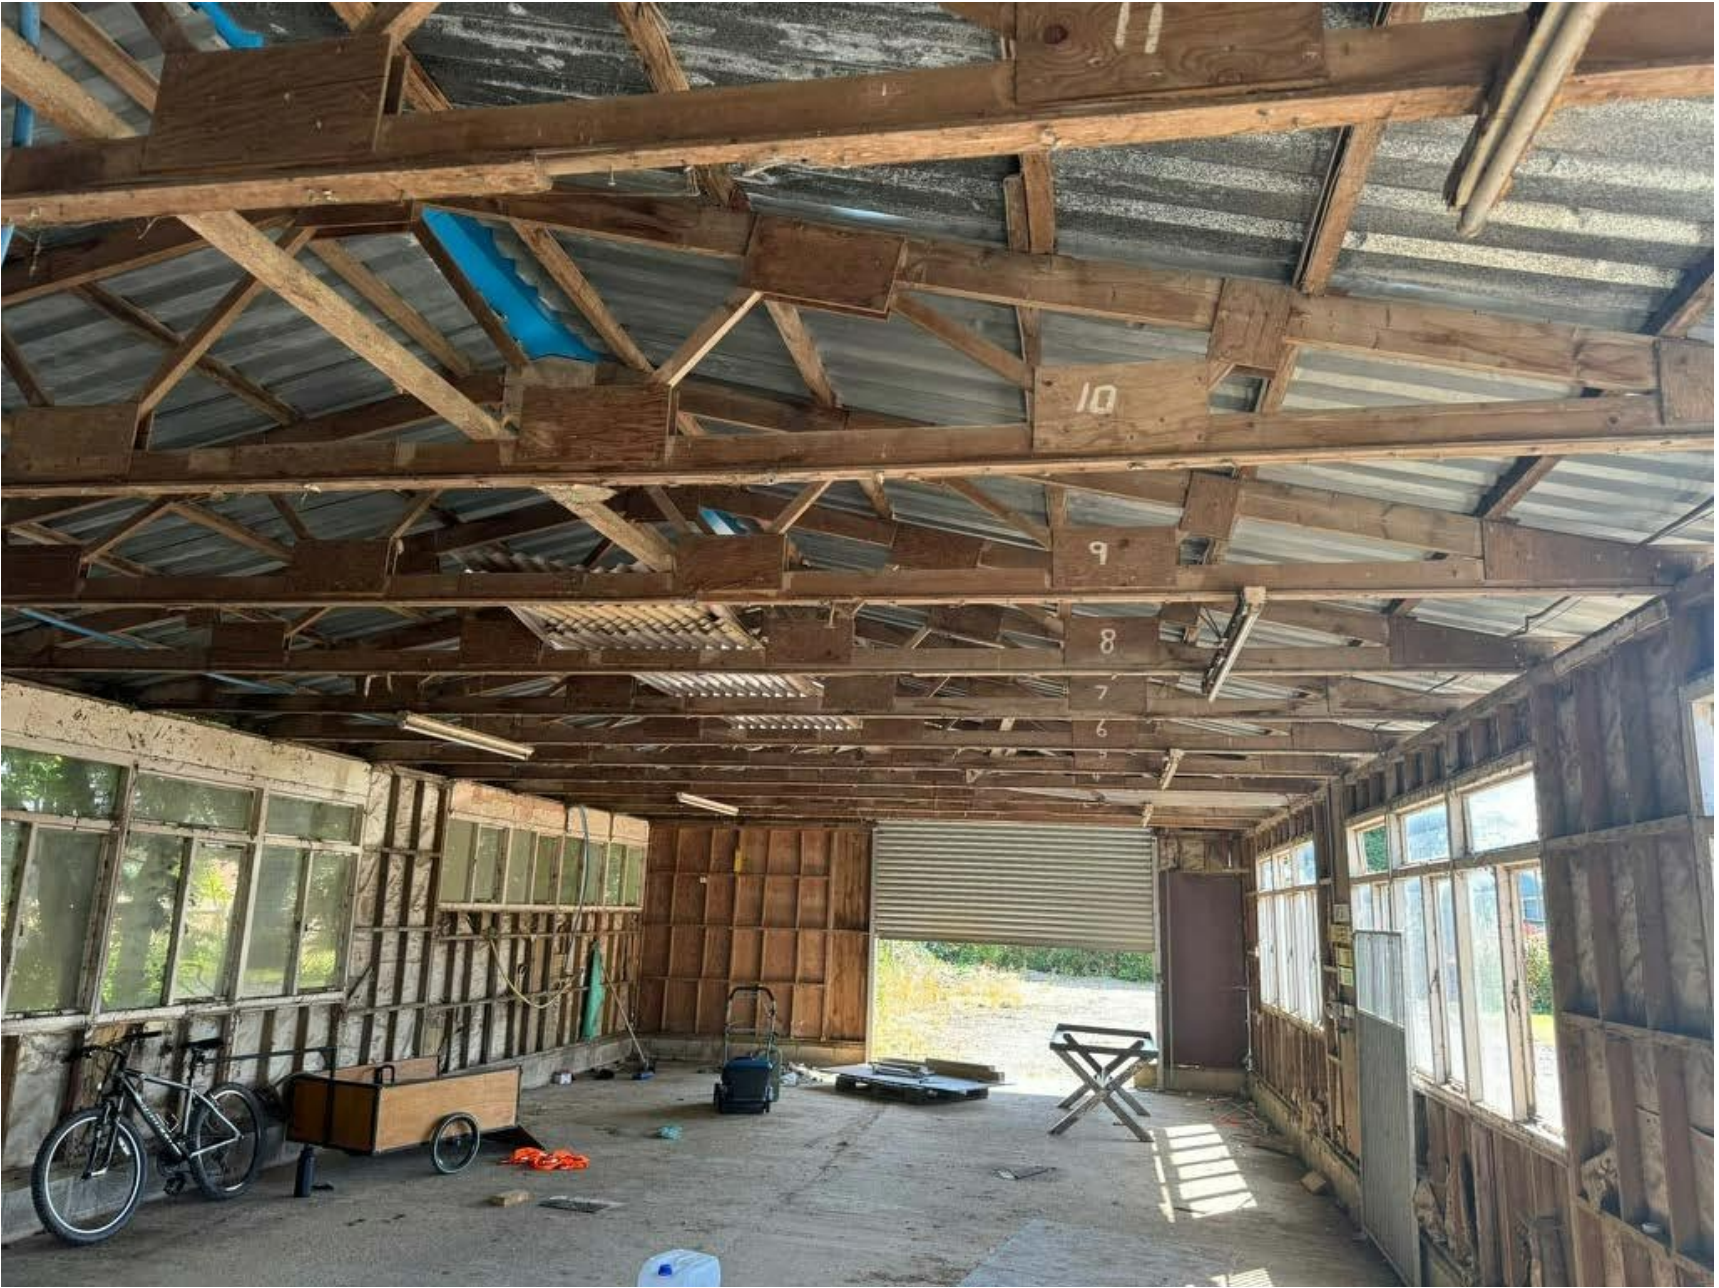
The roof structure is formed of hand-made double fink timber trusses, formed of solid timber sections to top chords, bottom chords and ties, overlain with plywood sections at joints.

Image 4.0: View of timber trusses forming roof structure

Trusses are set at approximate 1 m centres and support timber purlins running front to back, set at approximately 800 mm centres. To the head of purlins are set corrugated steel roofing sheets, laid to falls, running from ridge to eaves.

Timber trusses appear suitably sound. Ceiling chords remain straight and true, with no visible deflection, thereby indicating that the trusses are not over stressed. The trusses have been formed with consideration given to the purpose of each element, with joins and splices having been suitably introduced.

The timber trusses should be retained and incorporated within the proposed conversion, with works carried out so as to suitably prepare the elements for the addition of a ceiling. Existing nails to the underside of the timber trusses indicate that they previously

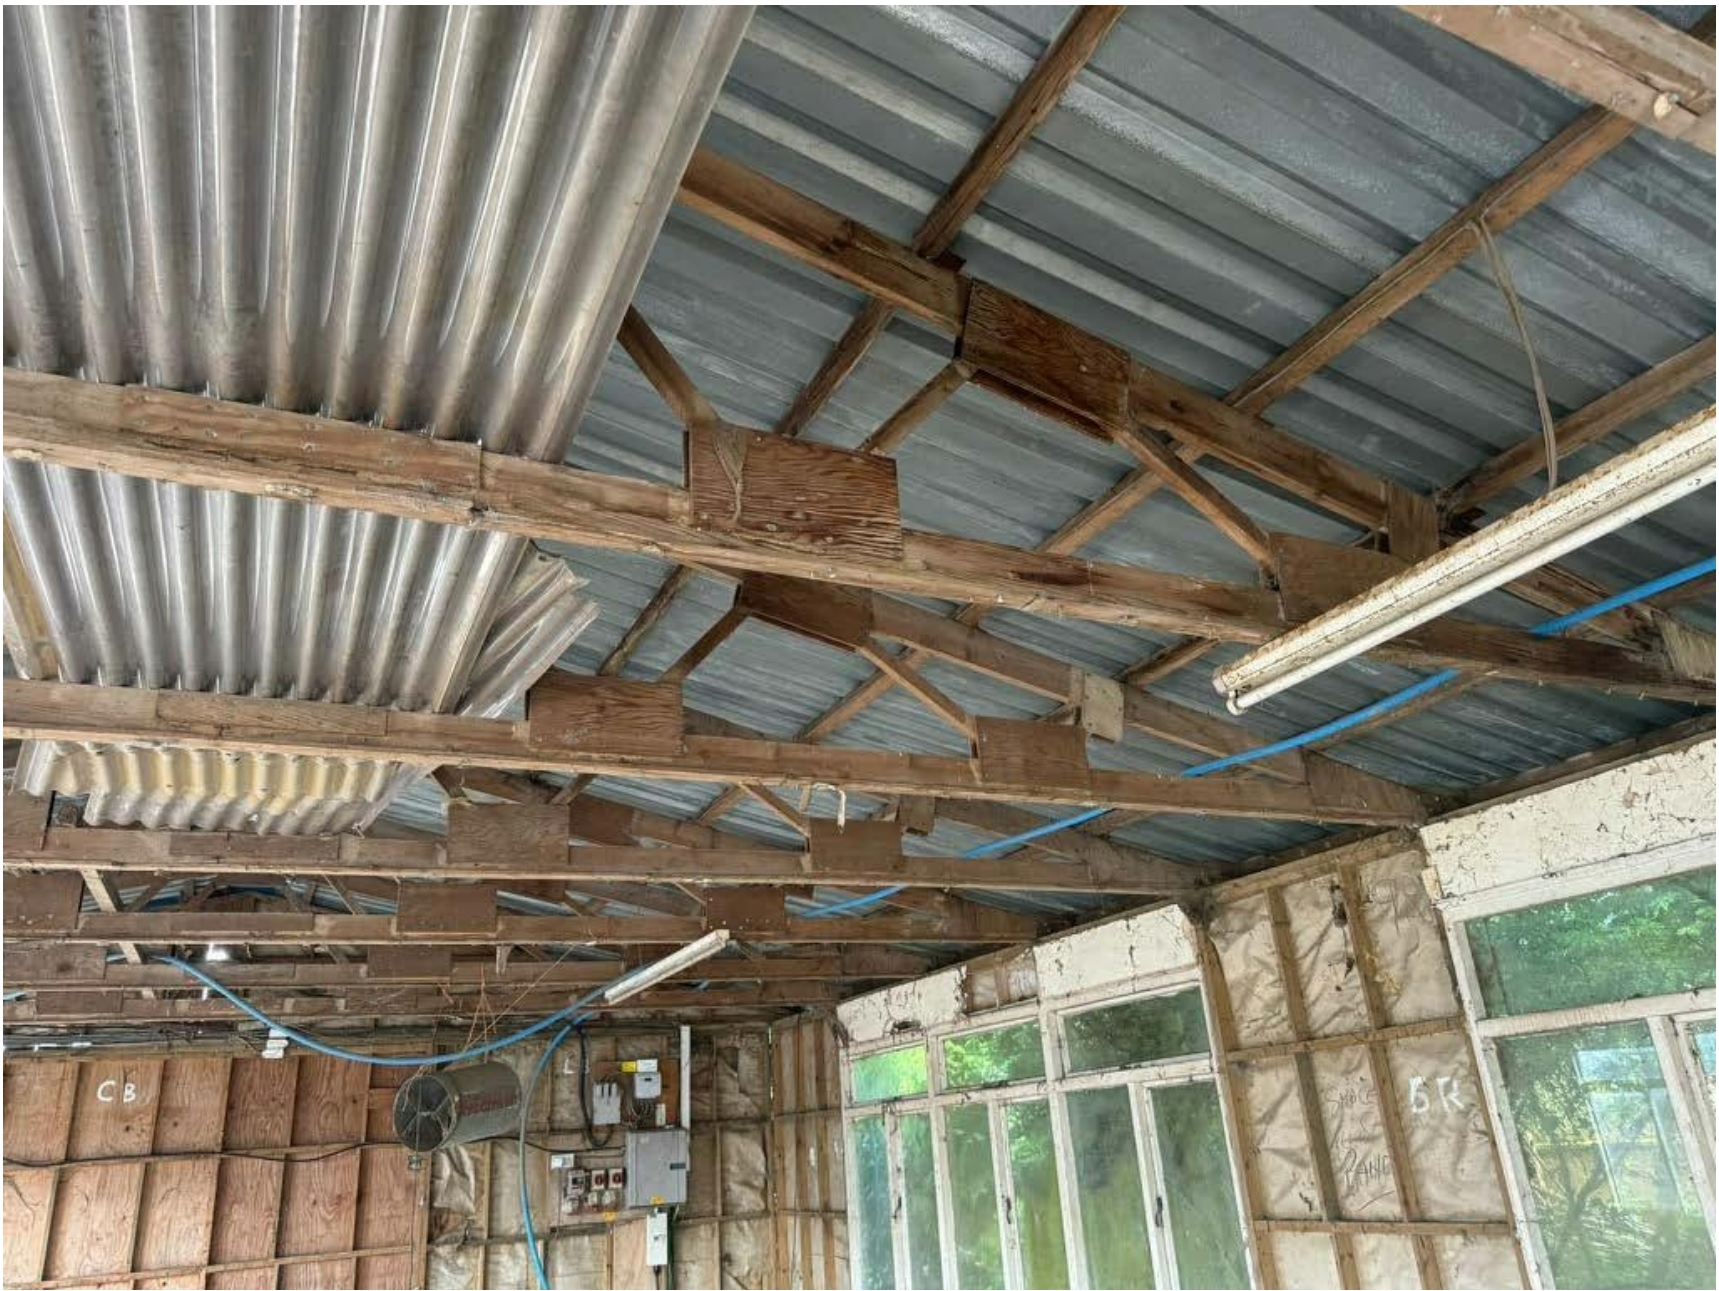
Image 5.0: View of corrugated steel roofing sheets

The roof should be finished in material similar in both weight and design philosophy to the current corrugated steel sheeting. Plate action provided by the steel sheeting should not be lost and on this basis, tiles must not be used. Where possible, the new roof covering should incorporate insulation, so as to enclose the roof void within the envelope of the building, thus preventing long term interstitial condensation through cold and the decay of existing timber elements.

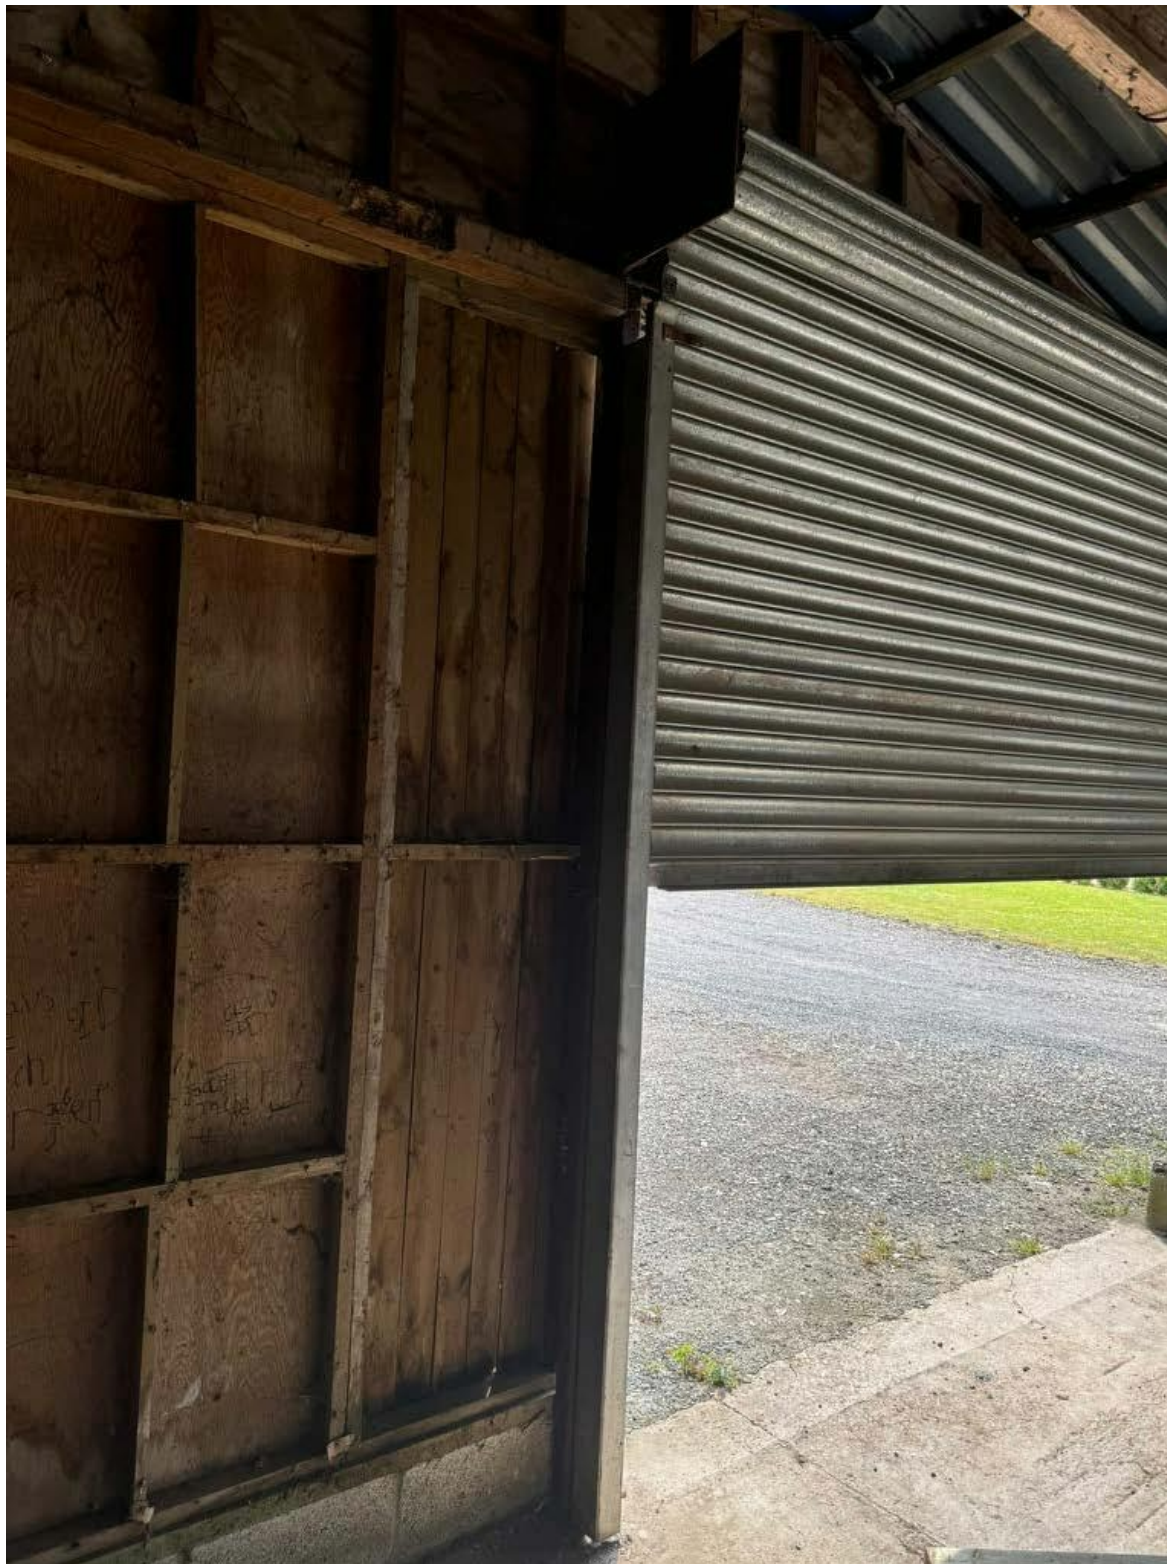
A roller shutter door is set to the front elevation, slung from two upright steel square hollow sections, forming support posts either end of the opening. The door opening appears to have been cut into the original front elevation, with timber framing modified to accommodate the opening.

Image 6.0: View of steel support structure to front roller shutter door

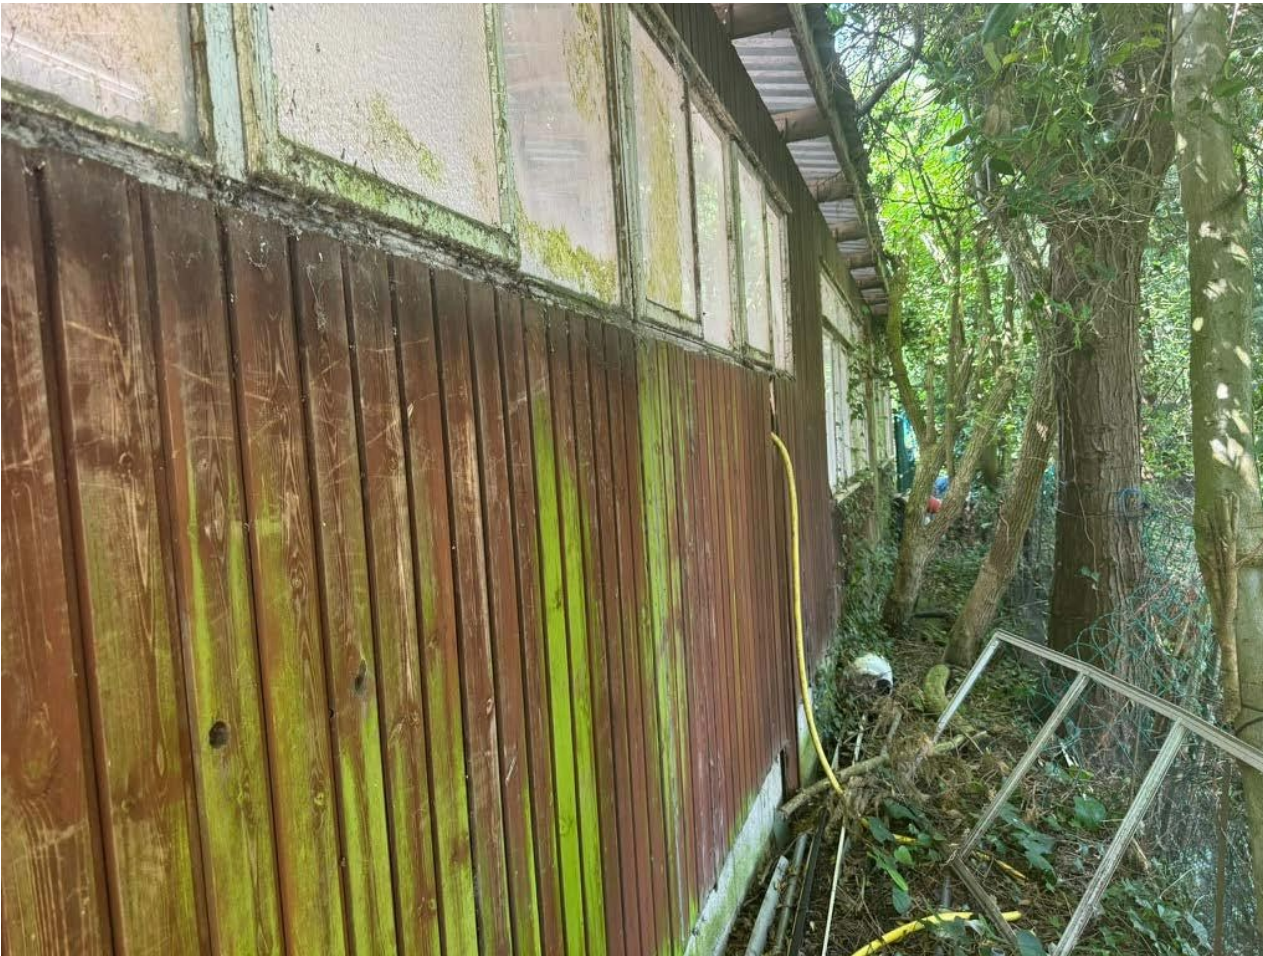
Inspection to the opposite side elevation of the building reveals the structure to be bounded by trees and shrubs, falling within 1 meter of the structure. The structure and slab were found to remain intact along this elevation with no significant movement or deviation evident.

Image 7.0: View along opposite side elevation of structure

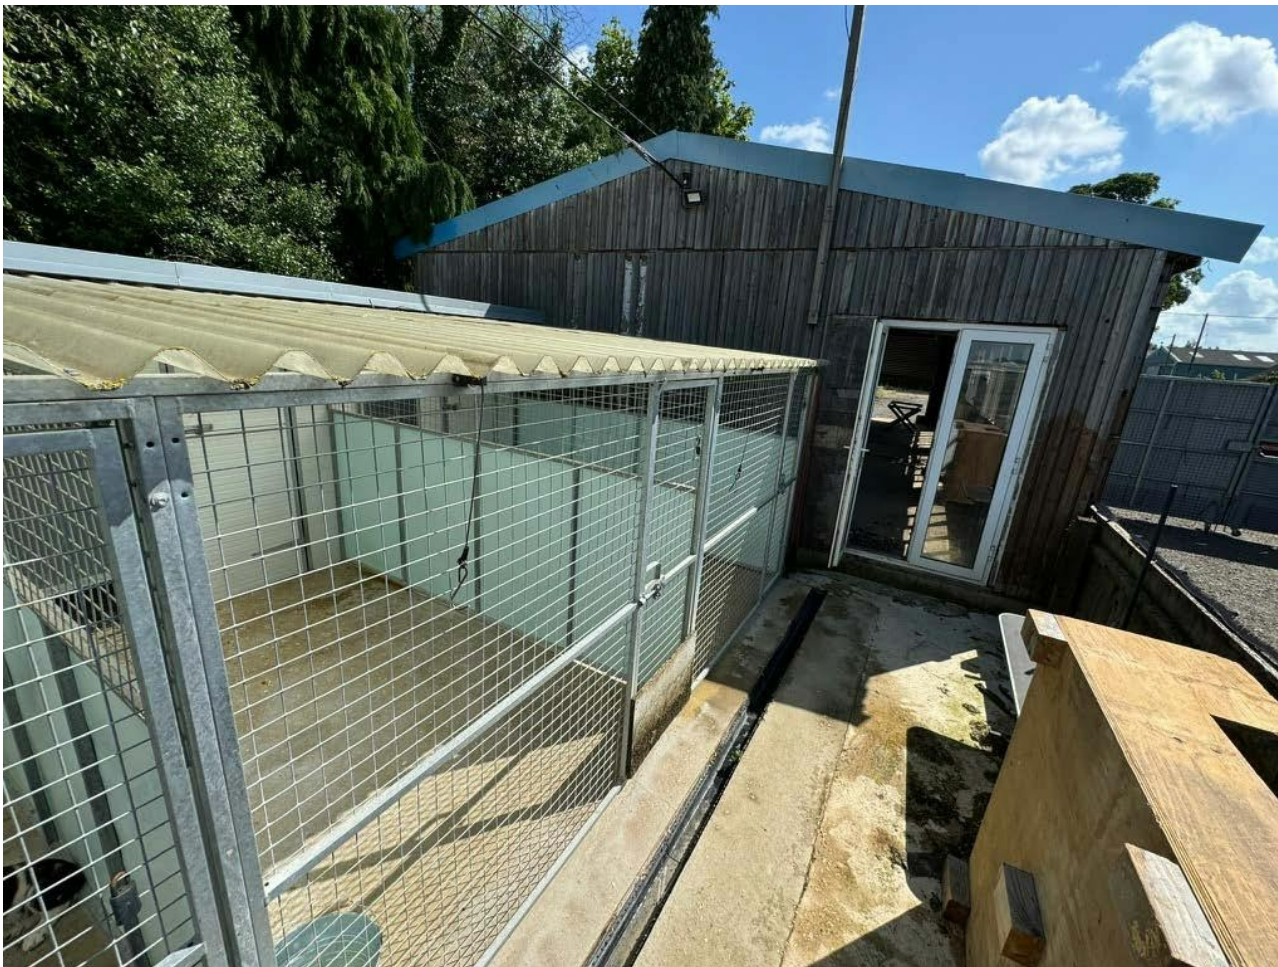
Image 8.0: View to rear of structure
