**Small Saints Pre-school, Holbeach – Beech tree**

Thank you for instructing me to inspect the Beech tree in the grounds of the pre-school, and report on its condition and management.

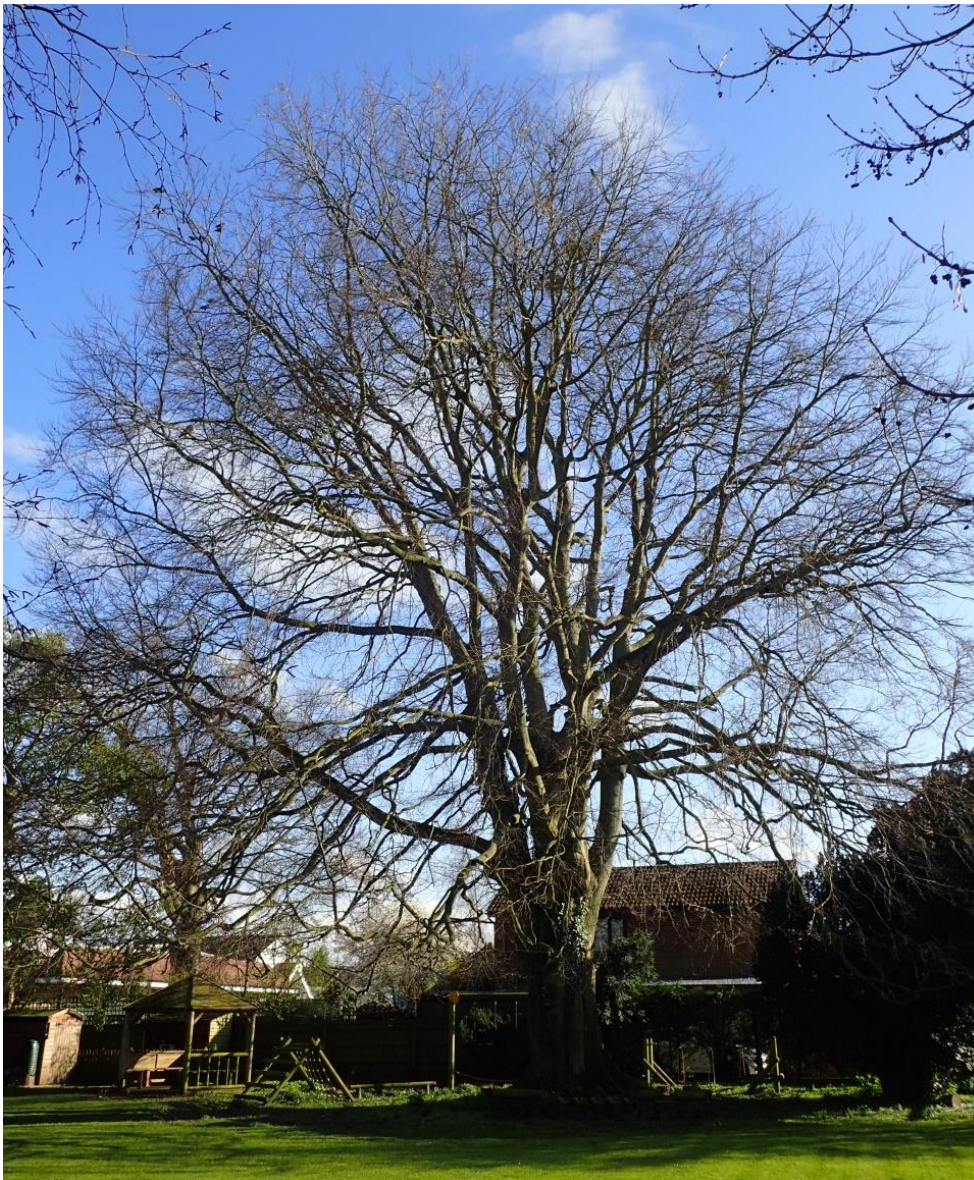
**Tree 1:**

A mature specimen tree, approx. 22m high, growing in a large shrubbery area where there has been little soil or root disturbance around the tree. Some wooden play equipment has been installed 2-3m from the tree.

The tree appears to have been pollarded early in its long history.

There are some old pruning wounds, some possibly following a branch failure. One branch failed in summer 2020.

The crown has little dead wood, the shoots have reasonable extension growth and vitality is good.

The southern part of the crown has some crossing and self-grafting branches; one branch is damaged and weak from rubbing.

- Remove the damaged crossing branch above the play equipment, on the southern side of the crown.
- Crown reduce by pruning the side branches back to reduce the crown width by approx. 3-4m overall, and by reducing the height by approx. 2m. The pruning points to be at appropriate break points decided by the tree surgeon in the tree. This will reduce crown weight and stress on the main unions.
- Inspect in late summer to confirm Meripulus is not present
- 3 yearly re-inspection; this will allow monitoring of the Ganoderma infection

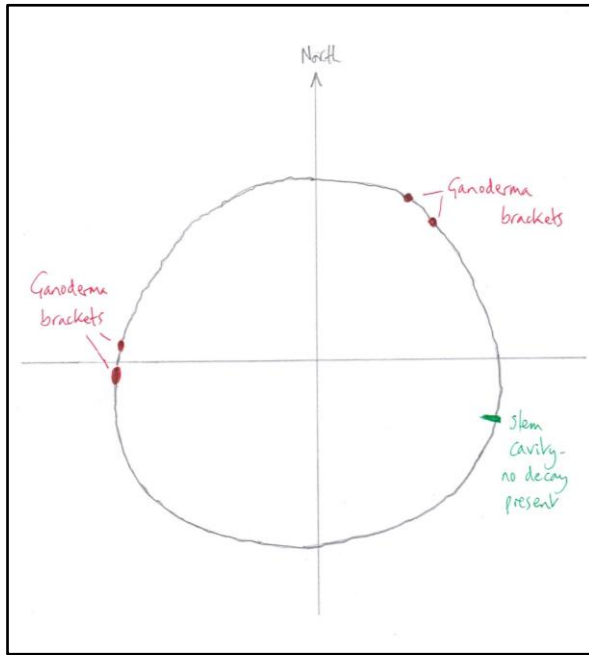
The main stem is sound; there are some small pockets of decay around the base with young Ganoderma brackets present. See stem diagram:

stem diameter approx. 160cm

No evidence of Meripulus was found.
