**PRELIMINARY STRUCTURAL REPORT  
UPON  
19 HIGH STREET  
HOLBEACH  
LINCOLNSHIRE  
PE12 7DU**

**Ref: 36717**

**DECEMBER 2017**

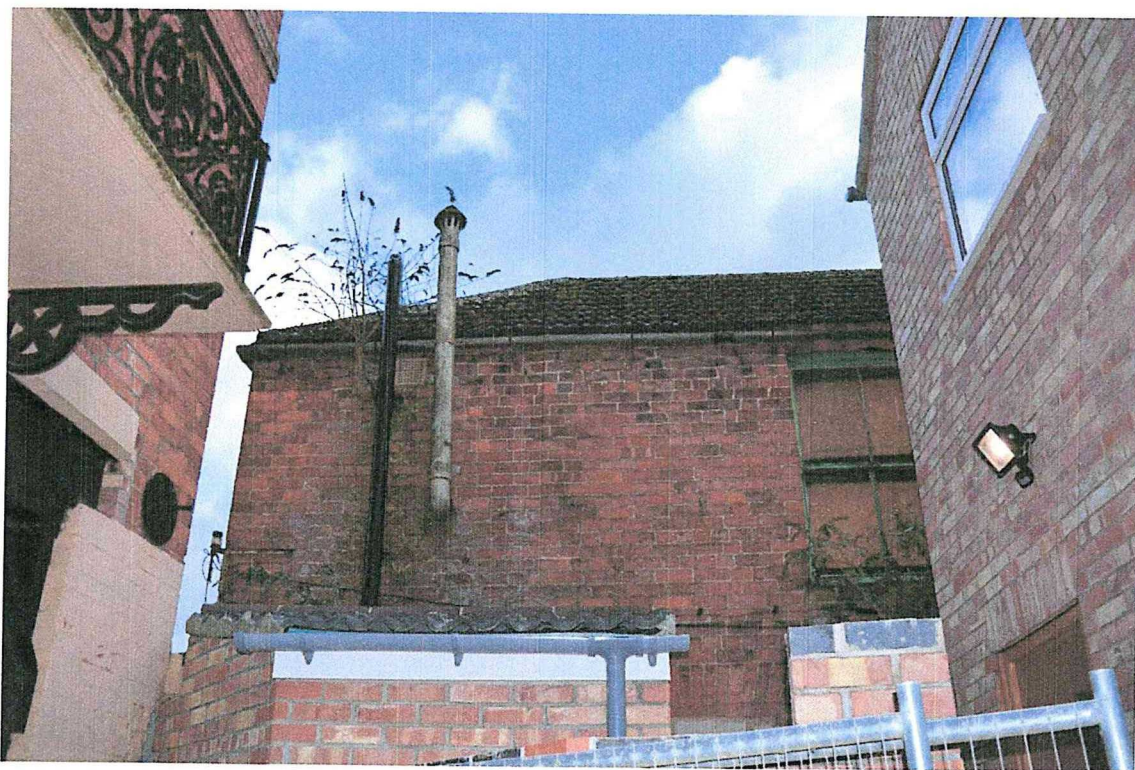
**PHOTOGRAPH 1**

To the rear, vegetation is growing from gutters and brickwork, - see photograph 1 – and a small outside toilet is in a state of disrepair.

New gutter and downpipes are required throughout and be connected to a suitable below ground drainage system to ensure water, both surface and foul, is discharged away from the building.

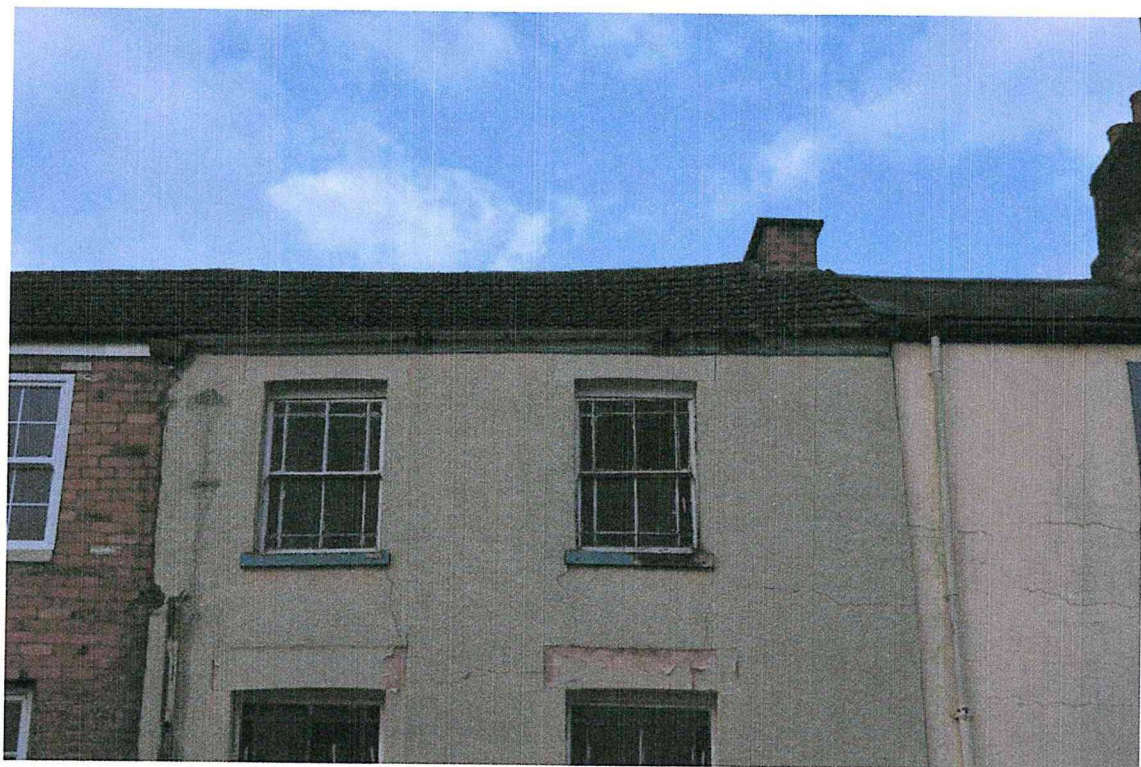
**PHOTOGRAPH 2**

The ridge line along the roof dips between party wall lines and no effective gutters are place, together with no down pipe, see photograph 2.

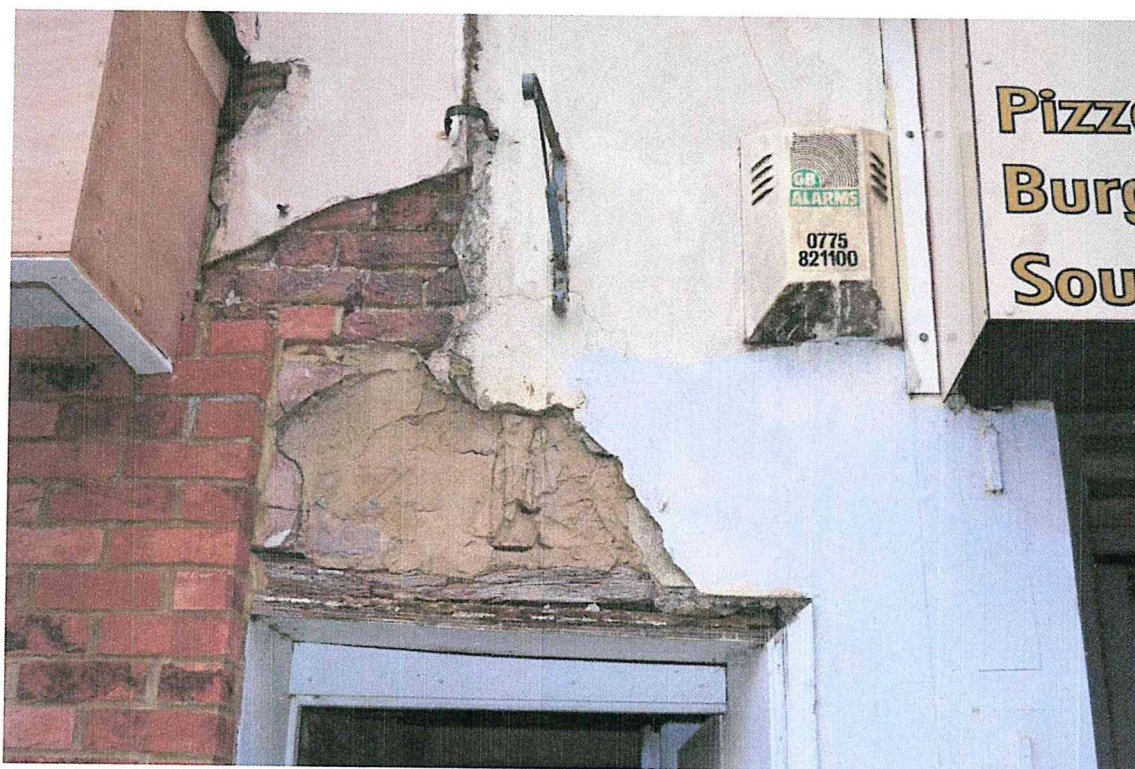
**PHOTOGRAPH 3**

A narrow passage way to the rear sits between the adjacent property. There is a large fall over this opening, with a decaying timber lintel present, see photograph 3.

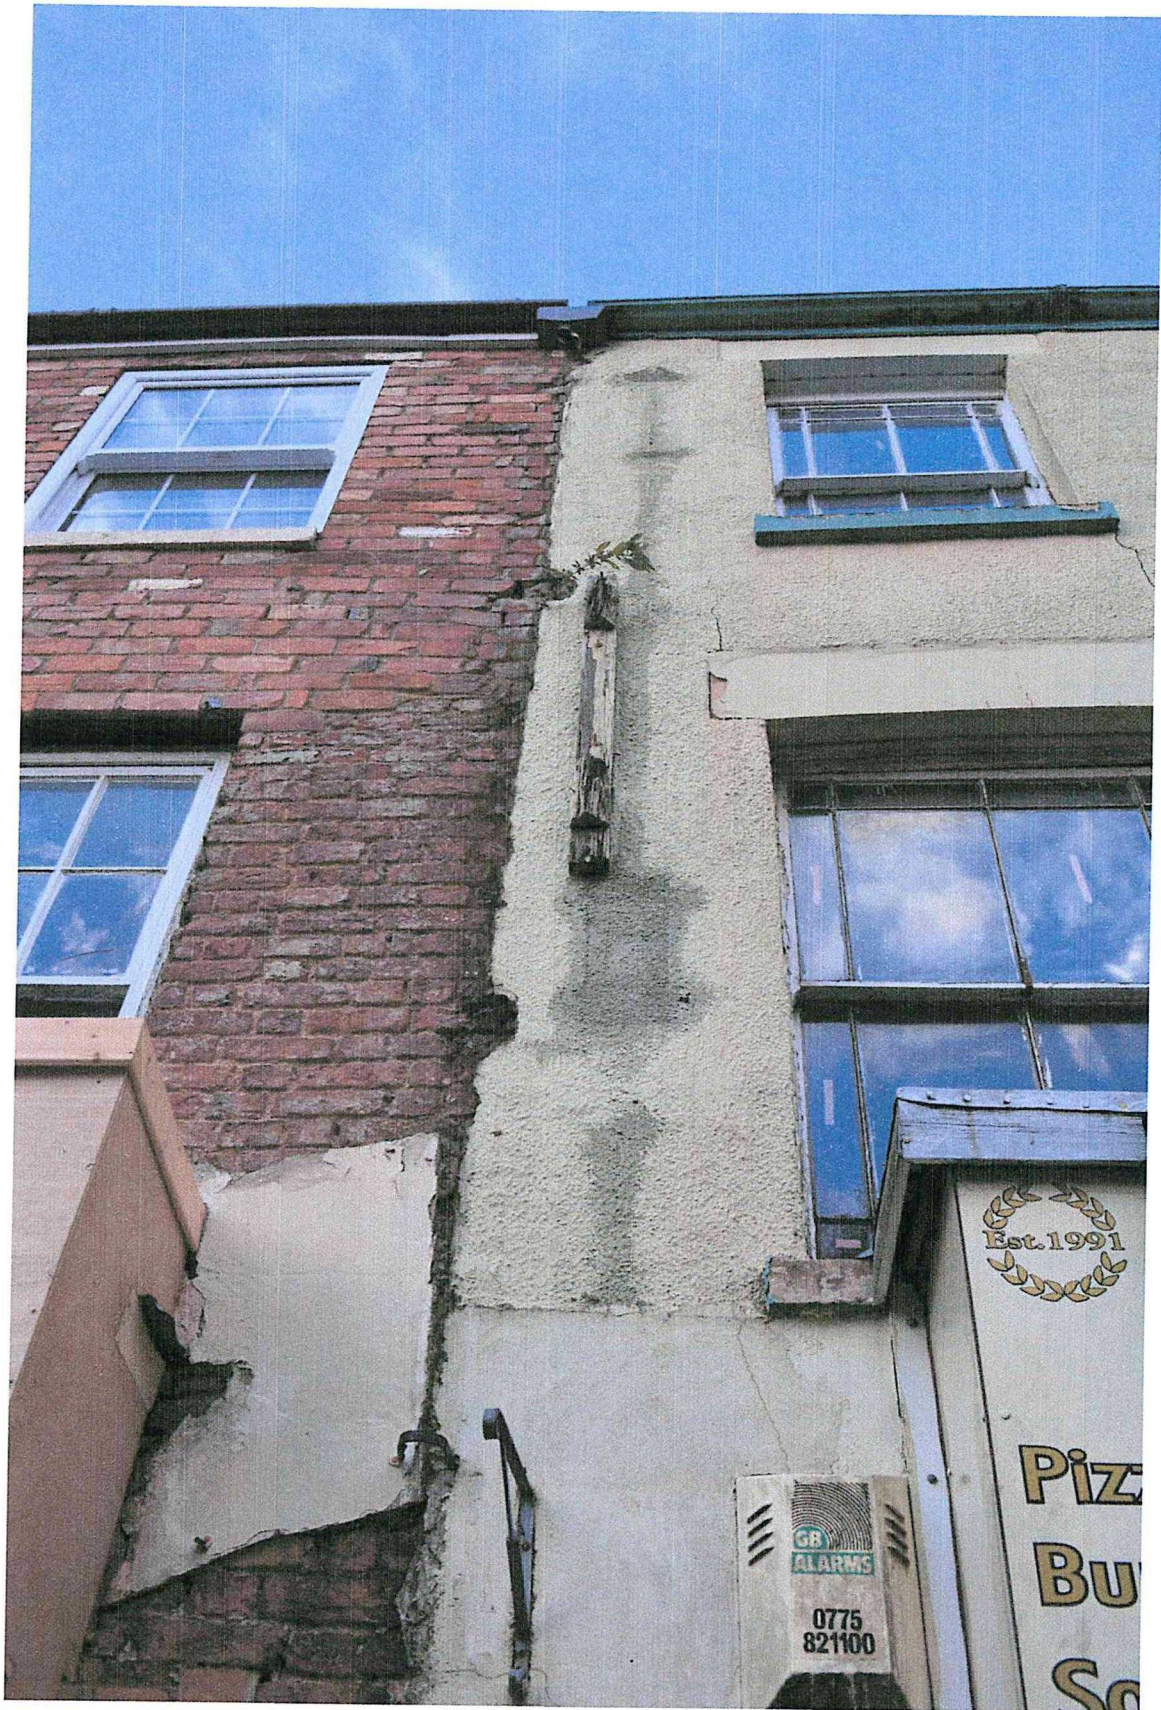
**PHOTOGRAPH 4**

The junction with the adjacent left hand property is poor, with concrete infill and loose render present – see photograph 4.

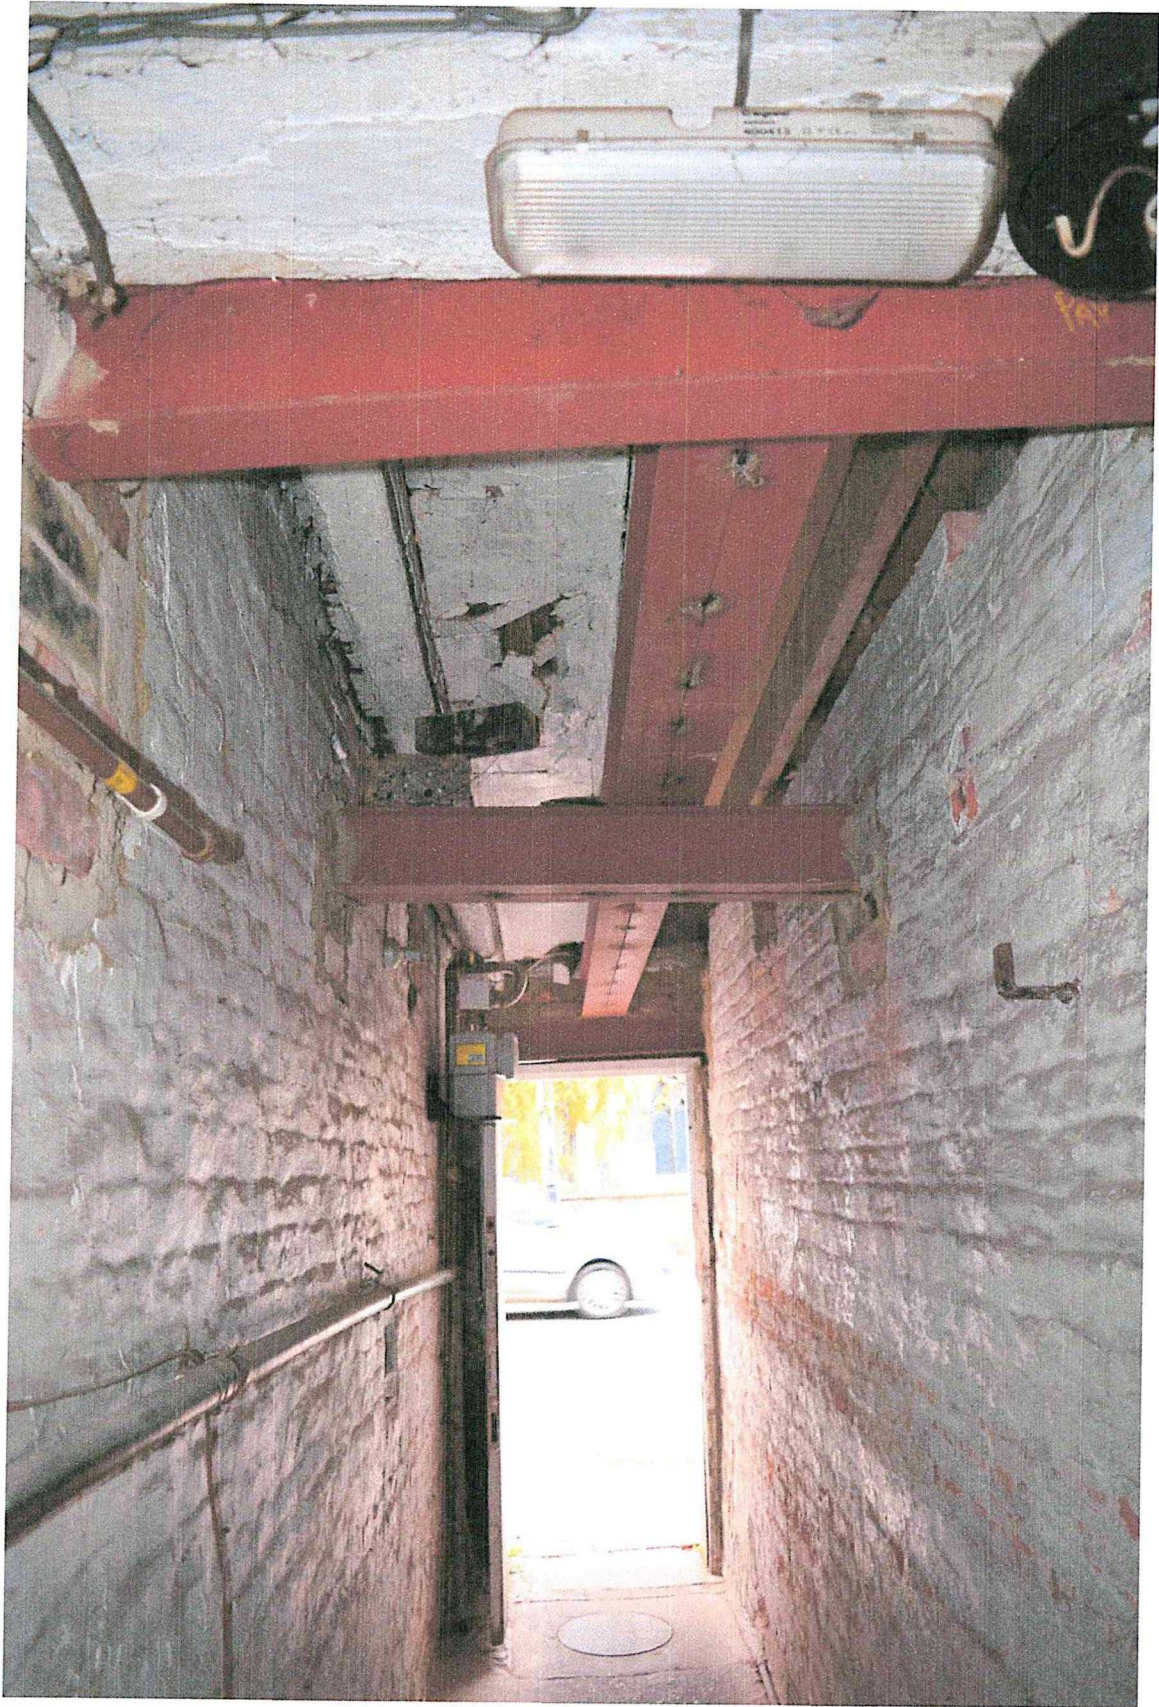
**PHOTOGRAPH 5**

Within the passageway, steelwork has recently been introduced to support the main party wall above – see photograph 5.

This remedial strengthening appears to have been introduced to enhance the condition of the adjacent property, since problems remain with this property.

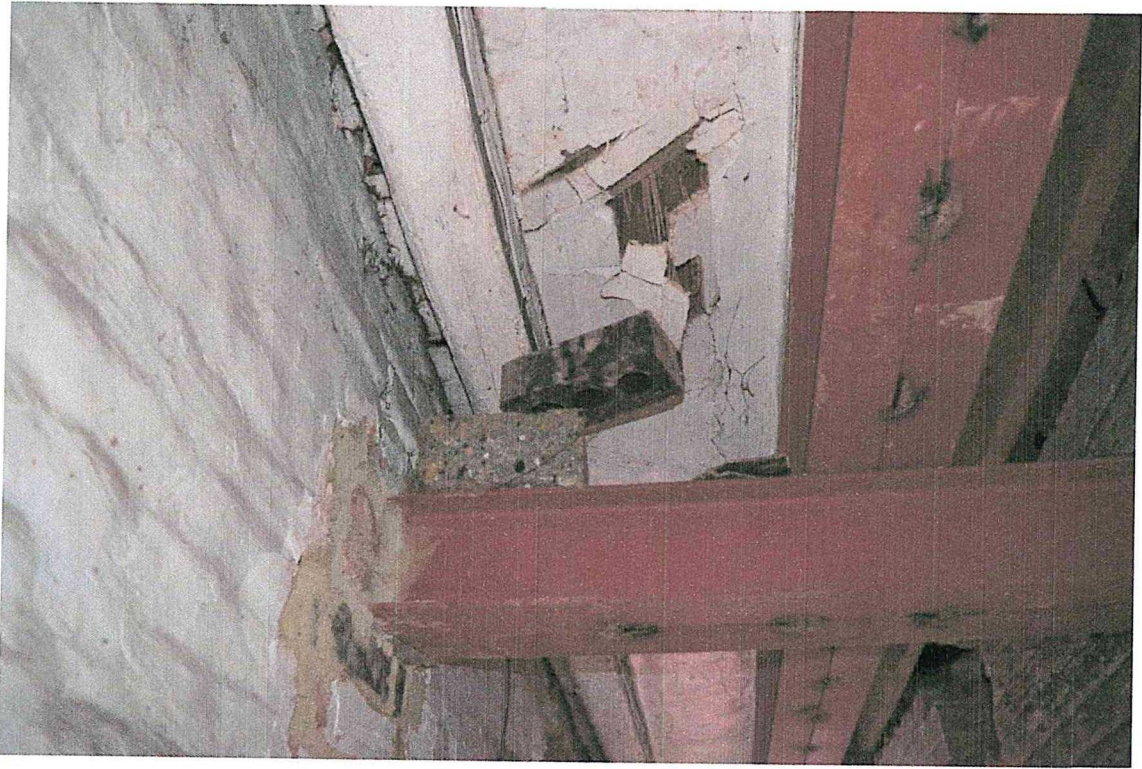
**PHOTOGRAPH 6**

Loose bricks and blocks support a timber joist with no effective support – see photograph 6, and the floor joist trimmer is not supported on the front wall – see photograph 7.

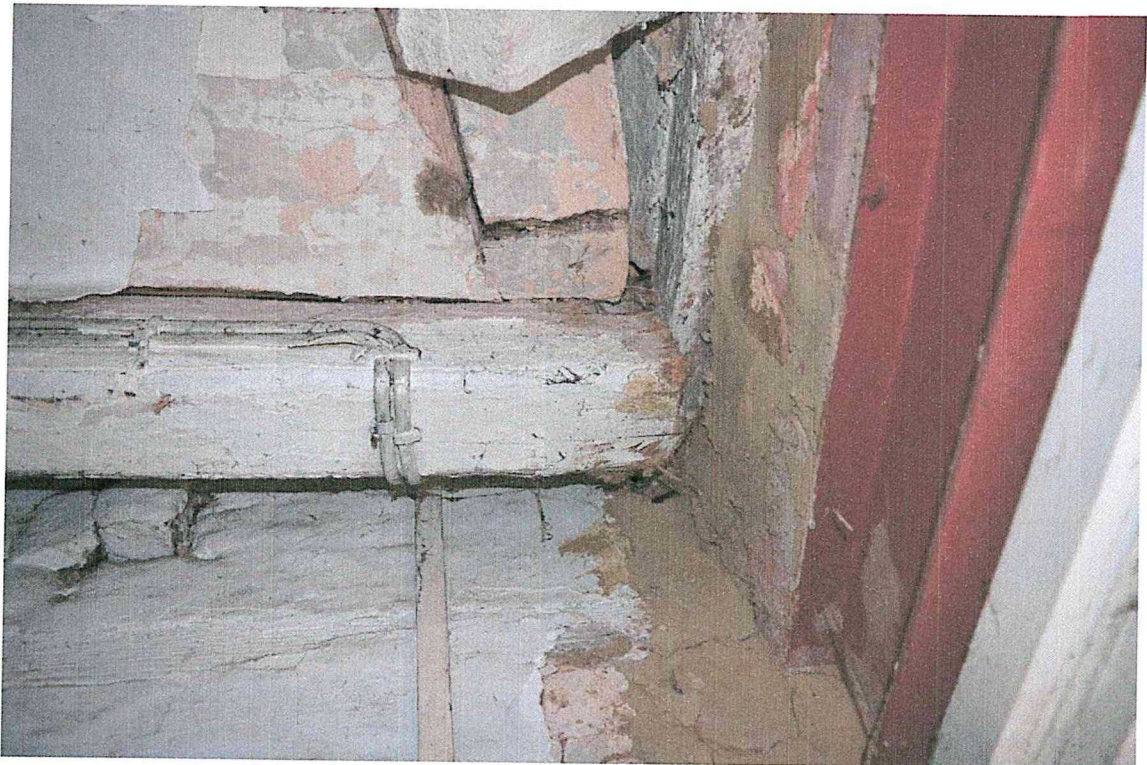
**PHOTOGRAPH 7**

Furthermore the trimming floor joist, visible in the passageway is not adequately supported, resulting in a problem that needs immediate attention.

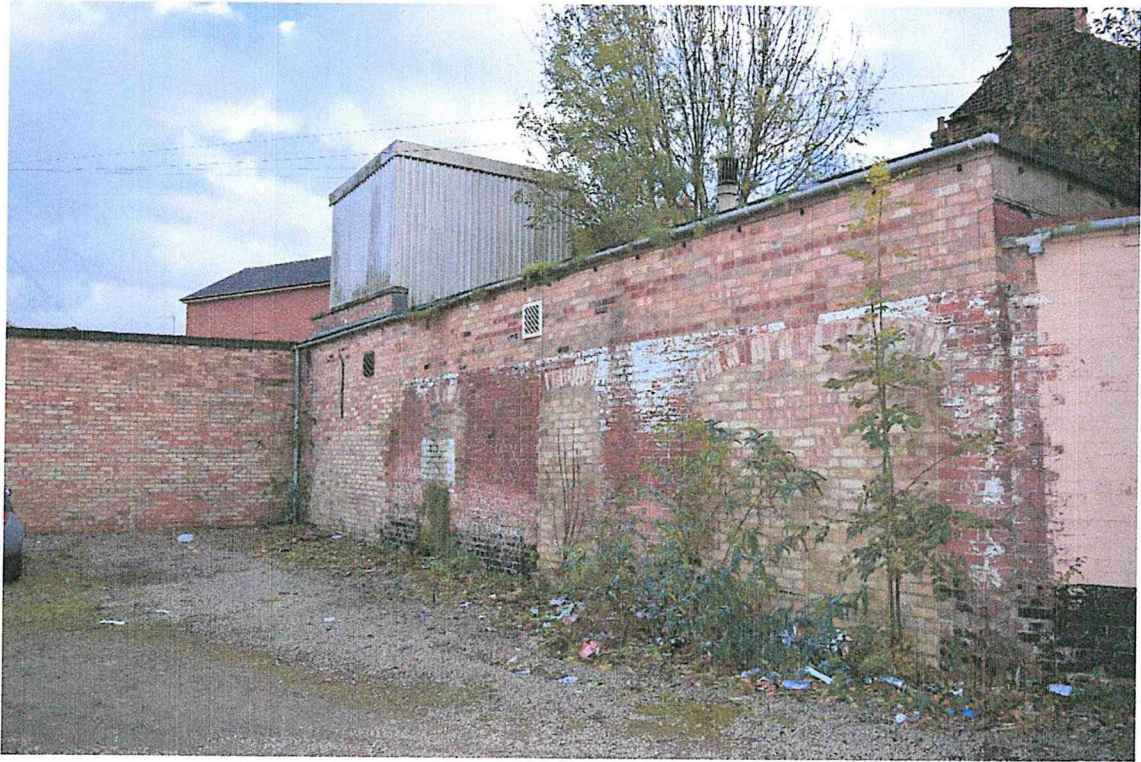
**PHOTOGRAPH 8**

To the rear, it is clear the single storey walls have been extended upwards, with previous openings having been filled in. The gutters are blocked, but the walls themselves appear relatively sound and true, see photograph 8.

It is likely the single storey rear buildings will require new roof structures throughout, together with a new ground floor construction.

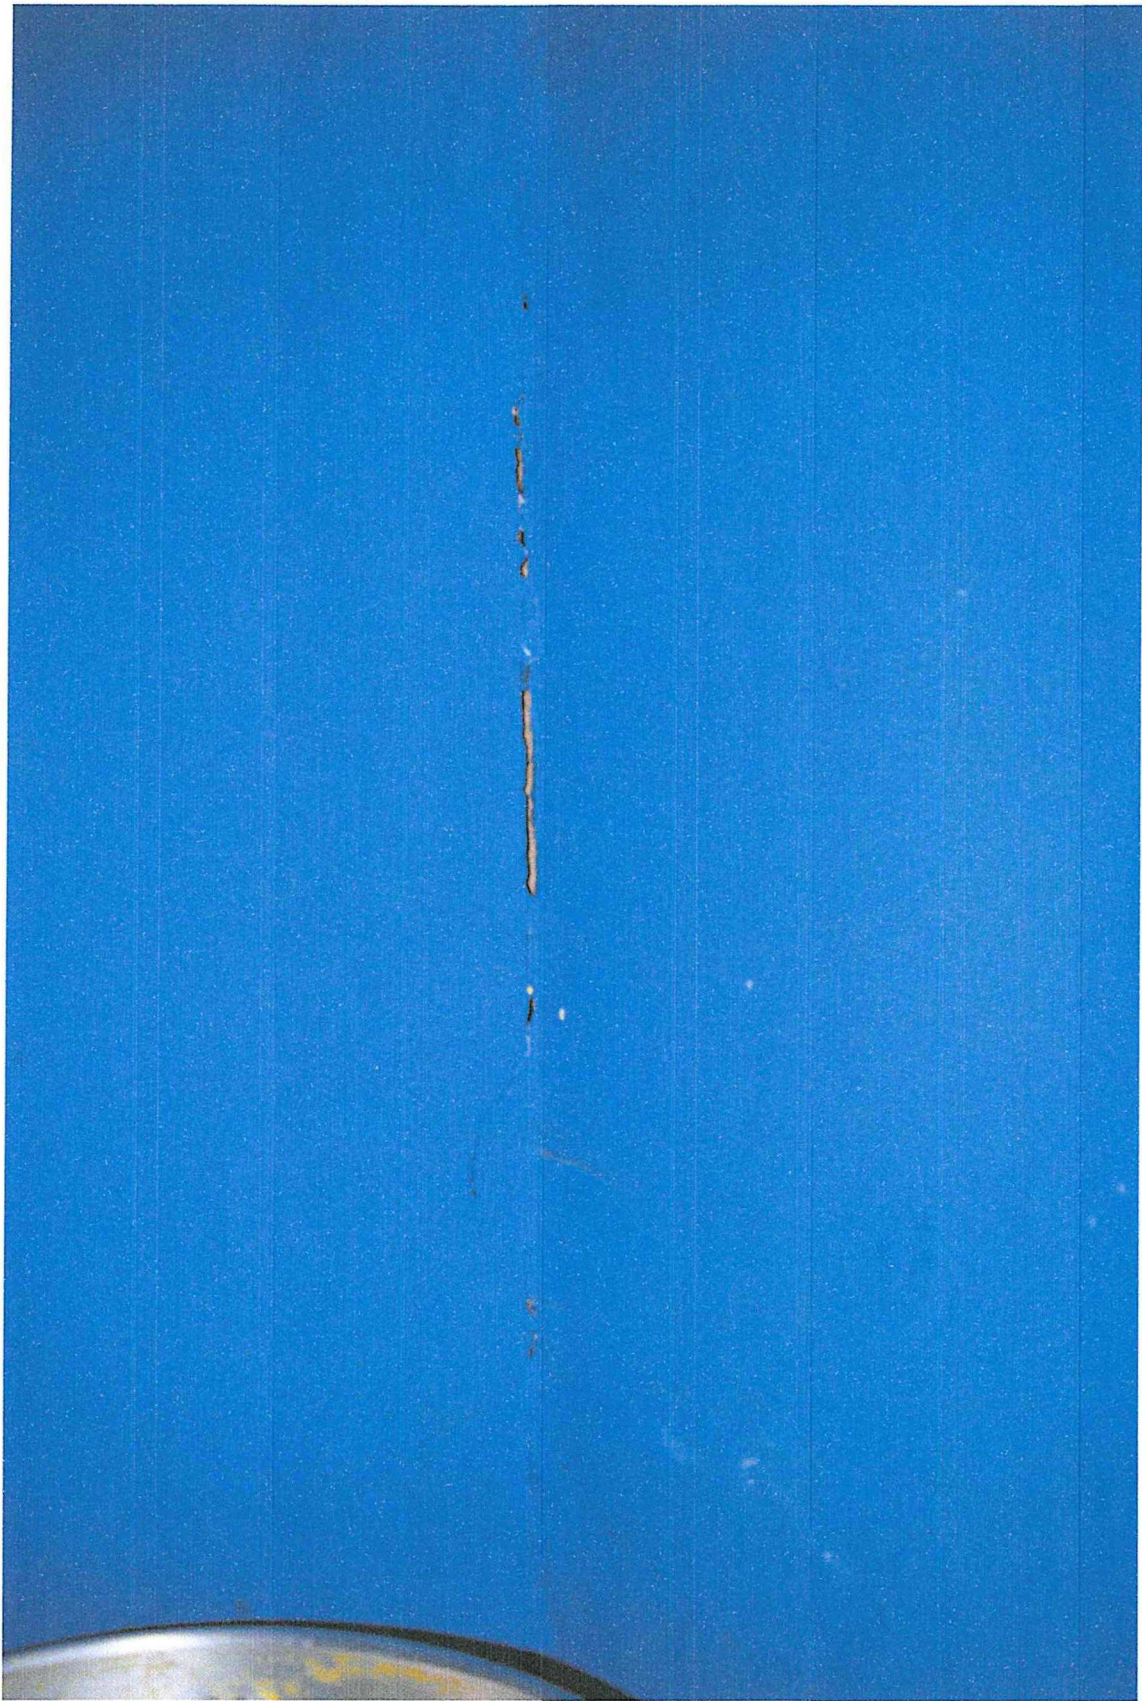
PHOTOGRAPH 9

Internally at ground floor level, the walls and ceiling to the front portion of the property are not accessible, due to stainless steel coverings etc. However, to the rear vertical cracking was present in the painted walls – see photograph 9 – together with cracking and falling plasterboard around a roof light – see photograph 10.

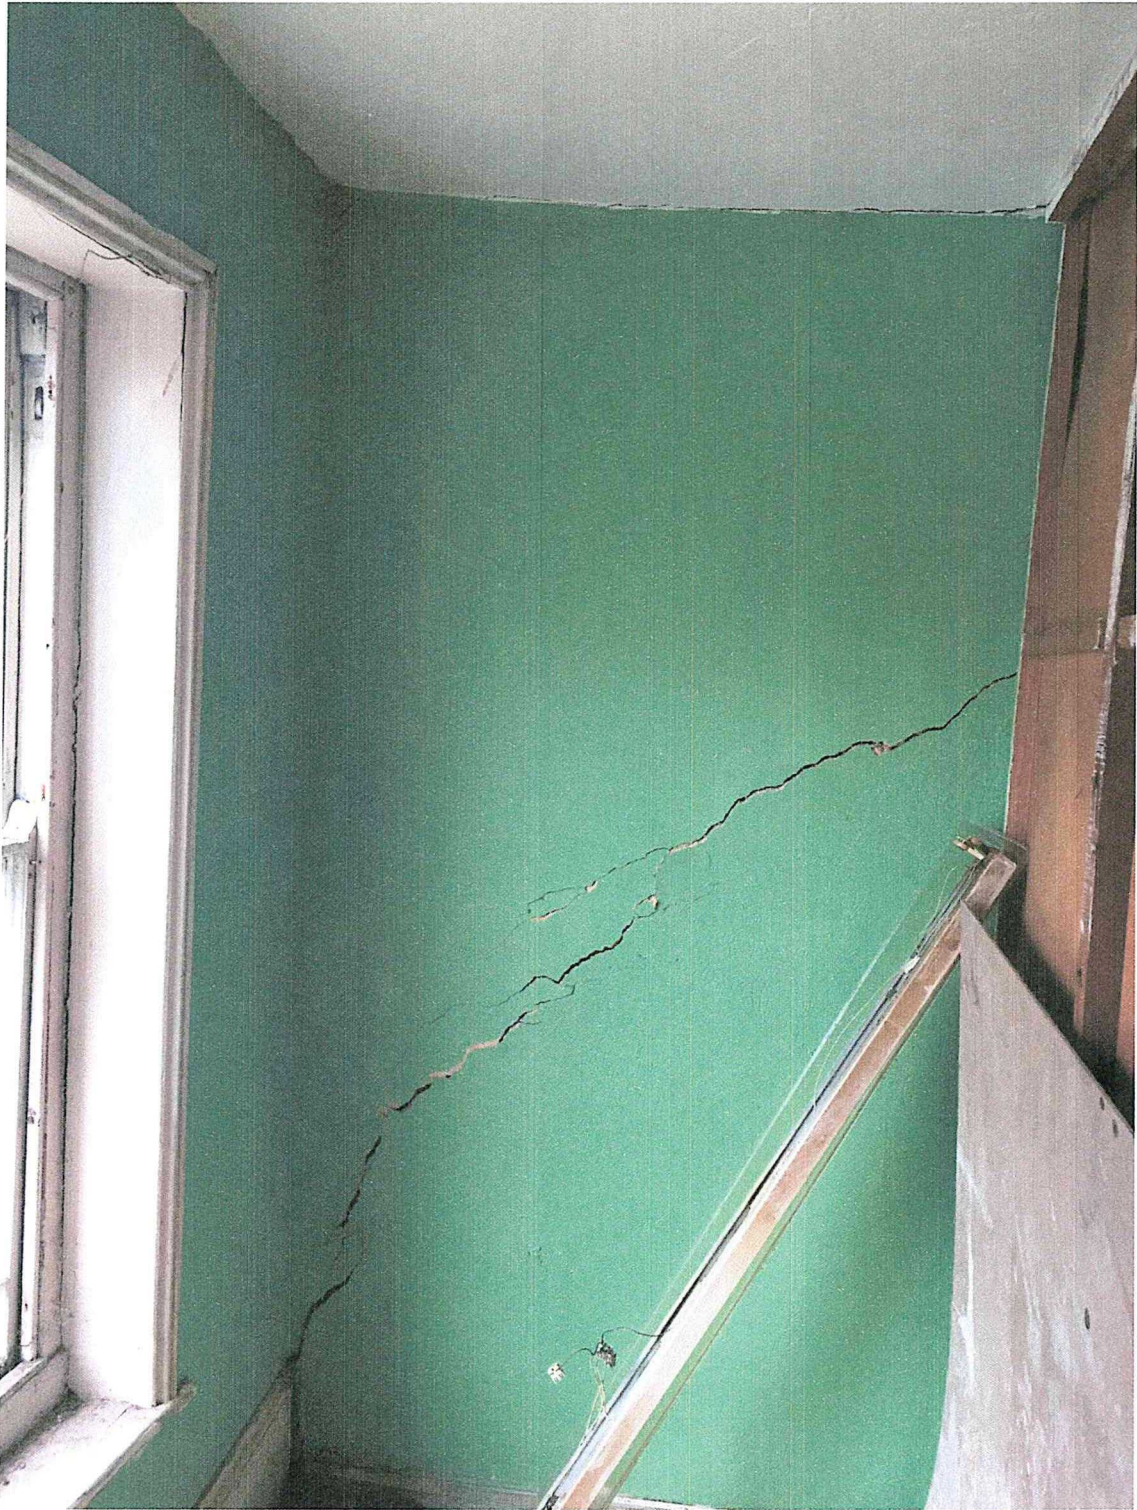
**PHOTOGRAPH 11**

The party wall abutting the front elevation exhibits a large diagonal crack – see photograph 11, with the front wall bowing outwards away from the skirting board – see photograph 12.

The floor joists run parallel with the front wall, with the front wall not tied to these joists. This is the main cause of the outward movement of the wall and the internal cracking.

A scheme to ensure structural stability to the front elevation should be prepared and implemented as soon as possible. This would entail some rebuilding of the masonry and external parrass plates tied to the floor construction

All walls should be tied to the first and second floor.

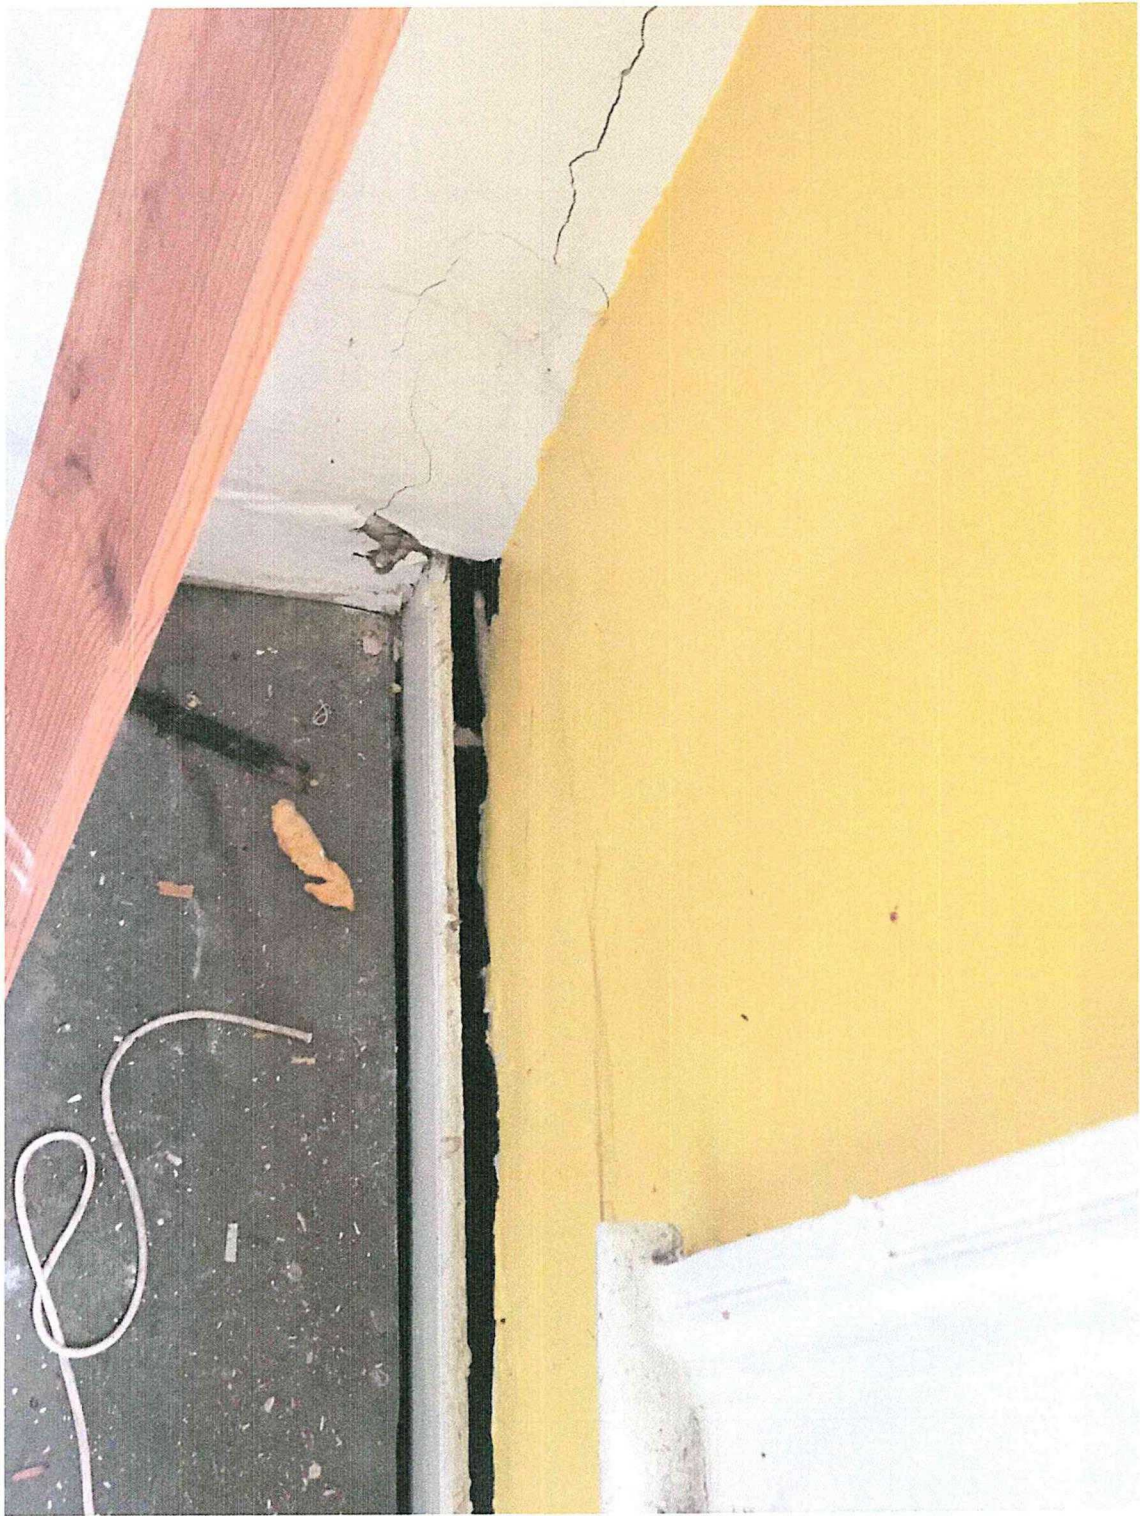
**PHOTOGRAPH 13**

At second floor level, similar outward movement of the front wall was visible, with a vertical crack noted where the internal wall abuts the front wall and a large gap is present between the wall and the skirting board - see photograph 13.

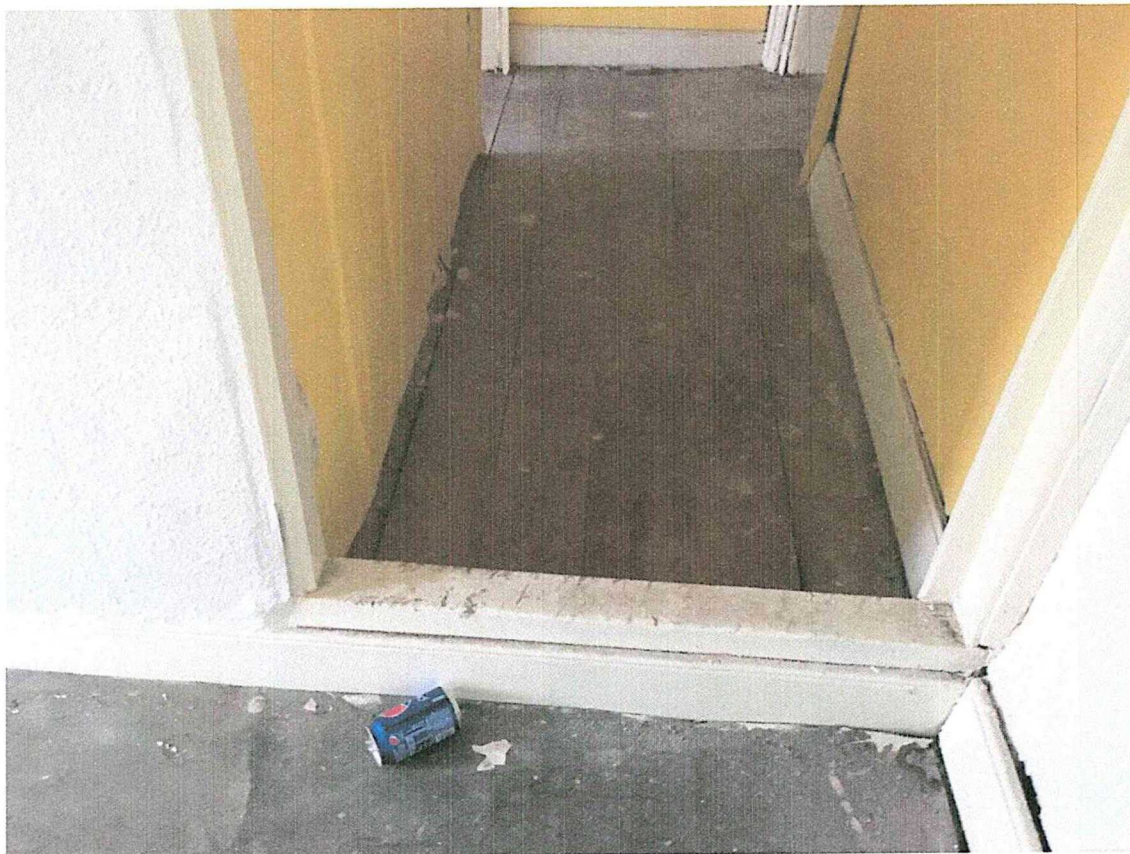
**PHOTOGRAPH 14**

Support for a partition wall at second floor level, is gained by a beam above the floor, which is present in the doorway – see photograph 14.

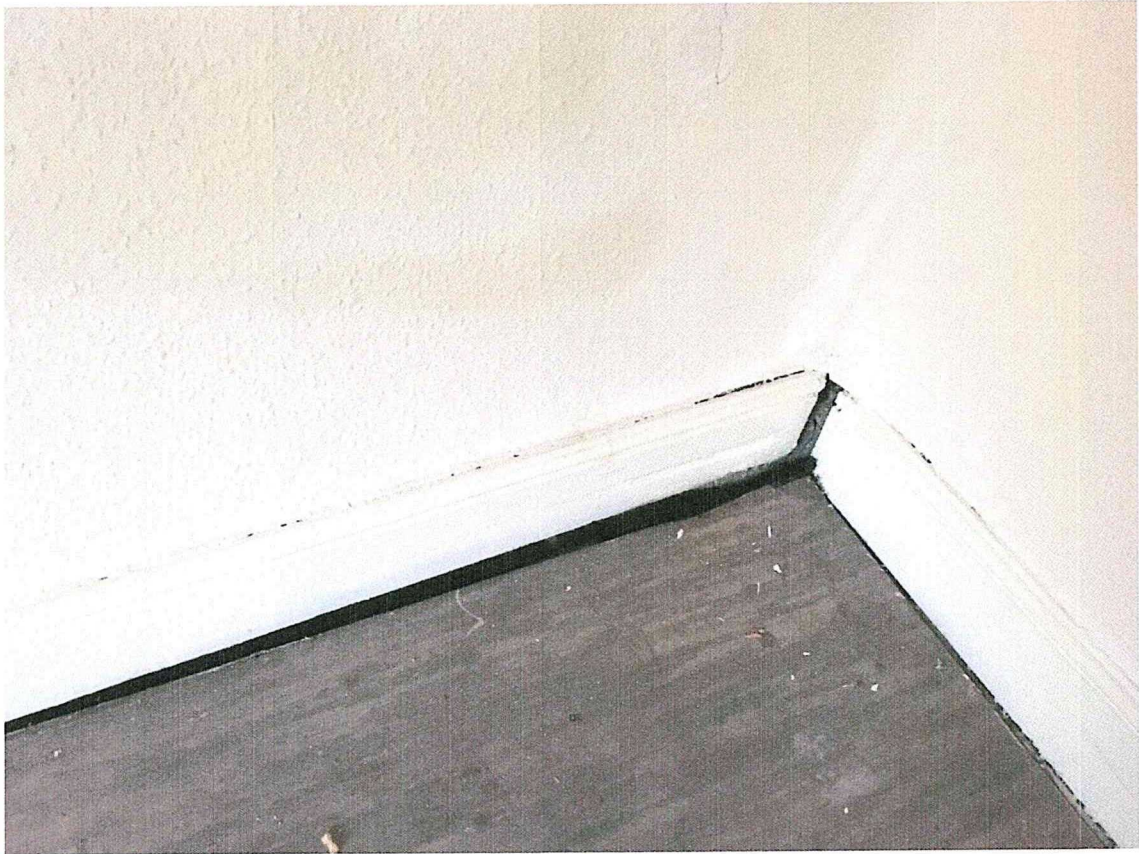
**PHOTOGRAPH 15**

Further movement of the walls away from the floors was also noted in the rear rooms – see photograph 15.
