STRUCTURAL INSPECTION

DERELICT FARMHOUSE  
HURN ROAD  
HOLBEACH  
PE12 8LT

JOB No. 177691

DATE : FEBRUARY 2017

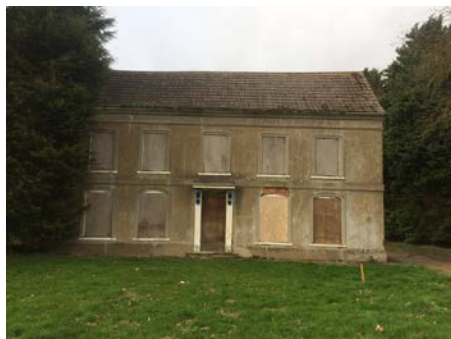
- 2.1 The property is a detached two-storey house set in a wooded area at the end of a farm track just off Hurn Road. Historically the original front building appears to have been extended to form the rear wing, whilst more recently a flat roofed extension has been added.
- 2.2 The property is situated on a site surrounded by Leylandii Cypress trees, all within the zone of influence of the foundations. There is also a mature Leylandii Cypress within 2 metres of the west gable wall (see photos 1 and 2).

*Photo 1 – Front elevation with  
Leylandii Cypress close to west gable*

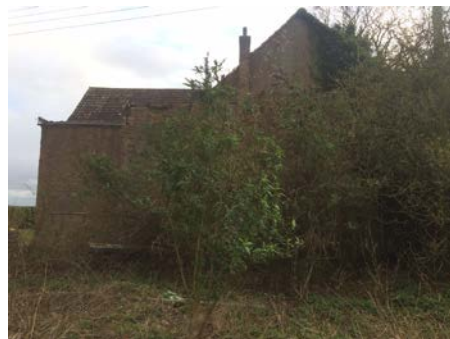
*Photo 2 – Rear elevation*

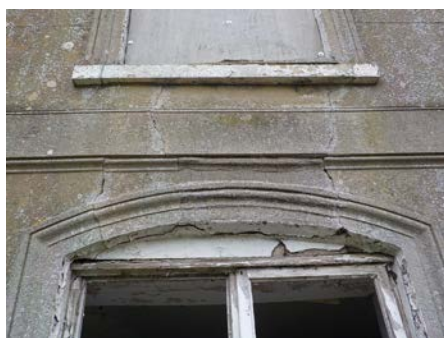
- 3.8 The front elevation has been covered entirely with cement render to form architectural details around doors and windows. The render is visibly cracked in numerous locations above and below openings, central to panels (see photo 3). As the elevation is south facing, this cracking is most likely due to thermal expansion / contraction of the cement render, with cracking occurring at masonry weak points between openings. Weather penetration has occurred in all these locations allowing water to get behind the render. A large section of the render has dropped away from the arch over the ground floor window to the right of the front door, exposing the brickwork arch behind. The bricks and lime mortar joints have also weathered significantly from between the bricks (see photo 4).

*Photo 3 – Render cracking between windows. Masonry bearing onto timber window*

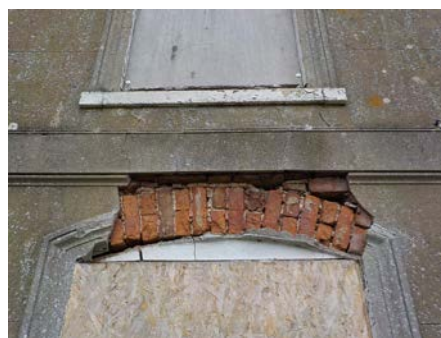
*Photo 4 – Render missing over front window and masonry bearing onto timber windows*

- 3.9 Timber lintels likely behind masonry arches have probably failed as masonry appears to be bearing onto timber windows.
- 3.10 Historical diagonal cracking was noted above first floor window and below the ground floor window, at the western front corner, indicating movement of the masonry towards the corner, most likely slight foundation movement to the corner of the building caused by the close proximity of the Leylandii Cypress (see photos 5 and 6).

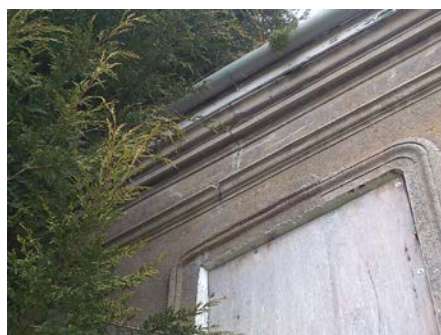
*Photo 5 – Diagonal cracking above first floor window*

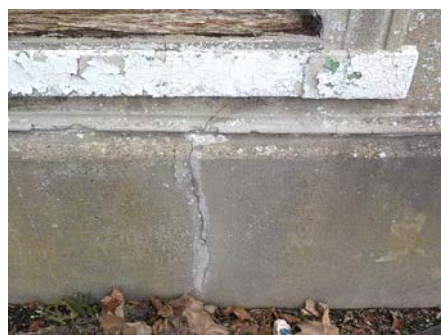
*Photo 6 – Previously repointed cracking below ground floor window*

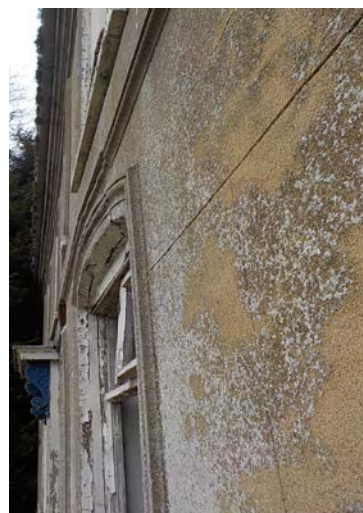
- 3.11 Considerable outward bowing of the front elevation wall has occurred at first floor level also indicated by the cracking above and around the windows. Significant lateral movement of the masonry within the vicinity of the window heads has occurred, likely to be due to lack of restraint provided by a deteriorated timber first floor structure (see photo 7).

*Photo 7 – Lateral bowing out of masonry above ground floor windows*

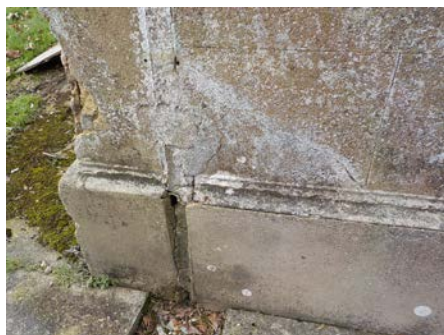
- 3.12 The gable wall bows out considerably at its centre around first floor level.
- 3.13 Extensive vertical cracking runs full height up to eaves level in the centre of the wall. The cracks have been historically repointed indicating ongoing movement. There is also cracking at the south east corner, indicating some previous separation of the front wall from the gable wall, also historically repointed (see photos 8 and 9).

*Photo 8 – Diagonal corner cracking, historically repointed*

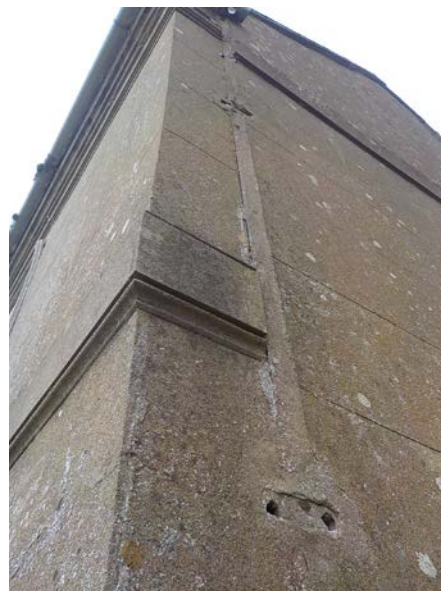
*Photo 9 – Vertical cracking at corner junction between front panel and gable wall*

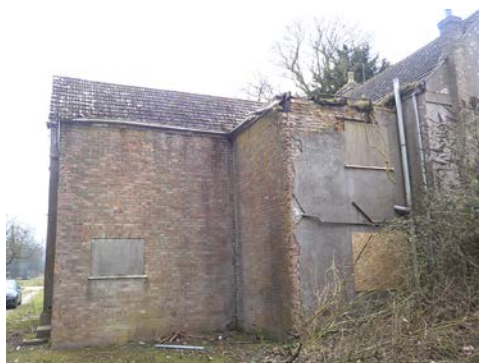
- 3.17 The main roof has a number of tiles damaged and missing. Water penetration is occurring in a number of locations.
- 3.18 The low level flat roof has collapsed and the flat roofed rafters have entirely rotten away, allowing full weather penetration into the building (see photo 10). The guttering is no longer working and has dropped off the building in a number of positions. At the top section of the rear extension, the outer leaf of the cavity wall has delaminated away from the inner leaf and has collapsed (see photo 11). The lintels over the windows have become rotten and are no longer functioning properly. The render has become dislodged and has dropped away from the building allowing further water to penetrate behind. We would expect the brickwork at lower level to also be highly deteriorated.

*Photo 10 – Part rear elevation,  
collapsed timber roof and masonry  
panel*

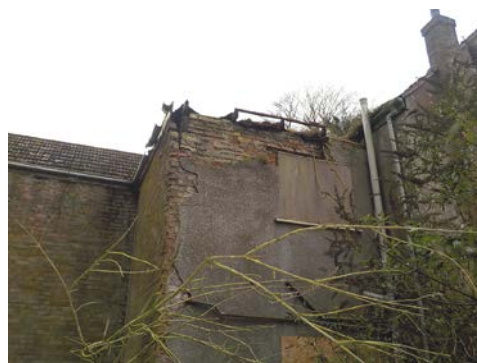
*Photo 11 – Collapsed masonry  
section*

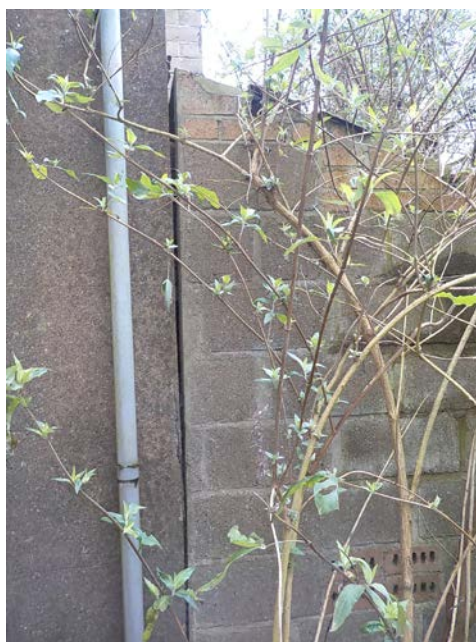
- 3.19 There are notable dips in the main roof pitch and the ridge to the rear wing roof, indicating likely deterioration of the roof timbers. The small chimney on the rear wing has a lean away from the building for the top section.
- 3.20 There is a small external boiler house to the rear of the property, the roof of which has completely failed and collapsed. It was also noted that the masonry walls are rotating away from the gable wall most likely due to inadequate foundations (see photo 12).

*Photo 12 – Rotational movement  
visible between sections of masonry*

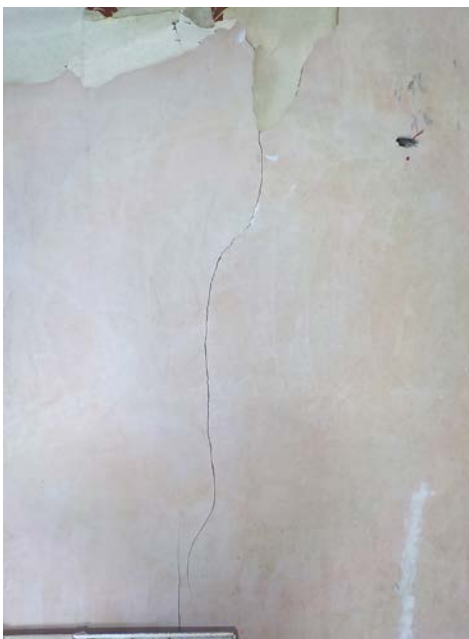
- 4.1 In the front reception room large vertical cracking is visible in the rear wall. The crack is approximately 5mm in width (see photo 13).

*Photo 13 – Vertical cracking  
in the reception room*

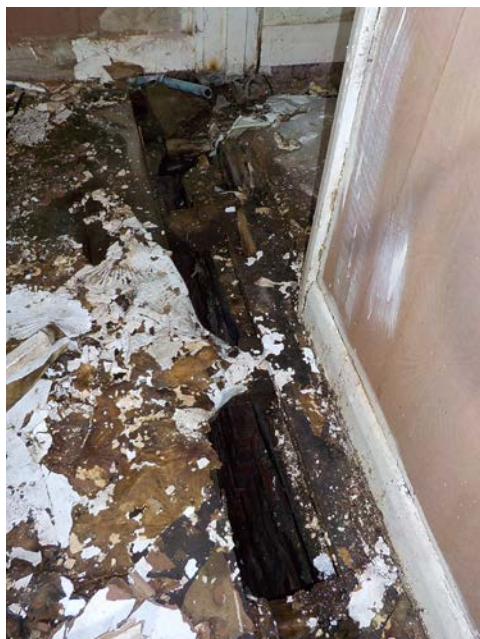
- 4.2 The timber floor joists are visible in the hall area and have suffered significant rot and general damage. Areas of ground floor have fallen through to the ventilation void below the floor (see photos 14 and 15).

*Photo 14 – Rotten collapsed timber floor in hall*

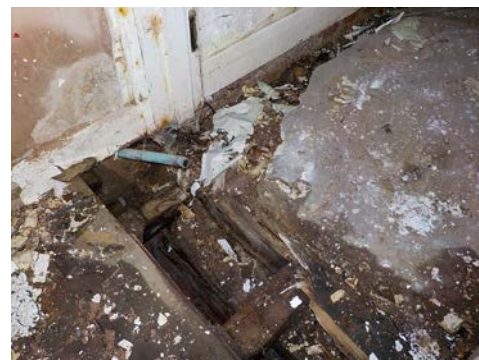
*Photo 15 – Collapsed floor in rear extension*

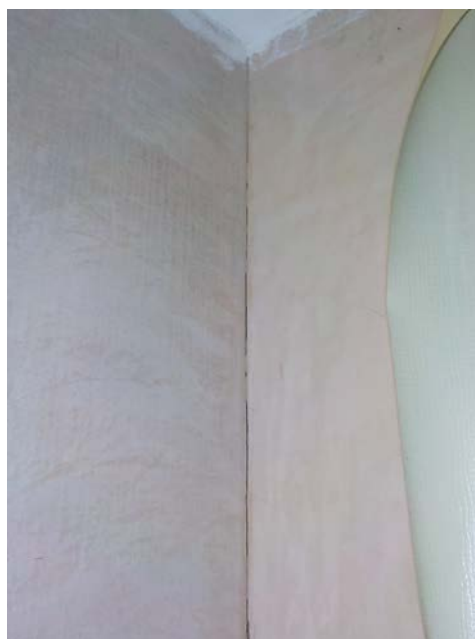
- 4.3 In the lounge there are vertical cracks above the door and a full height vertical crack in the rear wall (see photo 16). There is a 5mm vertical crack in the corner junction between the front wall and the west gable wall, corresponding to vertical cracking externally between gable and front wall.

*Photo 16 – Vertical cracking visible in lounge south west corner*

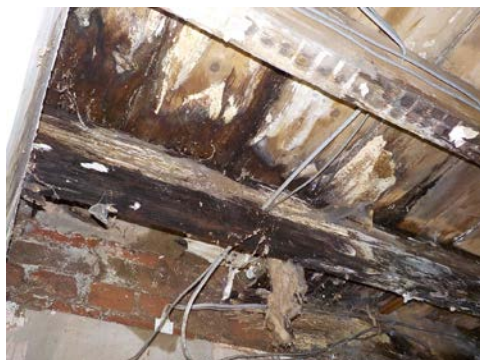
- 4.4 The first floor structure in the hall is visibly rotten and has collapsed in a number of areas. The wall plates and joists are damp and have also suffered from extensive rot (see photos 17 and 18).

*Photo 17 – Rotten timber first floor*

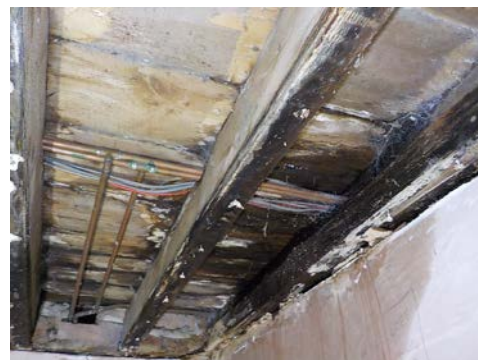
*Photo 18 – Rotten timber first floor to rear extension*

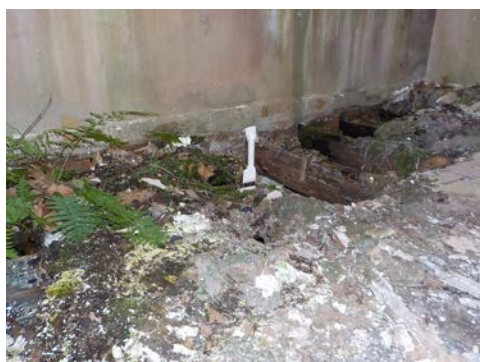
- 4.5 The roof structure was not fully inspected, however it could be seen that the rear roof structure has completely rotted away and collapsed in a number of areas as has the timber first floor structure (see photos 19 and 20). It was deemed unsafe to walk around on the existing first floor structure and therefore the upper storey could not be safely investigated.

*Photo 19 – Collapsed timber first floor*

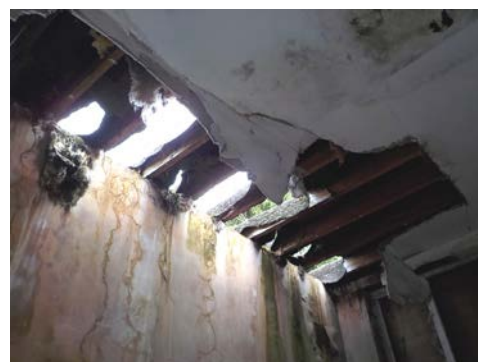
*Photo 20 – Rotten collapsed timber flat roof to rear*

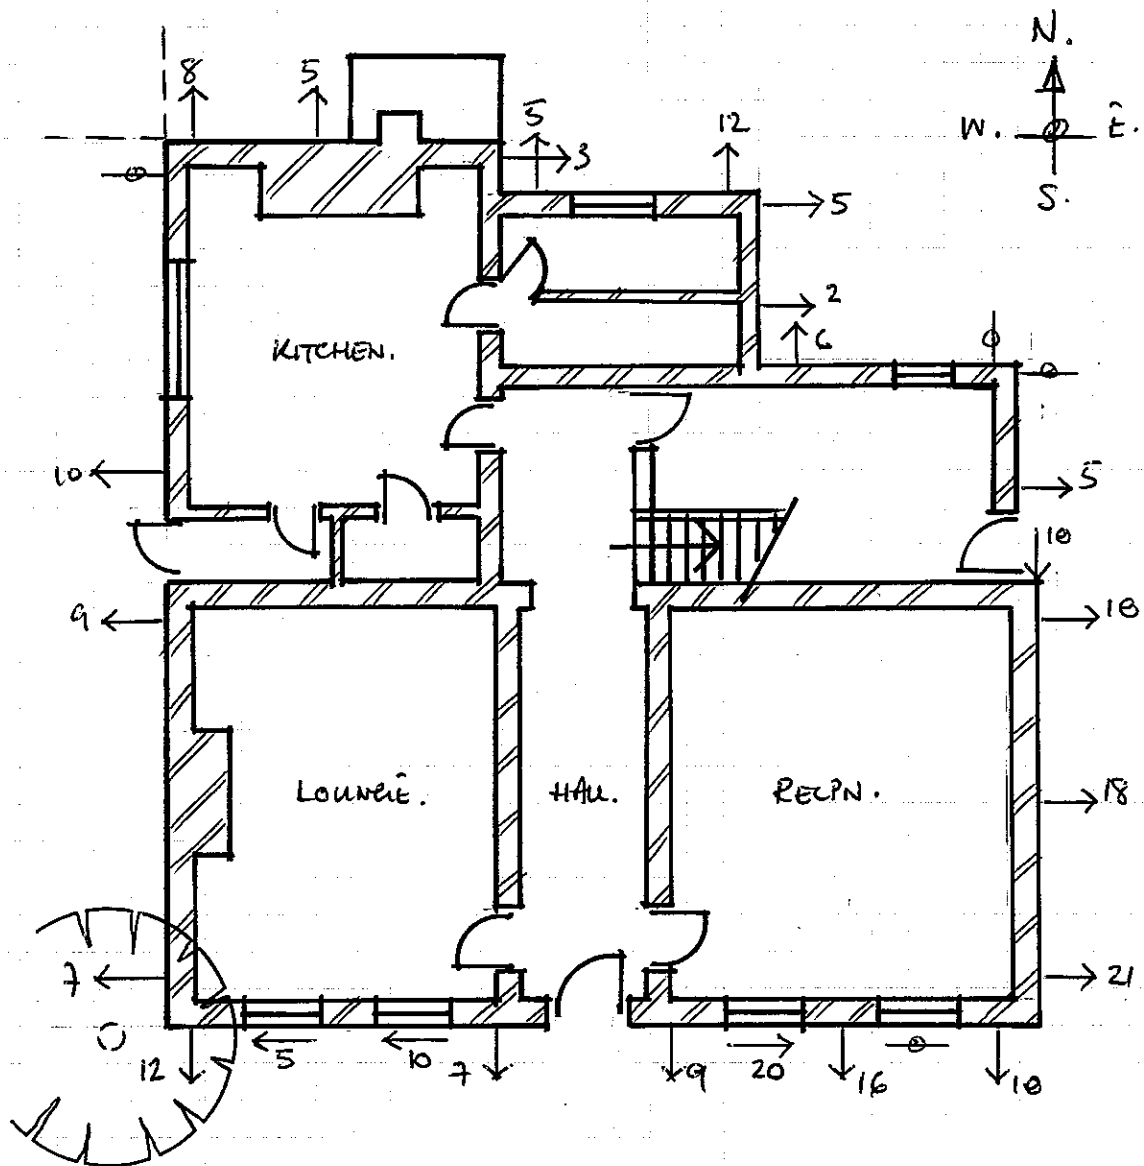
Drawing 177691 / 01

- 3.1 A visual inspection of the external wall surfaces was carried out.
- 3.2 All external wall surfaces were checked at their corners, panels and buttresses using a 1200mm long spirit level, the leans in millimetres over the length of the level are noted on sketch drawing 177691 / 01.

- 3.3 External door and window cills were also checked for crossfalls where possible and the crossfalls in millimetres are also indicated on sketch drawing 177691 / 01.

- 3.5 These measurements indicate that most of the external walls have an outward lean. In particular the eastern gable is leaning to the east quite significantly and the front elevation also has a forward lean. The western gable of the front section also leans to the west. Levelling of the window cills on the front elevation confirms settlement at both gable walls. At the rear the northern gable is leaning away from the building and there are also significant leans on the two storey flat roofed sections of the property. All of these measurements indicate a general deterioration in the building fabric.
