KJ Ecology Ltd,  
17, The Meadow,  
Caistor,  
Lincs,  
LN7 6XD.

11<sup>th</sup> September 2025

**RE H09-0705-25-Hooks of Holbeach**

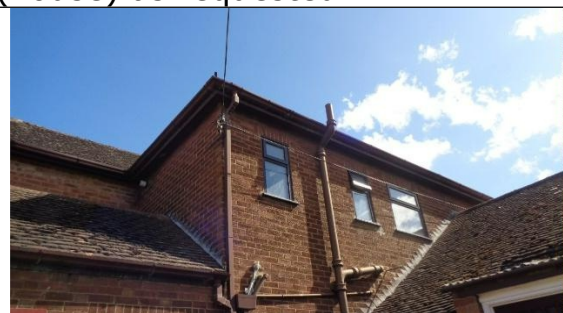
Photo 1: Typical flashing on extensions on West side of the house

The lead flashing around the house was in good condition and tight to the brickwork (Photos 1 and 3). The soffits were also tight to the brickwork with cobwebs in places (Photo 2). The soffits were also made of uPVC which bats do not like as they cannot grip on them and the way they control temperature. All the pantiles and ridge tiles were in good

condition. No signs of bats were seen around the house and there were no opportunities for them to enter the space between the pantiles and the bitumen felt. For this reason the house was given a negligible bat roost status.

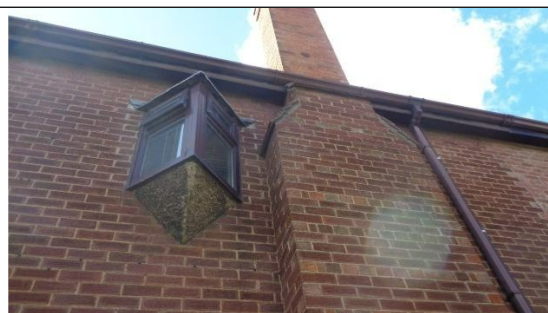
Photo 2: Typical soffit/ wall connection on house

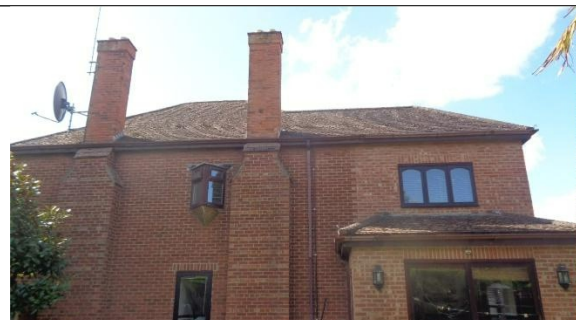
Photo 3: Typical flashing around chimneys

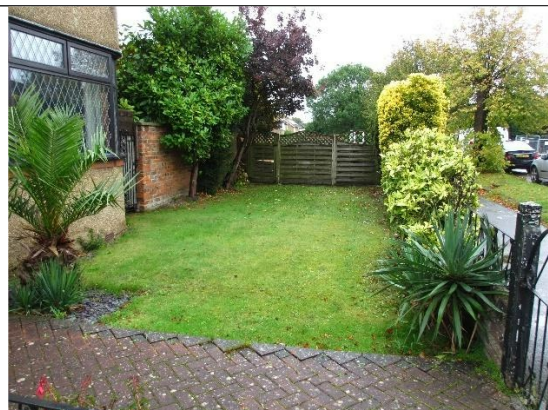
Photo 4: Hedge in front garden

For the BNG please see Photo 4 which shows the front hedge. The hedge was not included in the biometric as under the biometric rules it is classed as garden. As garden hedges cannot be counted in the biometric, then any new hedges on site, can also not be counted in the biometric, even if they are in public spaces as there will be an instant net gain and not accepted by the biometric.
