## ***REFURBISHMENT & DEMOLITION ASBESTOS SURVEY REPORT***

| Conducted at: | The Limmings Building & Out Building<br>Park Road<br>Holbeach<br>PE12 7EE |

Survey Reference: WEAAR-25-RD-1069

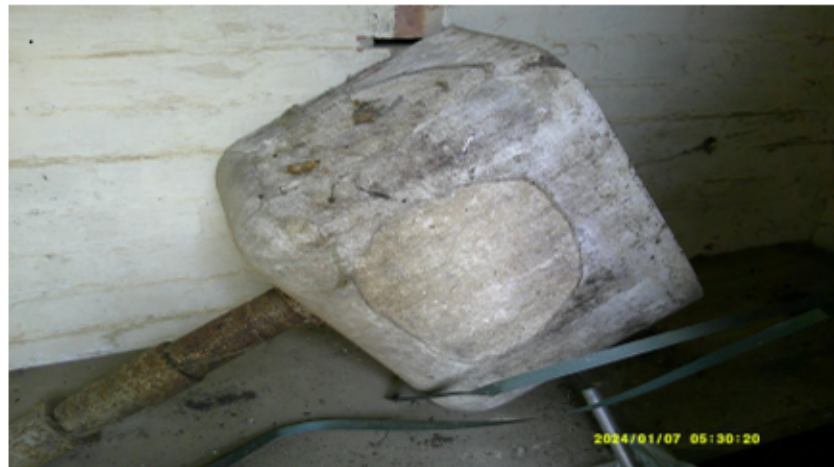
| Photo No. | 0396 | |

| Sample No | Photo No. | Floor Level | Area Ref / Location | Material Sampled | Approx Extent | Likelihood of Disturbance | Personnel Accessibility | HSG 264 Material Assessment Algorithm | | | | | | |
|---|---|---|---|---|---|---|---|---|---|---|---|---|---|---|
| 1 | 0396 | Ground | G7 Water Tank | Cement | <1m2 | High | Easy | 1 | 3 | 1 | 1 | 6 | C | See photo assessment |

| Damage | 3 | High damage |

**To be removed by a trained operative wearing the correct RPE & PPE**

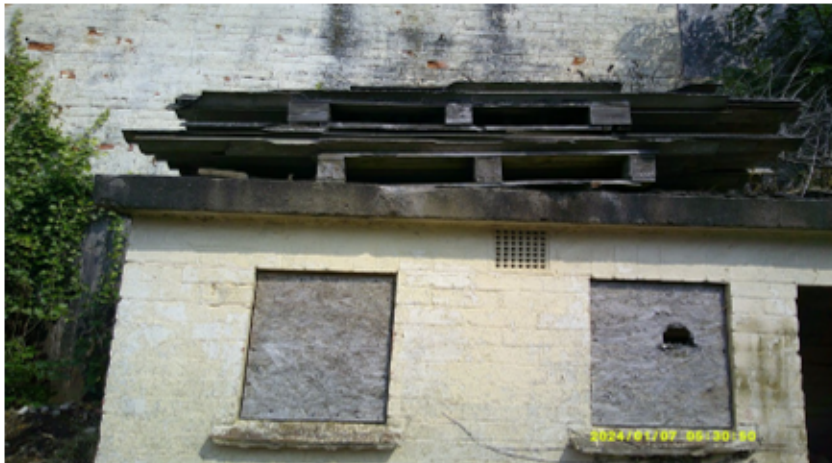
| | | | Photo No. | 0397 |

| Sample No | Photo No. | Floor Level | Area Ref / Location | Material Sampled | Approx Extent | Likelihood of Disturbance | Personnel Accessibility | HSG 264 Material Assessment Algorithm | | | | | | |
|---|---|---|---|---|---|---|---|---|---|---|---|---|---|---|
| 2 | 0397 | External | G7 Roof | Cement Sheets on pallet | 10m2 | High | Easy | 1 | 3 | 1 | 1 | 6 | C | See photo assessment |

| | | | Damage | 3 High damage |

| <b>To be removed by a trained operative wearing the correct RPE &amp; PPE</b> | | | Treatment | 1 Asbestos cement sheets etc |

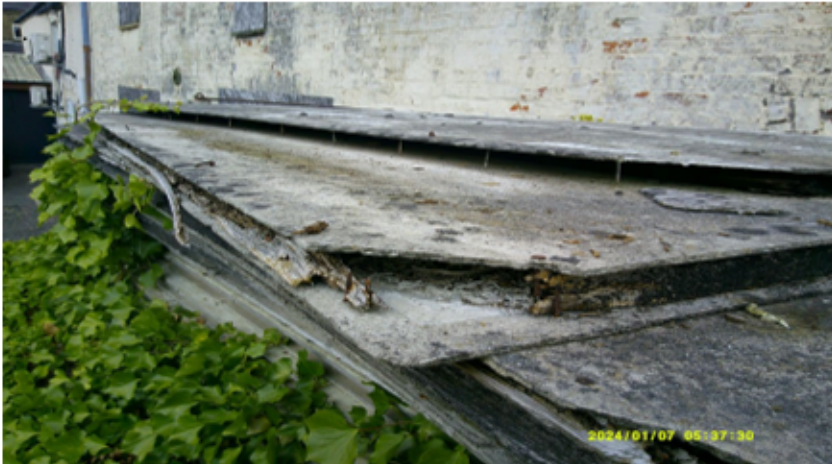
| | | | Photo No. | 0398 |

| Sample No | Photo No. | Floor Level | Area Ref / Location | Material Sampled | Approx Extent | Likelihood of Disturbance | Personnel Accessibility | HSG 264 Material Assessment Algorithm | | | | | | |
|---|---|---|---|---|---|---|---|---|---|---|---|---|---|---|
| 3 | 0398 | External | G6 Roof | Cement Strammit Boards | 28m2 | High | Easy | 1 | 3 | 1 | 1 | 6 | C | See photo assessment |

| | | | Damage | 3 High damage |

| <b>To be removed by a trained operative wearing the correct RPE &amp; PPE</b> | | | Treatment | 1 Asbestos cement sheets etc |

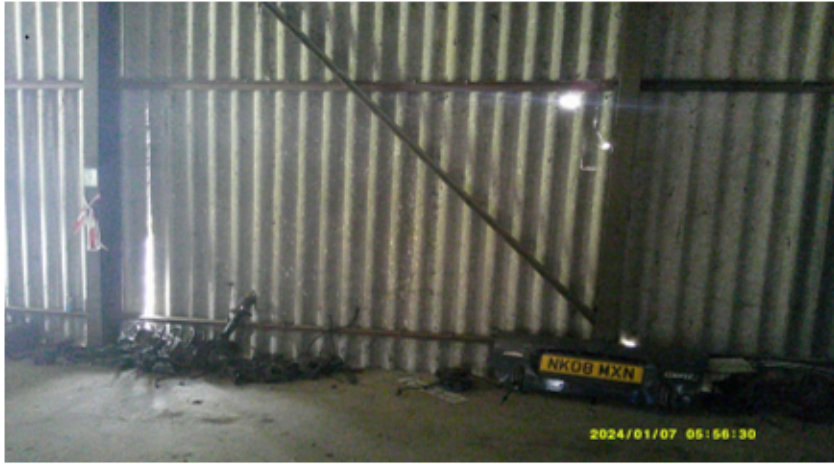
| | | | Photo No. | 0400 | |

| Sample No | Photo No. | Floor Level | Area Ref / Location | Material Sampled | Approx Extent | Likelihood of Disturbance | Personnel Accessibility | HSG 264 Material Assessment Algorithm | | | | | | |
|---|---|---|---|---|---|---|---|---|---|---|---|---|---|---|
| 4 | 0400 | Out Building 1 - Ground | Walls | Cement Board | 240m2 | High | Easy | 1 | 3 | 1 | 1 | 6 | C | See photo assessment |

| | | | Damage | 3 | High damage |

| <b>To be removed by a trained operative wearing the correct RPE &amp; PPE</b> | | | Treatment | 1 | Asbestos cement sheets etc |

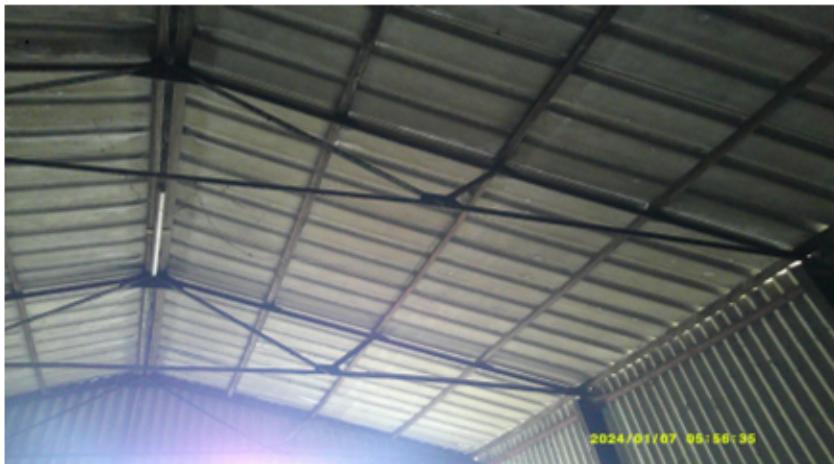
| | | | Photo No. | 0401 | |

| Sample No | Photo No. | Floor Level | Area Ref / Location | Material Sampled | Approx Extent | Likelihood of Disturbance | Personnel Accessibility | HSG 264 Material Assessment Algorithm | | | | | | |
|---|---|---|---|---|---|---|---|---|---|---|---|---|---|---|
| 5 | 0401 | Out Building 1 - Exterior | Roof | Cement Sheets | 160m2 | Low | Difficult | 1 | 1 | 1 | 1 | 4 | D | See photo assessment |

| | | | Damage | 1 | Low damage |

| <b>To be removed by a trained operative wearing the correct RPE &amp; PPE</b> | | | Treatment | 1 | Asbestos cement sheets etc |

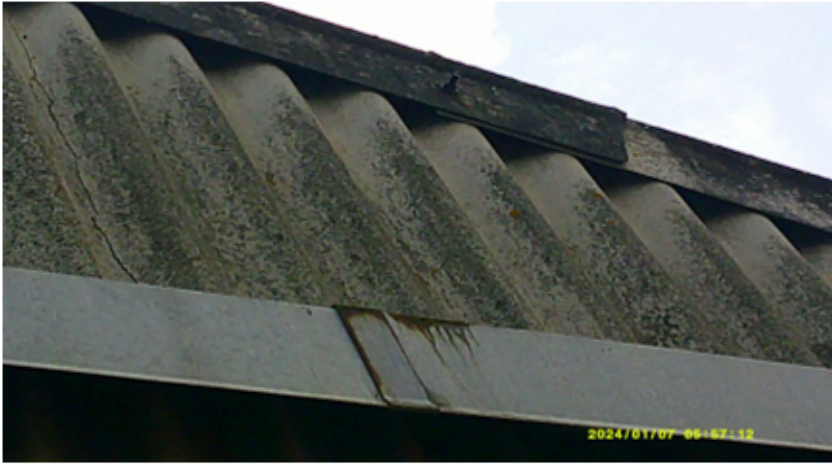
| | | Photo No. | 0402 | |

| Sample No. | Photo No. | Floor Level | Area Ref / Location | Material Sampled |
|---|---|---|---|---|
| 6 | 0402 | Out Building 1 - Exterior | Fascia | Cement |
