**STRUCTURAL REPORT ON  
LIMMINGS BUILDING,  
PARK ROAD, HOLBEACH,  
PE12 7EE**

**PROJECT NO.  
MGC/EH/HW/50247-RP001**

**STRUCTURAL REPORT ON LIMMINGS BUILDING, PARK ROAD, HOLBEACH,  
PE12 7EE**

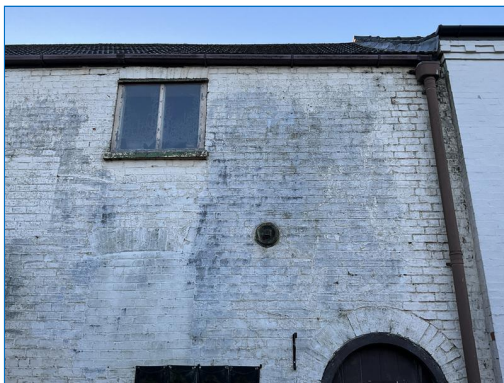
Photo - 2

There is fine stepped cracking, extending down in a south easterly direction from the far right hand window. There is also further cracking and pushing out of the brickwork around the central to first floor windows around eaves level.

The extent of the distortion in the brickwork to the front elevation (within the blue oval in the photograph below) is significant and has resulted in a loss of bonding between the brickwork. We would recommend that this is locally rebuilt or alternatively propped/supported to prevent ultimate failure to this part of the wall and to ensure that there is adequate support to the roof structure above.

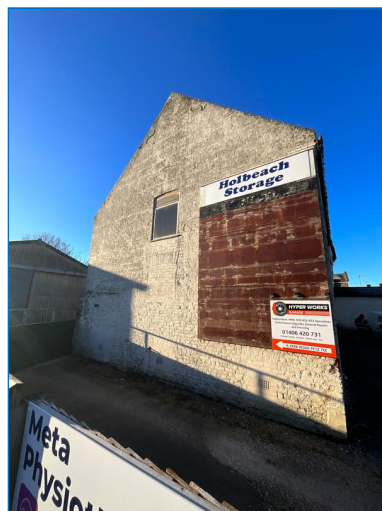
Photo - 8

There is some minor weathering and damage to the brickwork and further evidence of bricked up openings. An area of the wall is covered with signage. There is some cracking, generally vertical in direction, to the bottom left hand corner of the elevation along what appears to be a junction between original and newer/rebuilt brickwork sections which steps out to form a small pier to which the gate post abuts/is fixed.

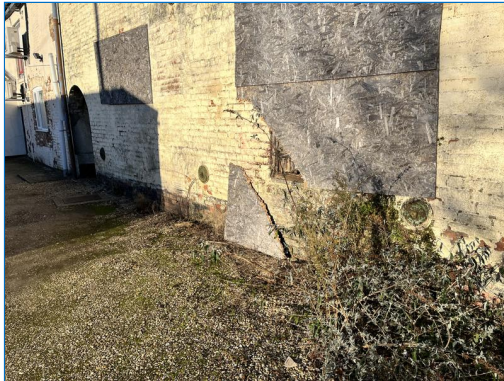
*Photo - 12*

As with the other elevations, the brickwork is largely in a commensurate condition for the building's age. A number of previous openings have been bricked up and there are again end plates to tie beams which do not appear to be present internally. A small section of the elevation is covered in climbing plants. The remaining openings have been boarded up, however, one has been damaged from recent trespass into the building.

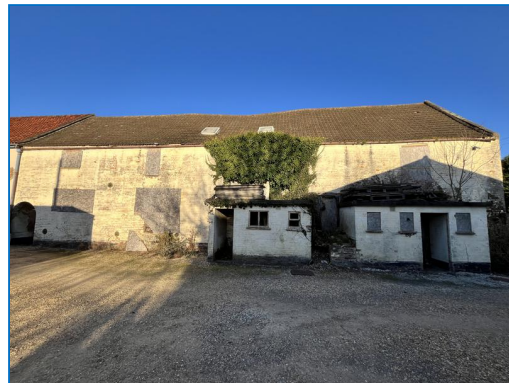
*Photo - 15*

To the far right of the elevation there is some stepped cracking which generally extends up in a north-westerly direction and appears to be wider at the base than at the top. There is also the remains of an assumed self-seedling tree that has grown from within the mortar joints.

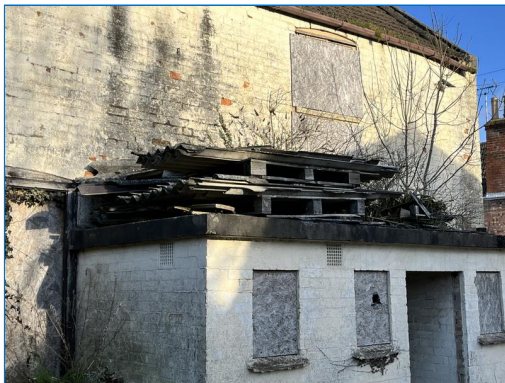
*Photo - 18*

There are two ancillary, single storey 'extensions' to the rear elevation. Access was limited but overall the structures appear to be relatively sound. Both had material piled up on the roofs and it was noted that there is profiled cement cladding sheets stacked on the right hand 'extension' - this sheeting can contain asbestos. This needs confirming by formal testing by a specialist but a number of the sheets appear to be damaged/broken which can result in the release of asbestos fibres and pose a health issue.

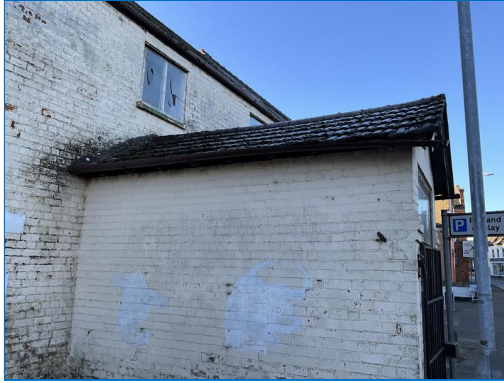
Photo - 24

The roof covering itself is in fair condition however, the rainwater goods are full of vegetation and/or are damaged or missing.

All gutters, fall pipes and drains should be examined, and where defective, the repairs should be carried out using new materials. All gutters and drain gratings should be kept free from all debris at all times as any ingress of water resulting from faults in these areas can affect the structural elements, particularly the roof timberwork.

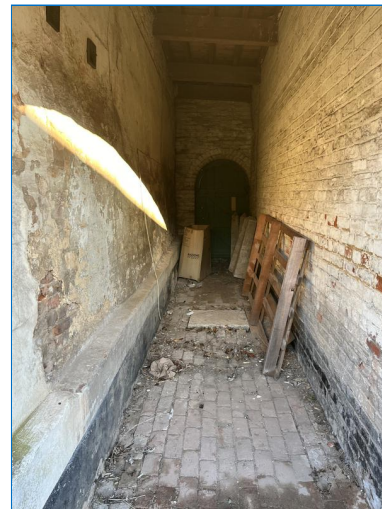
Photo - 27

The internal mezzanine floor joists are exposed to the soffit of the alleyway. The joists slope in an eastward direction when compared with the brickwork coursing.

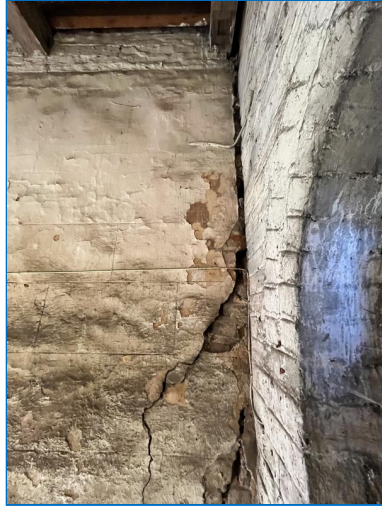
*Photo - 28*

There is significant cracking to the internal corners both sides of the arched door opening to the front elevation, as well as vertical cracking, extending down from the second floor joist above. The cracks to the internal corners are notably wider on the vertical, perpend joints as compared to the horizontal, bed joints.

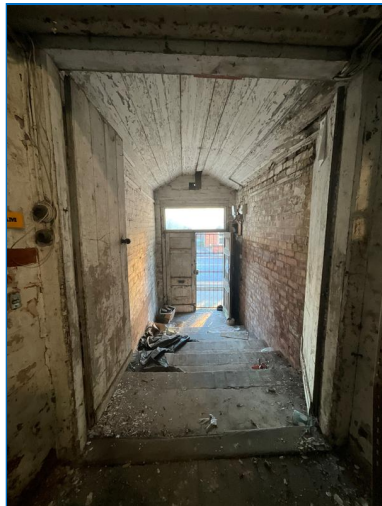
*Photo - 32*

The main building is accessed by a front porch facing the road.

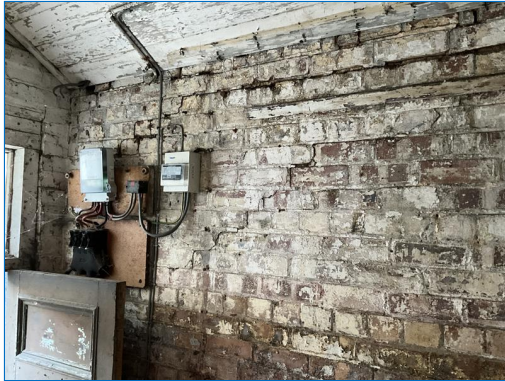
*Photo - 33*

There is stepped cracking in a north easterly direction, extending along the east side wall of the porch.

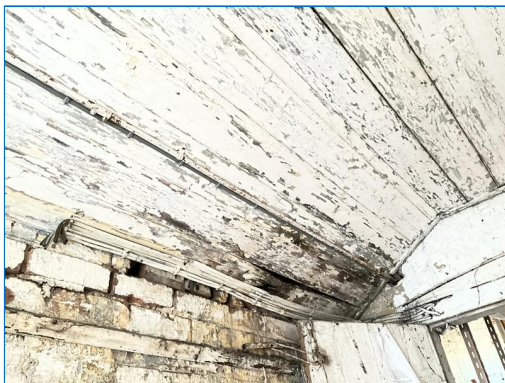
*Photo - 34*

The underside of the roof timbers are clad with timber panelling which is decayed and in a poorly maintained condition.

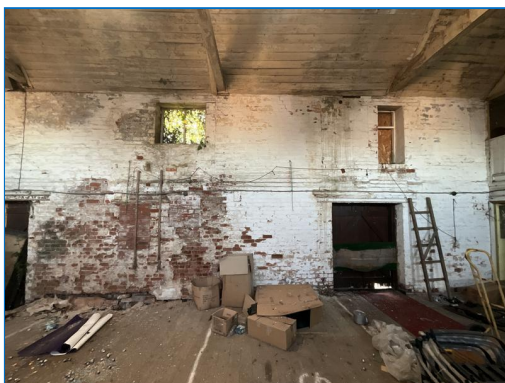
*Photo - 35*

Around the room there are various alterations to openings, with a number of old windows bricked up. There is widespread deterioration of the brickwork as well as spalling and salts to the surface evident.

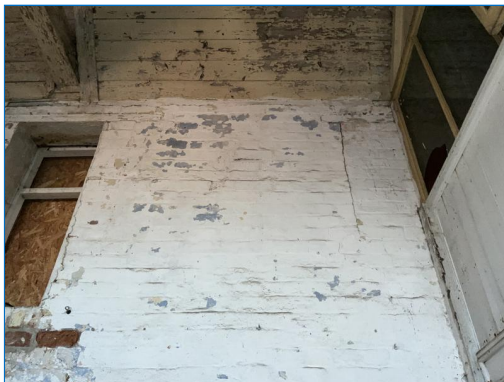
Photo - 40

There is some fine cracking along the junction between the original and newer brickwork where the openings have been bricked up.

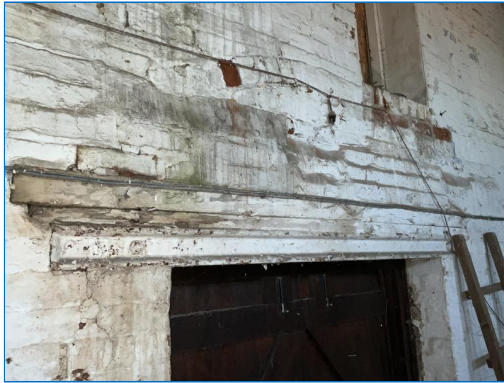
*Photo - 42*

Alterations to and bricking up of old openings to the south wall are evident. Timber and steel lintels have been retained above and there is a step out in the brickwork noted above the door openings. There is also stepped cracking extending down from the top left hand corner of the left hand door opening down in a south westerly direction.

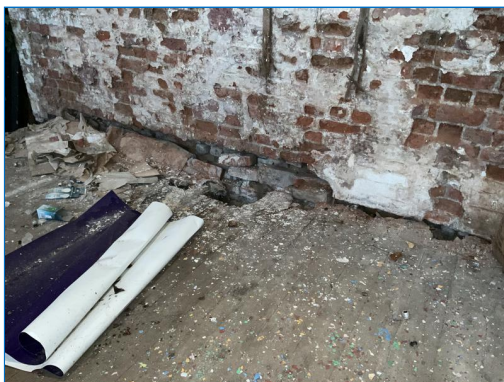
*Photo - 45*

The ends of a number of joists along the south wall have badly decayed, losing their bearing with the wall. The brickwork above it has also become dislodged/ dropped as a result.

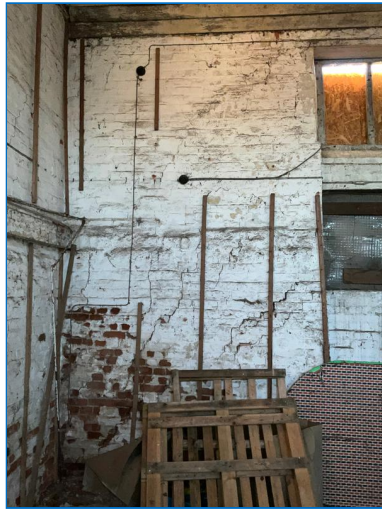
*Photo - 47*

There are a number of stepped cracks extending upwards in a north easterly direction to the left hand section of the south wall. The cracking appears to widen with height and is wider to the perpend joints (up to 10mm) that to the bed joints (up to 4mm).

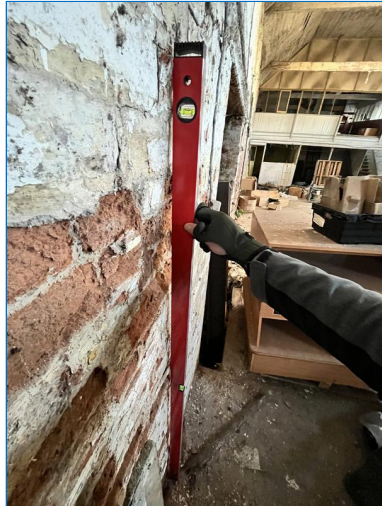
Photo - 50

The south wall is relatively plumb across its' length with only minor outward leaning noted.

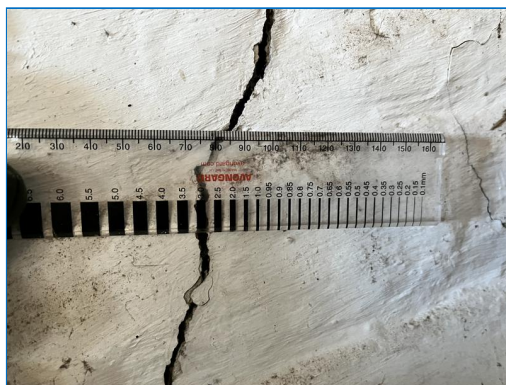
Photo - 51

There is stepped cracking in a north westerly direction to the left hand side of the gable end and in a north easterly direction to the right hand section of the same wall. The cracking is up to approximately 3mm in width.

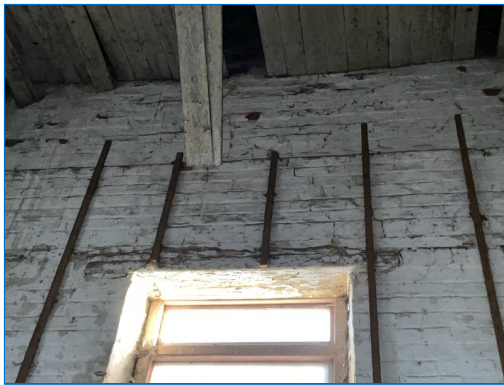
*Photo - 54*

There is also stepped cracking extending up from the top right hand corner of the high level window opening in a north westerly direction.

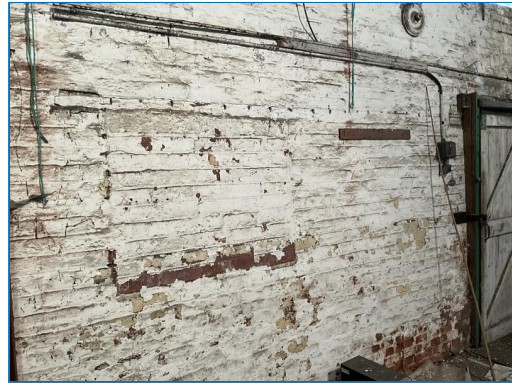
*Photo - 56*

There have been alterations to and bricking up of previous openings to the north wall, and the original timber lintels appear to have been retained.

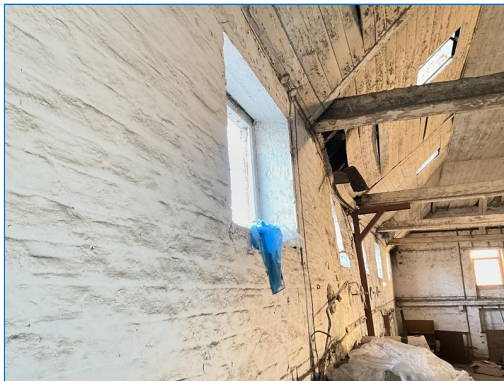
*Photo - 57*

There is extensive deviation in the line of the brickwork along the eaves level with the top of the wall leaning/bowing significantly outwards. This has led to severe stepped cracking around a couple of the high level windows.

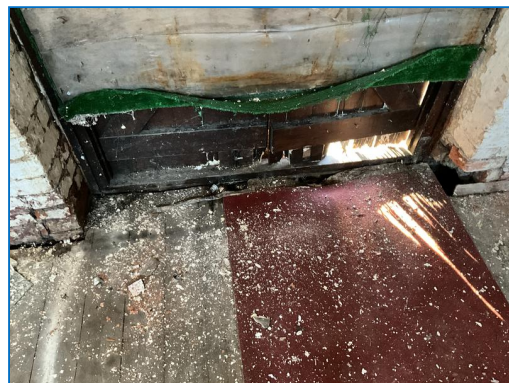
*Photo - 72*

There are a number of areas where the floorboards have dropped and rotted away, largely adjacent to the external walls of the building.

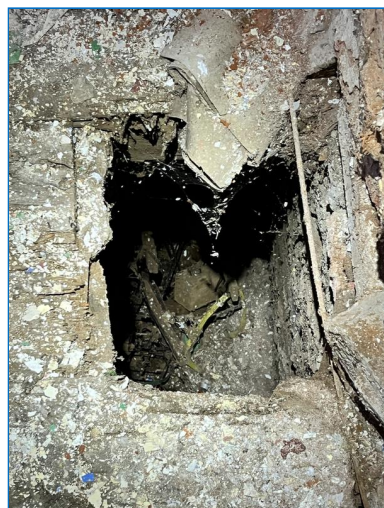
*Photo - 73*

A hole in the floorboards adjacent to the south wall shows that there is a significant void below the floor joists. This ties in with the position of some of the external low level openings that have been infilled which suggests there is a 'cellar' or 'lower ground floor' level. Due to the poor condition of the floor, a closer inspection could not be safely made.

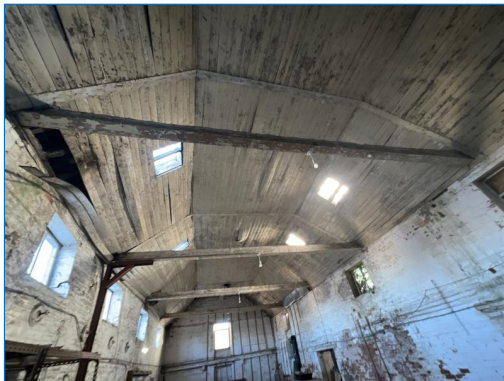
*Photo - 75*

As seen within the porch the underside of the roof structure has been lined with timber panelling restricting the view of the structure above.

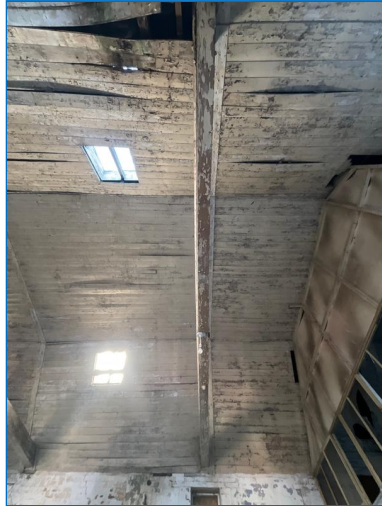
Photo - 76

The roof structure is generally a raised collar roof assumed to be a rafter and purlin construction with additional collars at eaves level. These collars are generally twisted and warped with some fissures (splits) noted.

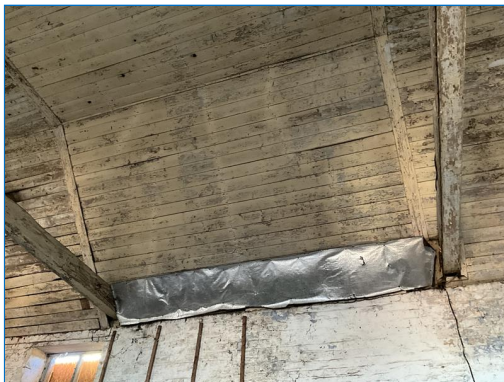
Photo - 78

There are a number of gaps and damage and patch repairs to the timber panelling evident. While the restricted view of the rafters (within these gaps) showed them to be relatively dry, it is assumed that there has been or is an issue with water ingress through the roof covering.

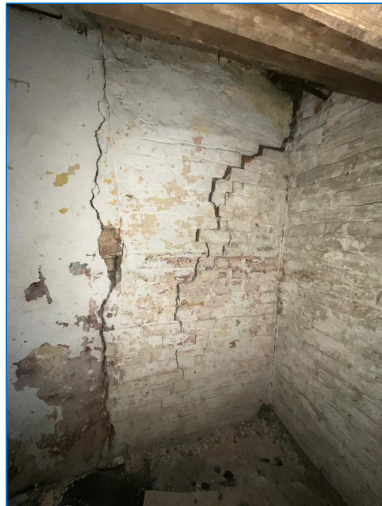
Photo - 84

There is a vertical crack (up to approximately 20mm in width) to the west wall to adjacent to the north west corner of the building which has a stepped crack, extending up generally in a north east direction. The cracking to the corner of the room is wider to the perpend as compared with the bed joints and widens with height up to approximately 42mm in width.

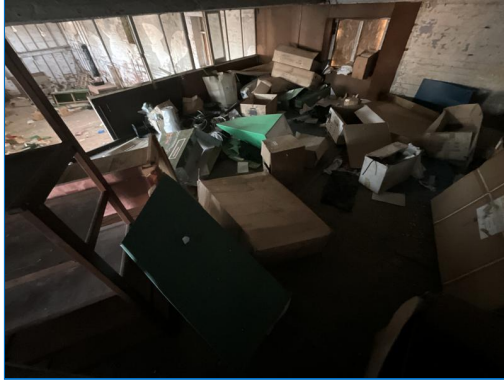
*Photo - 90*

The floor slopes significantly in an easterly direction. Access is restricted due to concerns of floor structure integrity and stored items.

Internally, we would also recommend that access onto the mezzanine level is restricted given the uncertainty surrounding the stairs and mezzanine floor structure's integrity.

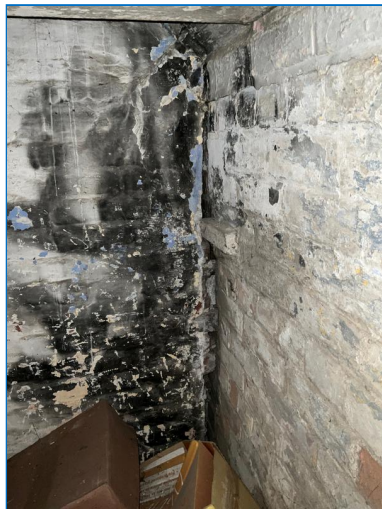
*Photo - 91*

As seen below, there is cracking along the north west internal corner of the room.

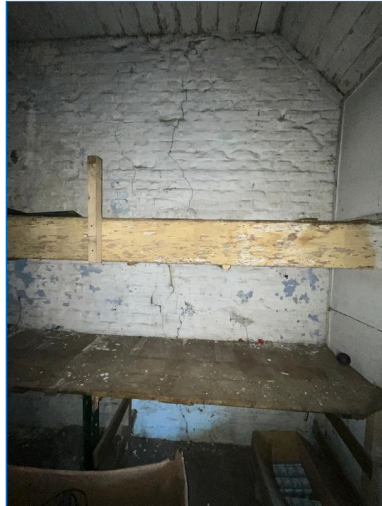
*Photo - 92*

There is further cracking, generally vertical in direction to the centre of the west mezzanine wall.

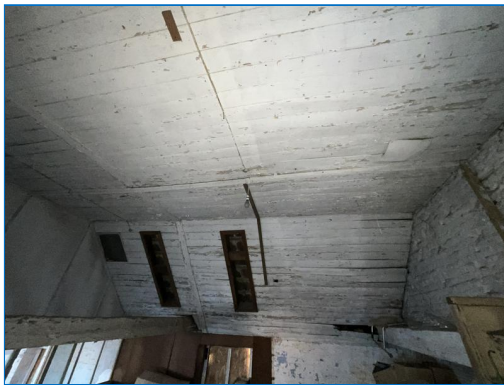
*Photo - 93*

The underside of the roof structure has been lined with timber panelling restricting the view of the structure above. There appears to be some staining to the underside of the sarking board but a close up inspection could not be made.
