# **N J PACEY LANDSCAPING**

## **Tree Safety Survey Report**

**17 Dam Gate  
Holbeach**

**28 September 2026**

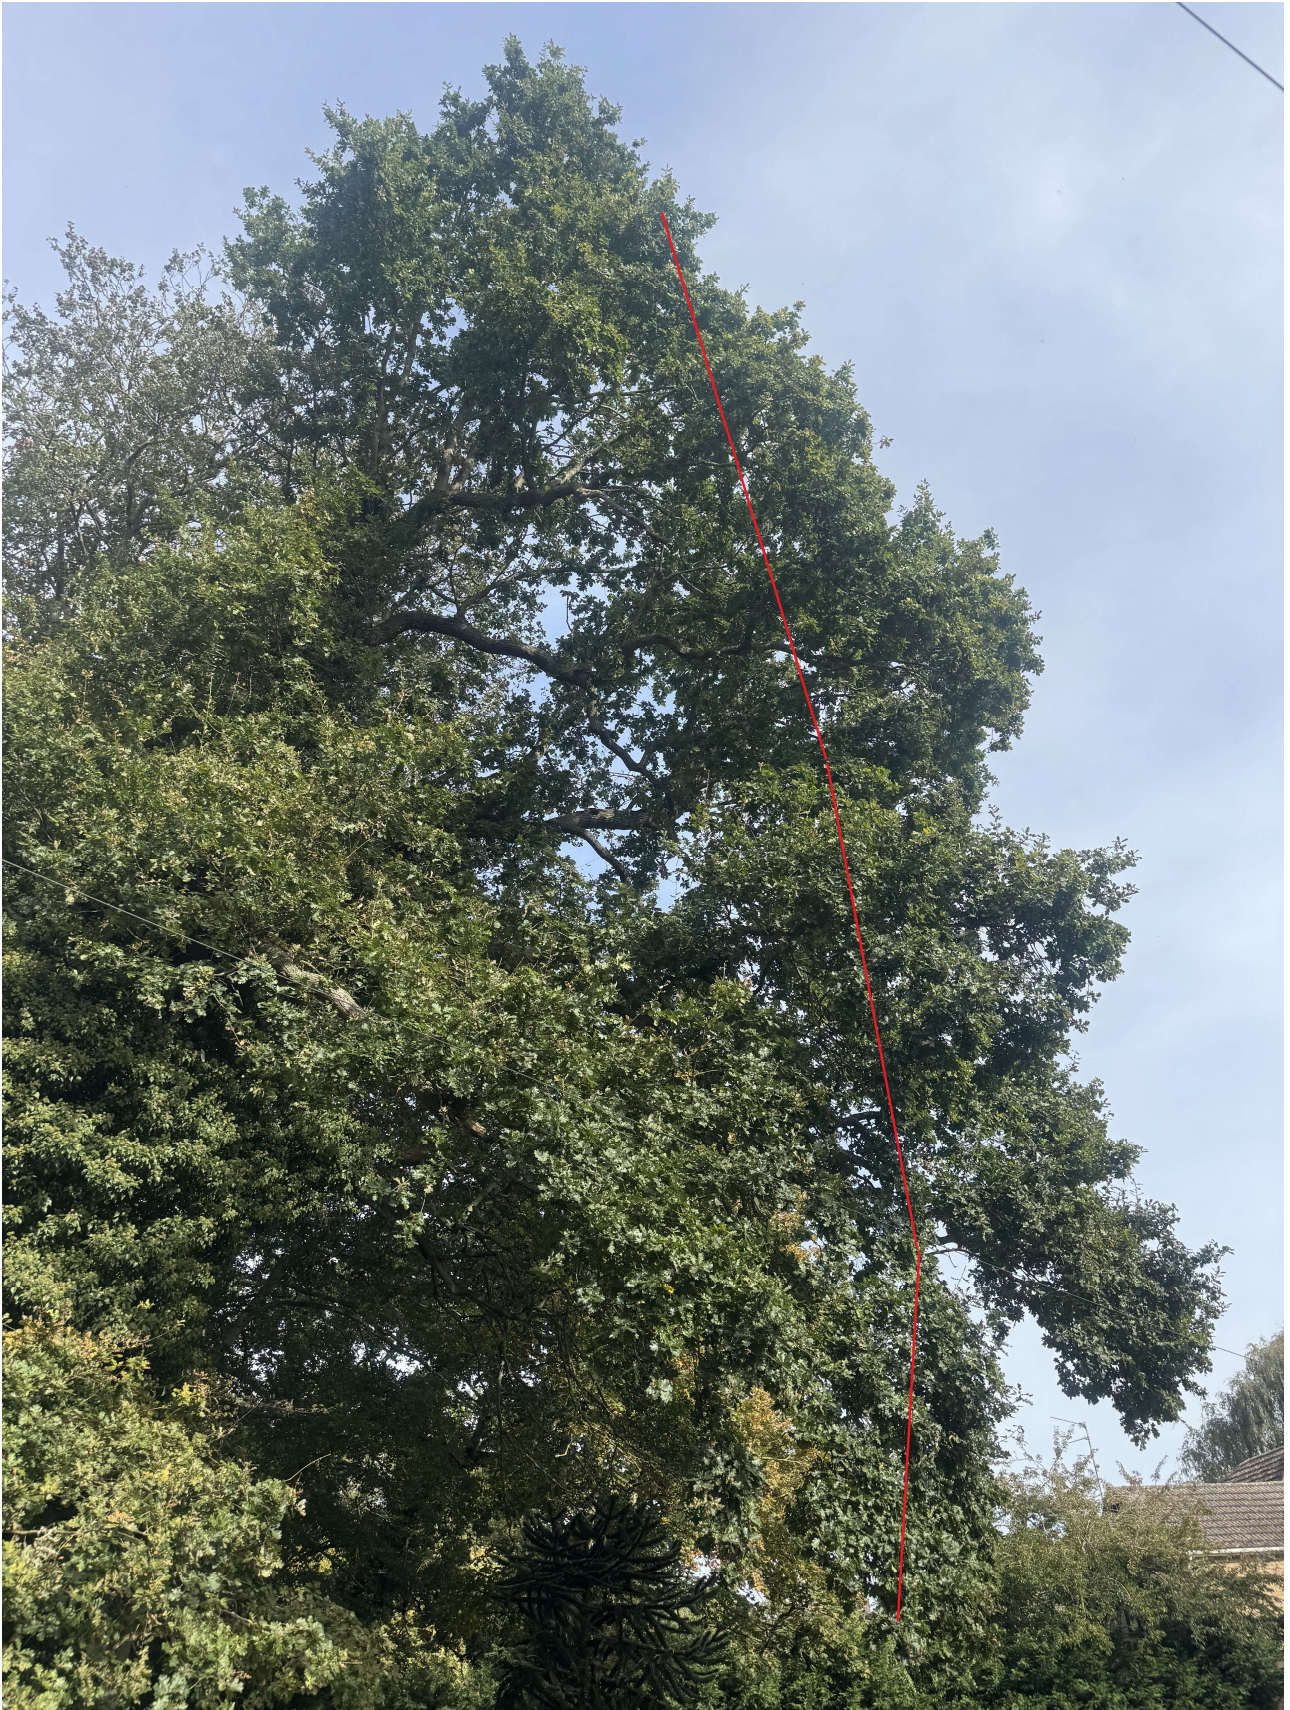
There is a large compost heap on west side increasing the soil level over the rooting area and potentially increasing soil temperatures and damaging the root system in this area. Within the area there is a large old beech stump with *Meripilus giganteus* FFB growing on stump.

No FFB of *Meripilus* is evident around the base of the Oak tree however areas of the root system are covered by the compost heap and the raised soil area. This white rot fungus can grow on oak.

Ivy on main stem and main structural branch unions preventing detailed inspection of the stem. Ivy is stretching to 18m up main stem and restricting visibility on main scaffold branches.

The stem leans stem eastwards towards the properties. Good vigour and good extension growth are visible. There is minor deadwood through the crown.

Carefully remove compost heap and if any remaining stumps are still present grind them out to reduce the risk of stump harbouring decay fungi such as, but not limited to *Meripilus giganteus*.

Cut the ivy at base without cutting into the cambium of the tree. This will allow the ivy to die and then a further visual inspection of the stem will be possible in likely 3-6months.

Crown reduce east side by 3m @ base tapering in to nothing at the leader to reduce the weight on the east side towards the properties and allow the tree to naturally develop a better balanced crown. All cuts to suitable growth points. See photo for illustration.

Remove any major deadwood.

All works should be undertaken within 6 months.

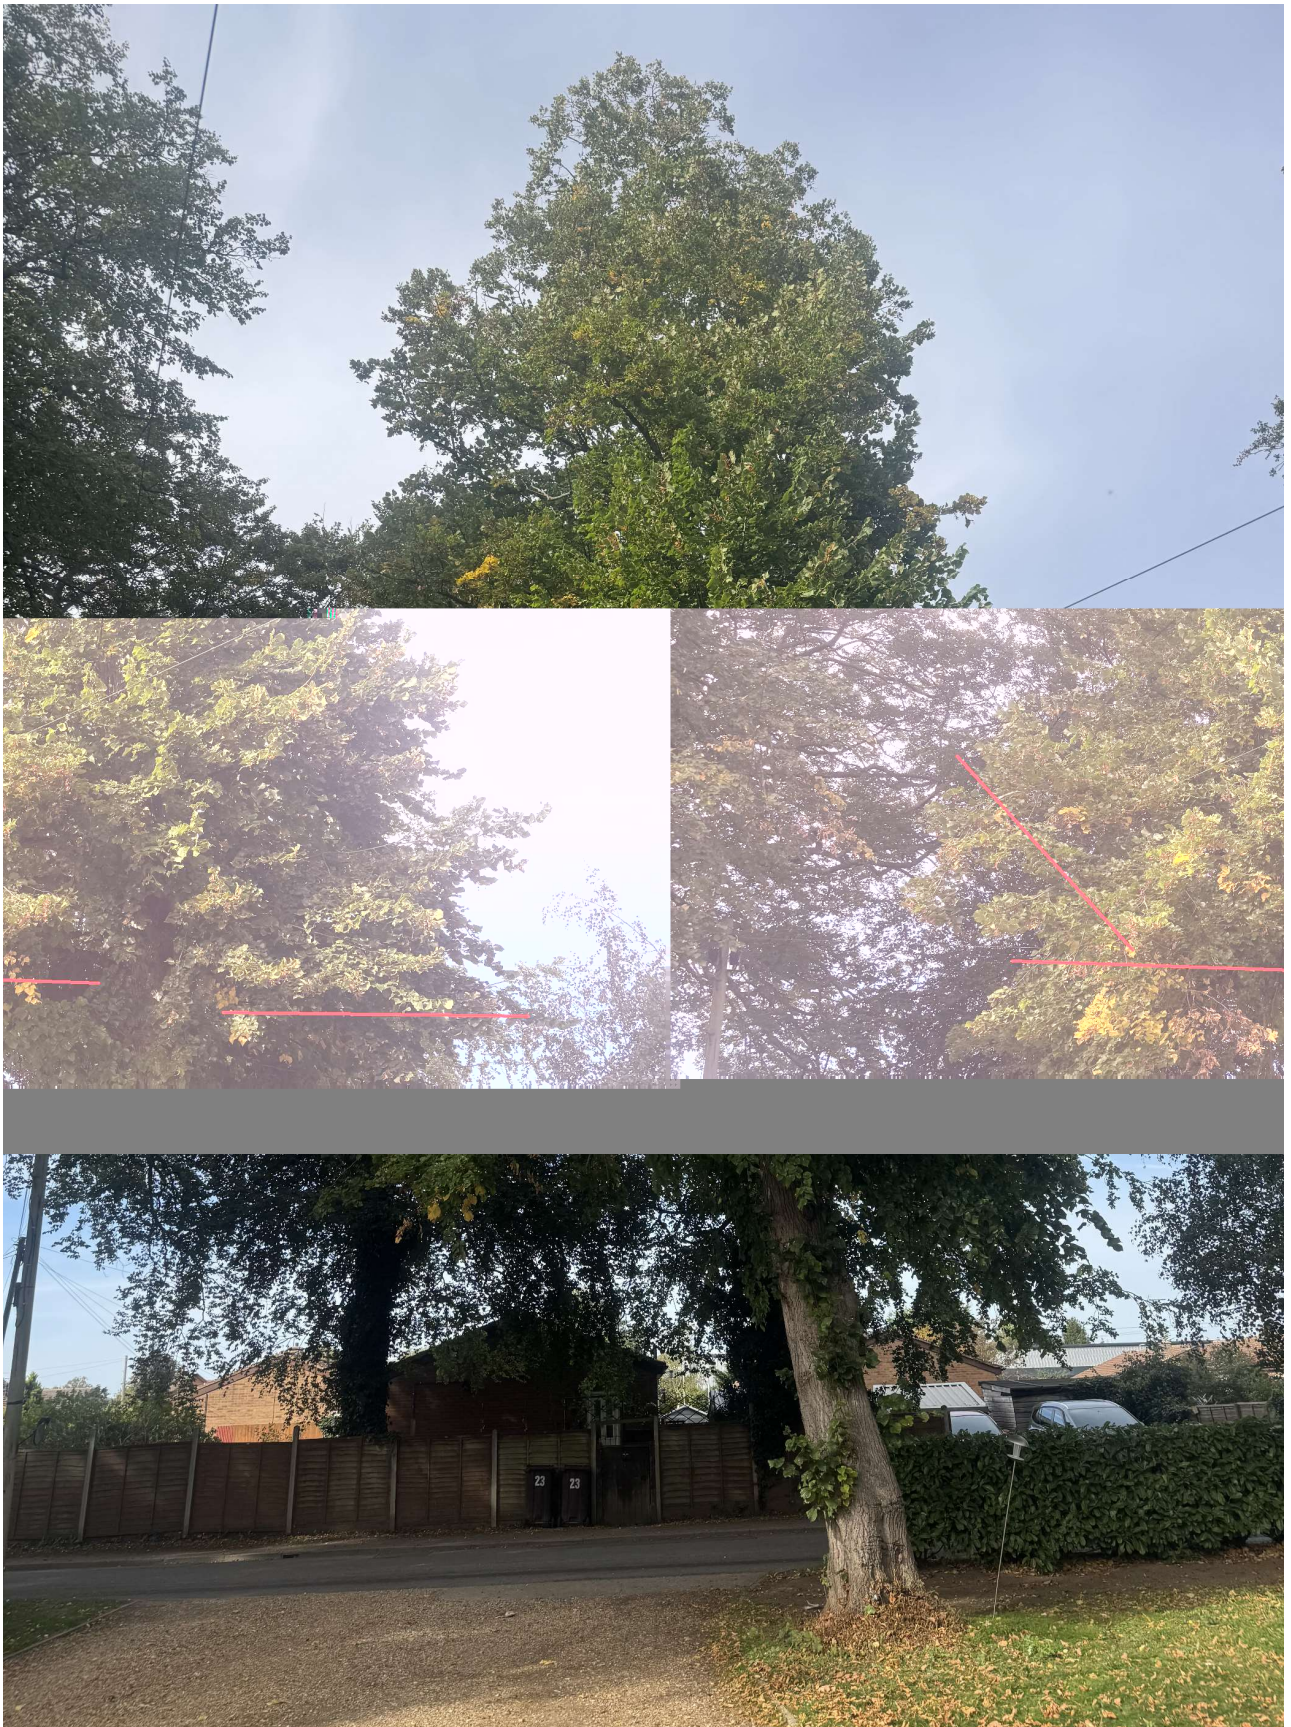
Good vigor in crown, basal growth has been recently cut allowing for inspection of buttress. Large limb previously lost at 6m with stub still present and young regrowth from the stub end.

Large crossing limb above drive to property and touching telecom cable. Low branches interfering with high sided vehicles entering property as reported by the home owner. Minor deadwood over drive. Interfering with telecoms cables along roadside edge.

There is the start of a dominant limb over road in the upper crown which could become an issue in the future.

Crown lift over drive by removing crossing and rubbing branches. Prune back from cables to insure a 1m minimum clearance. Crown lift northern side to balance.

Consider reducing the limb in the upper crown which is heading towards the road by approximately 2m to a suitable growth point to allow the vertical leader at the rear to continue to dominate thus avoiding a heavy limb over the road in the future.

All works should be undertaken within 2 years.
