**Structural Appraisal Report,  
Rose Villa, Holbeach Drove, Spalding, Lincolnshire**

## **Structural Appraisal Report,**

**Rose Villa**  
Drove Road,  
Holbeach Drove,  
Spalding,  
Lincolnshire  
PE12 0PS

**Our Ref;-** JC/14/07/1971

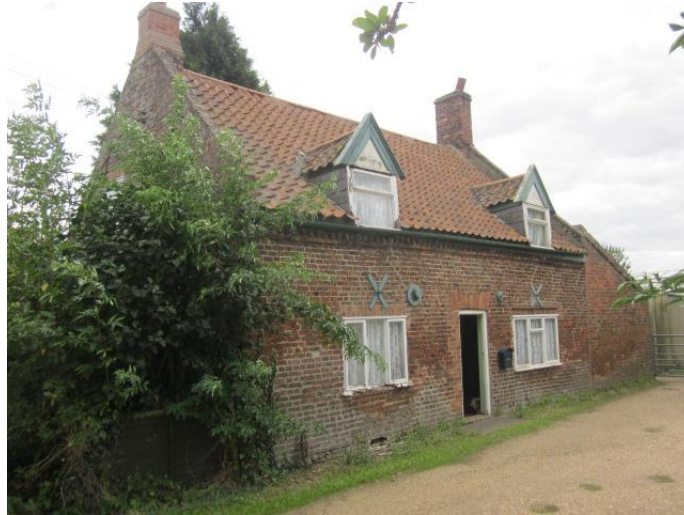
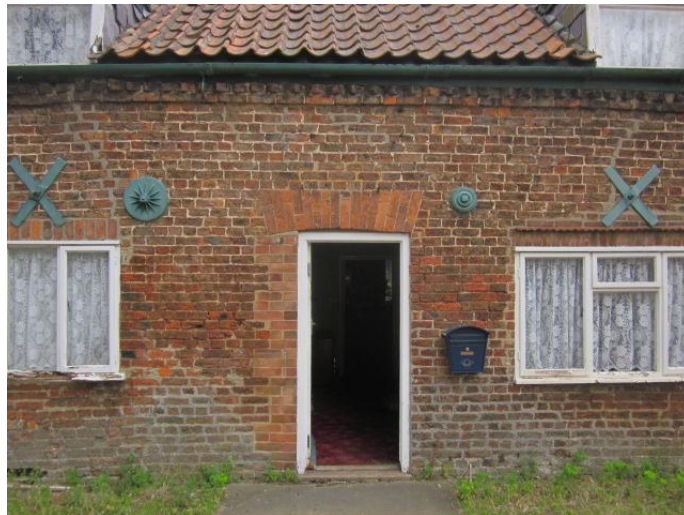
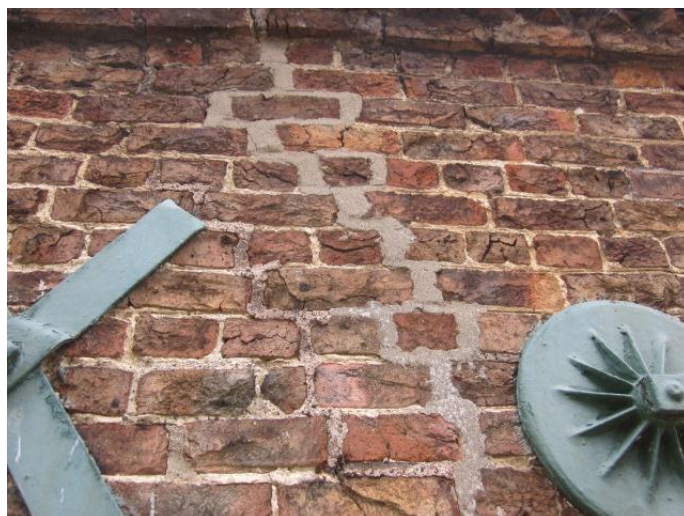
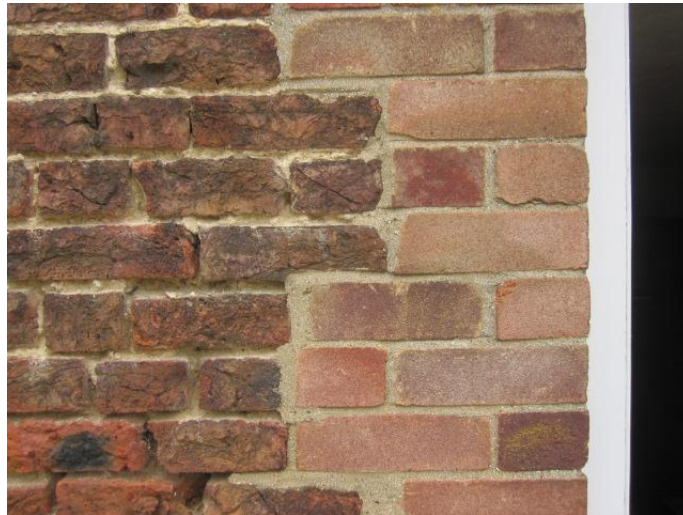
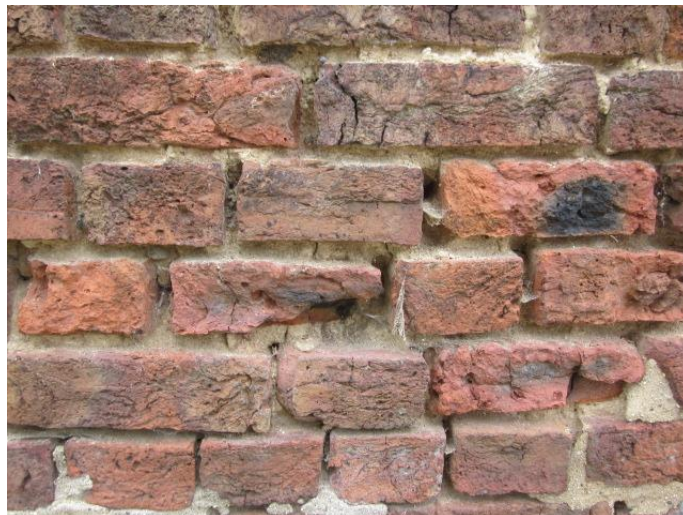
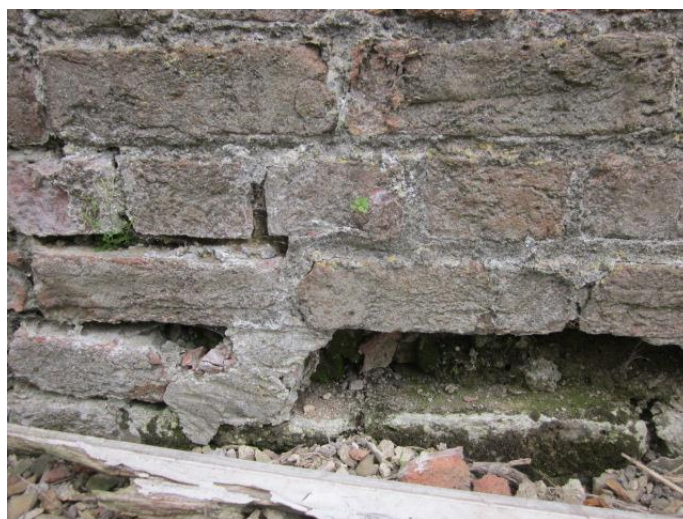
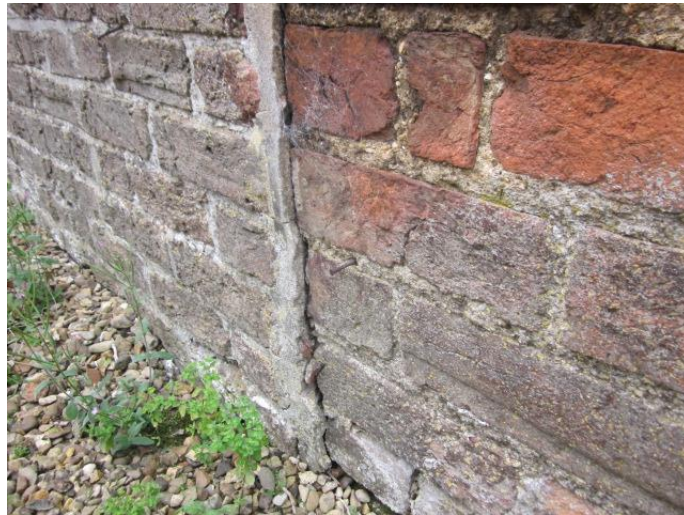
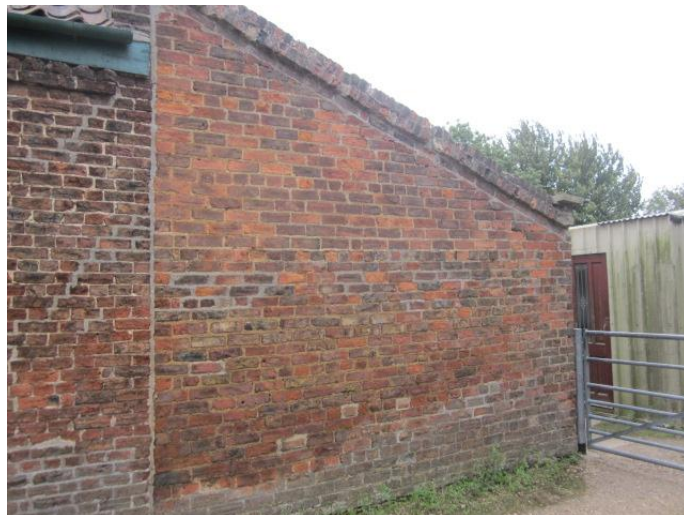
- Extensive cracking is evident over the ground floor window and door openings.
- Hard cement repointing has been used extensively throughout the elevation. The lower level of masonry, from ground to underside of windowsill is repointed throughout.

- When viewed along the elevation, it can be seen that the panels adjacent to both gable ends have settled, resulting in an arching effect of the elevation as a whole.
- Masonry at high level, below the wall-plate has pushed out. Observations suggest that the outward movement is up to +75mm over the mid-span of the elevation, and up to +50mm over the ground floor window locations. It is likely that a degree of roof spread has contributed towards the lateral movement.
- Masonry at low level adjacent ground level is missing in parts and is becoming eroded.
- In brief, the following estimates were recorded;-  
30% of brick units are extremely brittle and would need replacement.  
40% of brick units have been previously repointed using hard cement repointing.  
2-5% of brick units are modern replacement units around door openings.

- 5.4.4 The walls to the upper levels of the Front and Rear elevation have accommodated significant levels of movement, distortion and stress. We recommend that allowance is made for the walls to be carefully taken down to a suitable level between current wall plate level and top of ground floor window level, and rebuilt using a suitable wall construction.
- 5.4.5 The North Facing gable wall is severely distorted and is displaying considerable bulging. We recommend that allowance is made for this wall to be carefully taken down to a suitable level between current eaves level and first floor level, and rebuilt using a suitable wall construction.

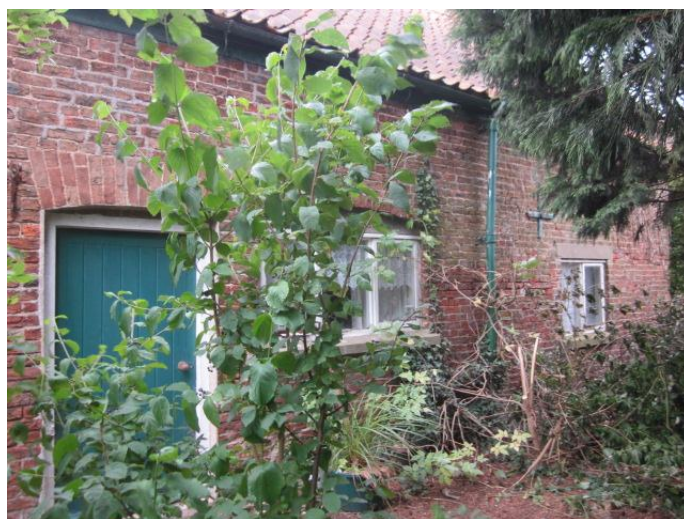
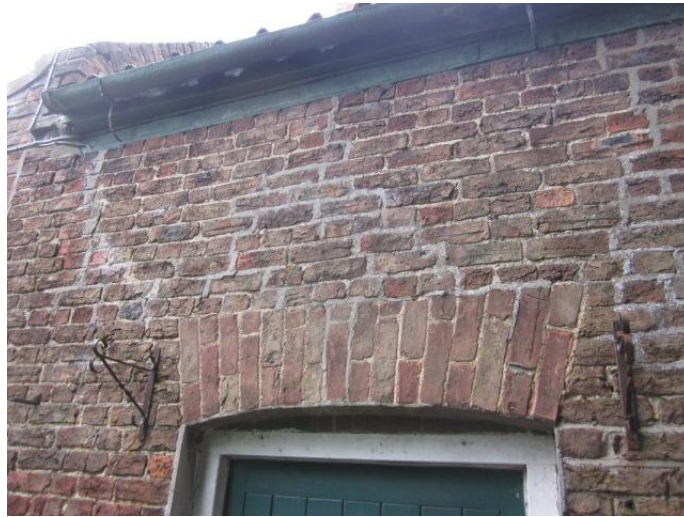
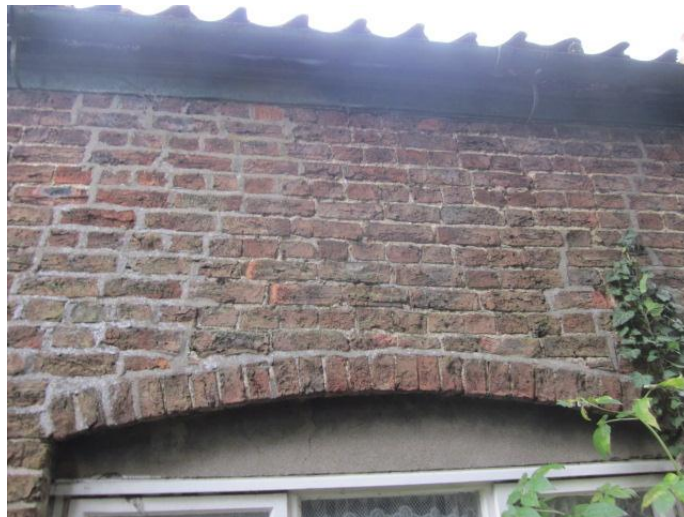
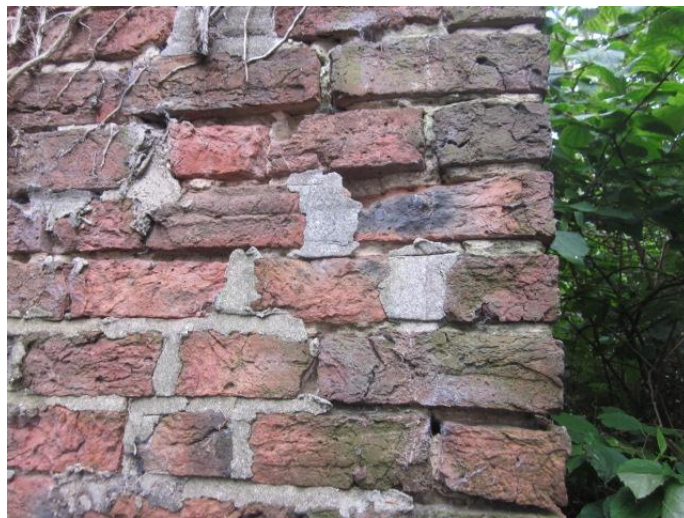
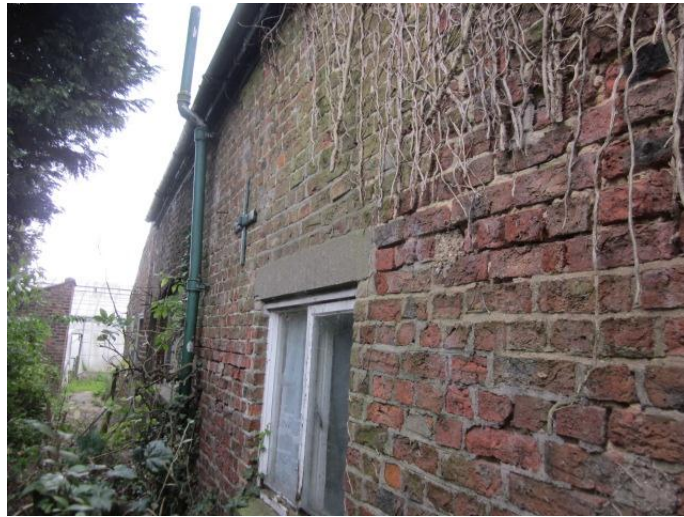
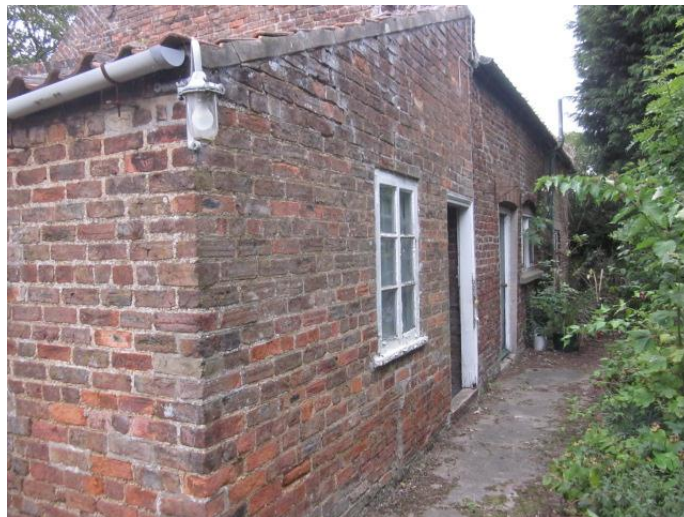
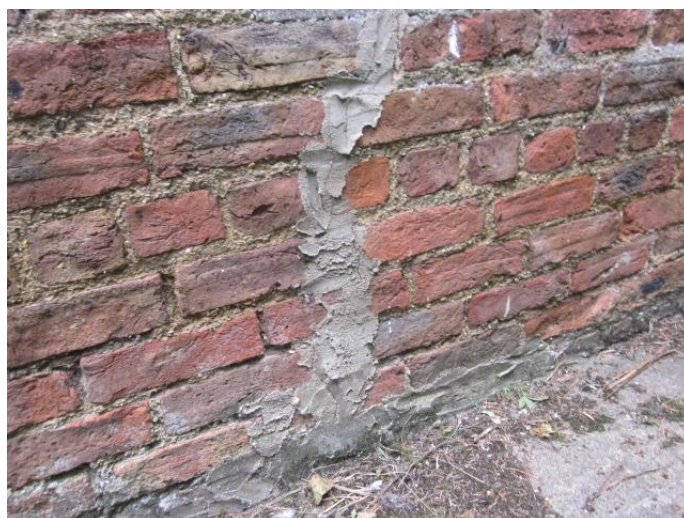
- Extensive cracking is evident over the ground floor window and door openings.
- Hard cement repointing has been used in a number of areas throughout the elevation.
- Similarly to the front elevation, it can be seen that the panels adjacent to both gable ends have settled, resulting in an arching effect of the elevation as a whole. This may have been exacerbated by the effects of the Leylandii trees that are close by.
- Significant outward movement was noted to the masonry panels around the window panels. Observations suggest that the outward movement is up-to +75mm to the panel between openings.
- A reasonable amount of rebuilding will be required to the elevation.
- In brief, the following estimates were recorded;-  
20% of brick units are extremely brittle and would need replacement.  
30% of brick units have been previously repointed using hard cement repointing.

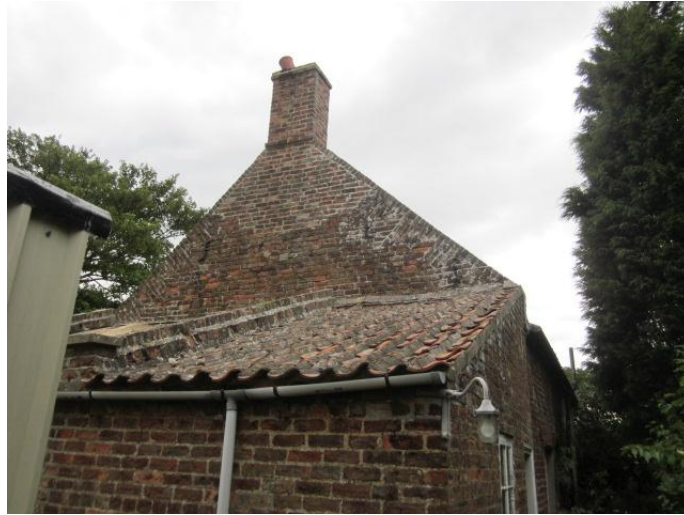
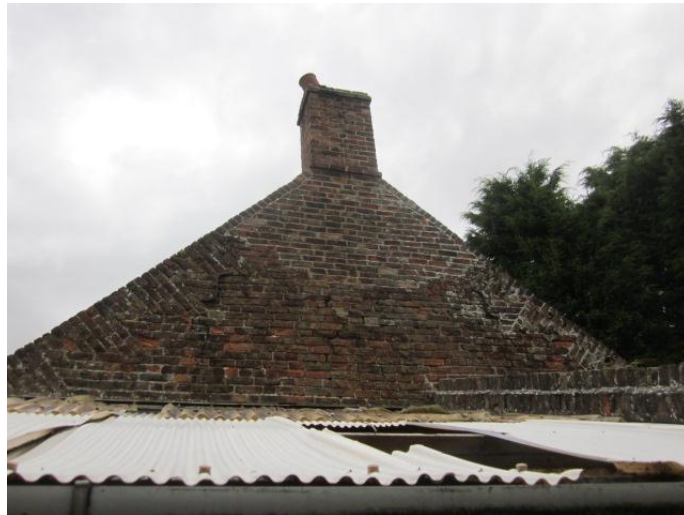
- Inspection was limited due to vegetation growing against the elevation.
- A Significant bulge was noted to the masonry panel around the gable window. Observations suggest that the outward movement is up-to +75mm. Observations suggest that there is no restraint between floor and wall at floor level.

- Localised cracking is evident throughout the elevations.

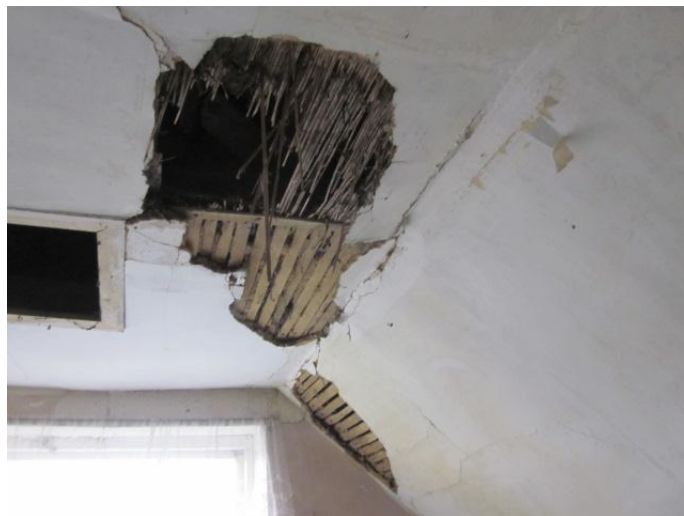
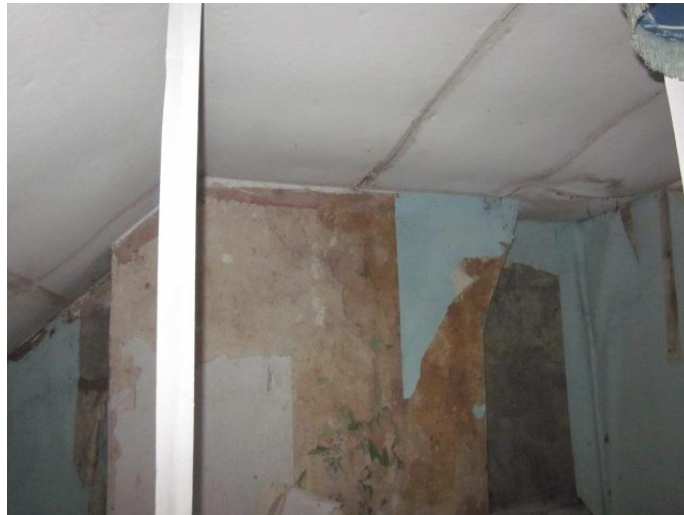
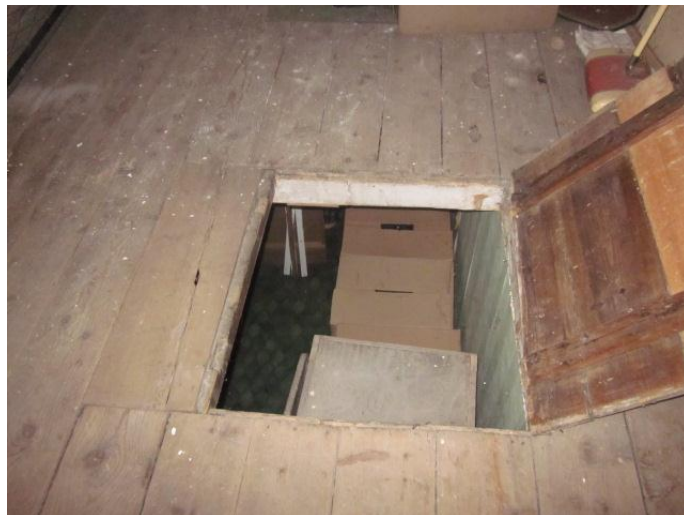
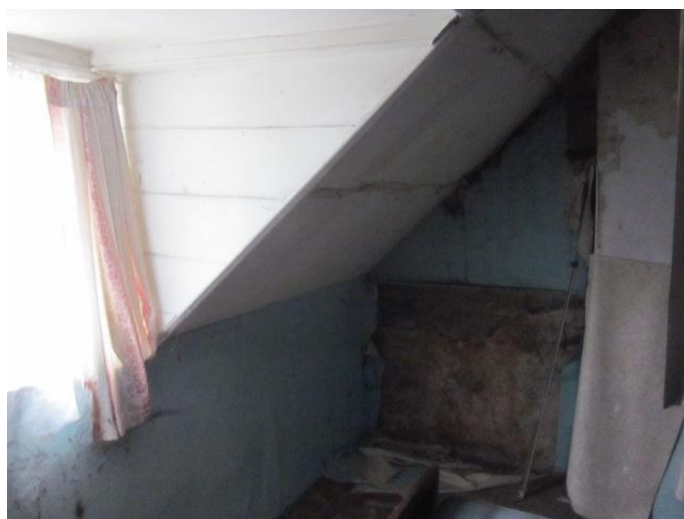
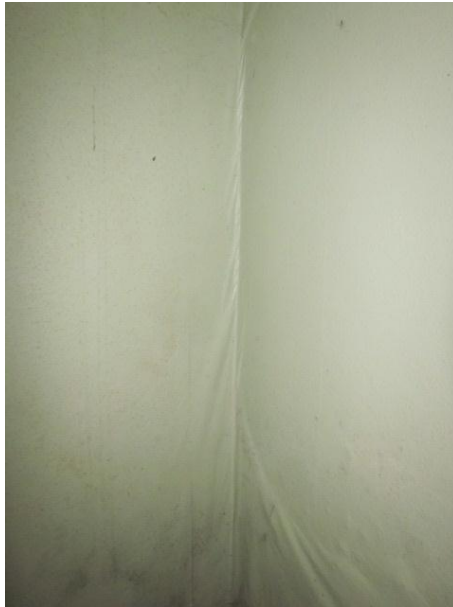
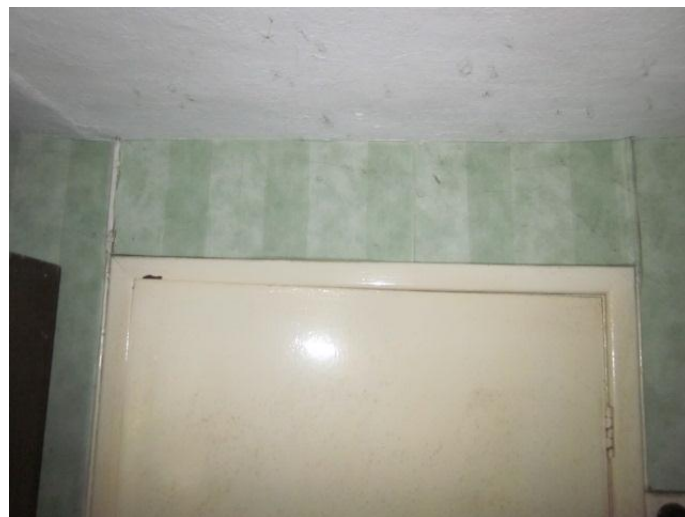
- When viewed internally, the majority of the wall finishes were free from major defect. There were minor cracks noted within the wall finish around a number of the door and window openings.
- Puckering wallpaper, and significant gaps were present at the corner of the rooms and at wall junctions, suggesting that restraint of the walls in these locations is minimal.
- The door frames to the majority of the openings were distorted.

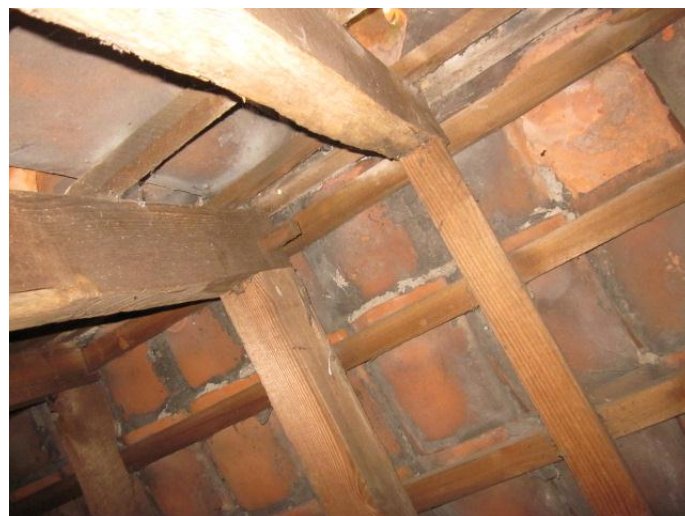
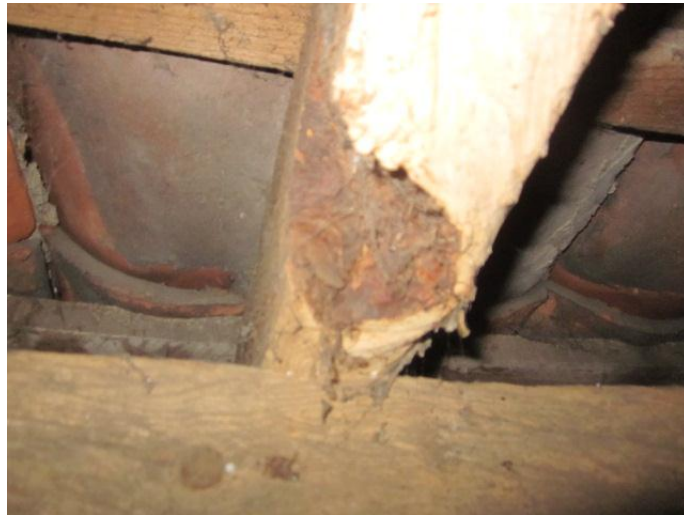
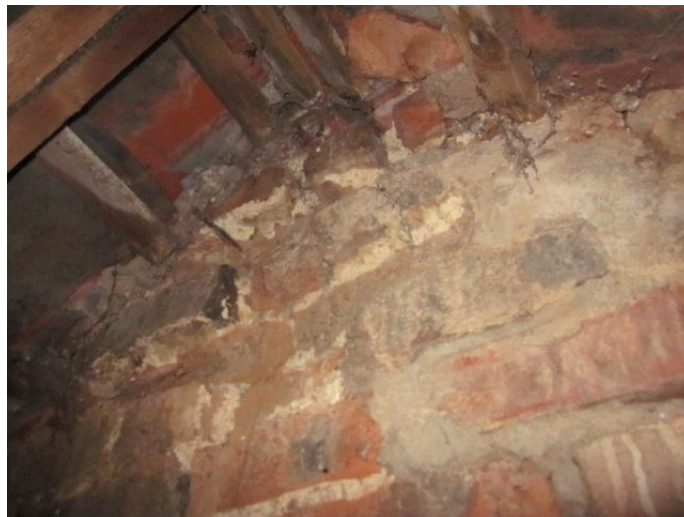
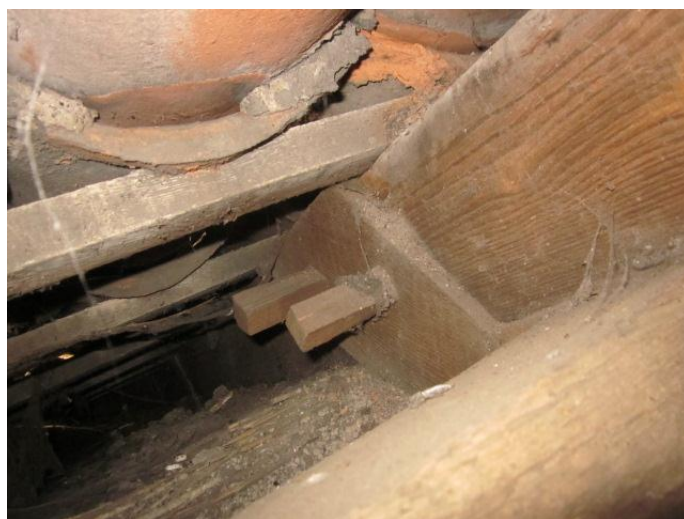
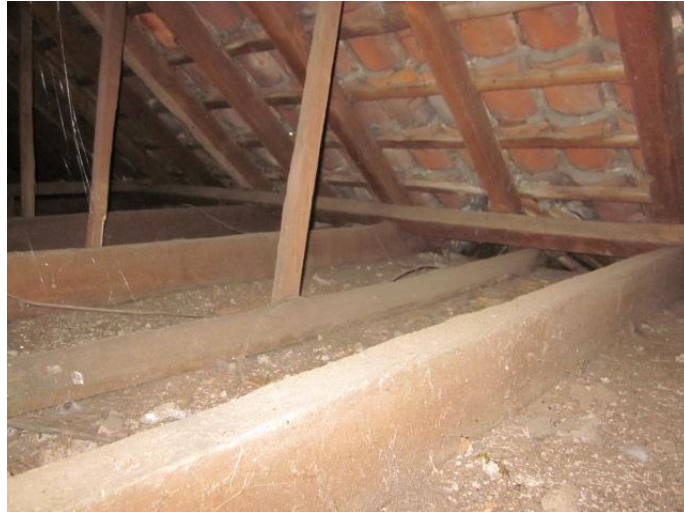
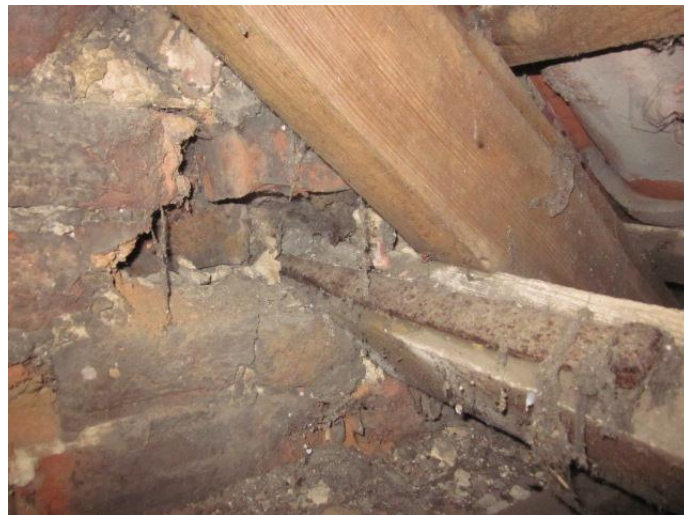
- When observed internally, it can be seen that the roof structure consists of a replacement pegged style tied roof system. The pitched roof appeared in reasonable condition, with no missing or defective roof elements noted. Older, presumably original roof timbers remain present in parts.

- 5.4.3 The roof will need considerable strengthening works. The installation of a remedial ridge beam, the strengthening of existing rafters and the installation of additional collar timbers will be required in order to cease the outward thrust and roof spread that is currently occurring. The amount of works required to the roof may result in the need for a replacement roof structure as a whole.

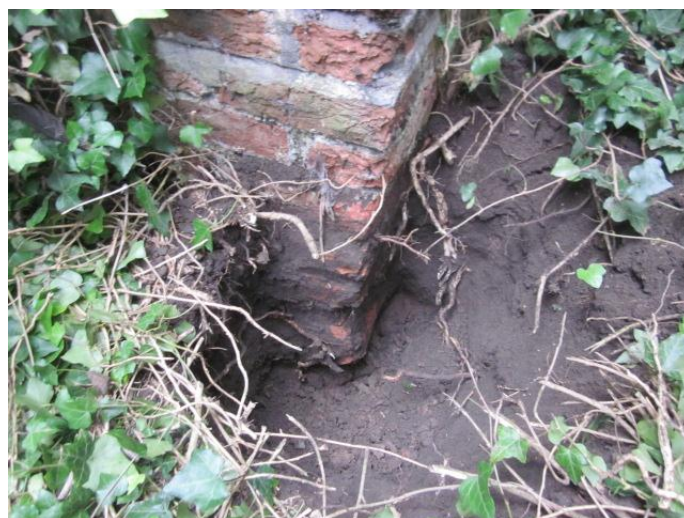
**# 30 – Foundations**

Foundations were exposed via a single trial hole. There is no foundation as such present. No corbelled masonry was identified. The wall construction continued at the same 215mm thickness for approximately 5No.courses (-375mm) below the ground level whereby it ceased. Extensive root activity was present within the trial hole.

- 5.4.1 The foundation should be enhanced via a suitable underpin system. Depending on ground conditions encountered at depth, this may consist of a traditional mass concrete type underpin, or alternatively a Pile and Reinforced Concrete Ground Beam / Needle type underpin arrangement maybe required.
