# **N J PACEY LANDSCAPING**

## **Tree Safety Survey Report**

**Small Saints Pre School  
The Chase, Holbeach**

**24<sup>th</sup> November 2020**

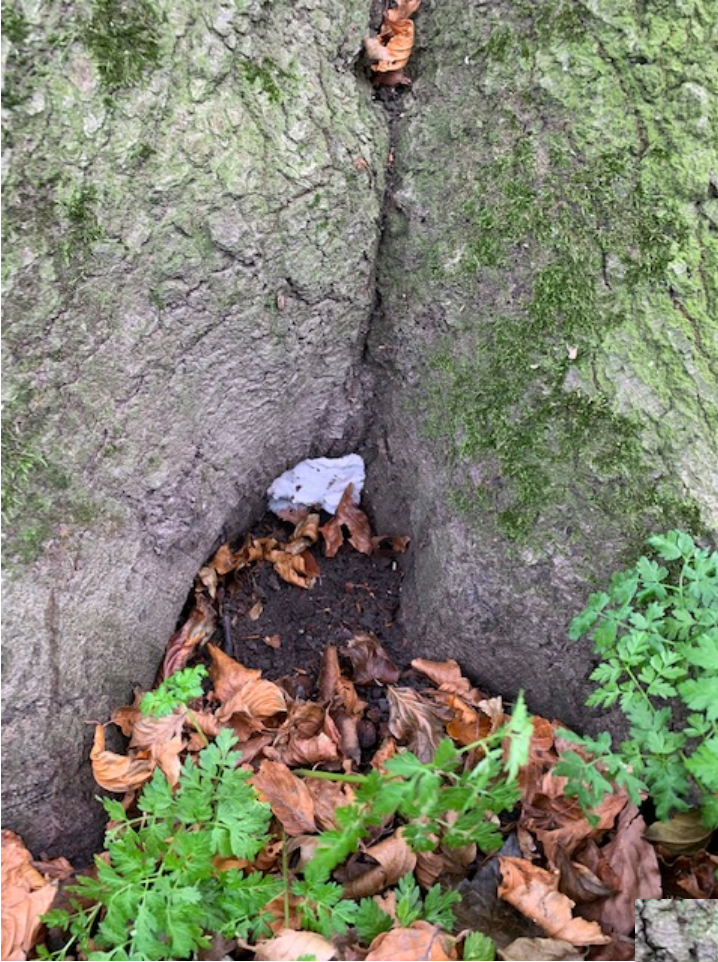
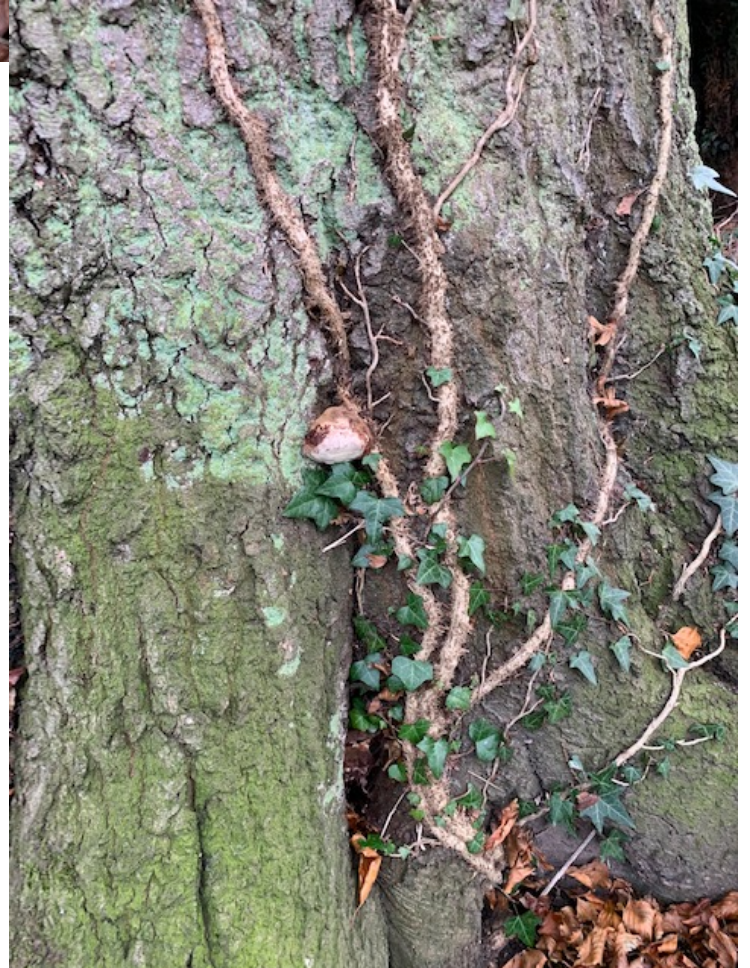
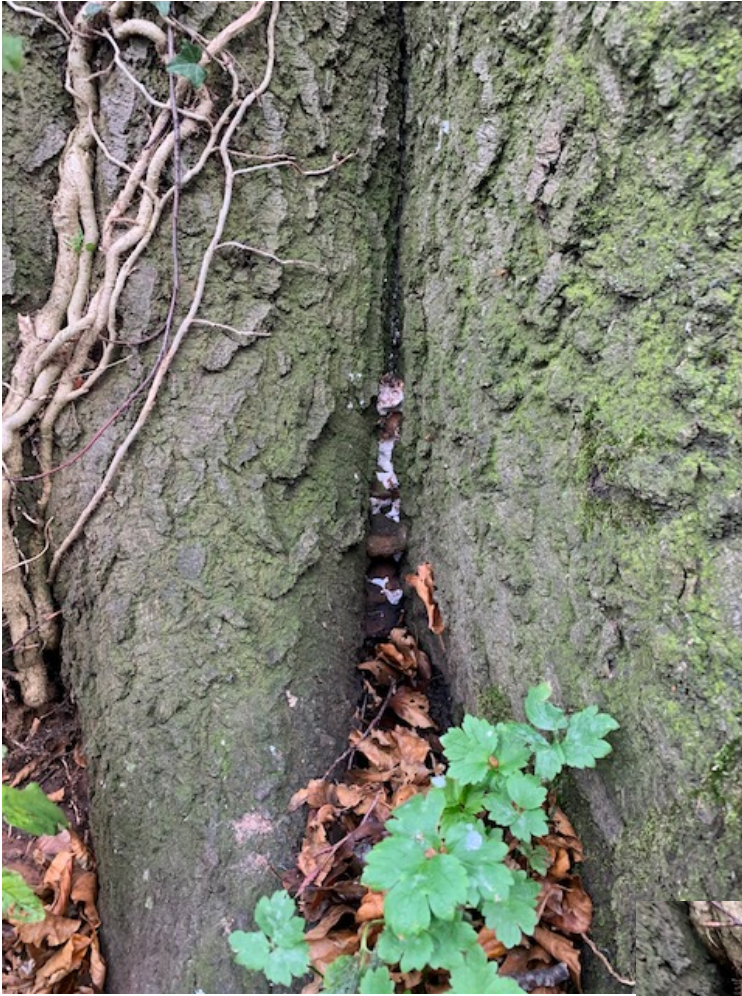
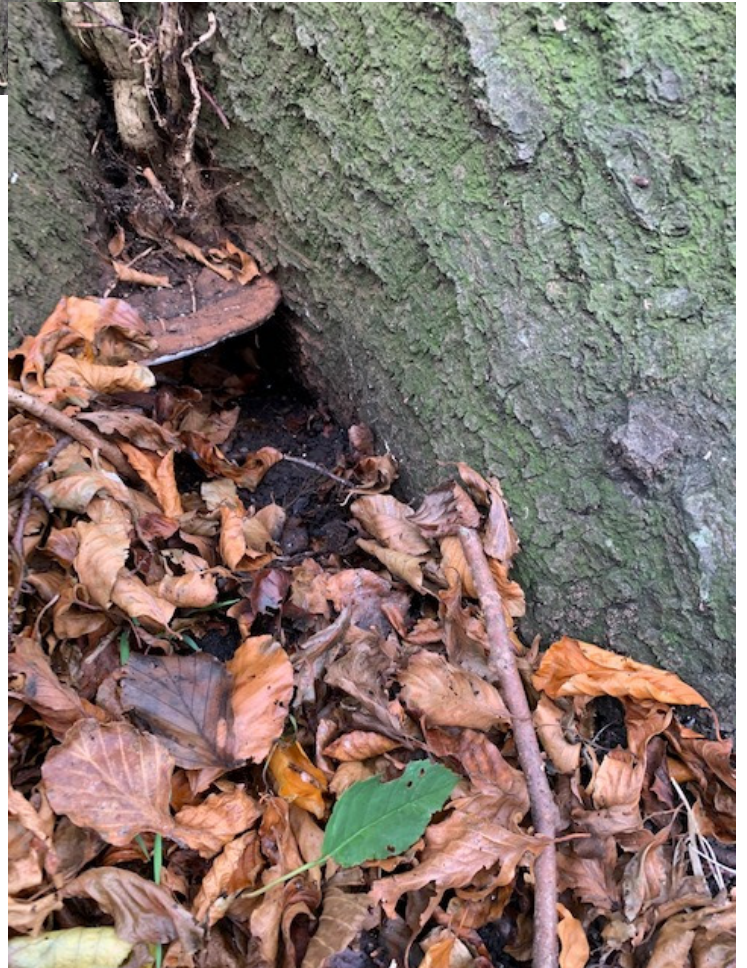
**Condition:** The tree has good, flared buttress at base. There is no signs of root plate movement.

We located fungal fruiting bodies of suspected ganoderma between the buttresses on both the north east and west sides of the stem.

The tree has very large limbs from where it forks at 4m. There are old pruning points through the canopy. FFB of *Polyporus squamosus*, commonly referred to as Dryad's Saddle on an old pruning wound at 5m West

Recent pruning wounds evident from cutting back from neighbour's property south.

Rubbing limb on branch heading South West towards neighbour's property causing significant concern.

Play area and play equipment beneath all the crown. The area is used heavily by the Pre School children.

Please consider Beech is also susceptible to summer branch drop which would be a concern with all the play equipment beneath the tree regardless of condition.

Having FFBs on both sides would indicate that the fungi has significant spread across the cross section of the main stem.

We recommend that the tree is felled and the stump removed.

**Priority:** 3 months
