## Structural Survey Report

on  
Agricultural Barn for Domestic Conversion

at  
184 Seagate Road  
Long Sutton  
Wisbech

Job reference: WECE-26-679

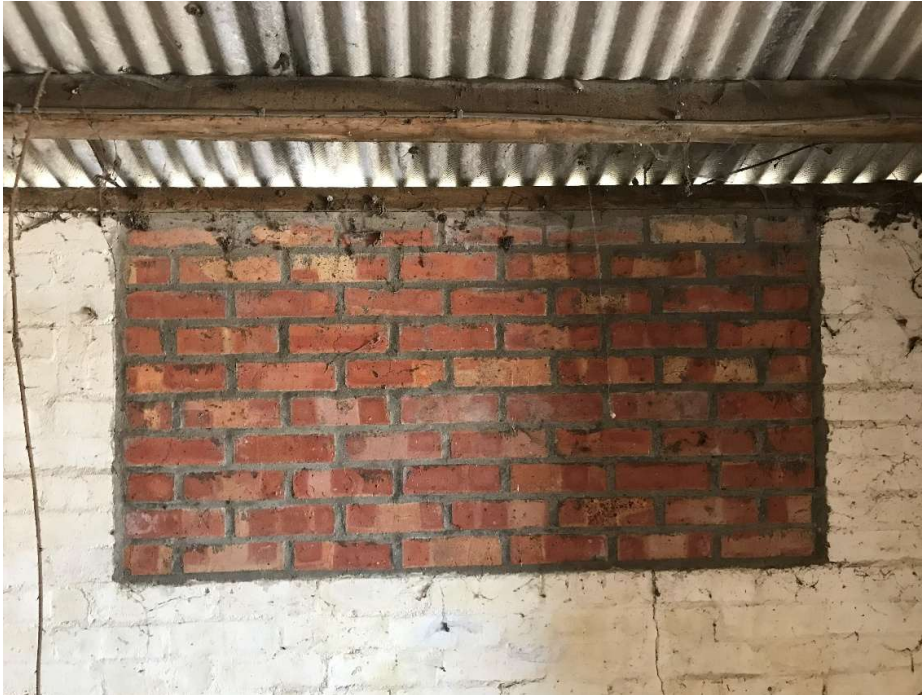
- 4.1. The agricultural barn is a rectangular, duo-pitched building approximately 8m wide x 20m long with an eaves height of about 2m.
- 4.2. The barns envelope walls are thought to be constructed as half-brick leaf bonded with lime mortar. Some openings have been infilled or repaired historically; these repairs may include mortar containing ordinary Portland cement.

Photo 7. Bricked-up Window

7. Replace severely weathered bricks or provide localised rebuilding of panels where masonry integrity is compromised. Where openings have been blocked with incompatible mortar, carefully cut out and rework to provide compatible joints.

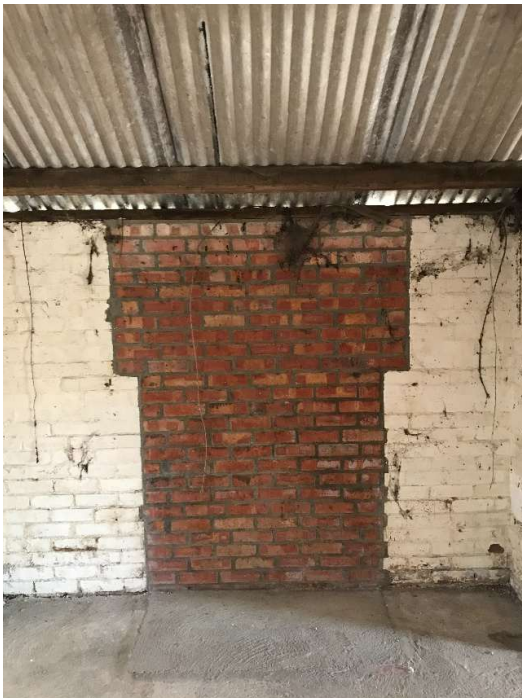
Photo 8. Bricked-up Door

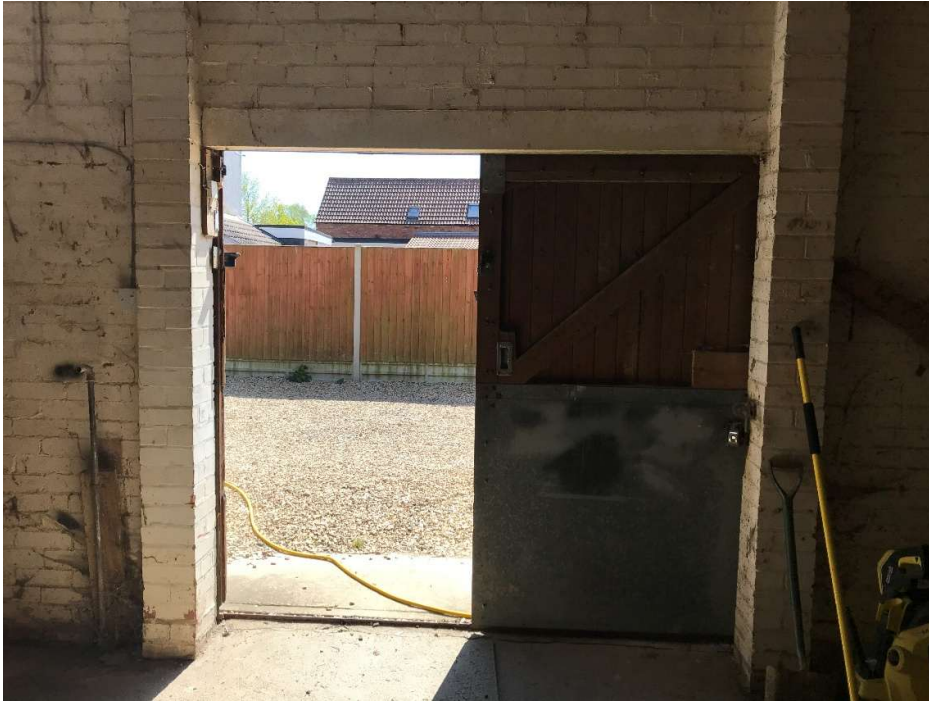
- 4.13. A pre-cast concrete lintel supports the masonry gable triangle above the double sliding door on the south elevation. Given the low eaves height and the position of the lower purlin, lintels were not provided at the head of the other openings around the building.

Photo 9. Front Door on Southern Gable End Elevation take from inside. PC Lintel above door

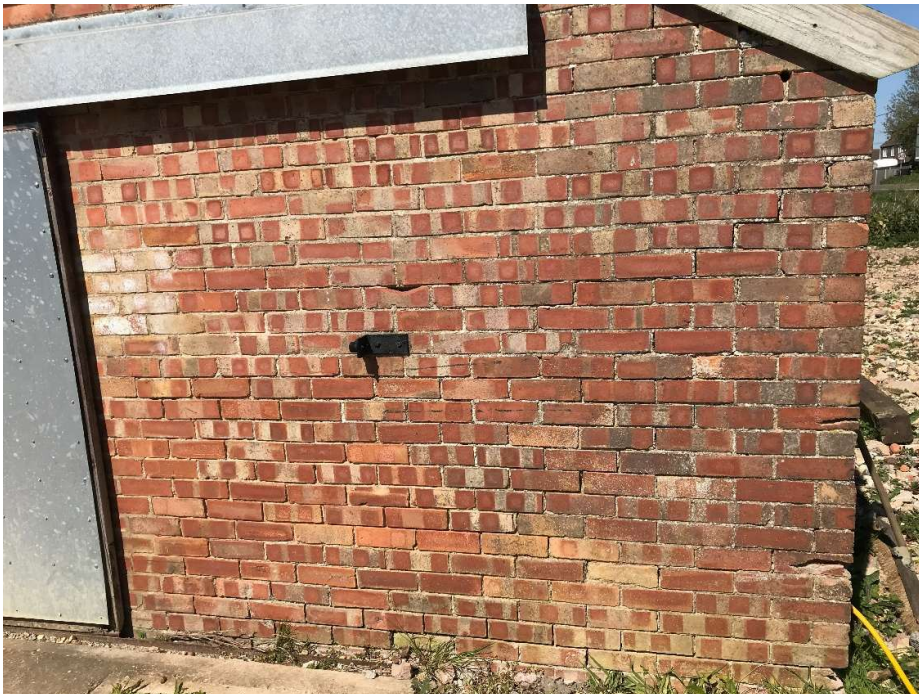
- 4.4. Some wall panels show weathering, notably at mortar joints, and there is occasional minor hairline cracking (typically 1–2 mm).
- 4.5. The roof covering appears to be predominantly fibre-cement sheeting with translucent areas affording light into the building. Evidence of some local holes and historical repairs; extensive moss growth obscures much of the roof surface.

Photo 10. East-side of Southern Gable End Elevation. Typical weathered masonry and hairline cracks

5. Repoint and repair mortar using a compatible lime mix (not hard OPC) to avoid trapped moisture and differential stiffness.
  6. Stitch with Helibar by Helifix (or similar proprietary system), or locally repair hairline cracks (1–2 mm) in masonry walls where active or where water ingress is possible.
